When is Enough Enough? SR 33 Micropiles for Bridge Stabilization

Allen Cadden¹ and Kerry Petrasic²

ABSTRACT

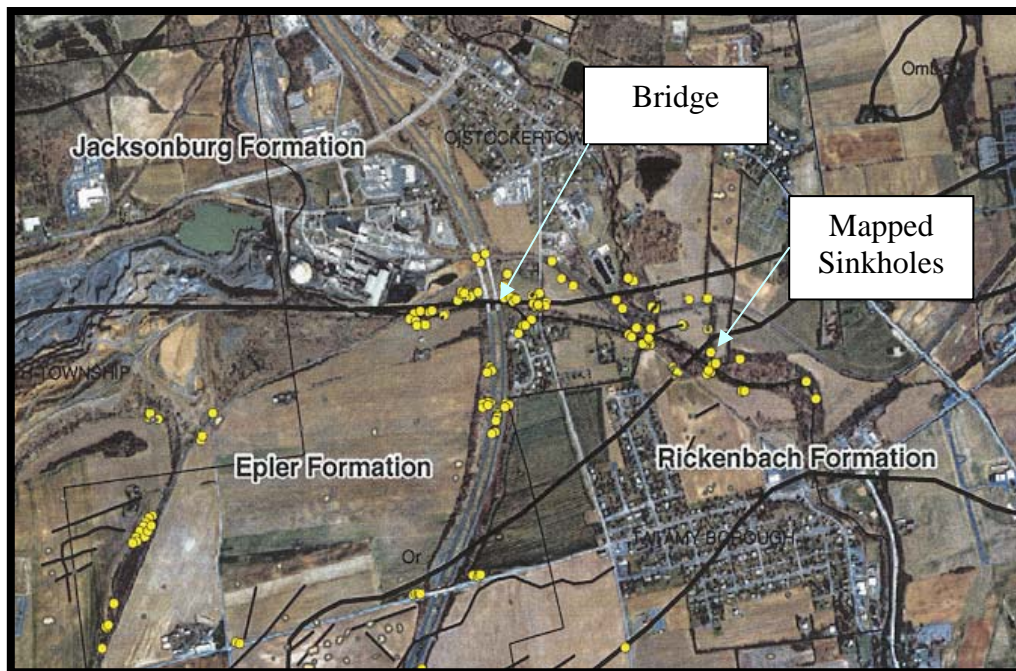
A large limestone quarry is located about two kilometers to the west of this area. Early estimates of the dewatering for this operation indicated that water was being drawn from a depth of about 80m and discharged about 1 to 2×10^5 m³ per day into the Bushkill Creek. Sinkhole activity in the area is extensive. Numerous documented depressions and sinks have been mapped as shown on Figure 1. Large sinkholes have resulted in the condemnation of homes and complete collapse of a smaller bridge immediately east of the Rt. 33 location.

Figure 1. Site location, geologic conditions, and sinkhole mapping.

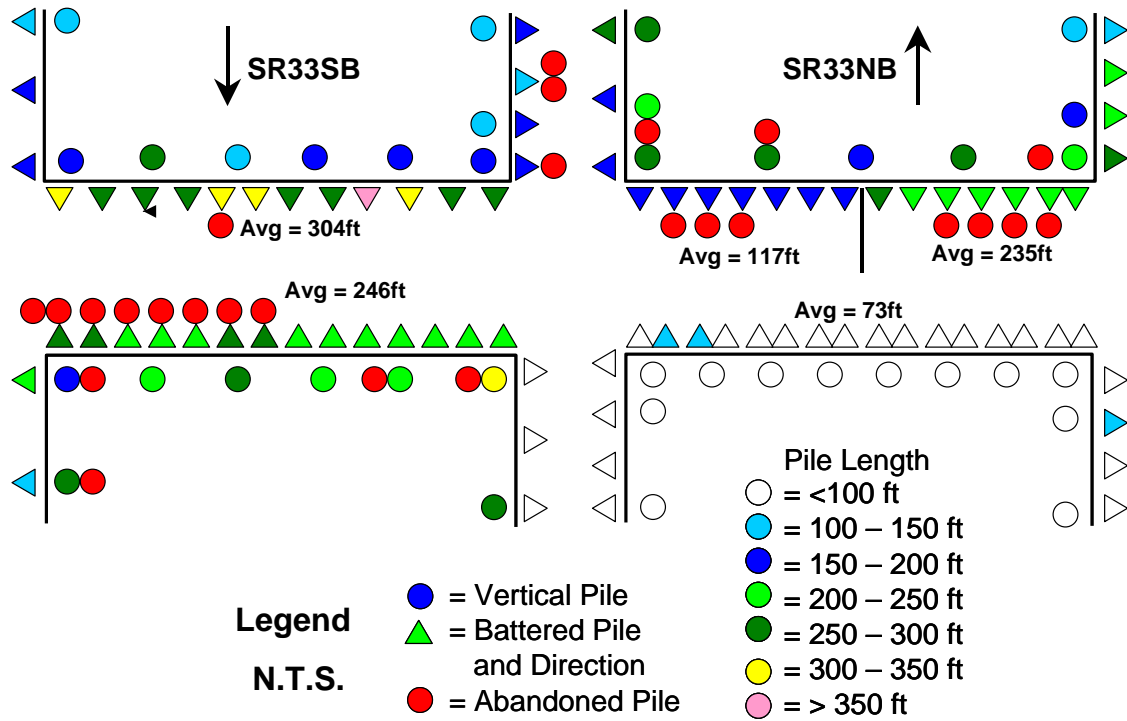
When construction moved to the northern abutment, it was another story all together. Pile lengths ranged from 35 to 70 m. Sinkholes developed during this work. Similar problems continued as the work proceeded to the two southbound bridge abutments. Pile lengths of nearly 110 m were built. Tables 1 and 2 provide a summary of the pile lengths and number of piles that were abandoned during construction for a variety of reasons including binding, breakage of drill strings, and loss of down hole hammers. Figures 2 and 3 depict the pile installation data in plan and 3-dimensional form to give a more detailed indication of the conditions encountered and final construction as completed.

Figure 2. Summary of pile installation (Petrasic, 2005).

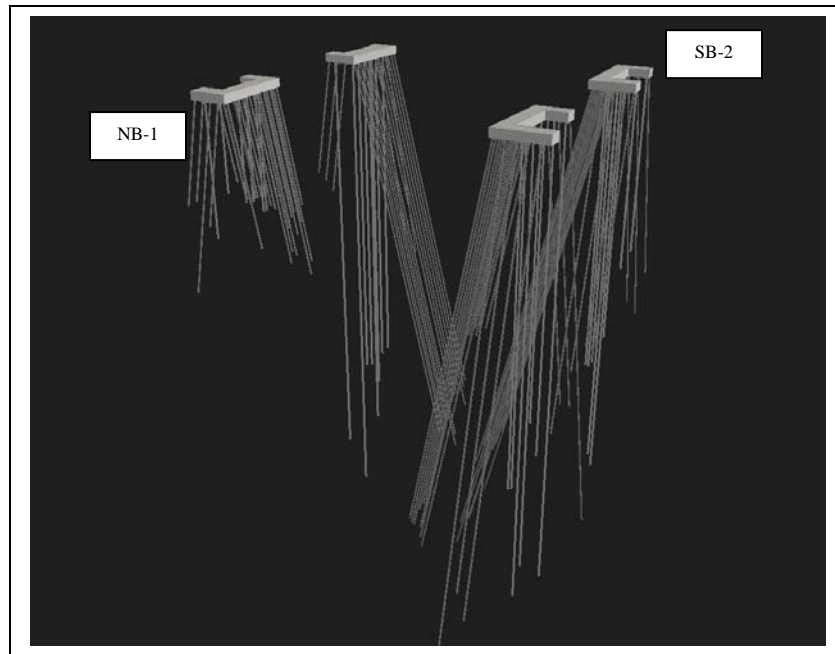
Figure 3. Three -dimensional view of micropile installation if holes are straight.

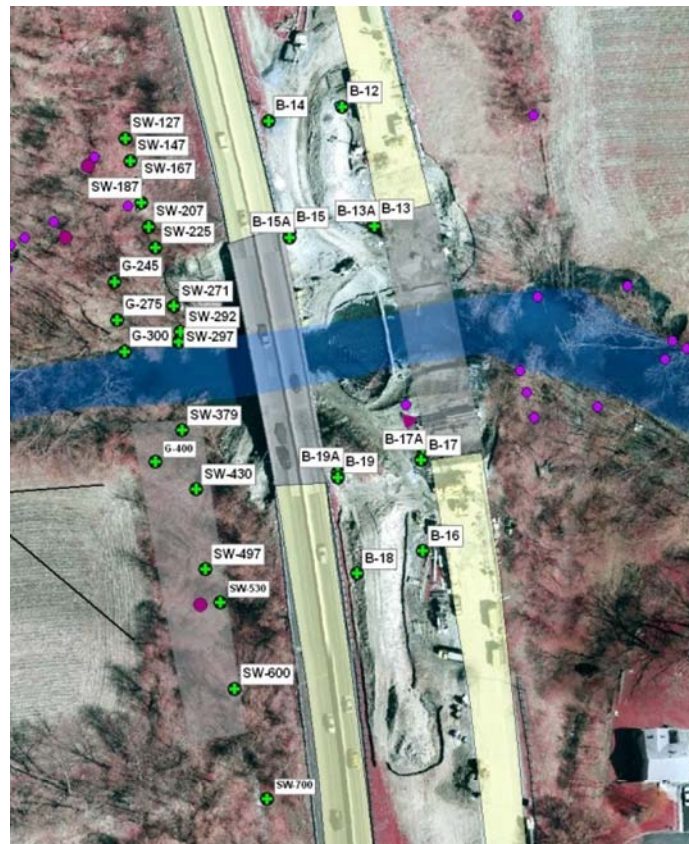
These new sonic borings extended to nearly 165 m in the vicinity of the creek but were limited to 50 m further away. Figure 4 depicts the test boring locations. The goal of this program was to explore well beyond fractured rock zones to develop a better understanding of the geologic conditions. Significant fracture zones were found at depths of about 10 to 150 m similar to the drilling records for the piles.

Figure 4. Test boring location plan

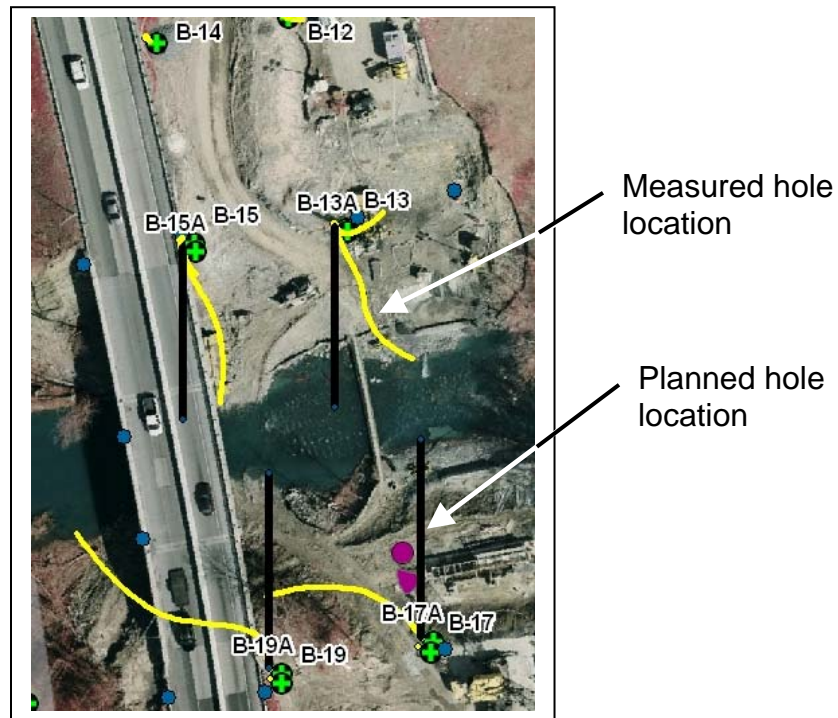
Deviation measurements were made on these borings to facilitate interpretation of the data. As can be seen in Figure 5, with depths of up to 110 m in some locations, the alignment of these borings is highly irregular. This deviation is most pronounced on the angled holes as would be expected. Inclusion of this information in the data evaluation was critical, and may be a further indication that the actual conditions of the deep micropiles may be far from intended.

Figure 5. Deviation measurements in angled test borings

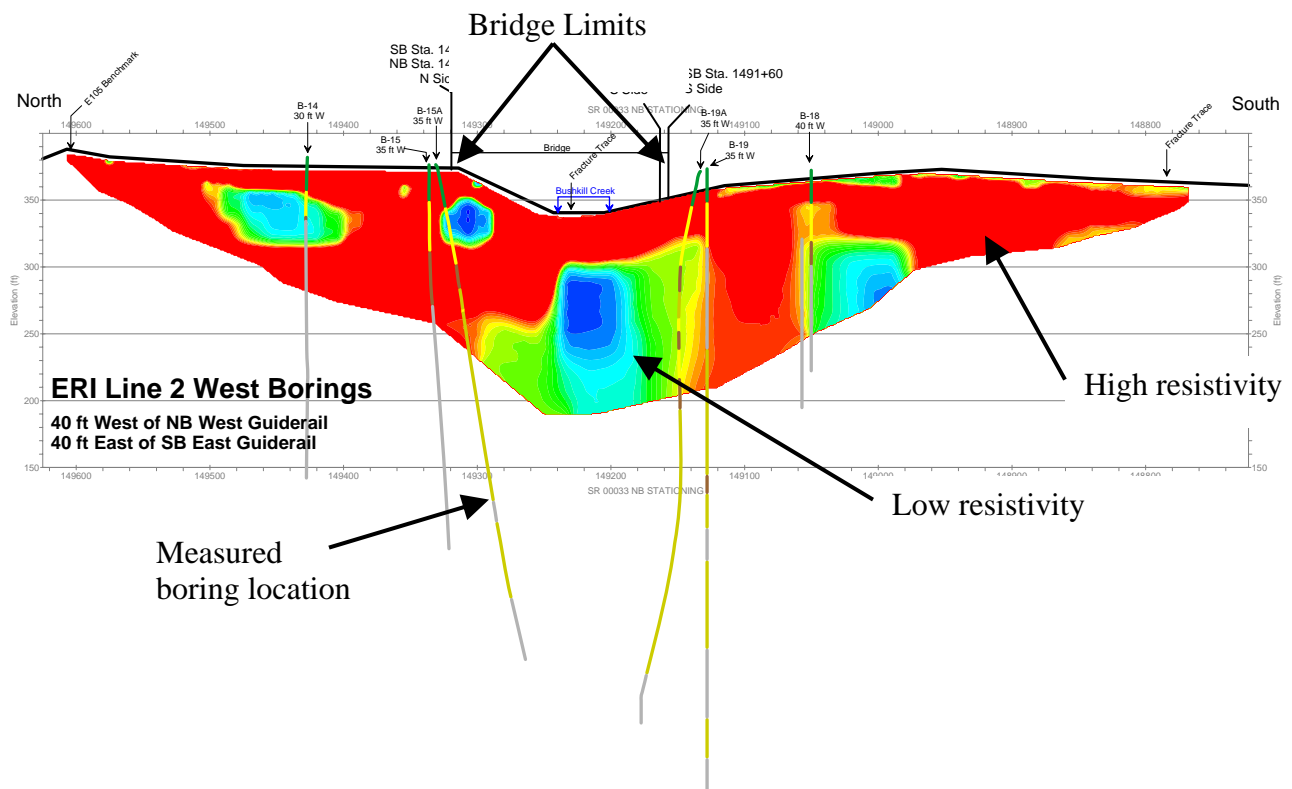
Figure 6. Typical two-dimensional resistivity section.

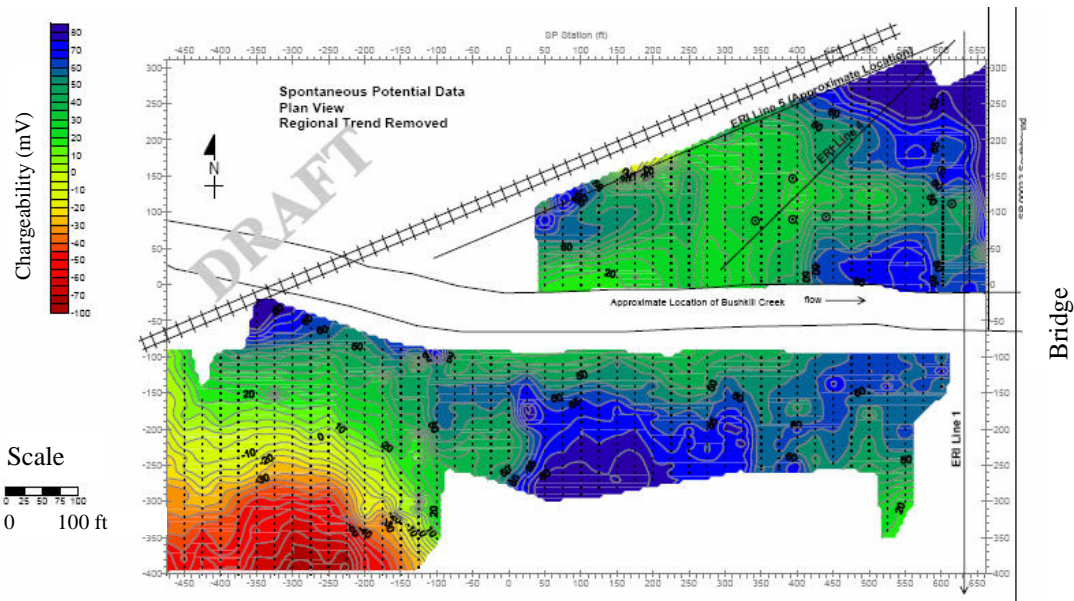
Figure 7. Spontaneous potential survey west of the bridge.

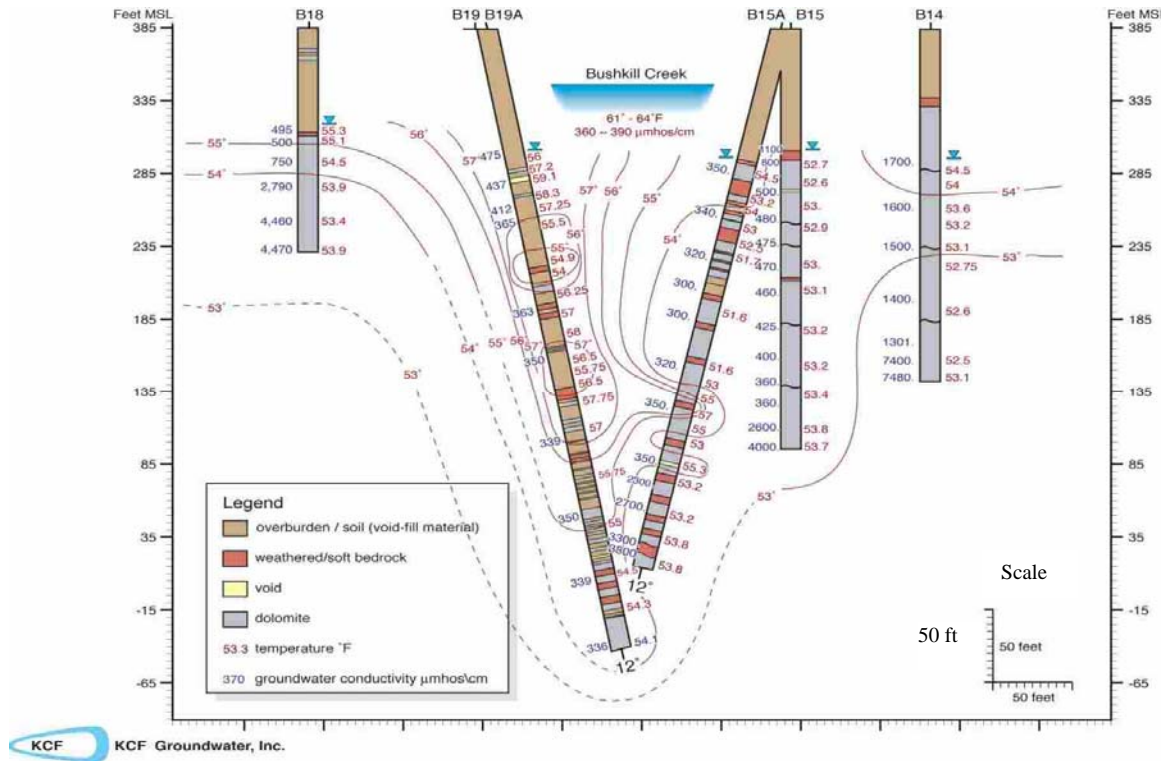
Figure 8. Typical temperature profile of groundwater-note depressed contours in area of flow (Lolcama, 2005)
