# Micropile Foundation Repair and Underpinning

Arts & Sciences Museum  
University of Puerto Rico, Mayaguez

John R. Wolosick, PE

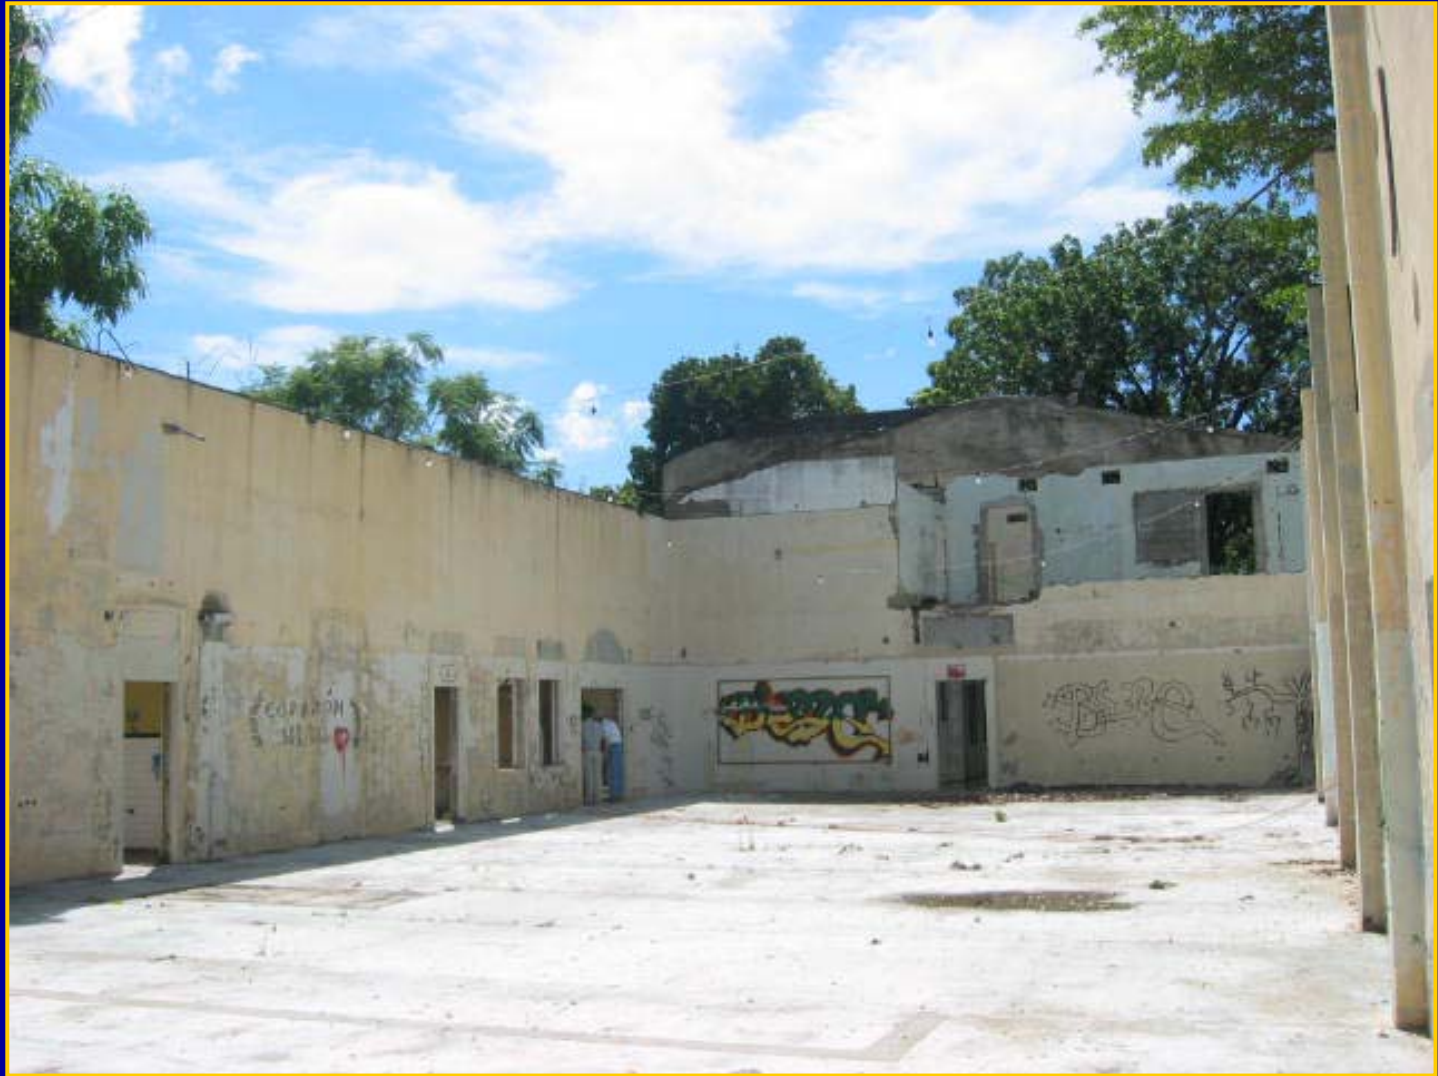
# Building after Hurricane Georges

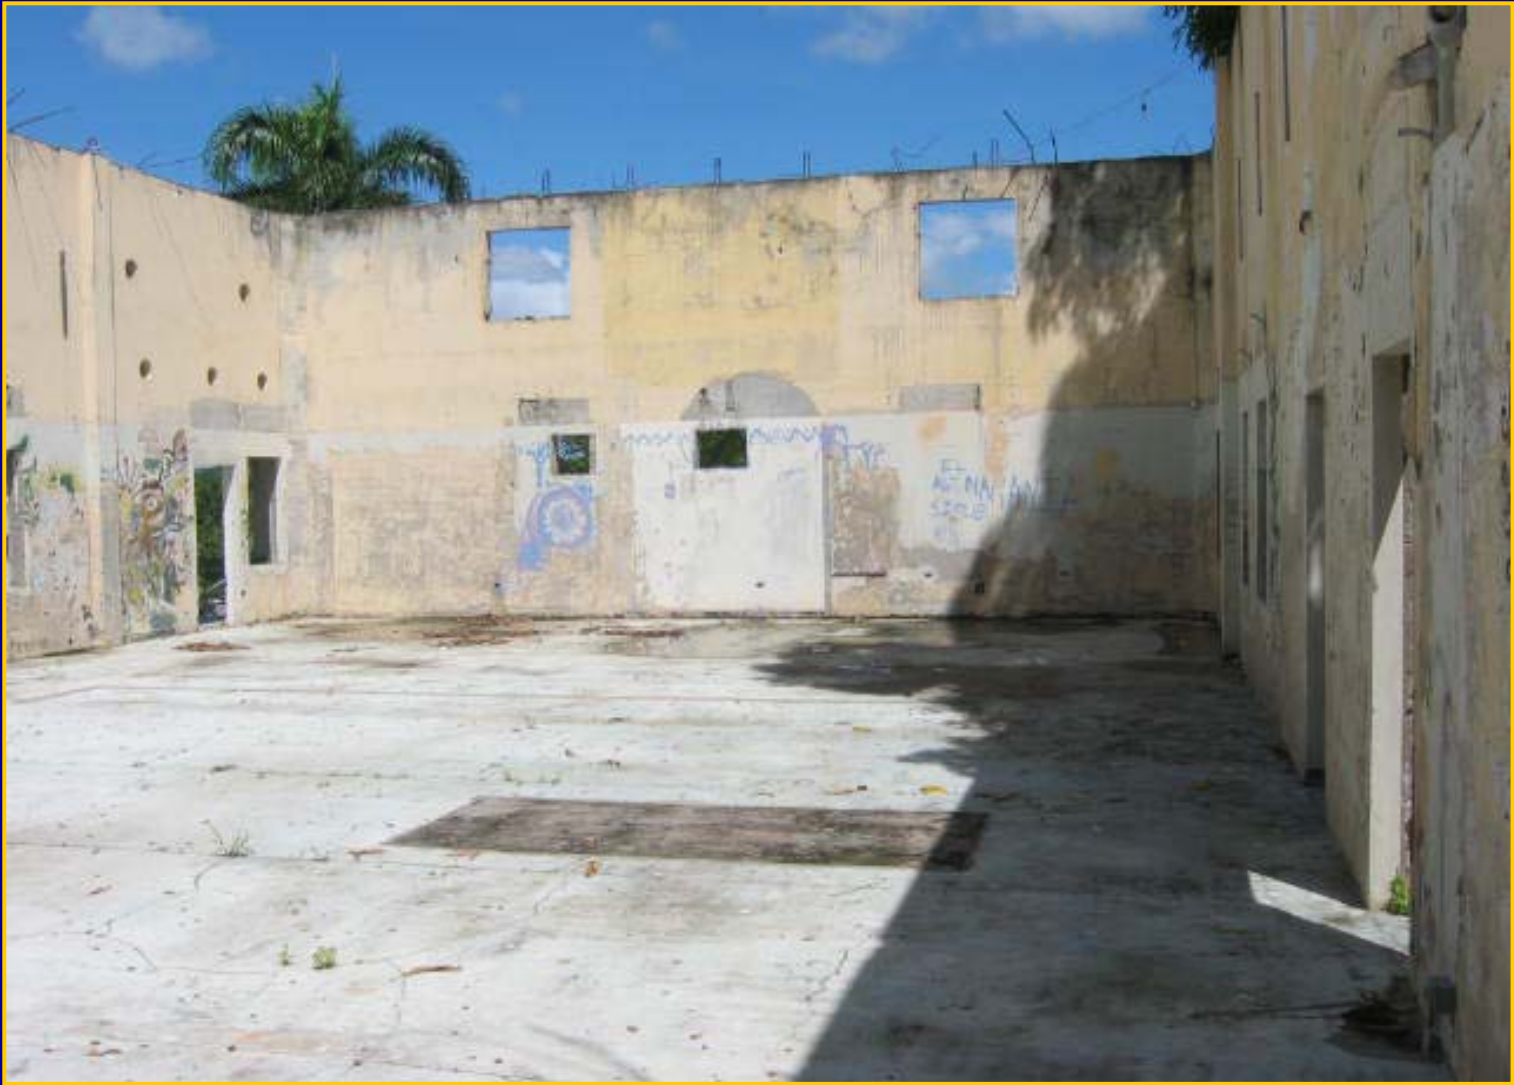
# Roof was Destroyed

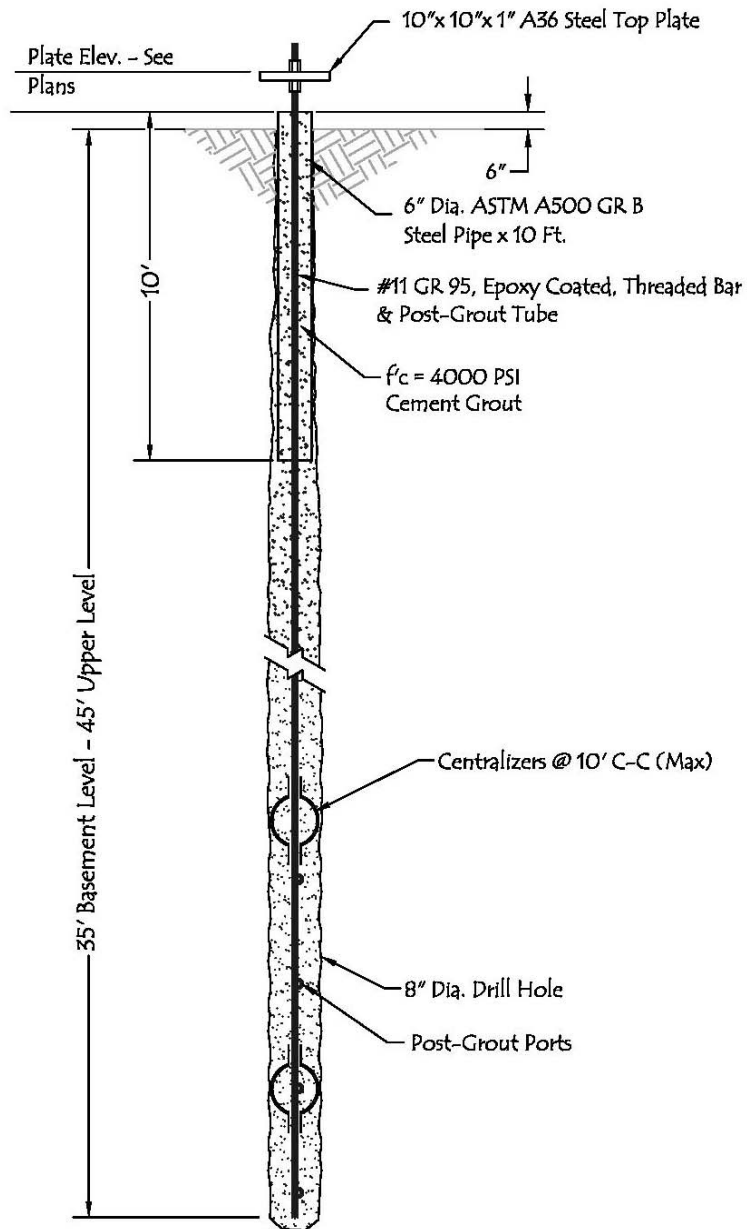
TYPICAL 50 kip MICROPILE DETAIL

Bond Zone in  
Medium Clay with  
Relatively High  
Moisture  
Contents

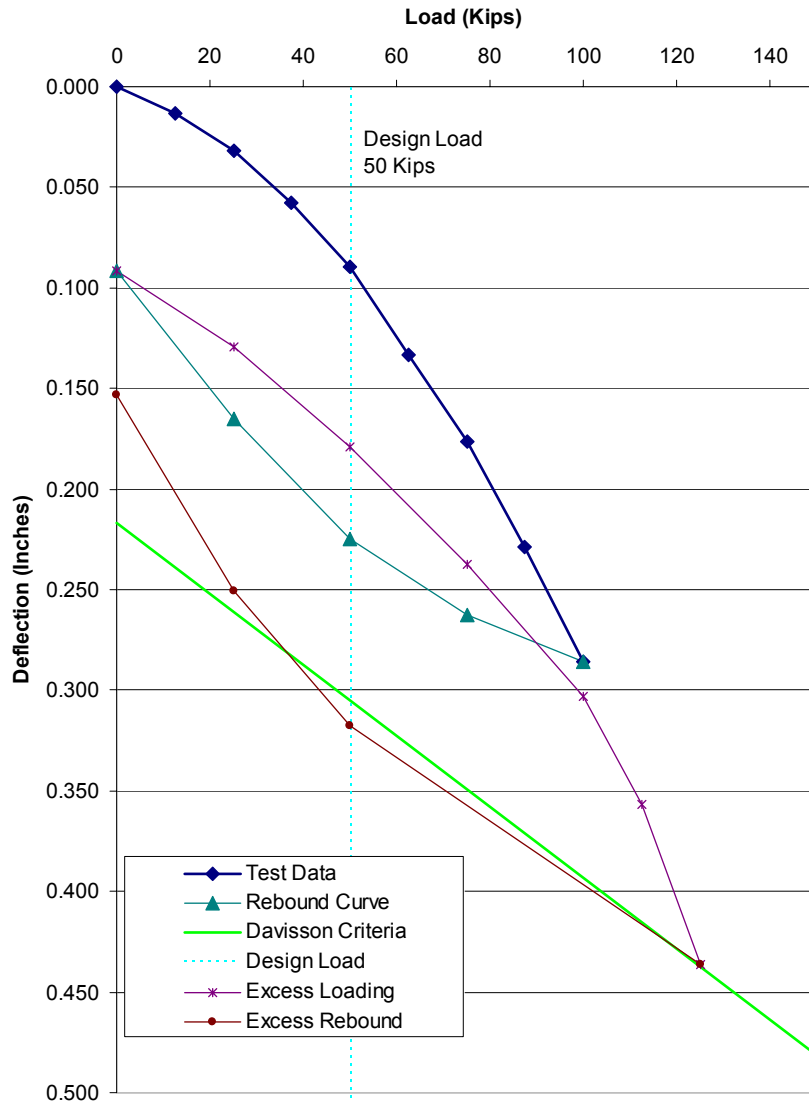
Museum of Arts & Sciences Micropile  
60 Ton Load Test  
Mayaguez, PR

25 Ton Working  
Load with 60 Ton  
Load Test as  
Specified
