Successful slope stabilization under severe conditions

Andreas BRANDNER, Dipl.-Ing., Chartered Consulting Engineer

Case 1 – Slope stabilization in high alpine surrounding

Case 2 – Slope stabilization in India

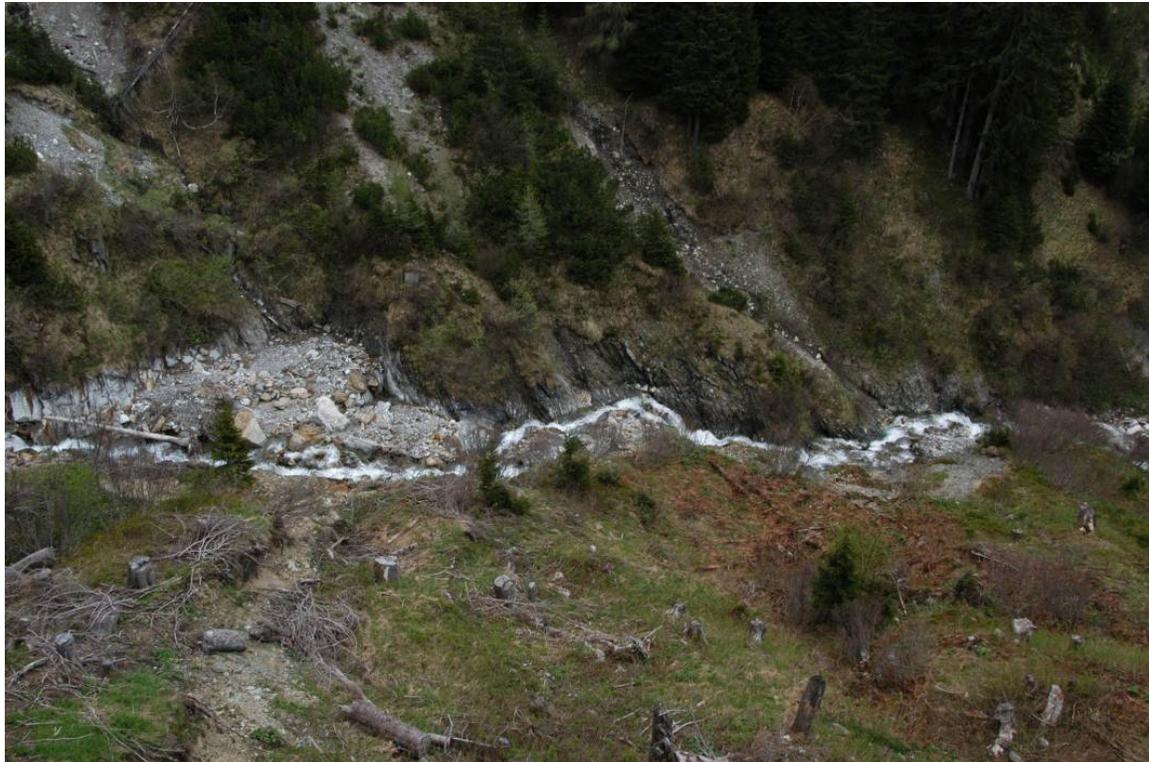
1 site view from top of station down to "Steissbach"

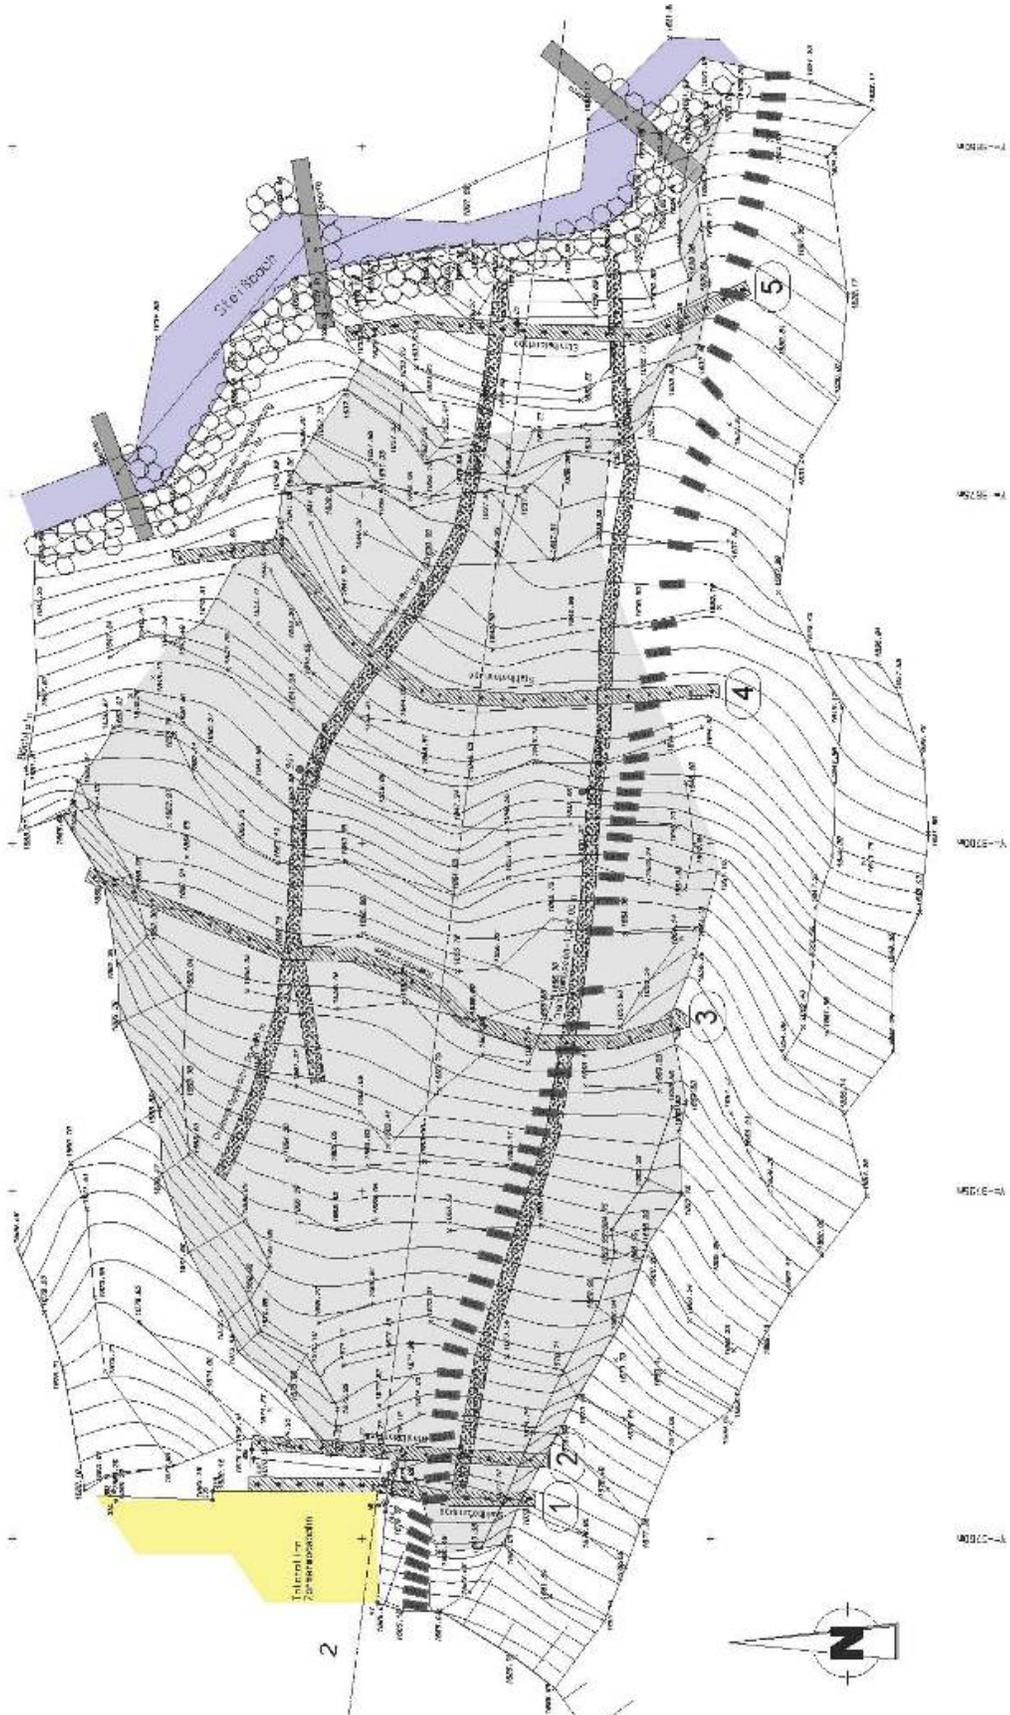
2 top view of site – 5 MP-walls, drainage and gulleys

Starting with stability analysis soil parameters were varied till safety proved to be around 1,00. Based on that, stabilizing measures and drainage systems were induced to lift stability to at least 1,40. This led to the final solution using 5 micropile walls – GEWI 50 – head connected with a concrete slab, drainage system and gulleys to bring surface water down to the torrent including bank line and river bed stabilization.

In order to support the station structure an A-system of micropiles was provided close to the foundation slab of the building. Micropile walls down the slope were seen as dowelling elements permitting head movement. At the bottom another A-system was installed in order to support overlying soil near torrent bank line. Stability was analyzed with circular sliding areas per KREY and polygonal areas per JANBU.

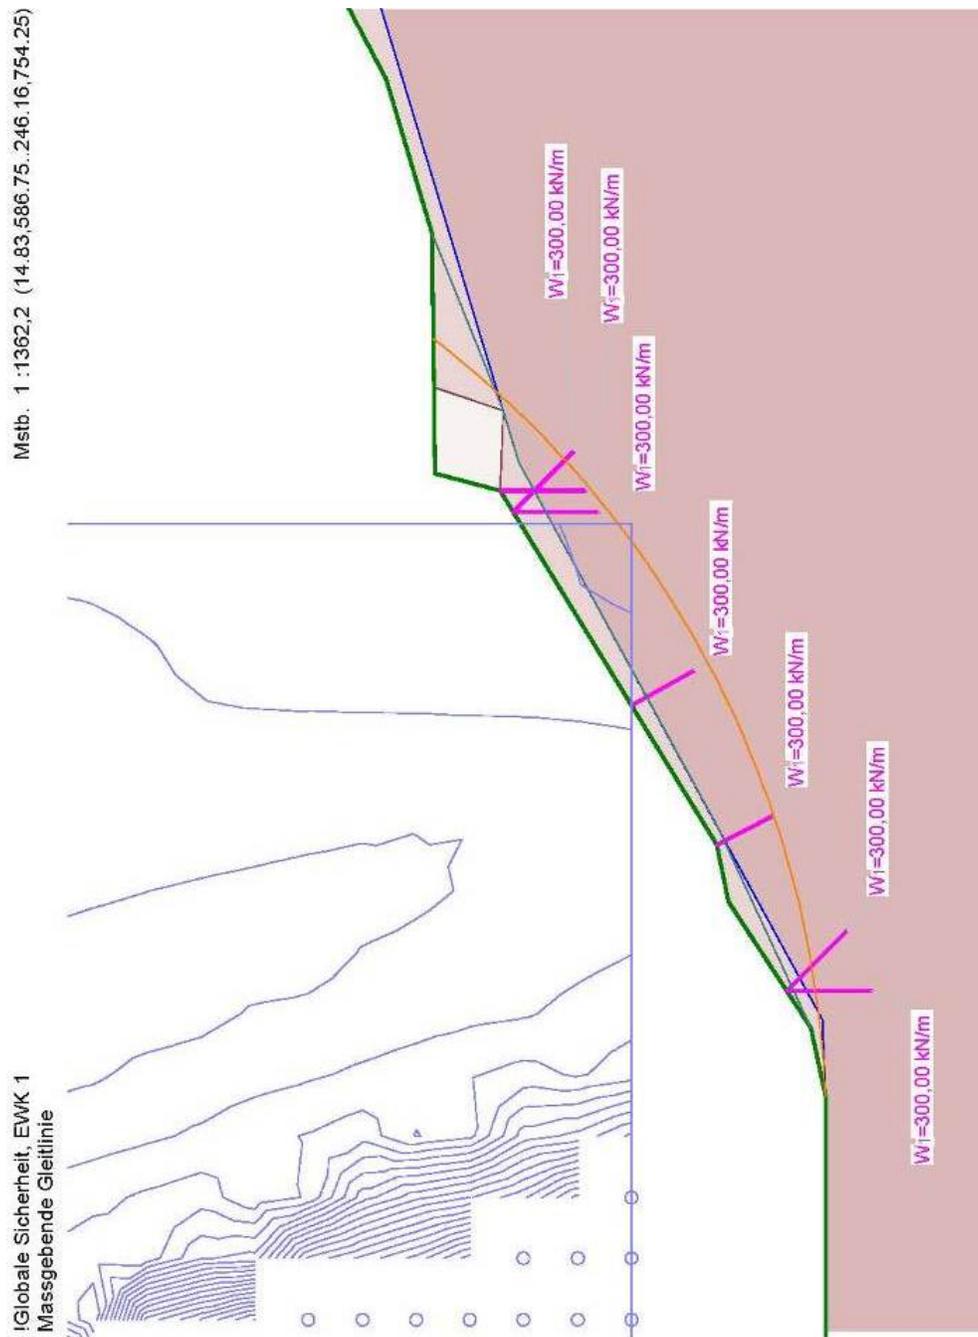
4 stability analysis KREY

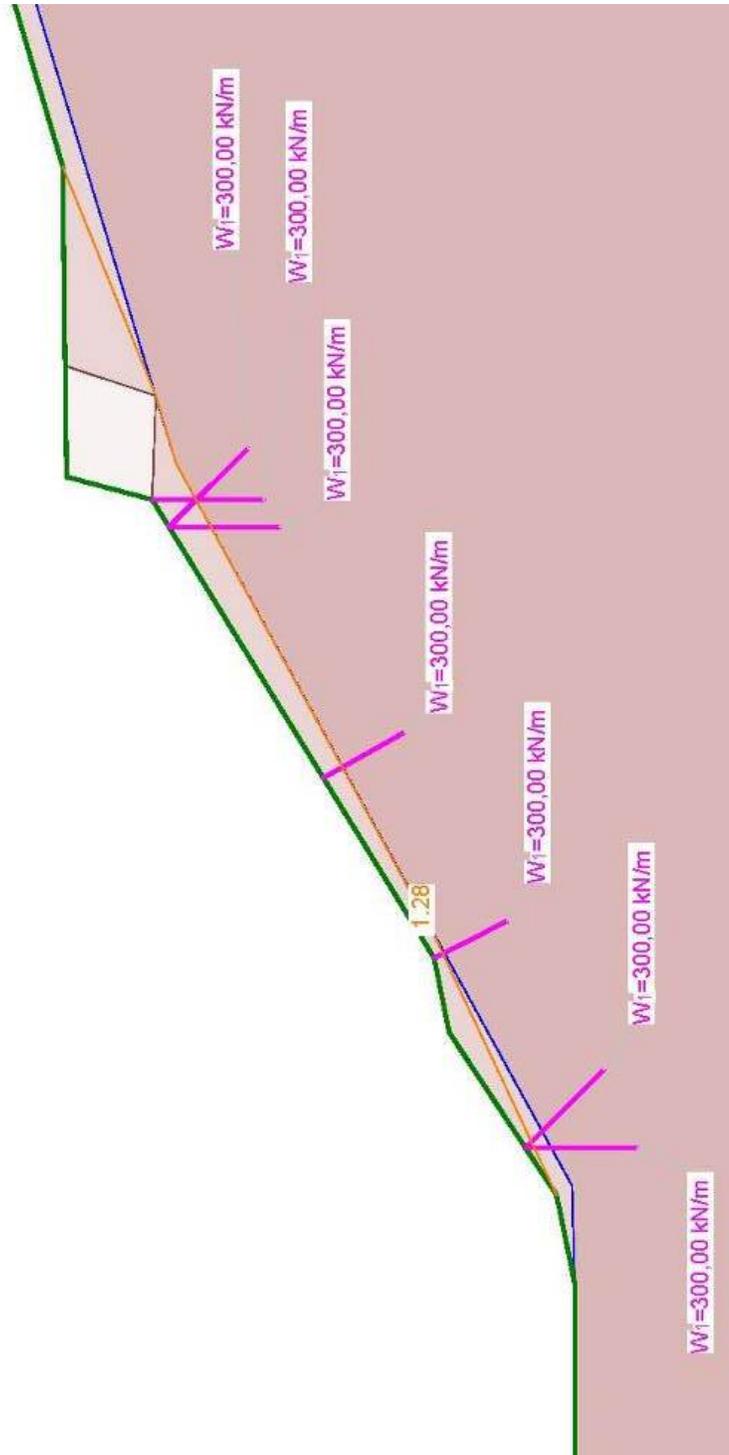
5 stability analysis JANBU

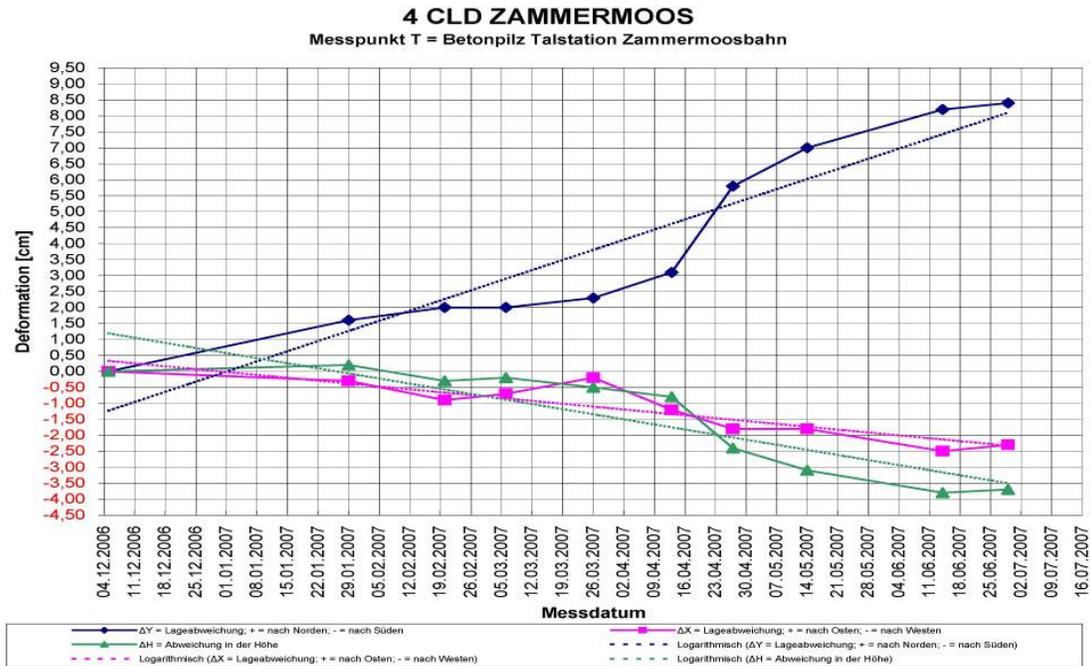
Survey in October 2005 did not show any increase of creeping speed, but in October 2006 survey proved, that movement had dramatically increased to 300 mm horizontal and 180 mm vertical. The Austrian Ropeway authority closed the ropeway and asked for a stabilization project and suggestions to allow running the ropeway during winter 2006/2007. A permanent survey of the slope and level control of the station building was installed and reviewed daily. Due to low temperatures and lack of water in the ground, creeping velocity decreased during winter to 5 mm per week. Starting spring movements increased again to 10 mm/week.

6 survey at beginning of stabilization work

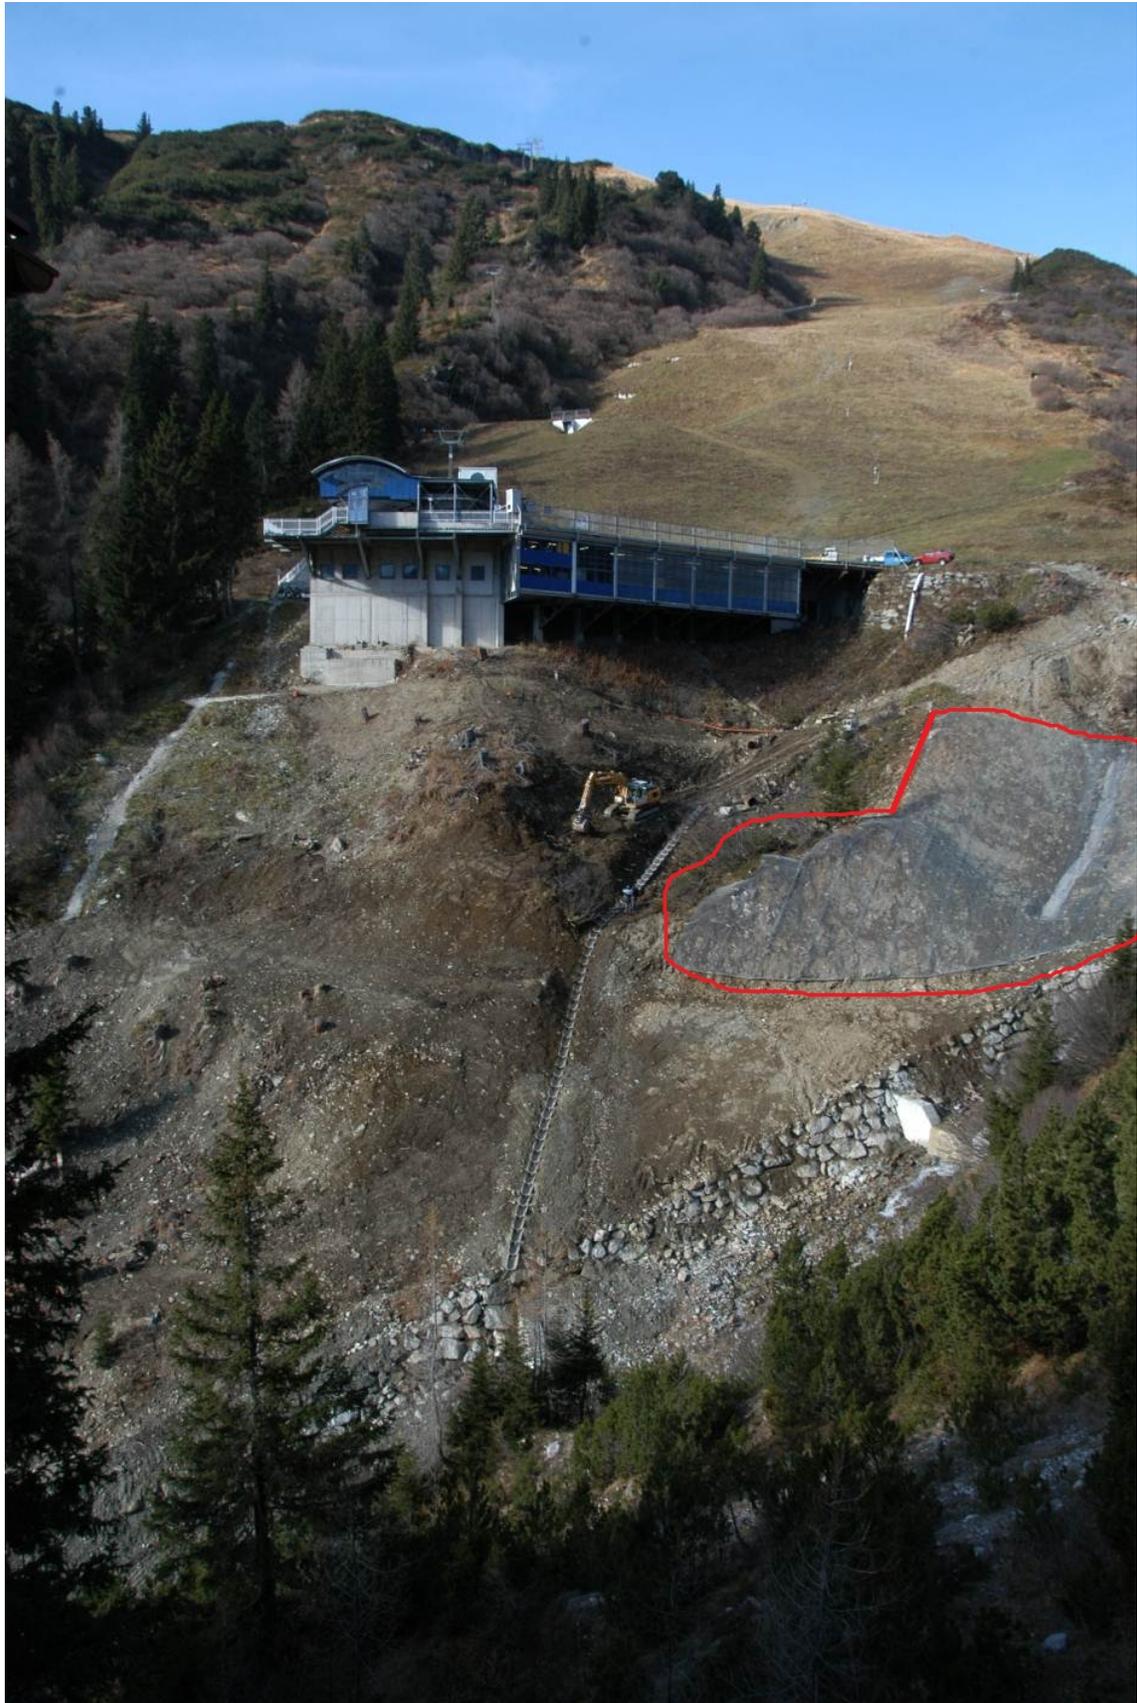
7 finished stabilization work in July 2008 – incl. wire mesh on right hand side

After another snowy winter stabilization works, which proved to be successful, were finished and everything cleaned. On the right hand side of the station building a surface stabilization with a system of heavy duty wire mesh and nails was provided to prevent shallow slippage and erosion – compare picture no 7.

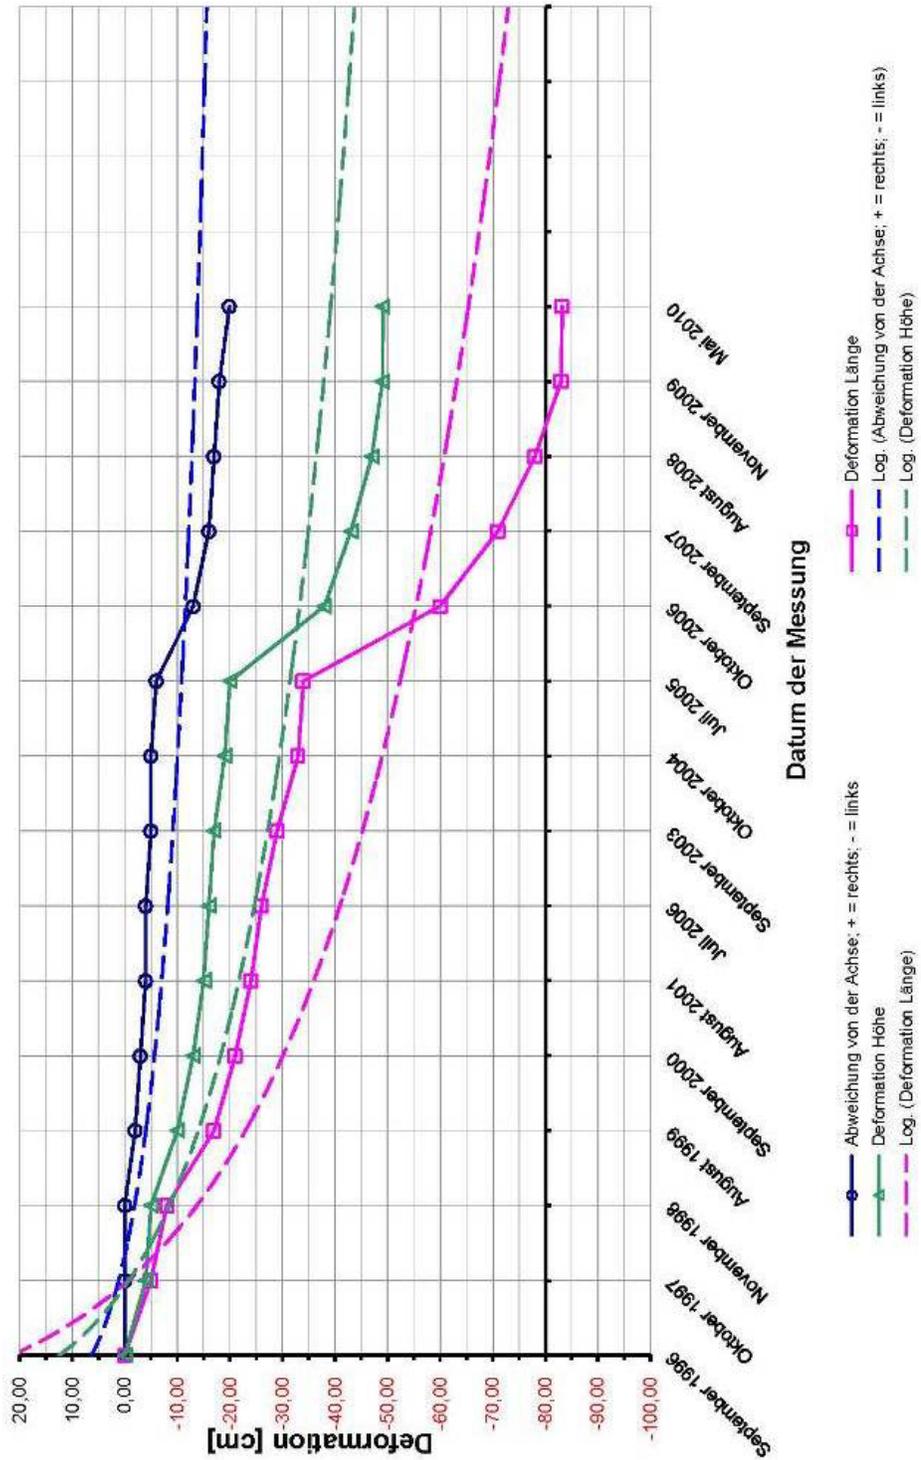
Survey was continued but laps between measurements were extended to 6 months. Review showed that movements decreased subsequently and reached values per year like before the flooding event in August 2005. The client, who already feared the need to build a new ropeway, is now happy with this solution, which helped to save a sum of 9 Million Euro.

Table 8 shows the positive effect of stabilization works on decrease of movements of station building and slope after finalizing works in summer 2008.

8 decrease of creeping velocity to a value < before flooding in 2005

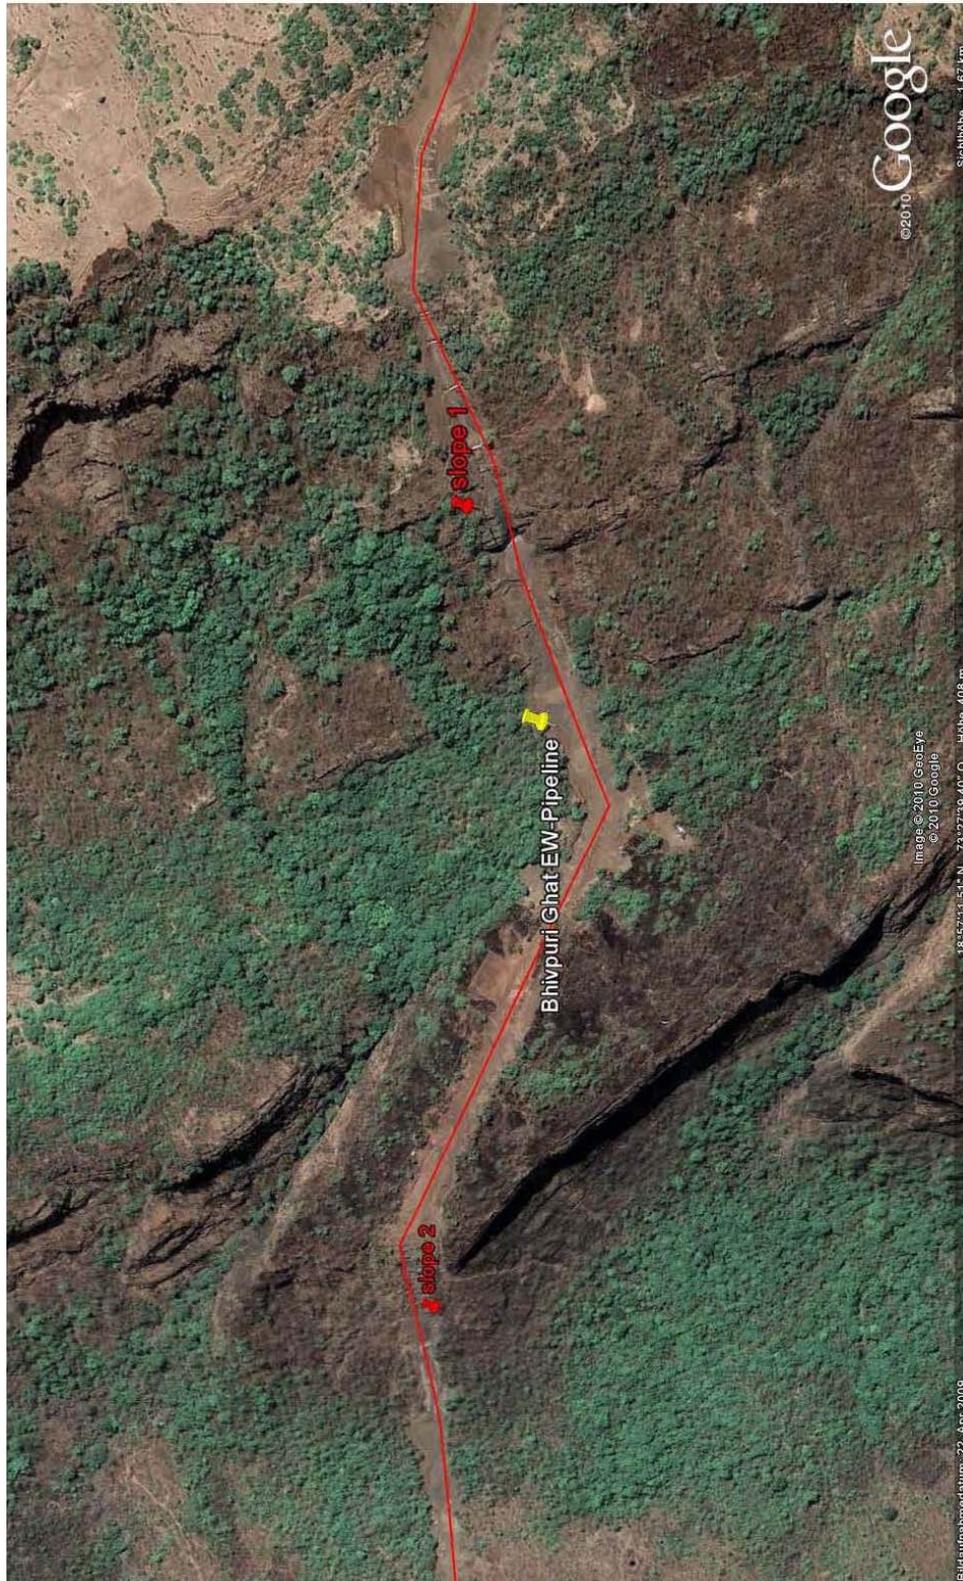
9 site view East-West-Gas-Pipeline

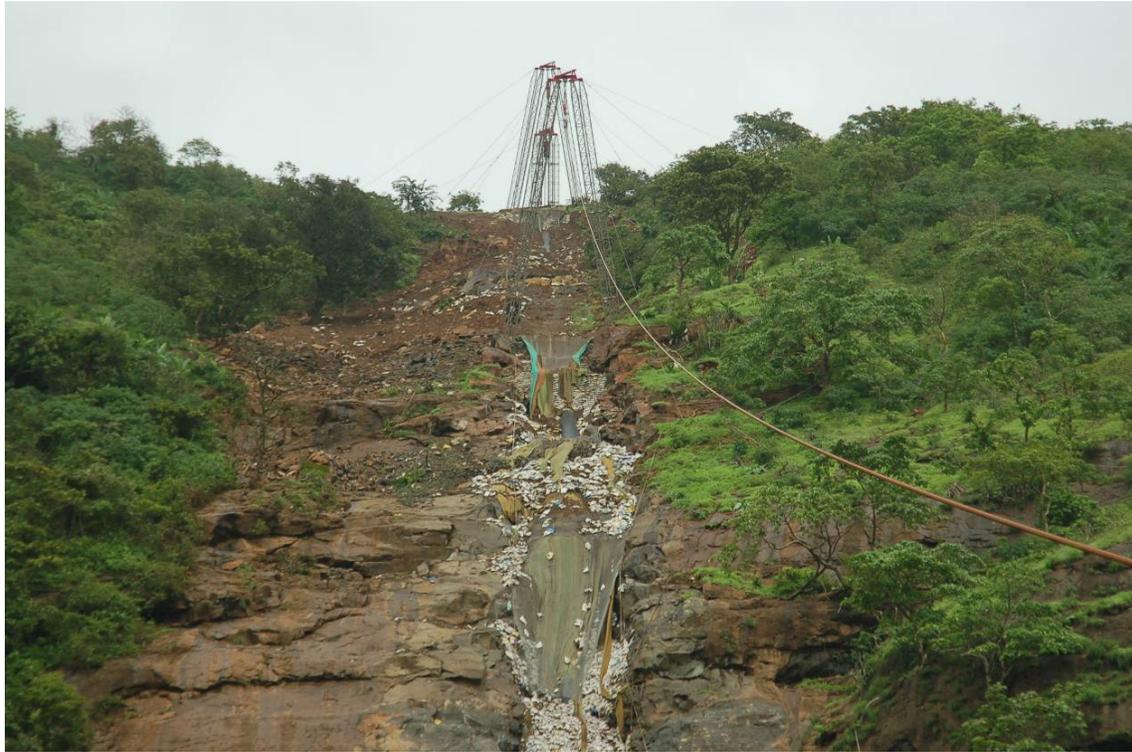
10 exposed pipeline at slope 1

Rainwater gathering in the trench of the pipeline caused slipping of backfill and exposed the pipe over nearly the whole two slopes. In the middle of slope 1 – the upper slope – a 45 m high part at an inclination of 70° - had to be refurbished and covered to protect the pipe from rockfall impact. On an overall length of nearly 700 m backfill had to be secured, erosion protection installed, rockfall prevention measures taken and slopes stabilized. Time for execution was restricted to dry season starting by end of October. It took nearly 8 weeks to get the clients decision for commencing the design of the stabilization works. Until handover of a site survey, another 6 weeks passed before design could start.

In the middle of slope 1 the pipe was totally exposed on a length of about 50 m and therefore rockfall could damage the pipe. In order to protect the pipe from rockfall impact a cover consisting of anchored gabions was put on a foundation with micropiles drilled into the surrounding weak and weathered rock. In addition rock surface was secured by heavy duty wire mesh anchored with rock bolts. The foundation block of the gabion wall was constructed on a micropile grille consisting of more than 90 hollow bar MAI IBO R38 micropiles. The micropiles took the weight of the gabion wall to keep the pipe free from weight of the proposed gabion wall.

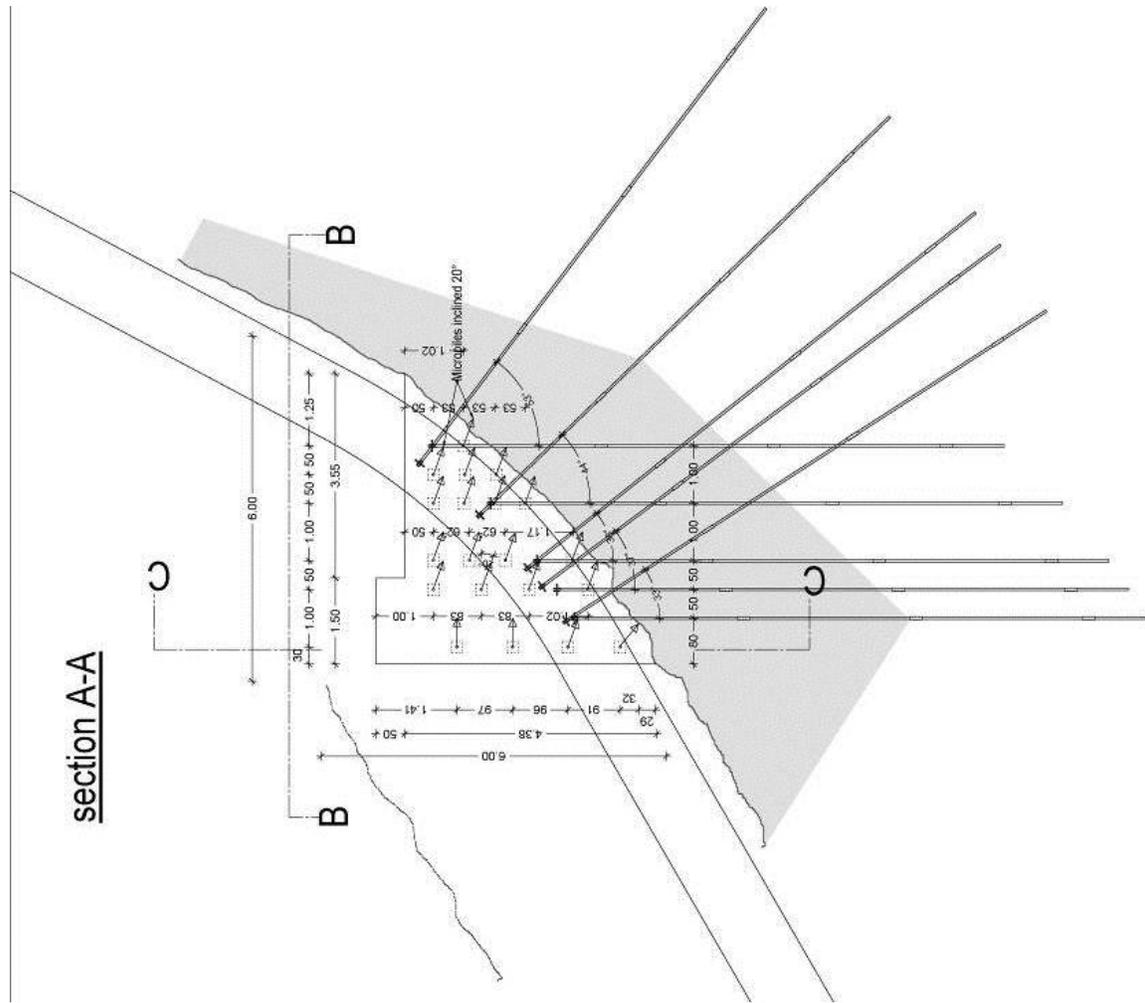
11 section of gabion wall foundation with micropiles MAI R38N

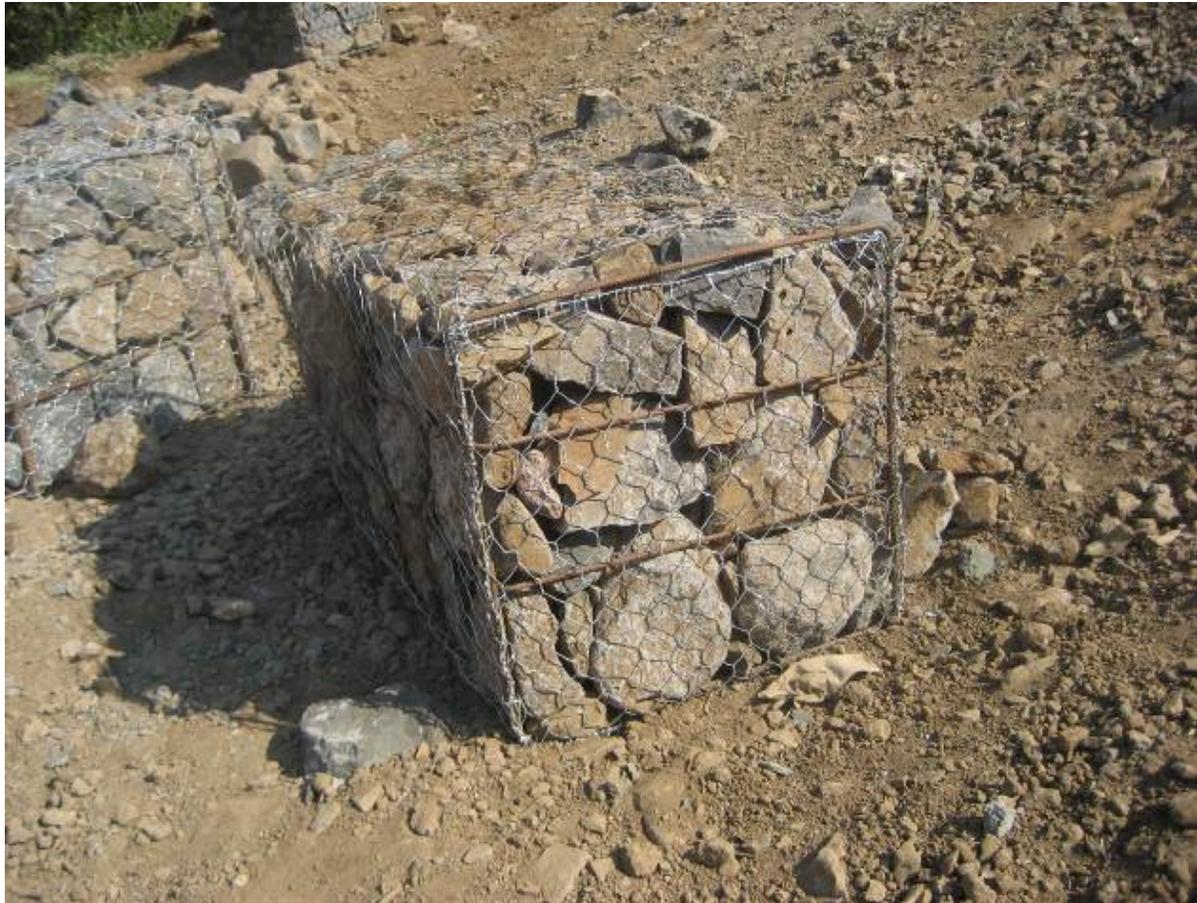
11 stone filled gabions

After finishing drilling the micropiles the foundation block was poured and construction of the gabion wall could be started. Gabions, each weighing more than 5 tons, were filled with stones at the bottom of the slope and brought to the site with help of the cable-crane.

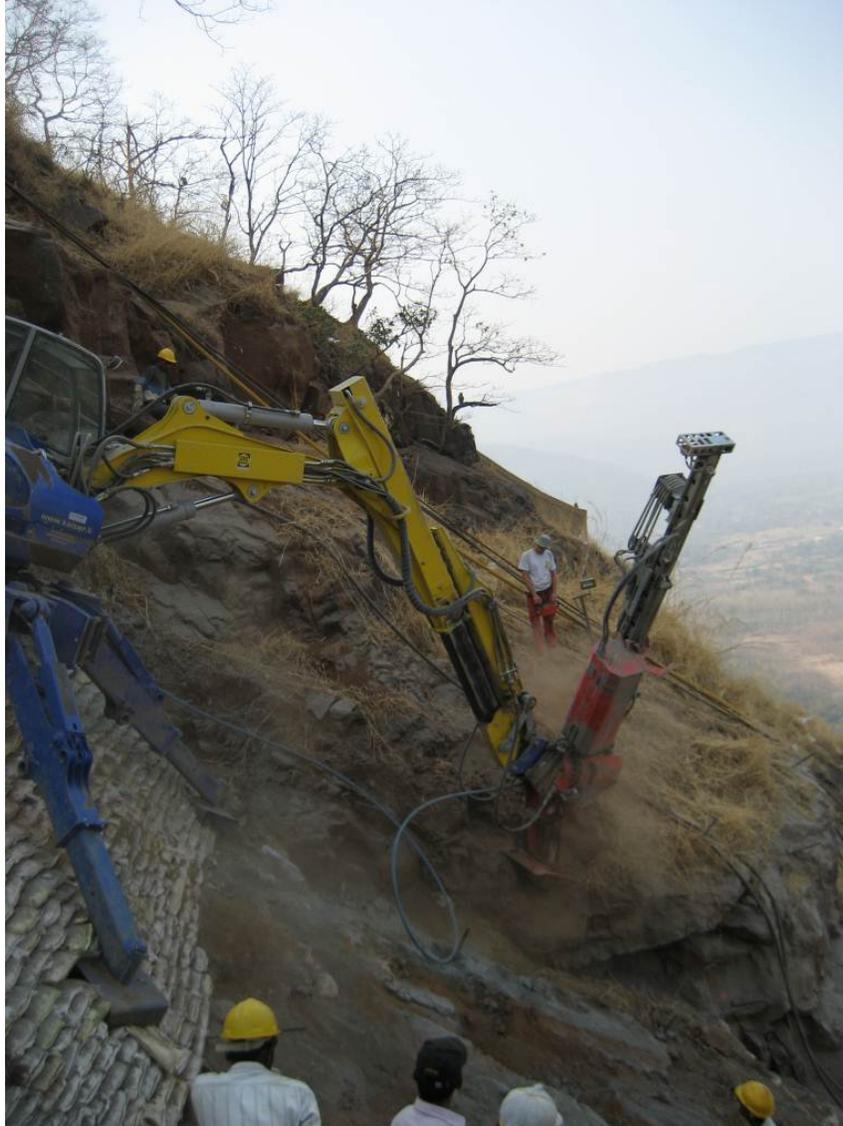
12 drilling from walking dragline slope 2

In slope 2 the existing 3 walls built from bags filled with soil had to be secured to avoid removing all soil and rebuilding the walls. This would have caused a big time problem. Therefore it was decided to support these walls with micropiles and secure them by anchored heavy duty wire mesh.
