DAMAGES TO BRIDGE FOUNDATIONS DURING THE HANSHIN EARTHQUAKE
Mr. Fukui, PWRI, Japan

DAMAGE TO BRIDGE FOUNDATIONS DURING THE HANSHIN EARTHQUAKE

Michio Okahara ¹⁾, Jiro Fukui ²⁾, Yoshitomi Kimura ³⁾

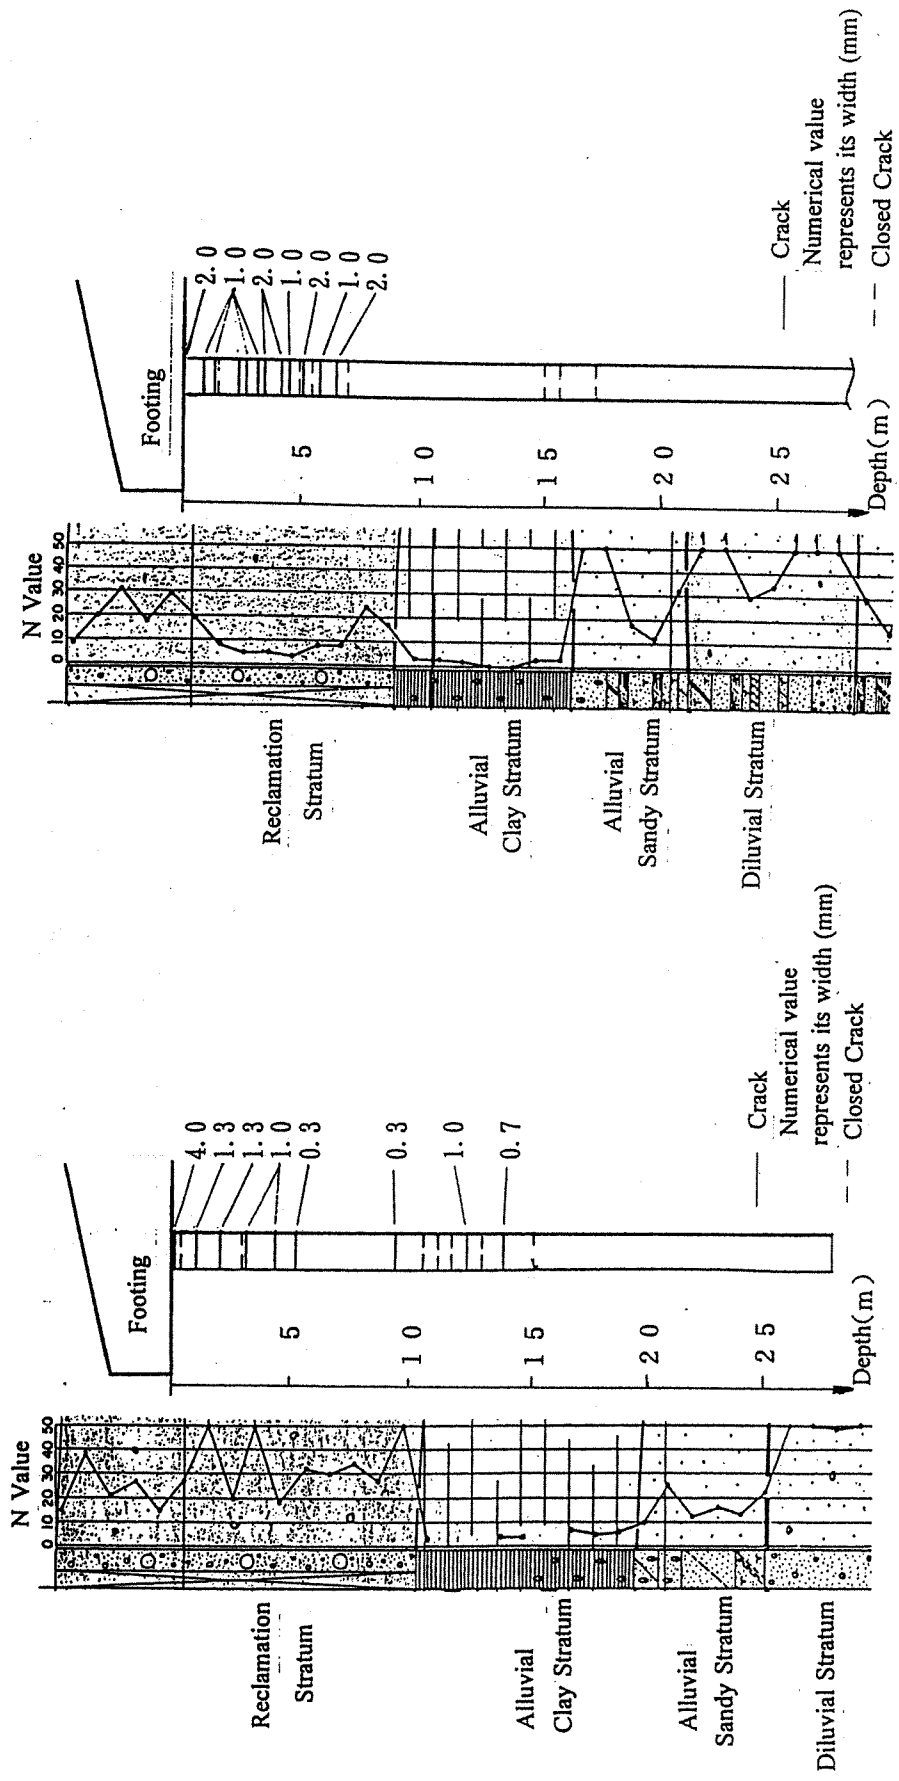
Figure 2 Examples of Cracking of Pile Bodies

Figure 2 shows examples of cracking of pile bodies. Sample (a) shows the widest crack discovered during the survey. This pile body crack was 4mm wide at its widest point, and many of them were found within the reclamation soil stratum, particularly in the top of the pile. Some cracks also occurred in the alluvial clay stratum. A study within a range of 5 m from the bottom surface of the footing reveals that the sub-total of the crack width equals 8.6 mm(4+1.3+1.3+1.0+1.0), and when calculated in terms of the unit length of the pile, it is 1.7 mm/m. Considering the fact that the diameter of the piles is 1.5 m, this can be considered as small damage. Figure 2 (b) shows the pile foundation for the bridge pier with the largest residual horizontal displacement. Within a range of about 6 m from the bottom surface of the footing, there are 12 cracks with a width of 0.5 mm or greater, but the widest of these cracks is rather small, at only 2 mm.

(a) Example of Pile with Wide Cracks

(b) Example of Pile with Large Residual Horizontal Displacement of a Bridge Pier

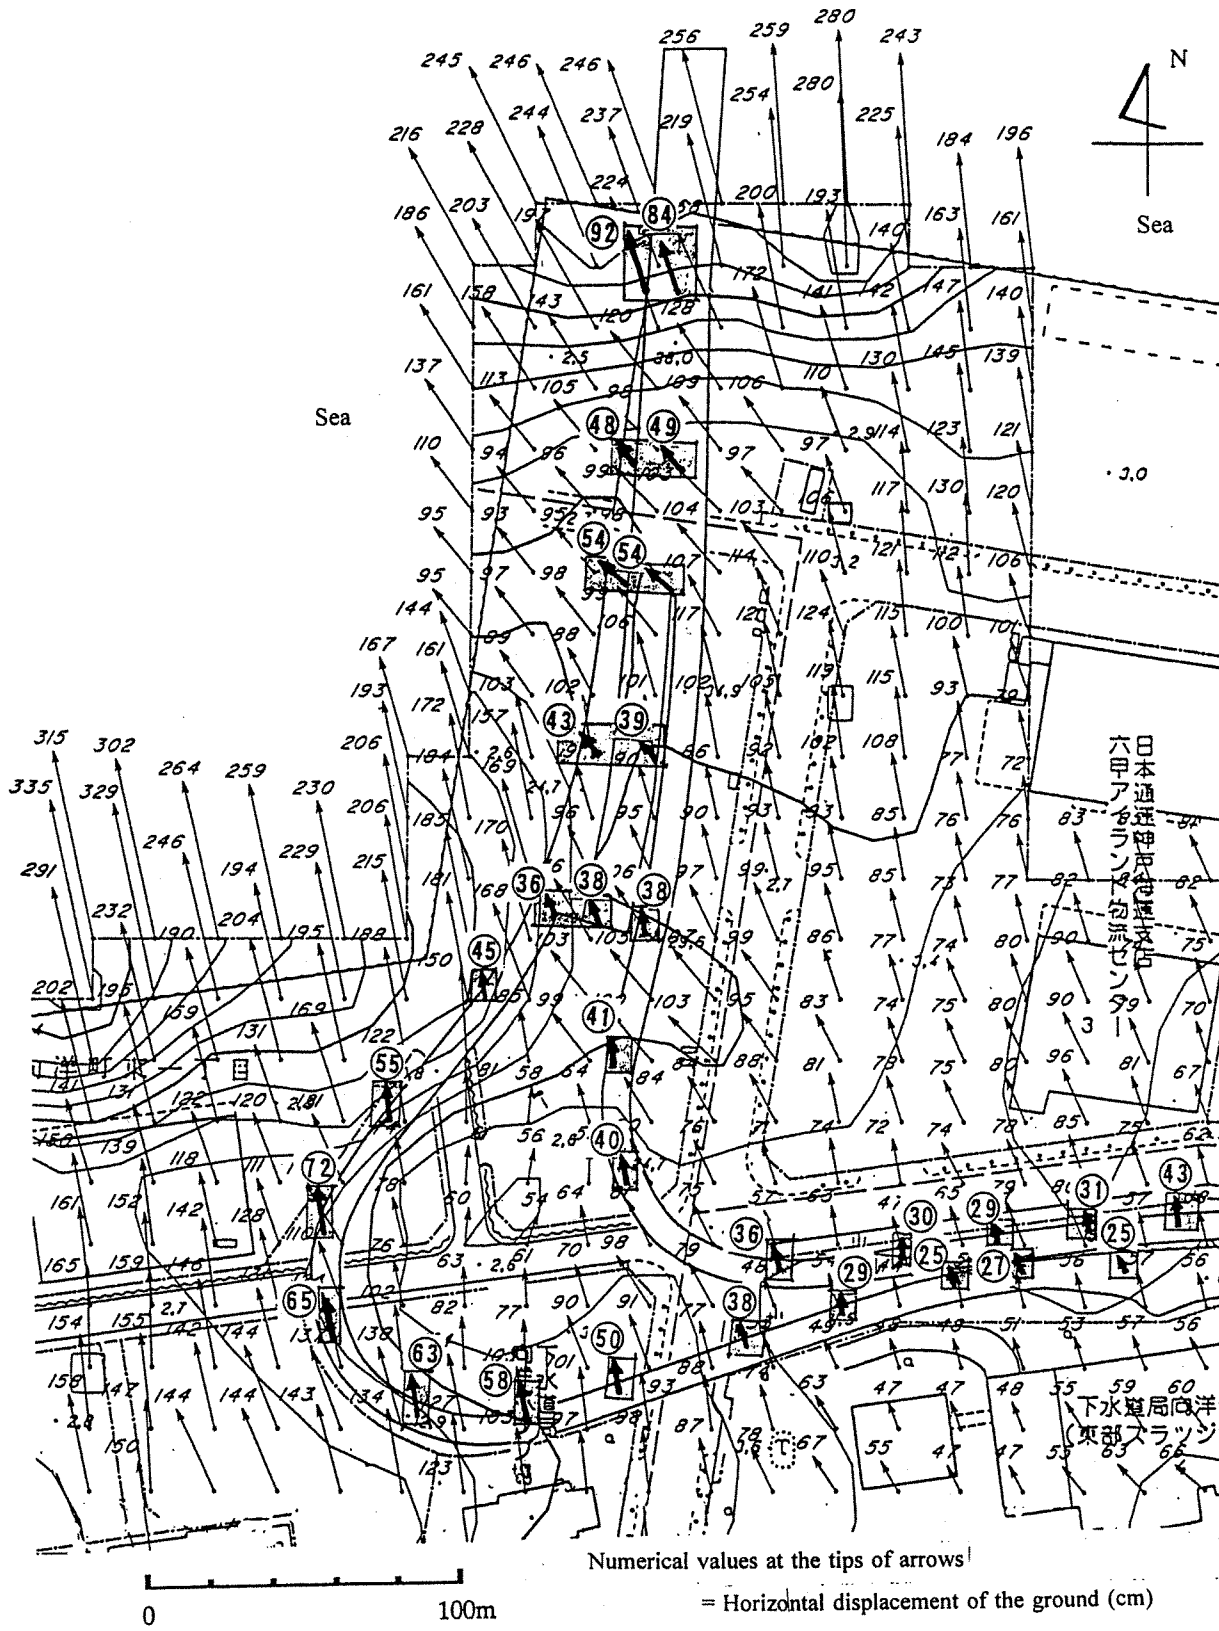
Figure 3 Horizontal Displacement of Ground and Residual Horizontal Displacement of Bridge Piers at Rokko Island
(Horizontal Displacement of the Ground Obtained by Modifying the Results of a Survey by Hamada et al. ²⁾)

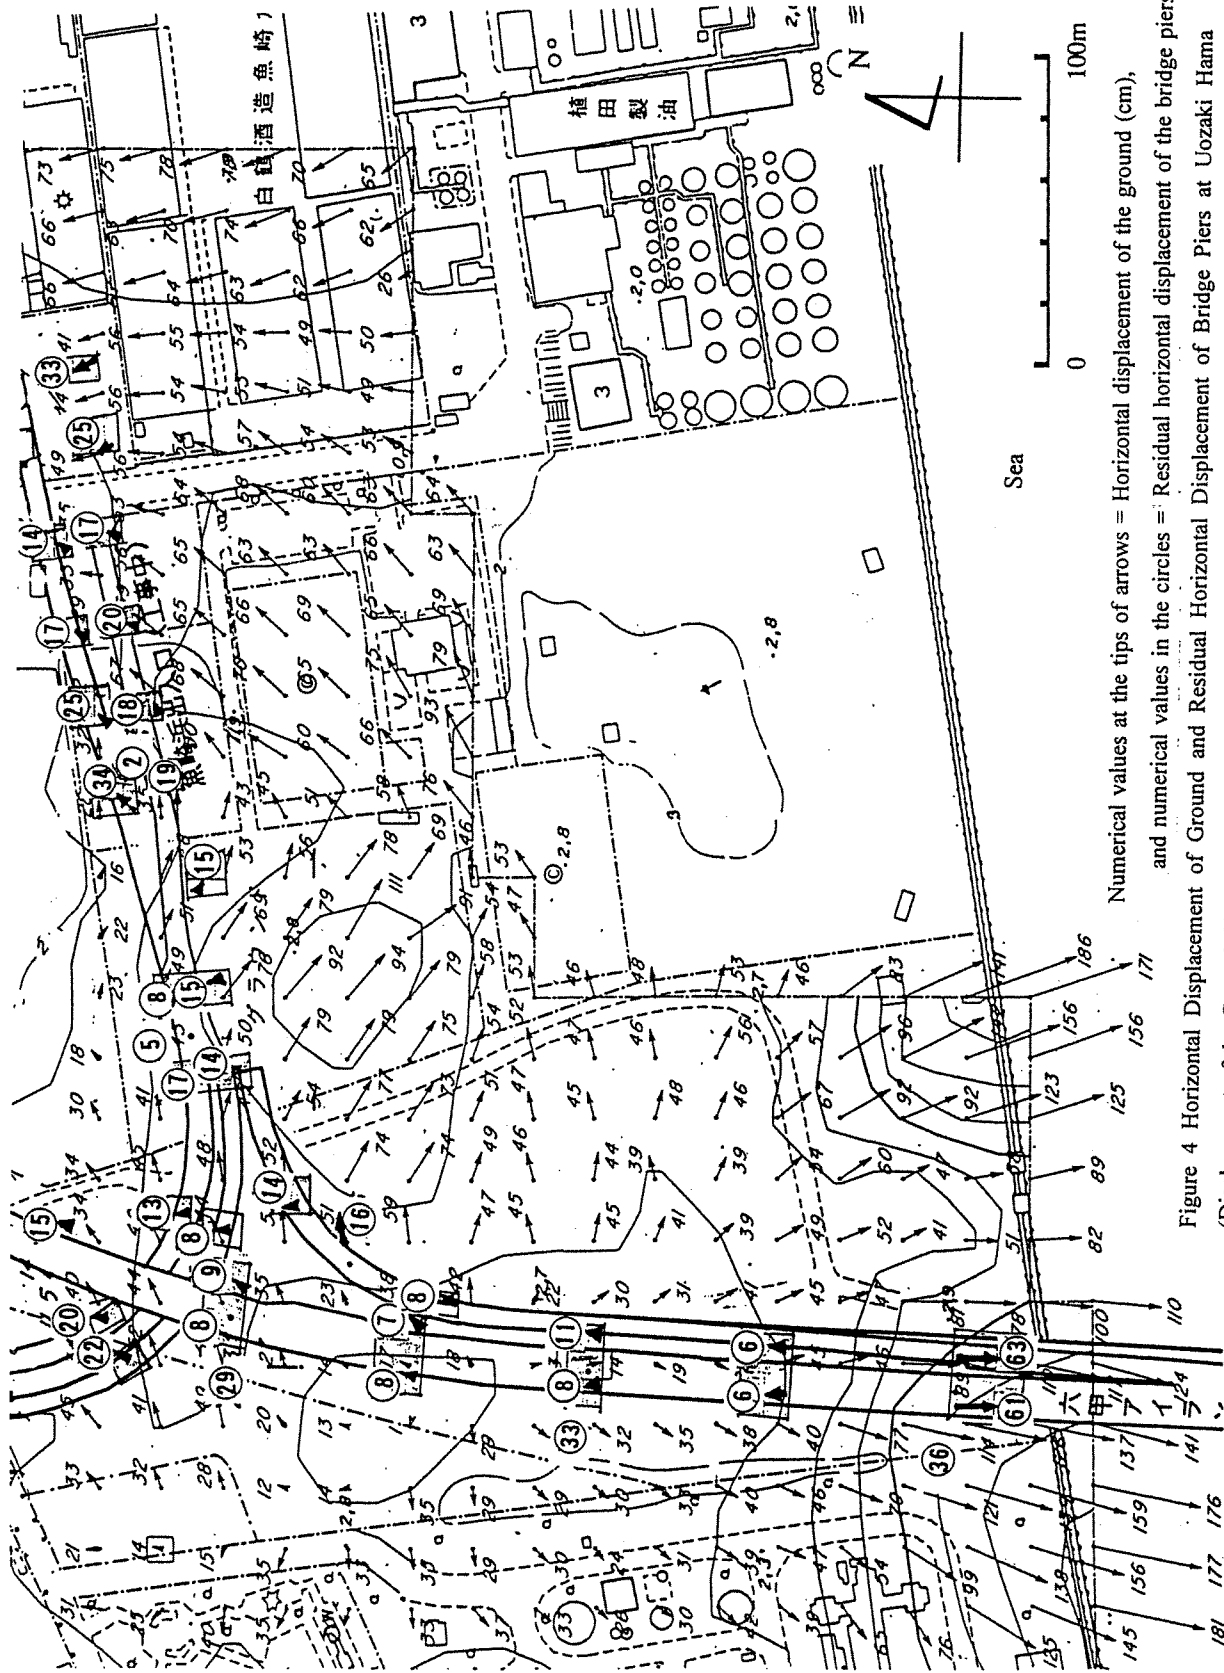
Figure 4 Horizontal Displacement of Ground and Residual Horizontal Displacement of Bridge Piers at Uozaki Hama
 (Displacement of the Ground Obtained by Modifying the Results of a Survey by Hamada et al. 2.)

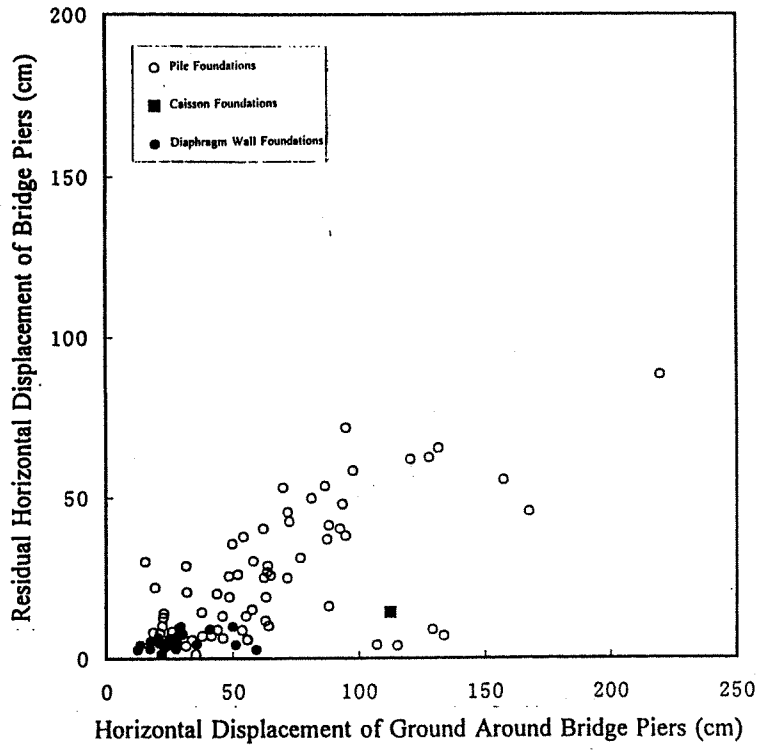
Figure 5 shows the relationship of the residual horizontal displacement of the bridge piers with the horizontal displacement of the ground around the bridge piers in Rokko Island, Uozaki Hama, and Fukae Hama. The results are considerably scattered, but overall, the residual horizontal displacement of the bridge piers tends to increase as the horizontal displacement of the surrounding ground rises. But the extent of the displacement of bridge piers which occurs when certain ground displacement occurs varies according to the rigidity of the foundation, and the residual horizontal displacement is smaller in the case of caisson foundations or diaphragm wall foundations: types with greater stiffness than pile foundations.

Figure 5 Ground Horizontal Displacement - Bridge Pier Residual Horizontal Displacement Relationship (For Bridge Piers on the No.5 Wangan Line of the Hanshin Expressway at Rokko Island, Uozaki Hama, and Fukae Hama)

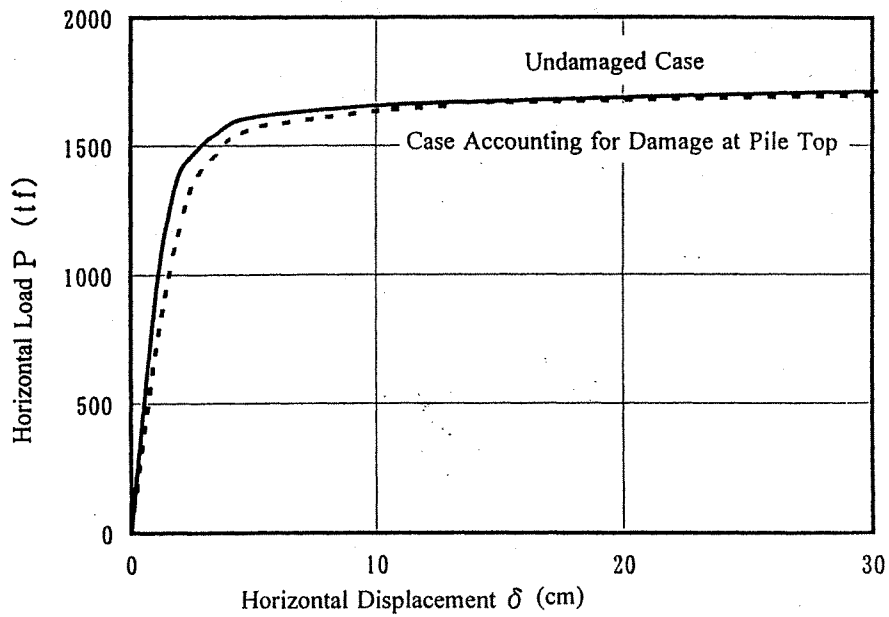
described analysis of the horizontal load - horizontal displacement relationship of the overall pile foundation. A comparison of this relationship when the pile has not been damaged with the relationship in a case where the pile top is assumed to have been damaged reveals that in the damaged case, the horizontal displacement under the same horizontal loading is slightly larger, but that the maximum horizontal bearing strength of the pile foundation hardly declines at all, demonstrating that damage to the pile body has only a slight effect on the overall pile foundation.

Figure 12 Effect of Pile Body Damage on the Horizontal Load Horizontal Displacement Curve of the Foundation (No.126 Pier)
