# MICROPILES UNDETECTED: BLUFF STABILIZATION ON THE SEVERN RIVER

C.Javier Rodríguez<sup>1</sup>, Jesús E. Gómez<sup>2</sup>, Helen D. Robinson<sup>3</sup>, Robert P. Traylor<sup>4</sup>

## **ABSTRACT**

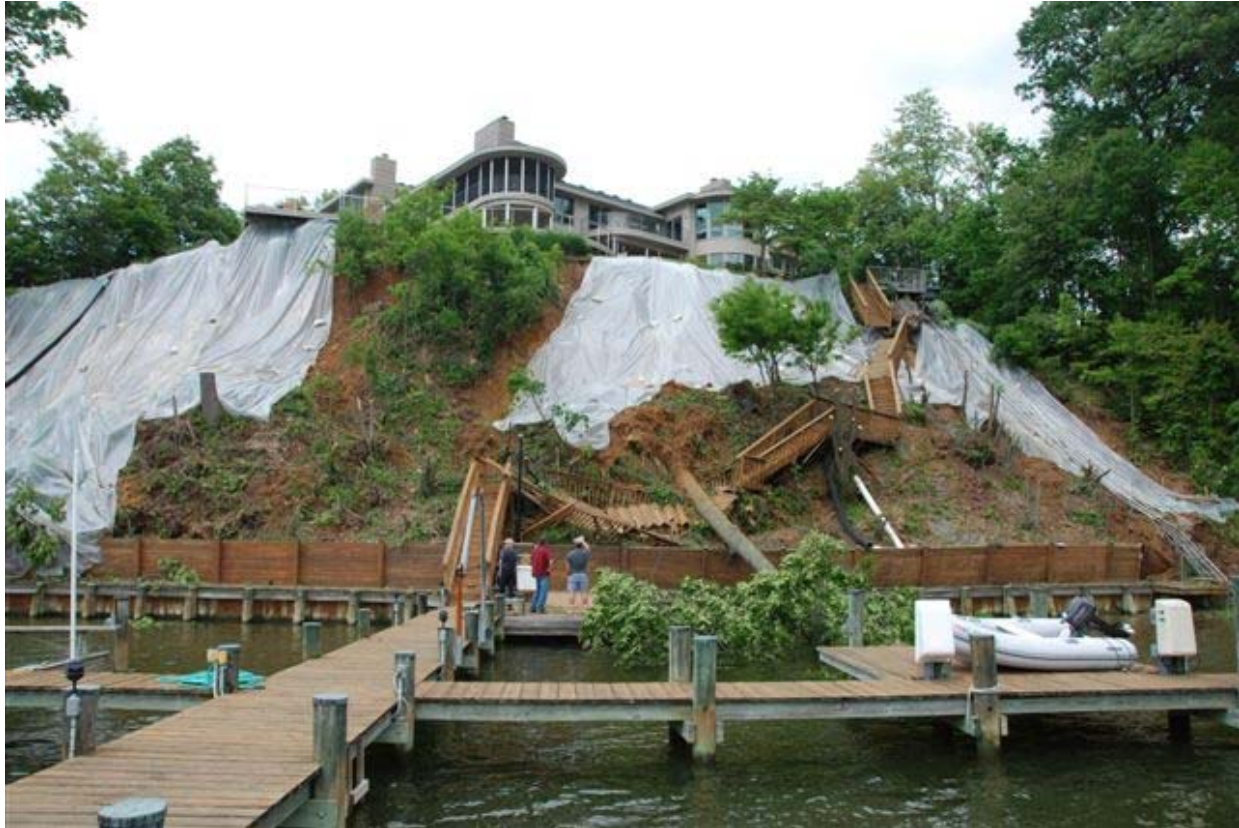
above an approximately 60-foot high bluff. The slope failure destroyed a wooden staircase, which had provided access to the private dock below, and demolished a trolley used for transferring heavy items from the dock to the house at the top of the slope (see Figure 2). A wooden bulkhead at the toe of the slope was subject to displacement and severe rotation with failure of some of the timber uprights. An 18-inch diameter tree was uprooted and fell on the bulkhead and dock. Portions of the dock supported on timber piles adjacent to the slope were subject to lateral thrust and several piles rotated as consequence of the movement. The landslide undermined a wooden deck supported on spread footings but the slide scarp did not reach the main structures. However, there was considerable concern that the slide would soon encompass a larger portion of the slope including the rear wing of the house.

Figure 2. View of the site immediately after the 2008 landslide. Note collapsed staircase and overturned tree (center), collapsed trolley (right), and undermined wooden deck (upper left).

The use of micropiles combined with anchors provided a cost-effective solution for this slope repair with difficult access. Utilizing a flexible geomembrane face of allowed for the growth of native vegetation and was an important design aspect that helped maintain the natural look of the slope.

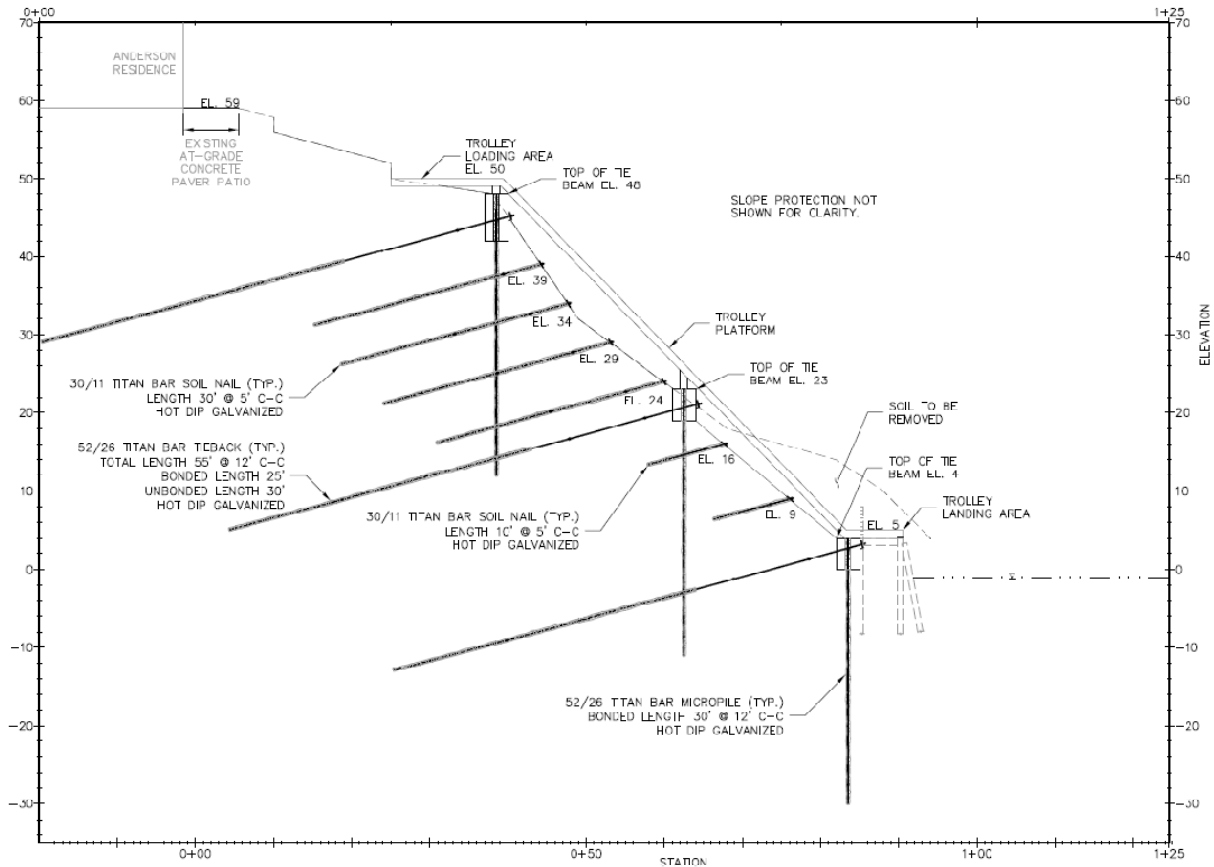
Figure 3 is a cross section through the bluff depicting the stabilization scheme selected for this project. Global stability concerns were addressed by including various rows of post-tensioned tiebacks distributed on the slope face. Two rows of tiebacks were installed across the central and southern thirds of the slope. The bottom row of tiebacks was installed immediately behind the existing bulkhead. The upper row was installed about mid height on the slope. The northern portion presented more severe stability problems and was also a natural path for water runoff. In this area, three rows of tiebacks were installed.

Figure 3. Typical cross section in northern portion of slope.

Local bearing capacity failure of the shallow loose soils under the tieback loads could compromise the efficiency of the tieback system. Therefore, reinforced concrete tie beams were included in the design to transfer the horizontal component of the tieback loads to the ground. The concrete tie beams were designed as simple beams over an elastic foundation and included vertical expansion joints at regular intervals because of their significant length. Smaller sections of beam also allowed it to follow the horizontal contours of the slope and provide a snug fit against the sinuous slope surface.

Micropiles were installed to provide vertical support for the tie beams under the vertical component of the tieback loads. They also provide additional safety in case scour at the base of the beams or local instability of the slope between the beams takes place over the life of the structure. In addition, the micropiles were conceived as soil reinforcing limiting the potential for localized soil “flow” under the tie beams and increasing the efficiency of the stabilization. The system of hollow core bar tiebacks and hollow core bar micropiles is therefore a post-tensioned A-Wall.

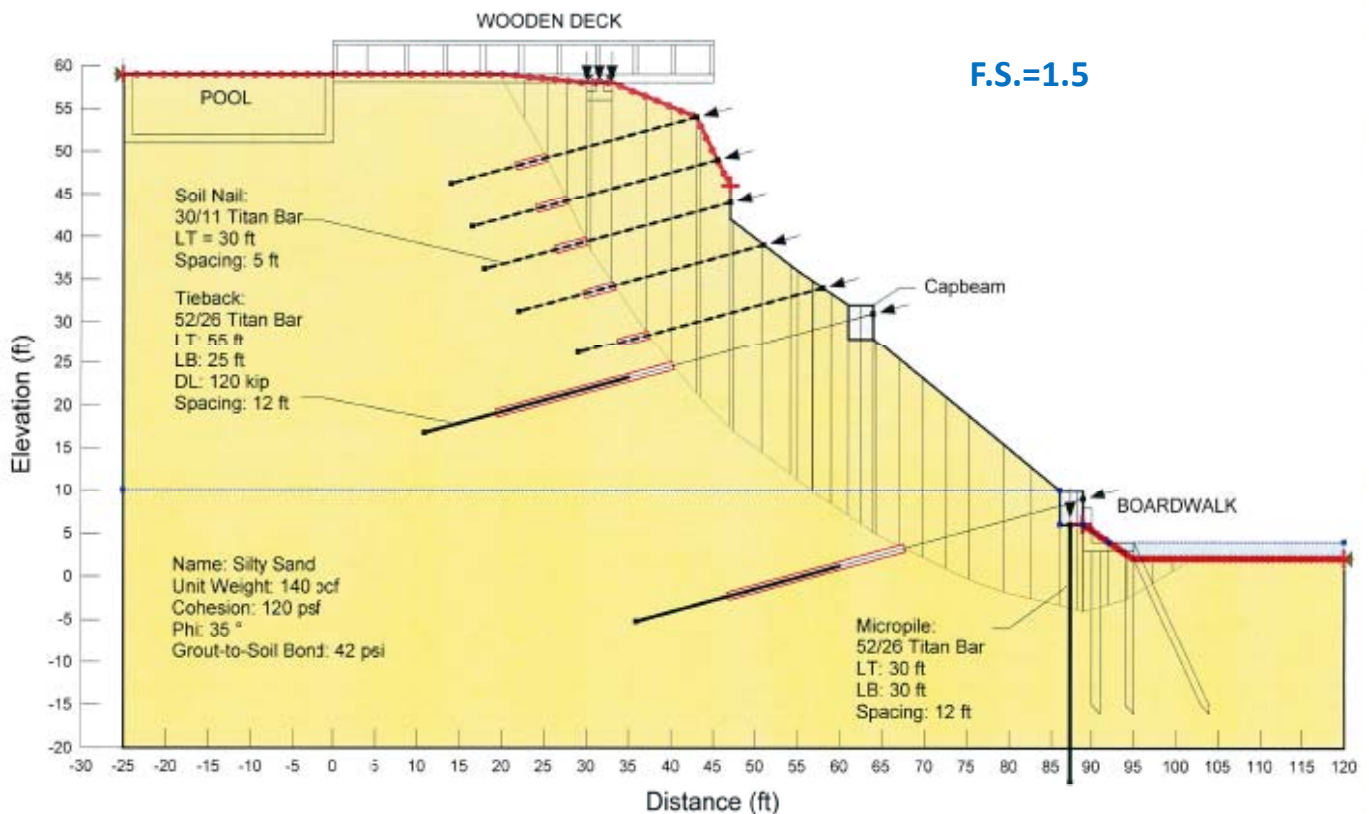
The use of micropiles in combination with tiebacks connected to concrete beams provided a stabilization solution that could be installed using light-weight equipment. The concrete beams could be partially buried or covered to blend with the vegetation on the slope. The designers used the computer software SlopeW by GeoSlope to perform local and global slope stability analyses of the slope. A back analysis was performed to estimate the properties of the soil strata at the site. These were compared to soil properties estimated based on correlations with Standard Penetration Test (SPT) blow count and grain size distribution. The minimum tieback forces required for a minimum factor of safety of 1.5 against global failure were determined considering the soil properties established from the back analysis. The analyses also considered the presence of the ground water table as depicted in Figure 4.

Figure 4. Slope Stability Analysis with Limiting Factor of Safety

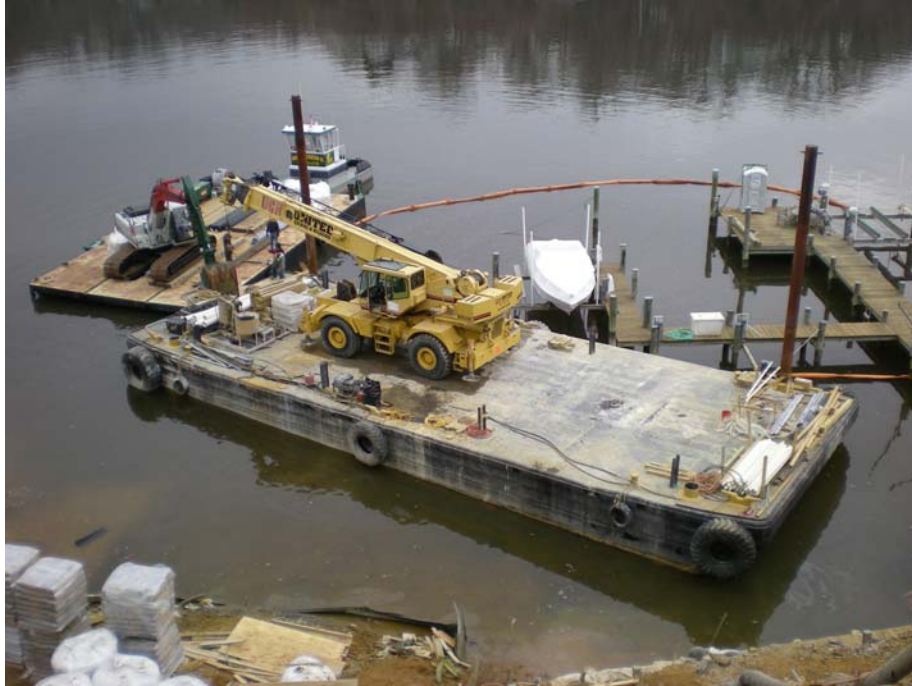
Figure 5. Barge arriving on site with crane and supplies.

The contractor Clark, Arvig, and Traylor (CAT) installed the micropiles using a drilling mast suspended from a crane. The crane was situated on a barge, which permitted limited lateral mobility on both sides of the dock. Toward the northern end of the site, it was necessary to position the crane on the shore as the barge could not approach the slope sufficiently. The reach of the crane boom allowed the drill mast to reach the upper portions of the slope to install vertical or sub-vertical micropiles (see Figures 5-8).

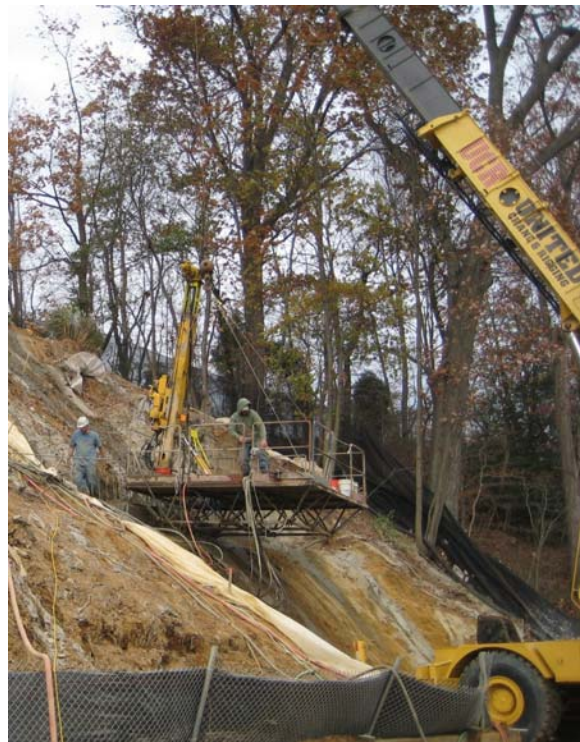
Figure 6. Crane-suspended mast for micropile installation

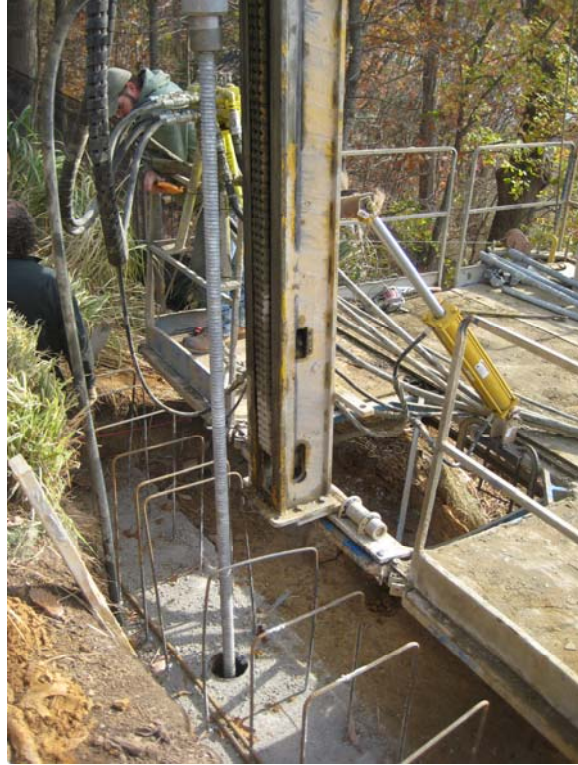
Figure 7. Installation of hollow core bar micropiles for tie beam.

Hollow core bars were specified in the design of the micropiles for several reasons. In the experience of the authors, hollow core bars are ideally suited for granular soil formations, where they can develop substantial geotechnical capacity. Hollow core bars allowed the use of a light drill mast, which was critical in order to reach the upper portions of the slope with a reasonably sized crane. Finally, installation of the hollow core bar system is faster, allowing a reduction in the construction schedule, which is important when working on an unstable slope.

The design considered the use of hot dip galvanized 52/26 CTS/IBO Titan Bars, installed using neat cement grout with compressive strength  $f'_c = 4,000$  psi at 28 days. Load testing of the micropiles was not required because hollow core bars were also used for the tiebacks and soil nails, which were subject to verification and proof testing. The test data shows that the soil nails and tiebacks were suitable for a design bond stress of 21 psi with a factor of safety of 2.0. Soil nails proved suitable for a load transfer ratio of 3.9 kips per foot considering a nominal grout body diameter of 5 inches (3 $\frac{5}{8}$ " nominal bit diameter) and a factor of safety of 2.0. Tiebacks showed a load transfer ratio of 4.8 kips per foot considering a nominal grout body diameter of 7 inches (5 $\frac{1}{4}$ " nominal bit diameter) and a minimum factor of safety of 2.0.

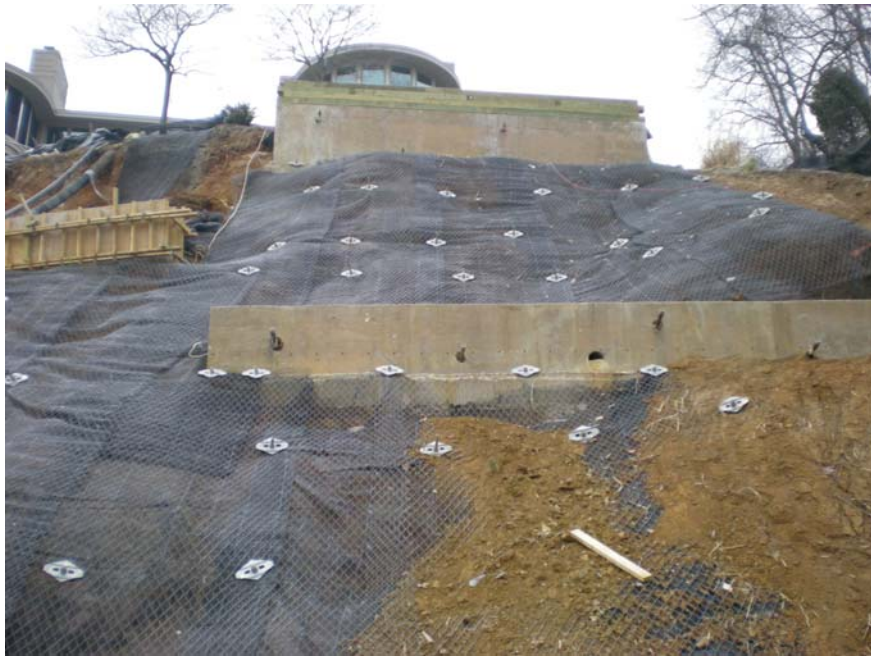
Figure 8. Completed tie beams on the northern end of the slope.

The micropiles were installed before completion of the tie beams. The connection of the micropile to the tie beams was achieved by direct bond of the hollow core bar to the beam concrete.

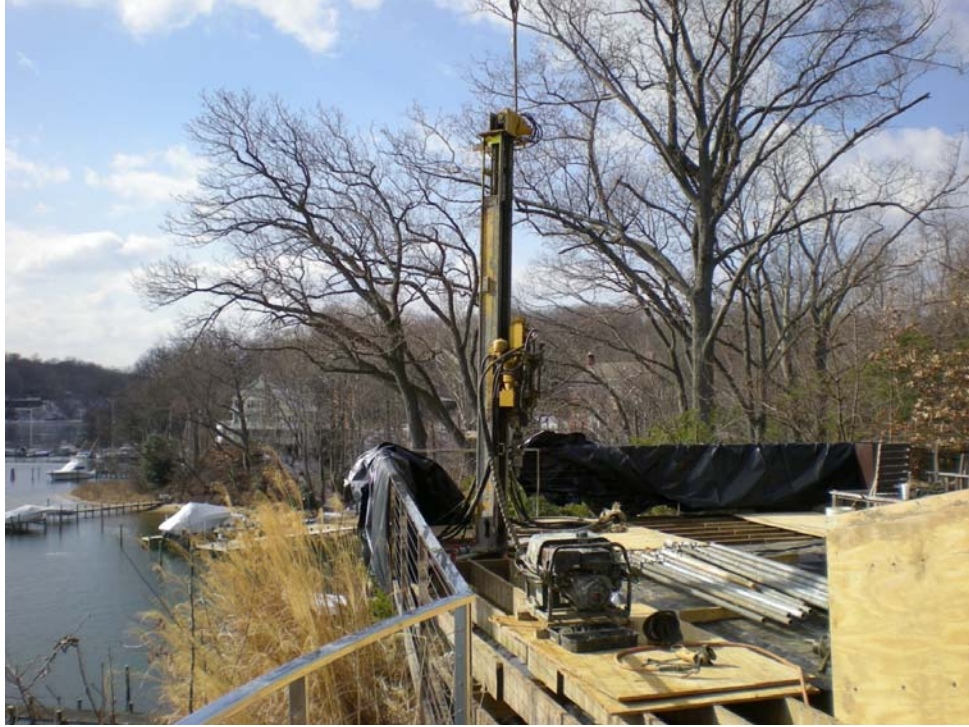
Figure 9. Installation of micropiles through existing deck. The drill mast is suspended from the crane located on a barge below.

The undermined wooden deck required stabilization, which was achieved by installing micropiles through the deck. Connection of the micropiles to the deck was developed using needle steel beams spanning the floor joists (see Figures 9 and 10). The micropiles were installed using the suspended drill mast and using hollow core bars identical to those used for the grade beams. The micropiles were adjacent to the top of portion of the slope, which sloped very steeply toward the middle tie beam below. Consequently, there was concern about the lateral stability of these micropiles. To address this issue, the density of soil nails was increased near the top of the slope to limit the potential for lateral movement of the micropiles.

The sequence of installation consisted of first removing the floor boards, then installing the micropiles using the suspended drill mast without placing any load on the deck. Then the needle beams were installed under the floor joists and bolted to the bearing plates of the micropiles to the floor boards. Finally, the needle beams were encased in concrete and the floor boards replaced. The owner indicated that this operation was closer to a surgical procedure than to typical construction. Once this operation was completed, there was no evidence of the significant foundation work that had just taken place.

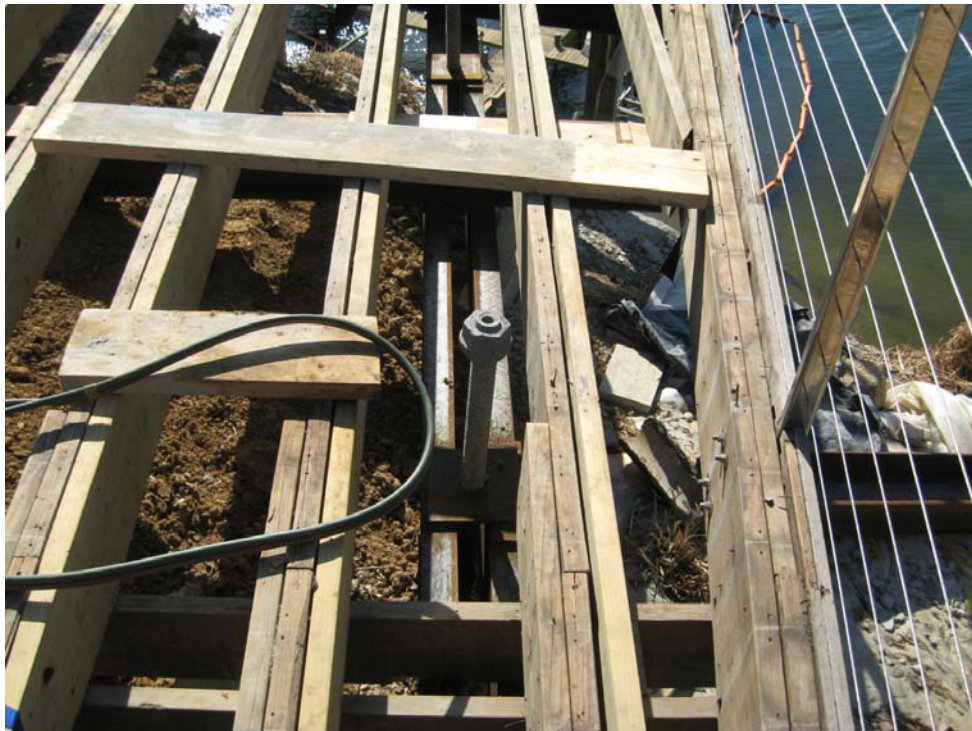
Figure 10. Needle beams for connection of micropiles to deck

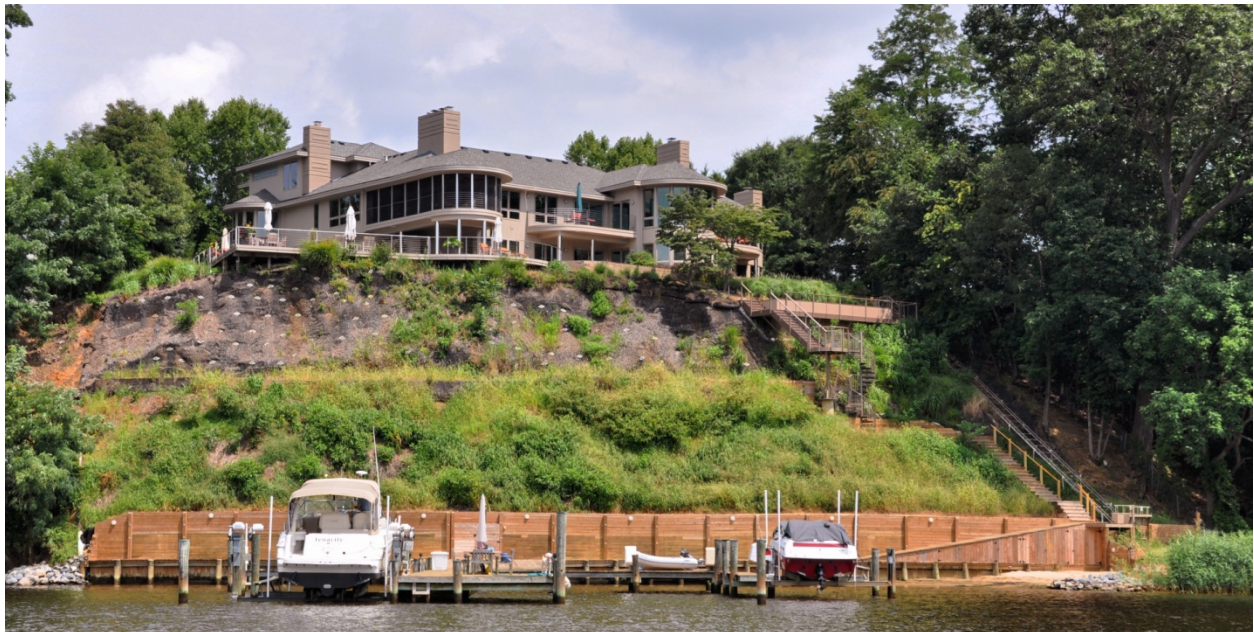
Figure 11 shows the completed stabilization. The partially developed vegetative cover now entirely conceals the lower half of the stabilization system. It is projected that the upper half of the slope will also be entirely covered, although specific vegetation species will be required in the steeper portions.

Figure 11. View of the completed stabilization a few months after end of construction. Note slope partially covered in vegetation (Photo courtesy of owner)
