DOUBLE NICKEL MICROPILE LANDSLIDE STABILIZATION

ABSTRACT

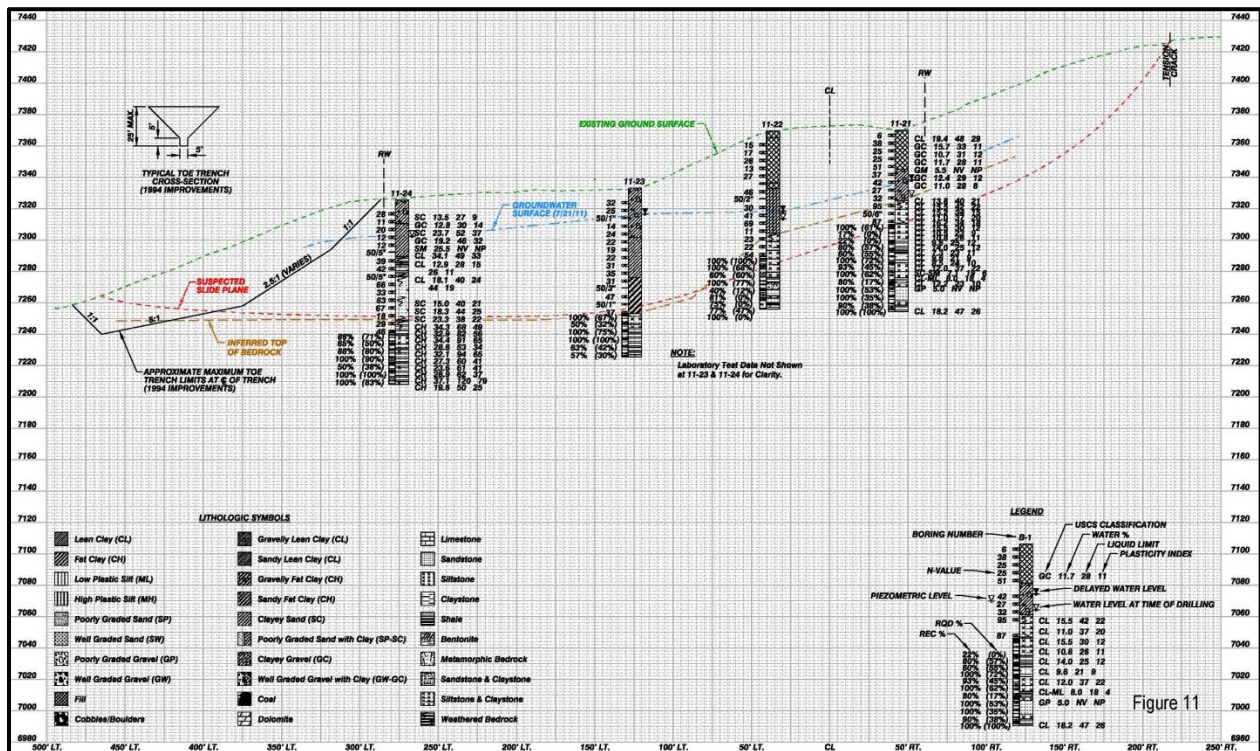
Figure 3. Cross-Section at Slide Axis (Sta. 735+50).

In general, the suspected slide plane (determined from inclinometer readings and direct observation of disturbed material) is positioned at or near the top of bedrock. The maximum depth of the slide plane below the ground surface is approximately 24.5 m (80 ft) at the axis of the landslide at approximately Sta. 735+50 (Figure 3). The depth to the slide plane decreases to about 18.5 m (60 ft) on the side flanks of the slide.

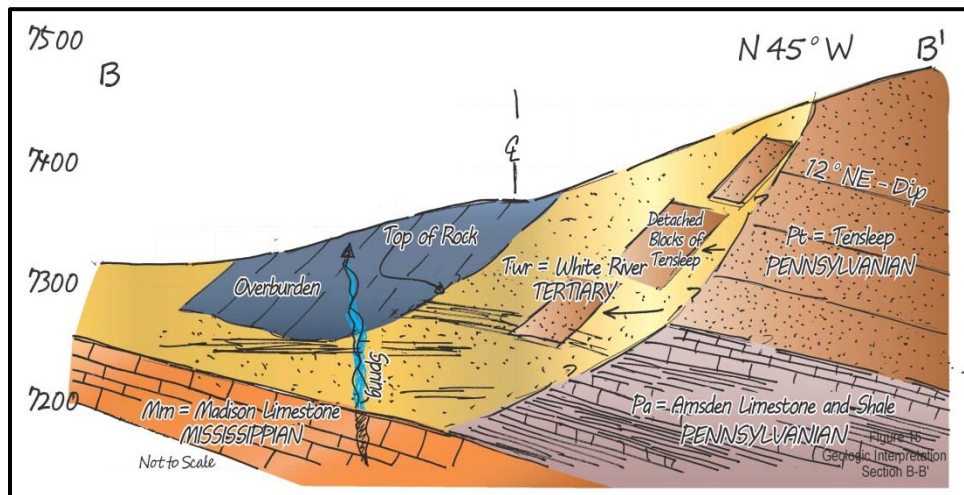
Figure 4. Geologic Interpretation of Slide Genesis

Groundwater is likely transmitted down dip with considerable head from southwest to northeast, downward from the continental divide to the site. When examined from along the strike, the Madison Formation could be directly contributing water laterally in the elevation range of 7250 to 7300 feet, further weakening the White River materials and providing a mechanism for slide movement.

In summary, it is believed the slide is occurring in overall weak Tertiary materials aided by bentonitic zones and weathering of the shale layers to fat clay. The axis of the slide appears to be positioned within a bedrock depression from a past erosional event. The mechanism is triggered by the addition of groundwater from the Madison Formation as well as along the contact between the Tertiary and Paleozoic formations. Surface water is also contributed near the present head scarp of the slide.

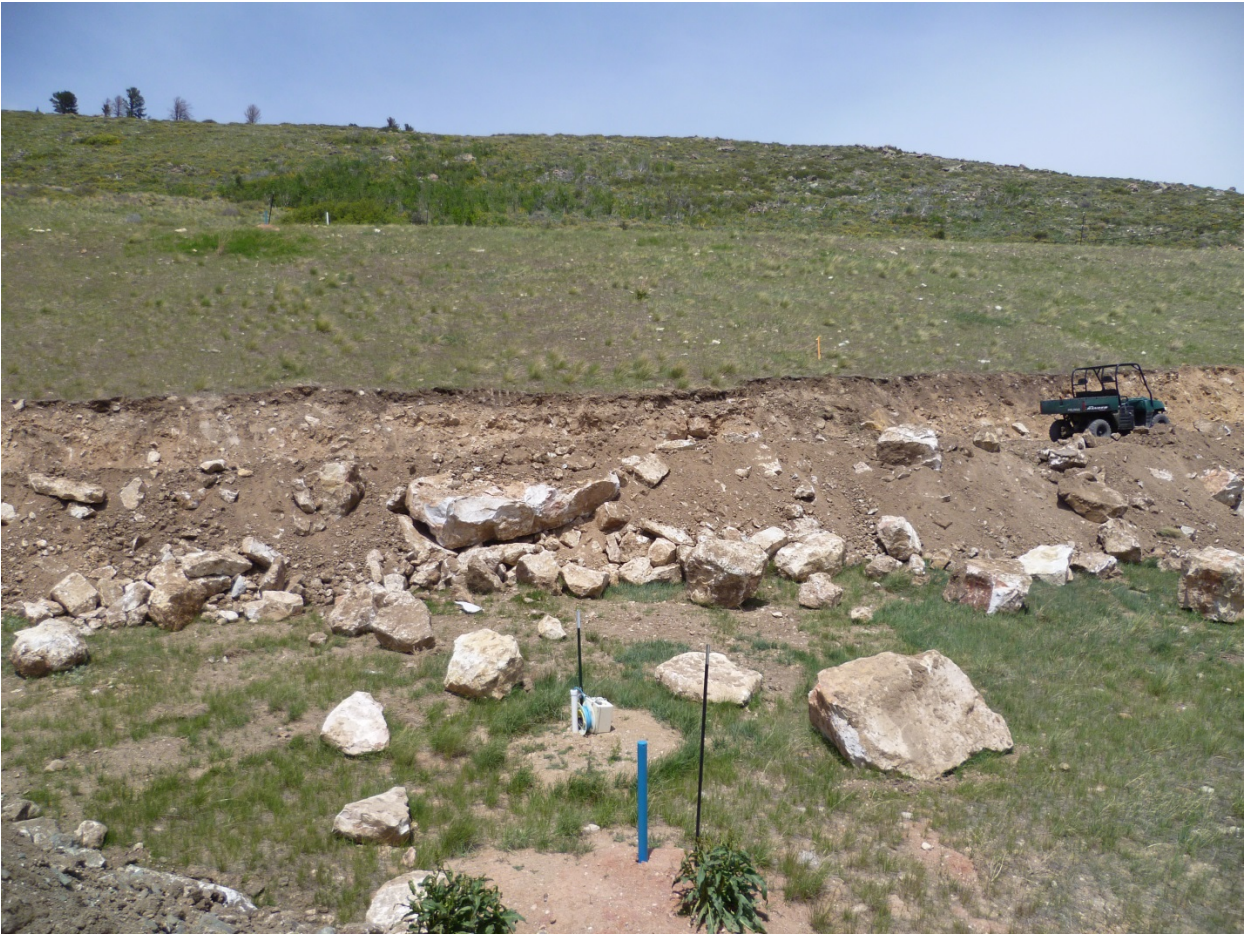
Figure 13. Grading For Drill Benches.

During this grading work, numerous boulders were encountered near the surface. One of these boulders had a 2" diameter hole drilled through it, indicating it was "shot rock", or rubble created from a blasting operation. This condition was not identified in the geotechnical report

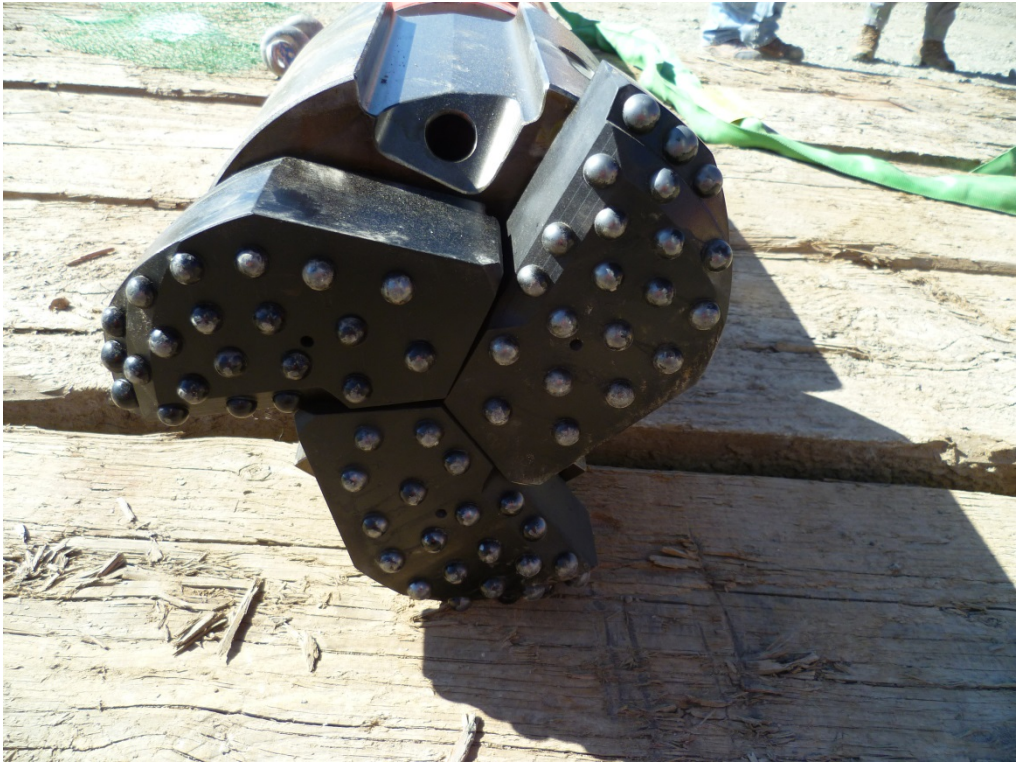
Figure 14. Down-The-Hole Hammer and Underreamer

There were challenges in the early stages of production at Row 4. In two instances, the casing could not be advanced to the required tip elevation. Initially, these challenges were attributed in part to the learning curve with the new equipment and drilling system, as well as the known ground conditions at Row 4. Various modifications were made to the drill tooling, including changes to the bit configuration and the type and quantity of cutting teeth on the permanent casing. In addition, the button bit and downhole hammer set-up was used on several shear piles during this period of the project. While production improved somewhat with these adjustments, it was still not adequate to meet the schedule requirements for the project.

Based on the experience gained during this initial production period, a new tooling system was selected. This system consisted of a 10" downhole hammer paired with an underreamer bit with a maximum diameter of 12 1/2". This system required the permanent casing to have a "blank" end with no cutting teeth. This system resulted in a much more reliable production rate than was achieved previously.
