# LANDSLIDE REMEDIATION IN DIFFICULT GROUND

Geoff Hurley, Simon Maggiora and Allan Herse

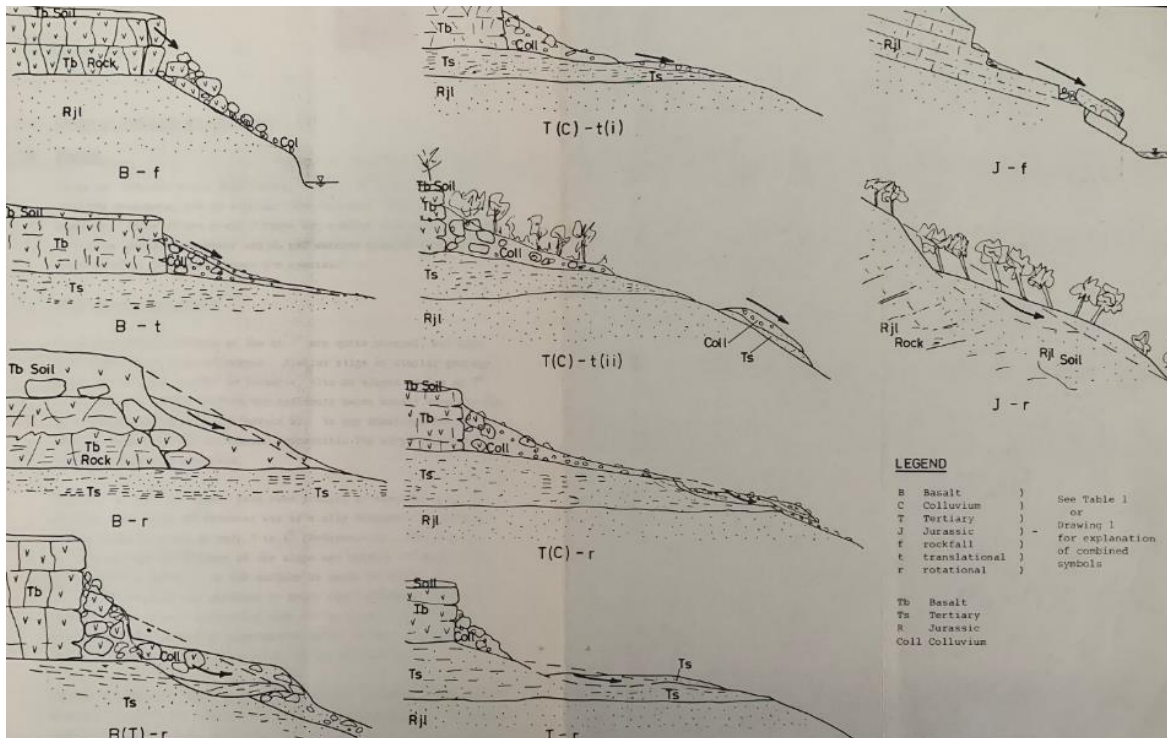
Buderim Mountain is formed by a basalt cap (typically 15 m to 25 m thick) underlain by Tertiary Sediments and then the Landsborough Sandstone formation. On the flanks of the mountain, the Tertiary Sediments and Sandstone are overlain by basalt colluvium. This colluvium is generally a sandy clay material containing large boulders of high strength basalt. Typical sections are shown below in Image 1.

**Image 1. Illustrations of geology and landslide types encountered (Courtesy of Coffey & Partners)**

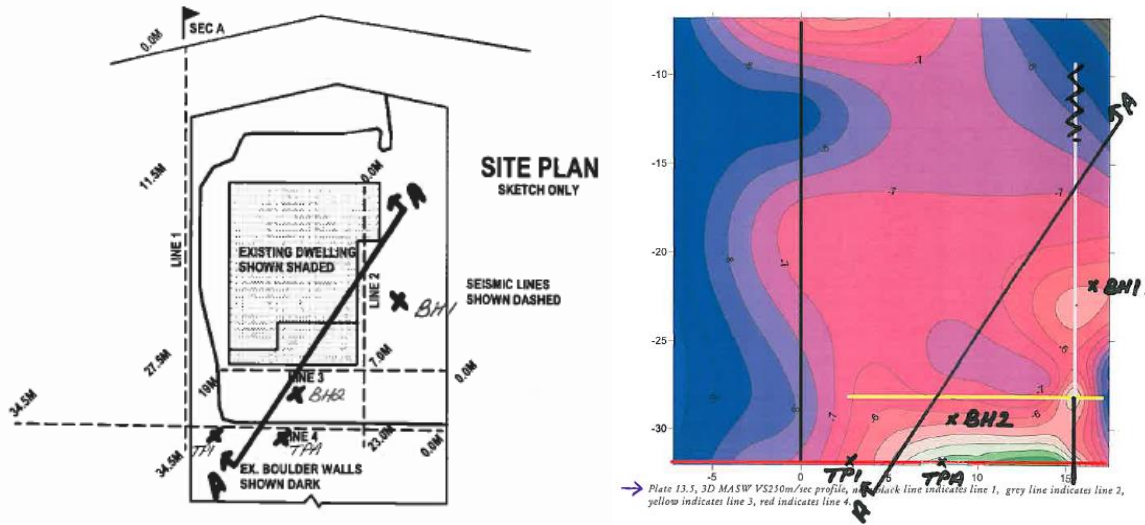
Subsurface (intrusive) investigation initially comprised test pitting and borehole drilling, followed up with MASW seismic surveys. Images 2 and 3 shows the investigation layout and results of MASW survey. Using that information, together with the results from previous investigations, a geotechnical model was developed. Image 4 displays a cross-sectional profile of the subsurface conditions.

The subsurface conditions encountered in the boreholes generally included fill materials comprising silty/sandy clay mixed with basalt cobbles and boulders up to a depth of 2.5 m. Fill materials were underlain by colluvial materials (up to 2.15 m thick) generally consisting of clay soils mixed with very high strength basalt cobbles and boulders (up to approximately 600 mm in diameter). These materials were underlain by the Tertiary sediments (including fissured clays) that were up to 5.1 m thick, overlying the Landsborough Sandstone Formation.

Image 2 (left) and Image 3 (right). Image 2 shows a plan of the investigation layout; Image 3 shows a 2D MASW shear wave velocity ( $V_s$ ) profile

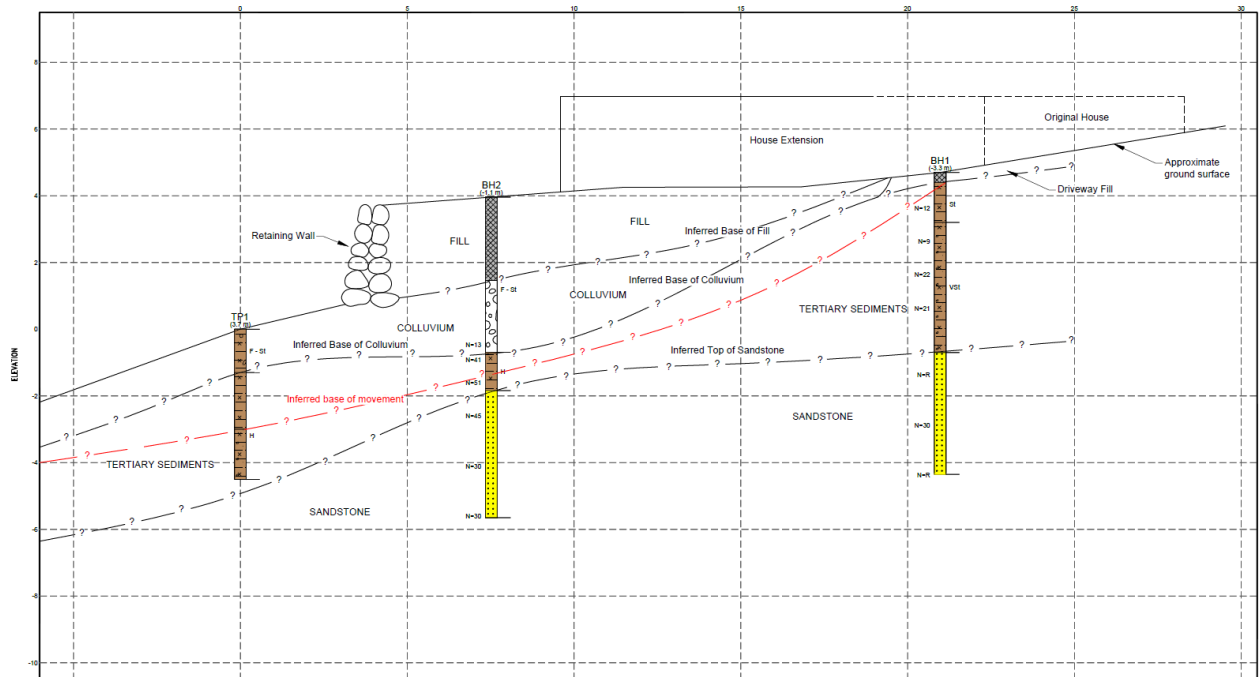
Image 4. Cross sectional profile of subsurface conditions

Further to the information provided in those reports, the results of our geotechnical investigation indicates that the ground movement is most likely associated with deep seated circular and/or translational movement of the fill, colluvium and underlying Tertiary Sediments. Our experience in the Buderim area suggests the Tertiary Sediments have relatively low shear strength parameters and are highly susceptible to movement, particularly when affected by groundwater.

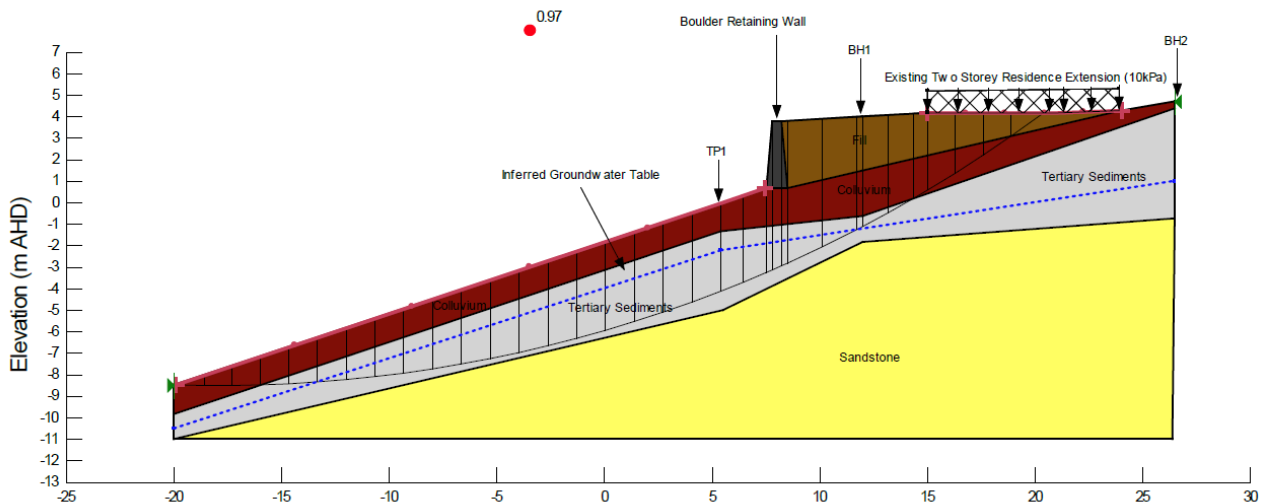
A geotechnical model was developed and used to carry out numerical back analysis of the ground movement. The back analysis (using the software SlopeW) aimed to identify the ground conditions at the time of failure (i.e. soil strength and groundwater conditions). Image 5 displays the SlopeW back-analysis output. This information was used for subsequent design of the remedial solution.

**Image 5. SlopeW back-analysis output**

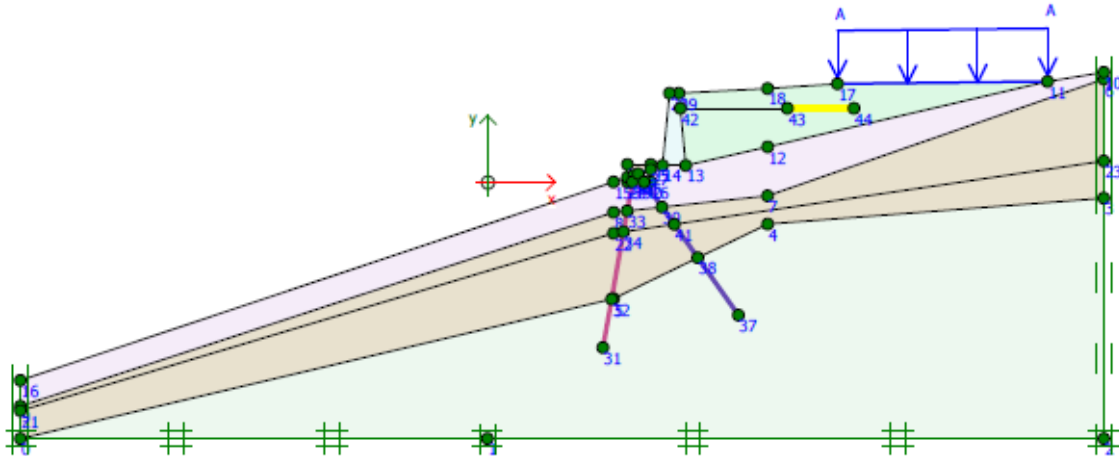
**Image 6. Plaxis model inputs of micropile system**

Using the results of the geotechnical investigation and numerical analysis, conceptual remedial design options were considered for the residence and lot. These remedial options included subsurface drainage measures, an earth bund, micropiled 'A-frame' walls, and under pinning of the residence using a micropile system. Our recommendation was to adopt the micropile systems downslope of the boulder wall to arrest future ground movement. A separate micropile system was also recommended to support the residence, in particular to support the extension built over the fill platform. Images 6 and 7 below show how the micropile system was modelled using Plaxis software.

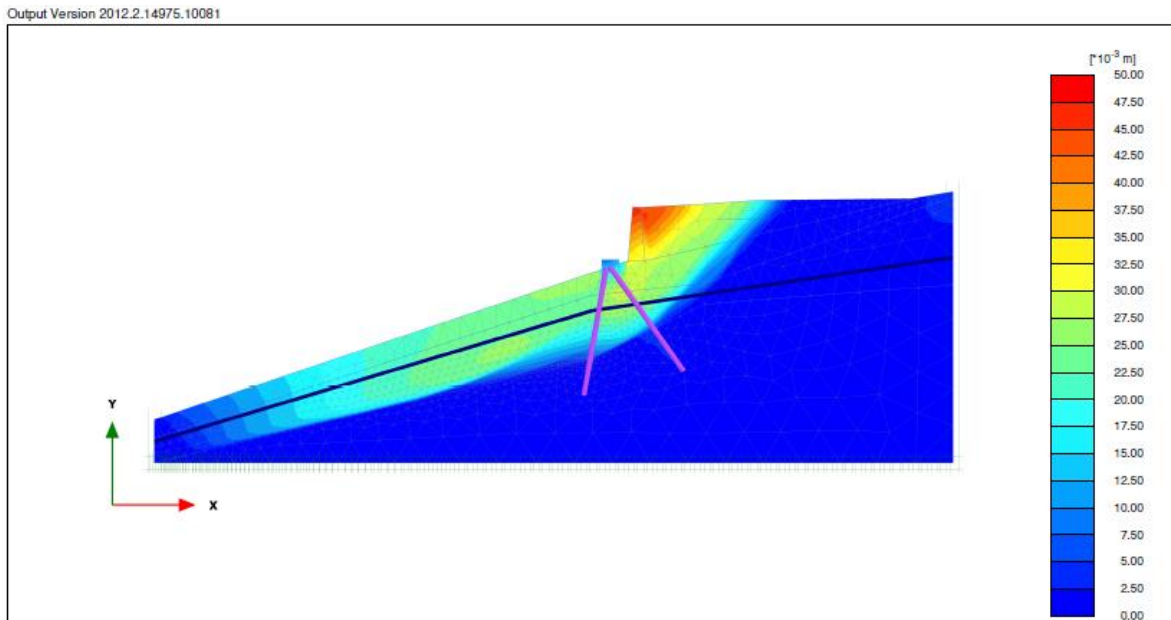
**Image 7. Plaxis model outputs of micropile system showing maximum deflections**
