15TH International Workshop On Micropiles

WHEN HEAT TREATMENT GIVES YOU LEMONS...

Quality Control for Galvanized Washers

presented by Justin Toney, P.E. | Crux Subsurface

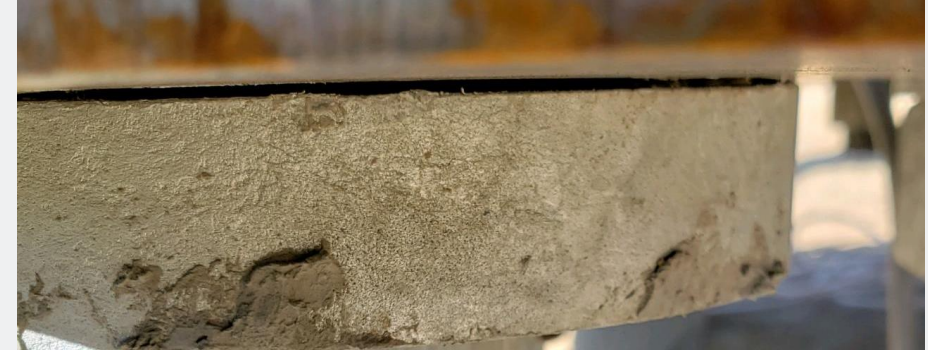
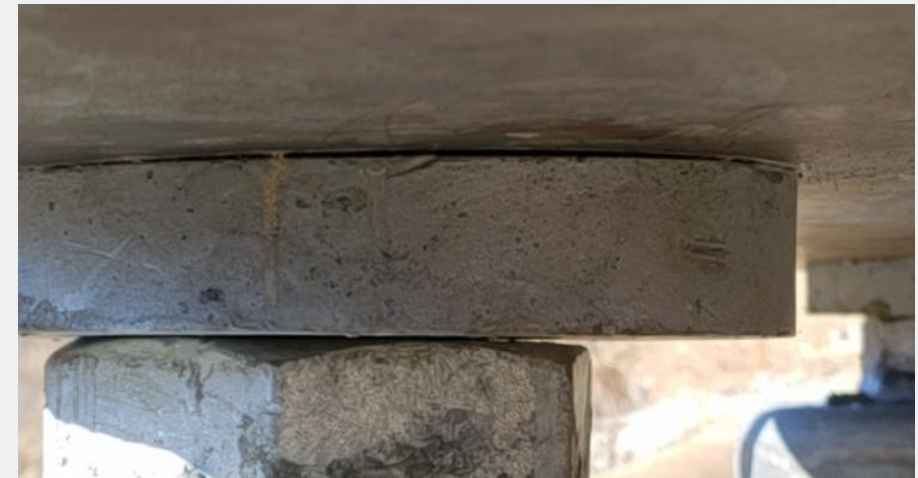
Discovered “Warped” Washers

- **October 2018** gaps observed between washer and pile cap surface
- Probable cause attributed to band saw cutting high yield strength (high hardness) parts
- Measured gaps up to 1 mm (0.04”) thick
- No defined allowable fabrication tolerance
- Client concern over reduced contact area and potential increase in bearing stress

- Flatness tolerance established for fabrication
 - 0.032” ASTM F438 washers greater than 3” nominal size
- Out of tolerance washers removed and re-worked to within tolerance where possible
- Solutions for future fabrication
 - Slower feed rate when cutting
 - Manually checking every washer
 - Additional machining prior to galvanizing

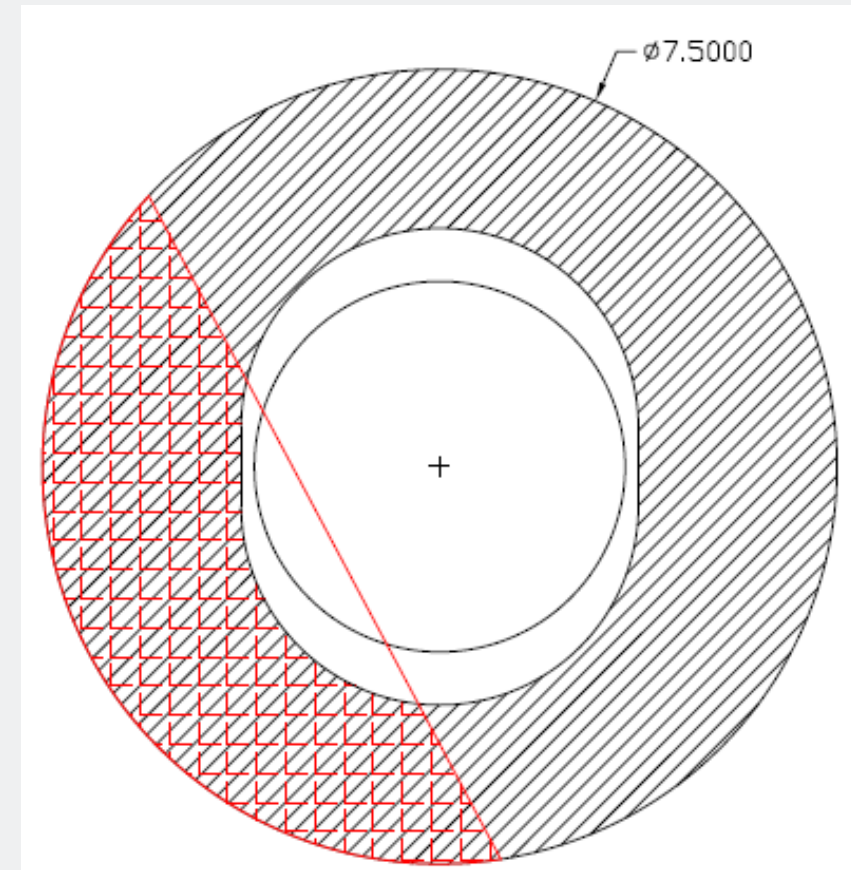
- Gaps identified at nearly 50 individual washers over 12 structure locations
- Feeler gauges used to determine extent and depth of gaps
- Measurements mapped
- Bearing analysis performed to analyze bearing stress under theoretical reduced area

Initial contact area = 30.3 in²

Gap area = 11.16 in²

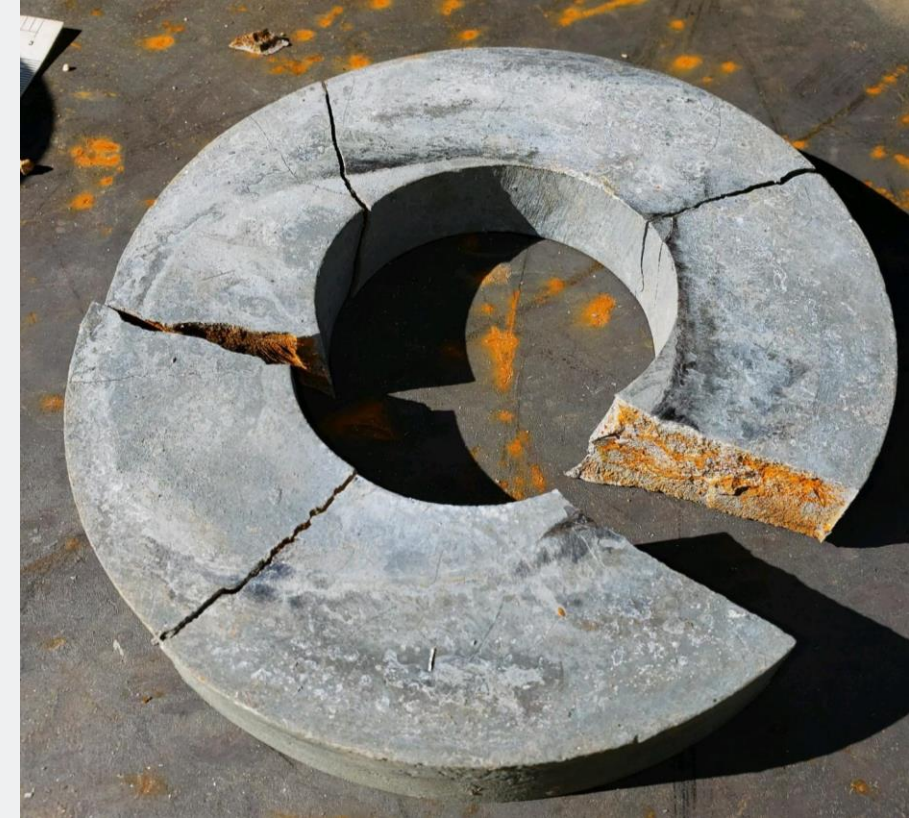
Discovered Fractured Washers

- **December 2018** single broken washer observed on segment “A”
 - 2.25” x 2.5 degree washer
 - Located on top of pile cap
 - Pole set but line not installed
- **May 2019** multiple broken washers observed on segment “B”
 - 2.25” x 5.0 degree washer
 - Located on both top and bottom of pile cap
 - Poles set and line energized

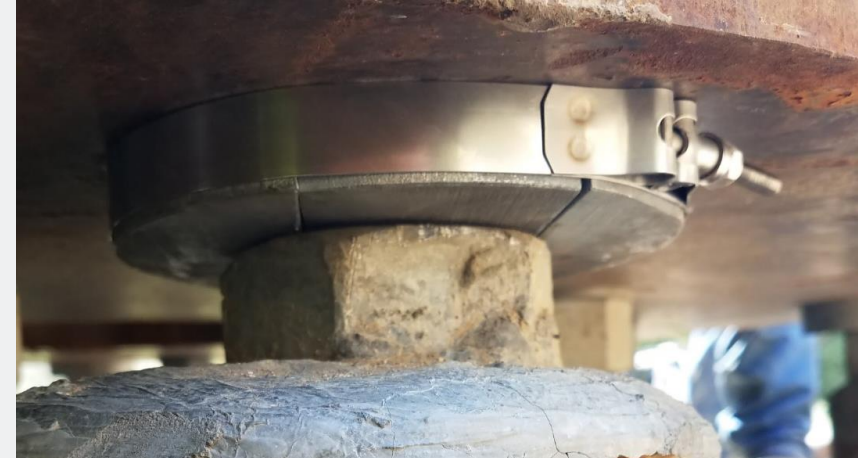
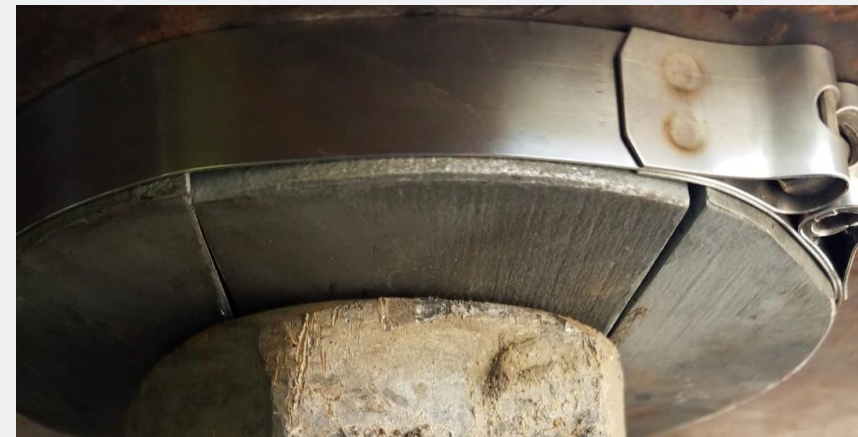
- No (**December 2018**)
 - Only one broken washer indicating isolated issue
 - No wire strung
- Possibly (**May 2019**)
 - Additional broken washers in different size indicate potential widespread issue
 - Energized line
- Mitigation measures
 - Broken and suspected top washers replaced
 - Bottom washers “banded” with temporary replacement washers

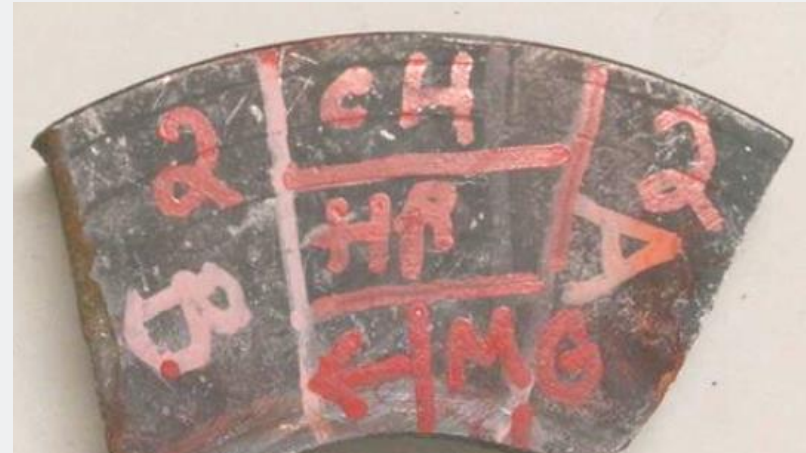
- 2.25" x 2.5 degree broken washer from segment "A" and control washer known to be fabricated for segment "A" sent to lab
- Chemical and physical testing identified the following for the broken washer
 - Rockwell C hardness 46.9 (30-35 specified)
 - Hydrogen embrittlement ruled out
 - Zinc deposits on fractured faces
 - Machining marks on washer surface

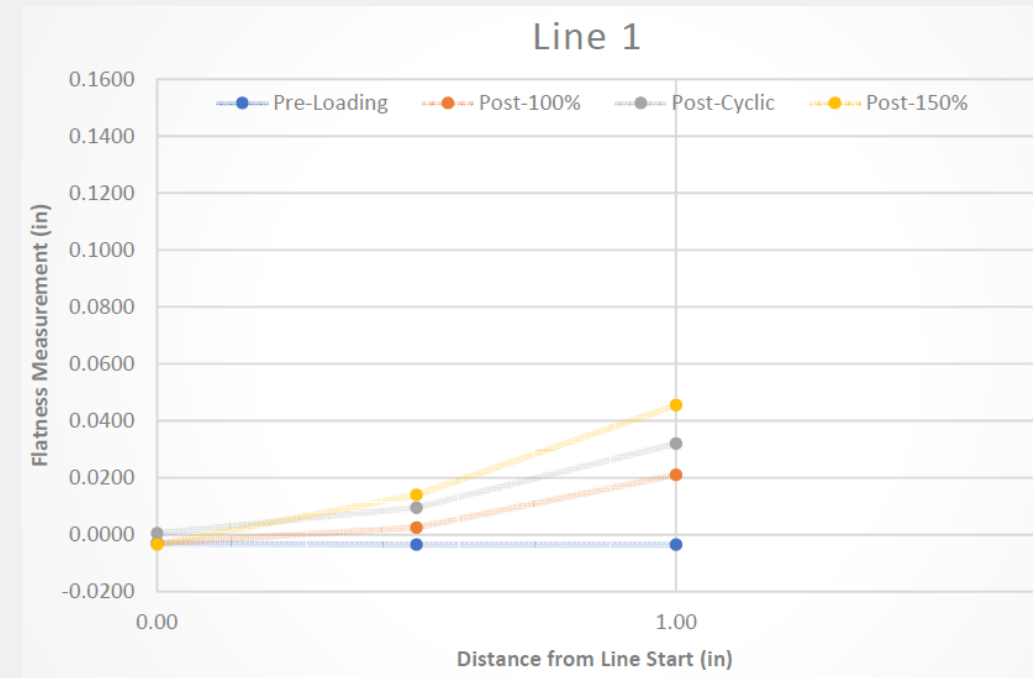
- Testing results
 - Good performance at 1.0 DL static test
 - Apparent bending and increased deflection at thin side during 1.0 DL cyclic test
 - Ductile behavior at 1.5 DL showed no sudden catastrophic failure
- Replacement washers fabricated to provide immediate temporary replacement to banded bottom washers
