Real-Time Monitoring During Underpinning Works

# Sol Data a case history

Real-time monitoring during underpinning works (micropiles)

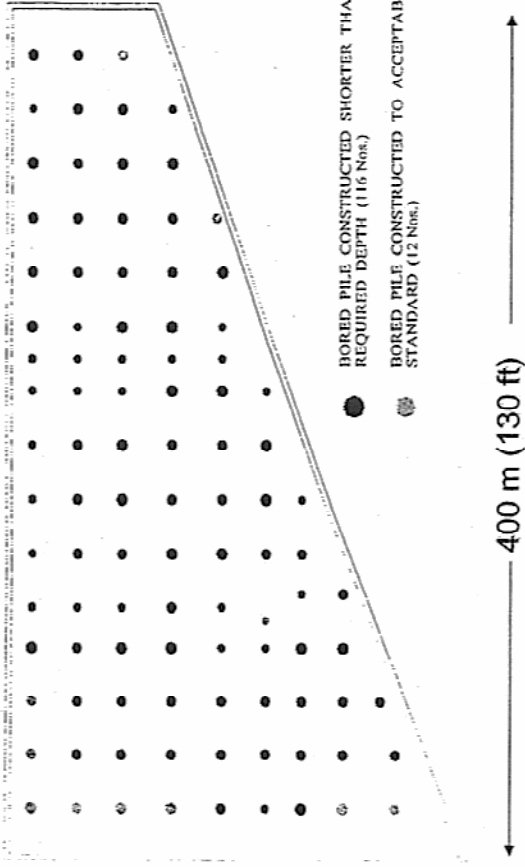
● BORED PILE CONSTRUCTED SHORTER THAN REQUIRED DEPTH (116 Nos.)  
 ○ BORED PILE CONSTRUCTED TO ACCEPTABLE STANDARD (12 Nos.)

- 3 Levels of basement Top-Down Construction carried out by a local company
- Large diameter bored piles constructed shorter than required depth
- 116 piles out of 128 to repair

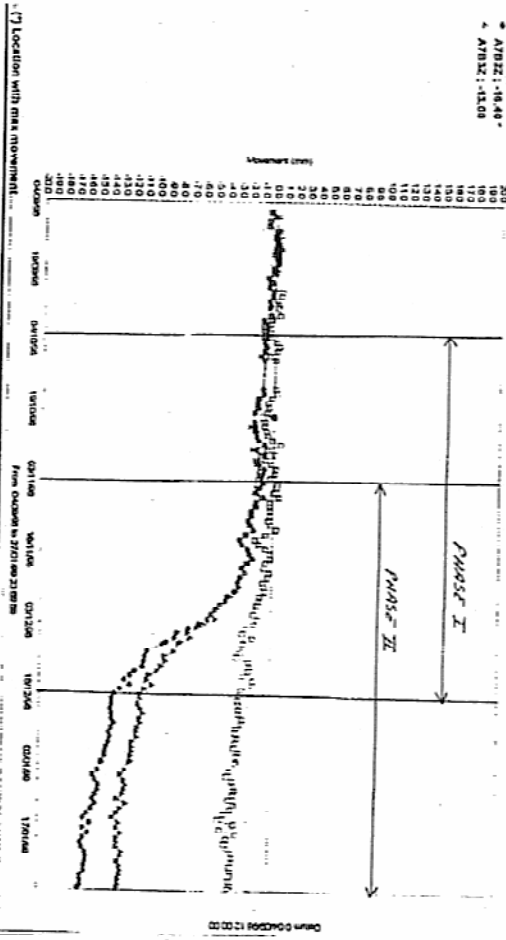
Column BP40, BP37 & BP38

Last data (mml):  
 U AB02Z: -2.45  
 V AB02Z: -18.40  
 W AB02Z: -13.08

MONITORING PERIOD GRAPH  
 FINAL REPORT  
 Cycles (Difference From Datum)
