Using micropiles for long-term stabilisation of slopes

A Queensland Department of Transport and Main Roads Perspective

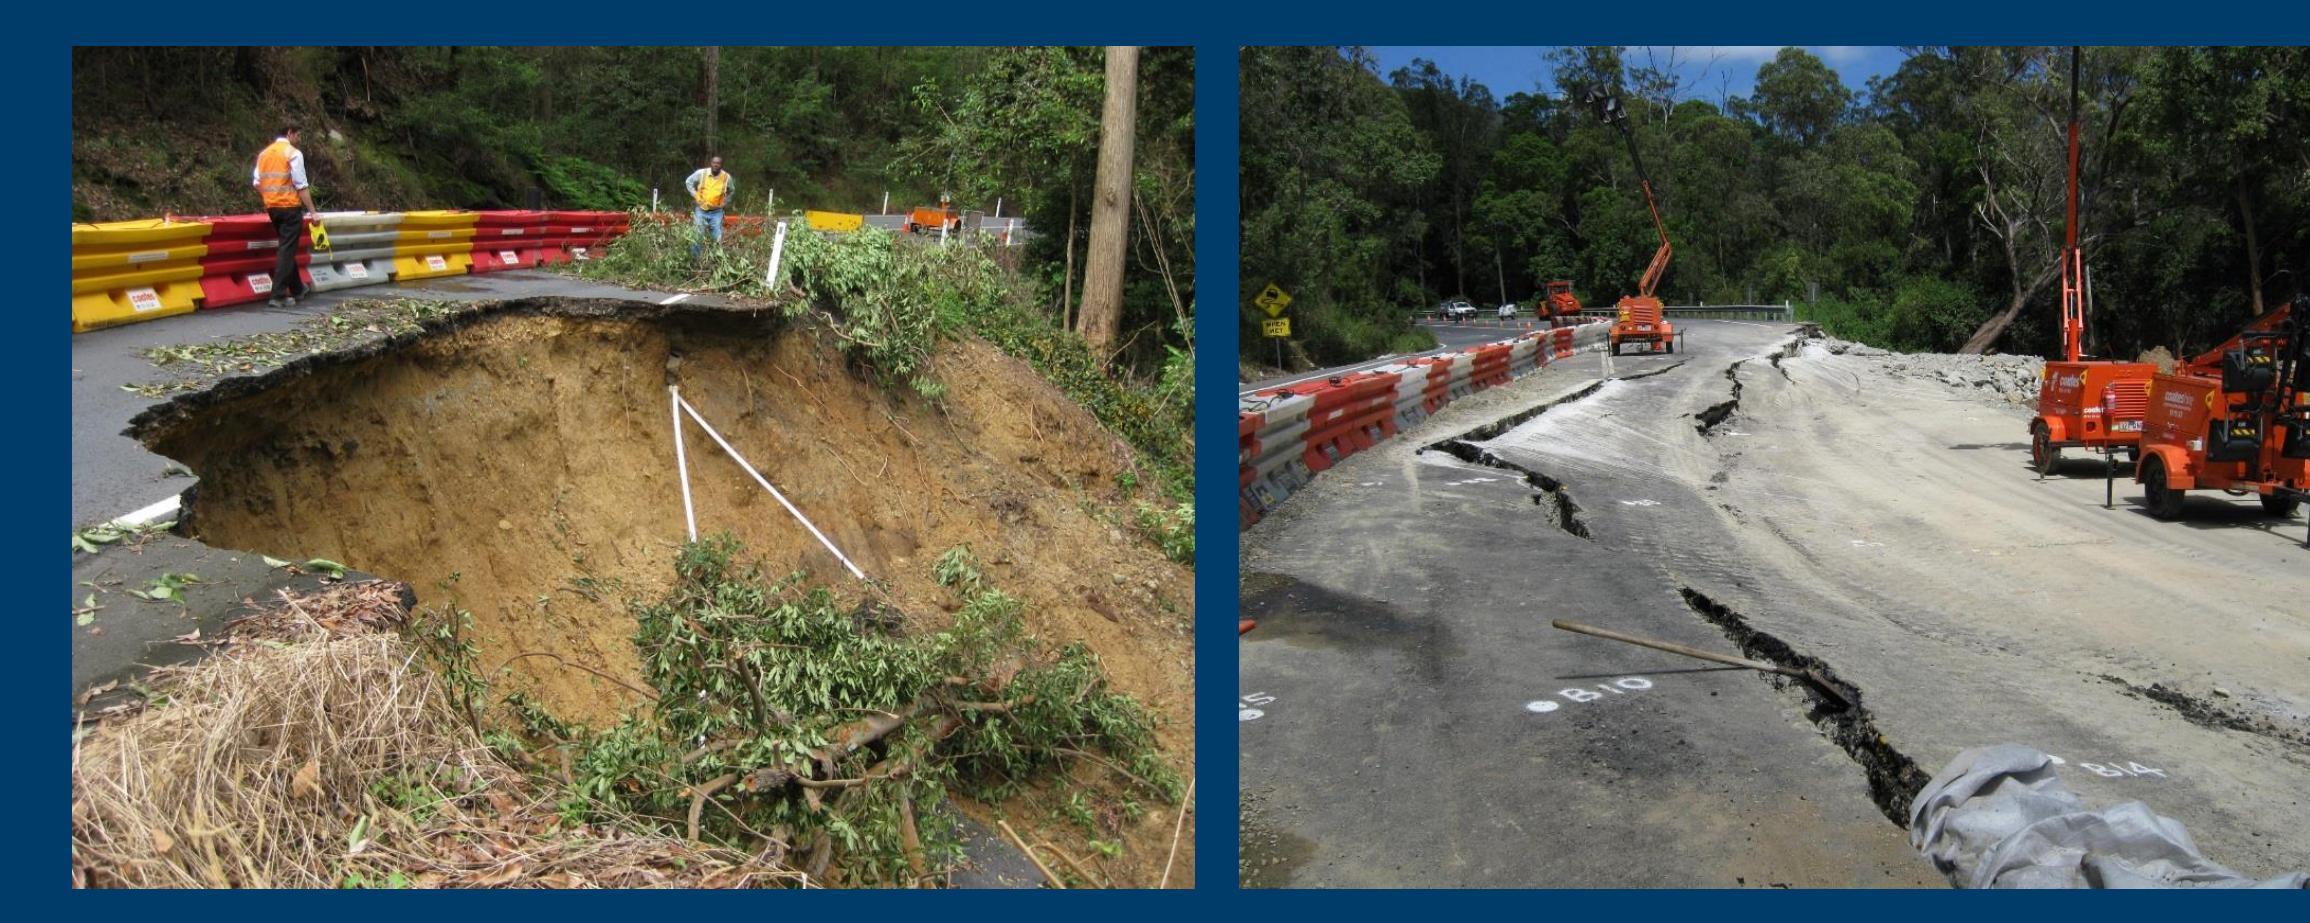
Kilcoy – Beerwah Road

Heavy rainfall – December 2008

Cunningham Highway

Rainfall/floods – ex Tropical Cyclone Yasi – Dec 2010/Jan 2011

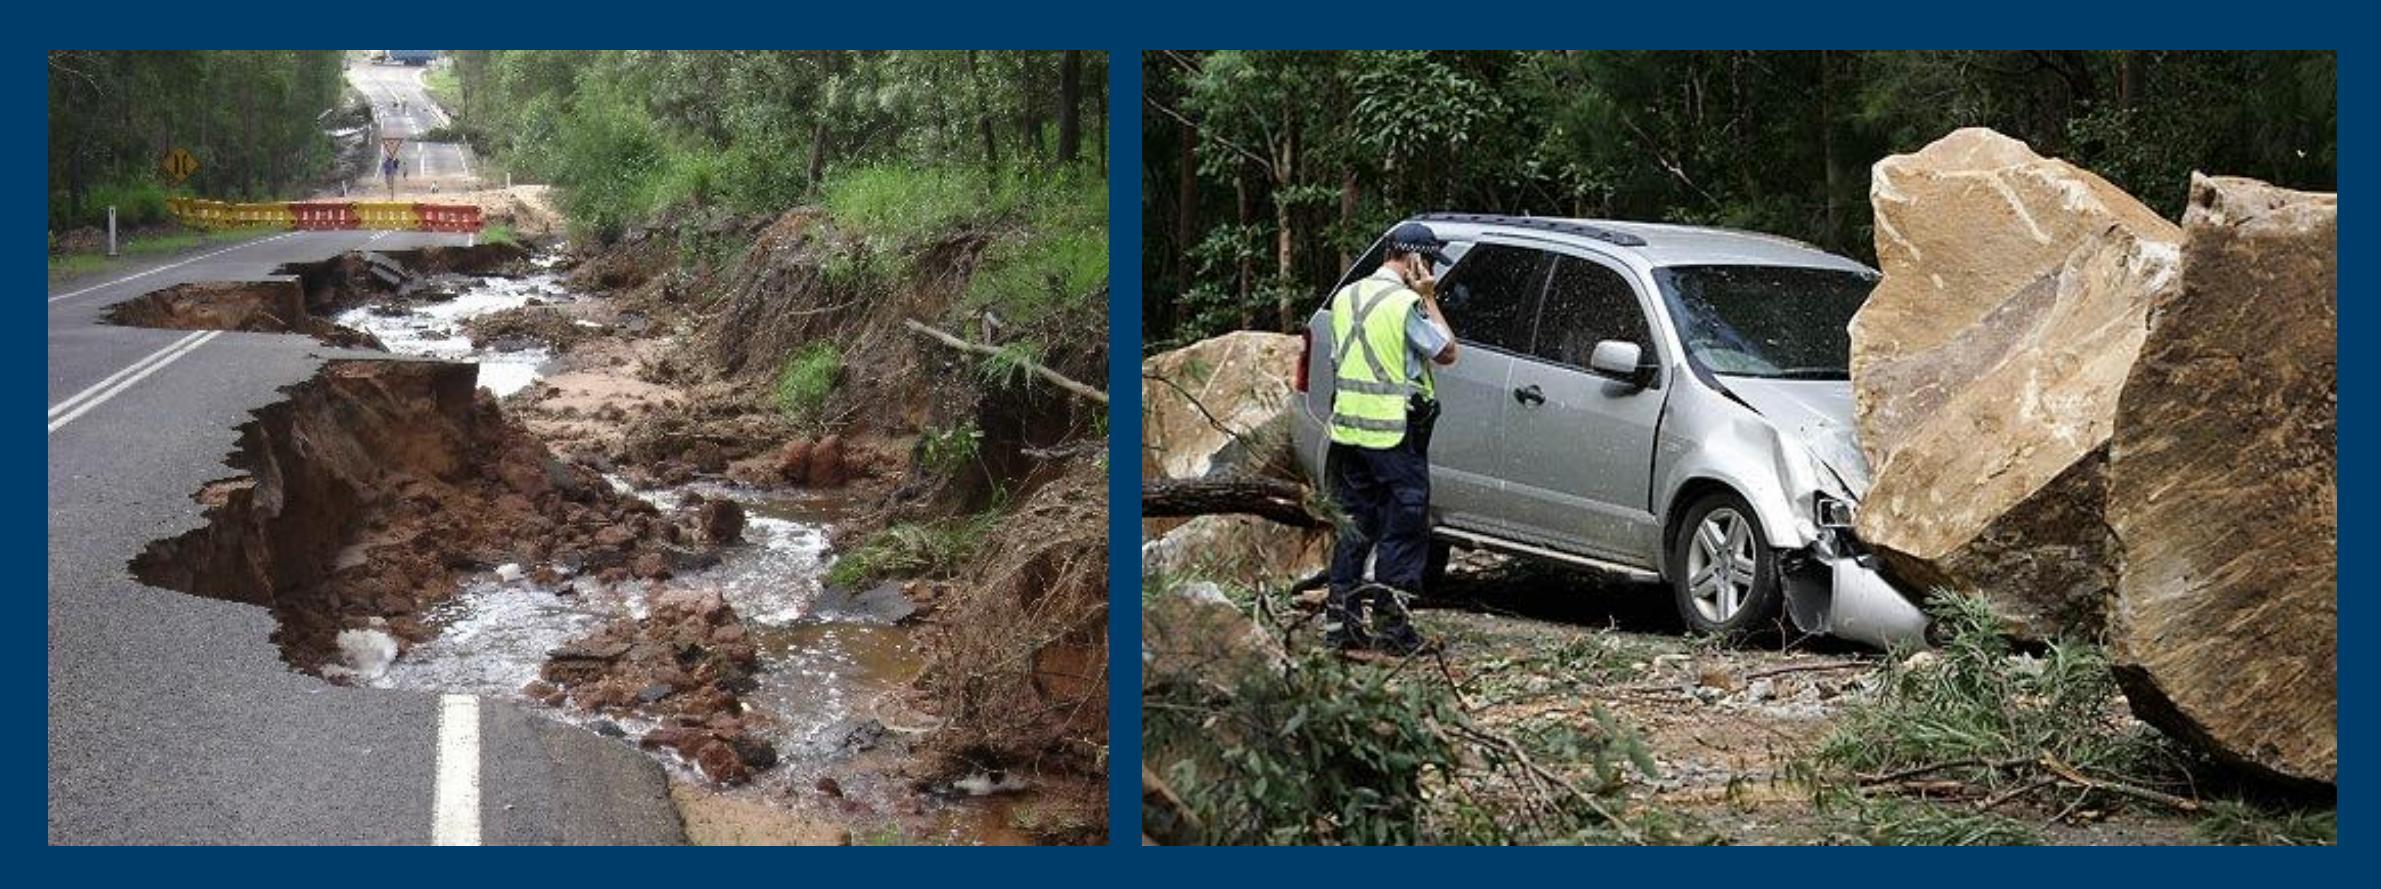
Goodwood Road Bundaberg Rainfall/floods – ex Tropical Cyclone Yasi – Dec 2010/Jan 2011

Springbrook Road – Gold Coast Hinterland, District 5 April 2009. Photo Source: Gold Coast Bulletin 6 April 2009

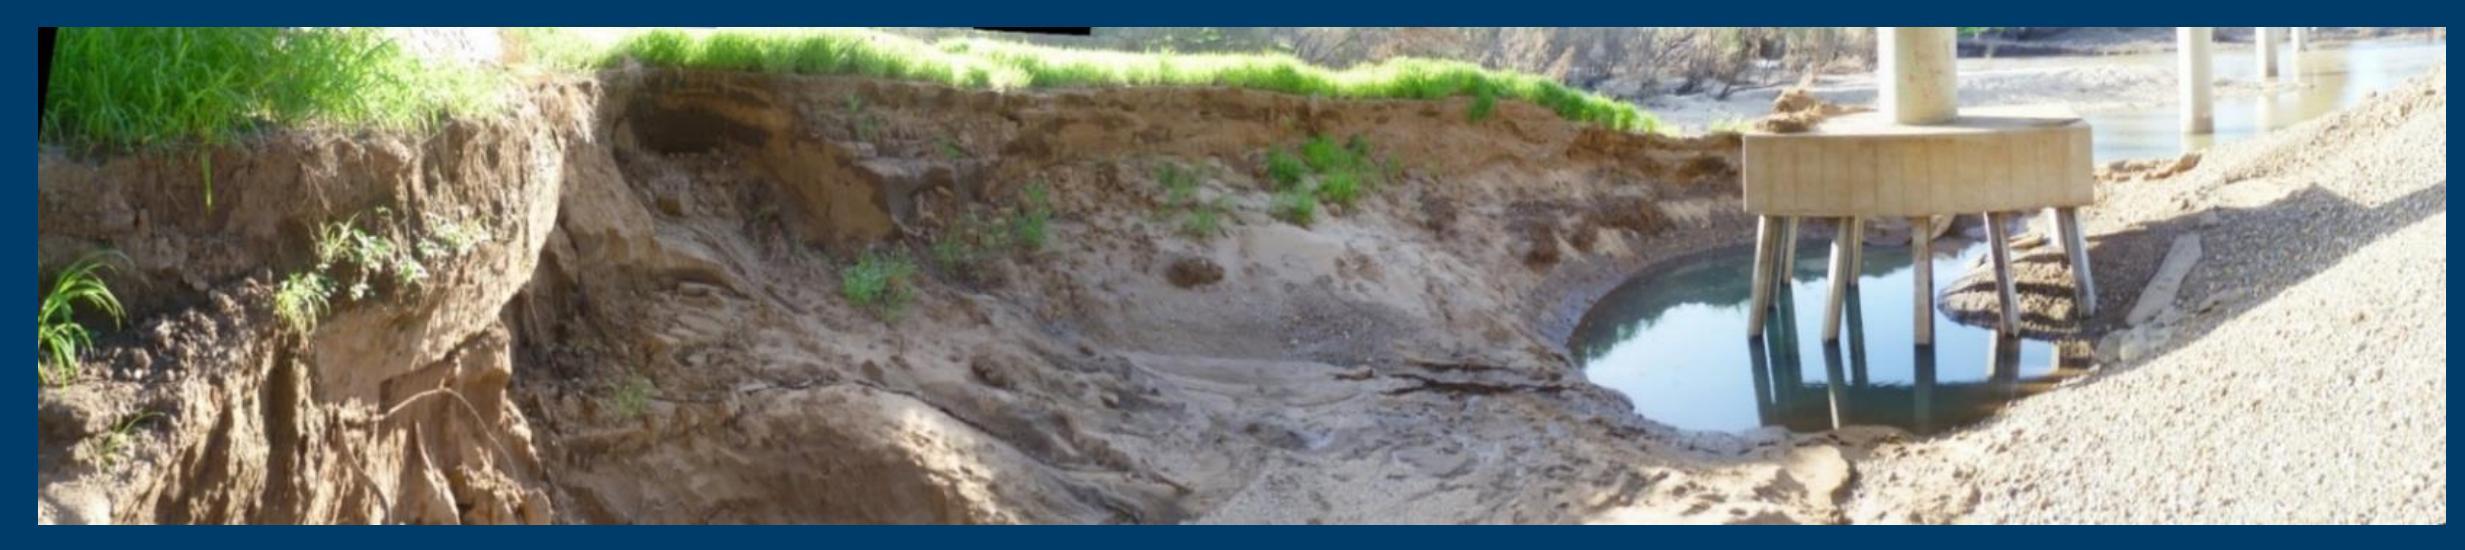
Geoff Fisher Bridge, Lockyer Valley, near Brisbane

Ex Tropical Cyclone Yasi – December 2010/January 2011

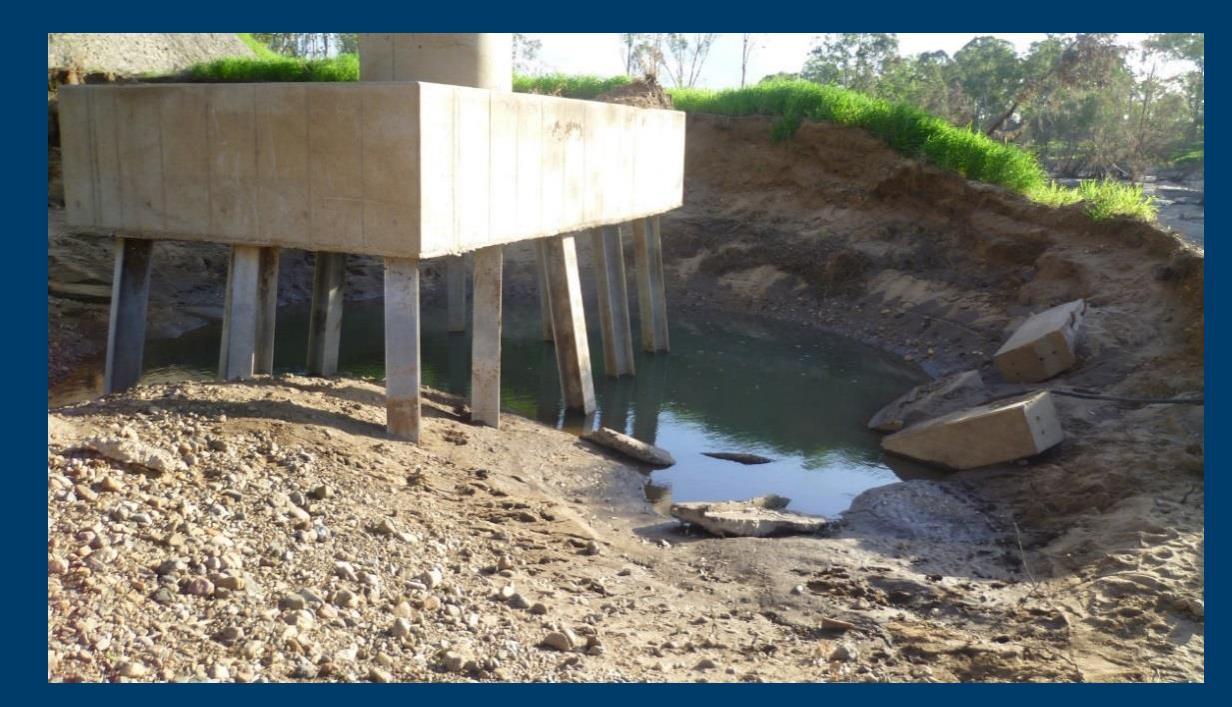
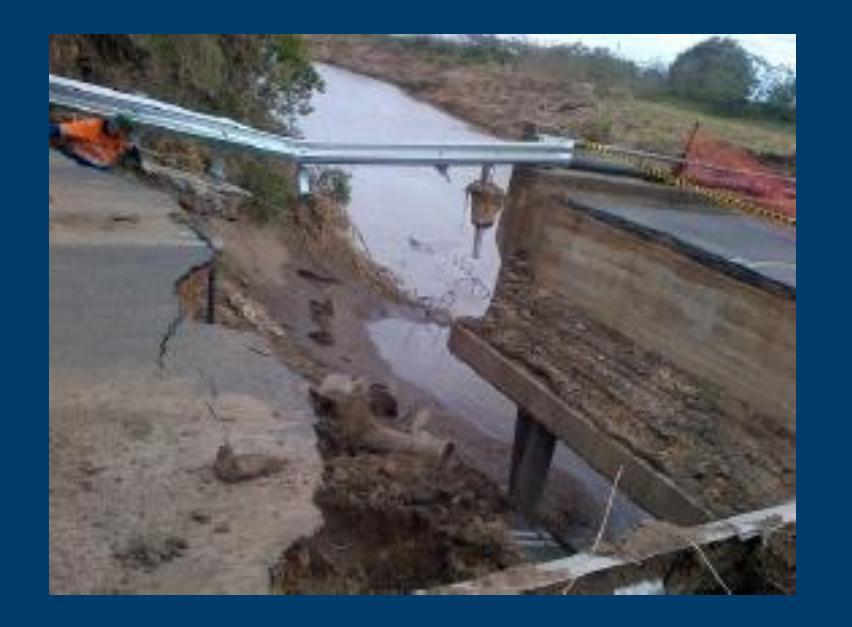
Lockyer Creek, Gatton-Esk Road

Ex Tropical Cyclone Yasi December 2010/January 2011

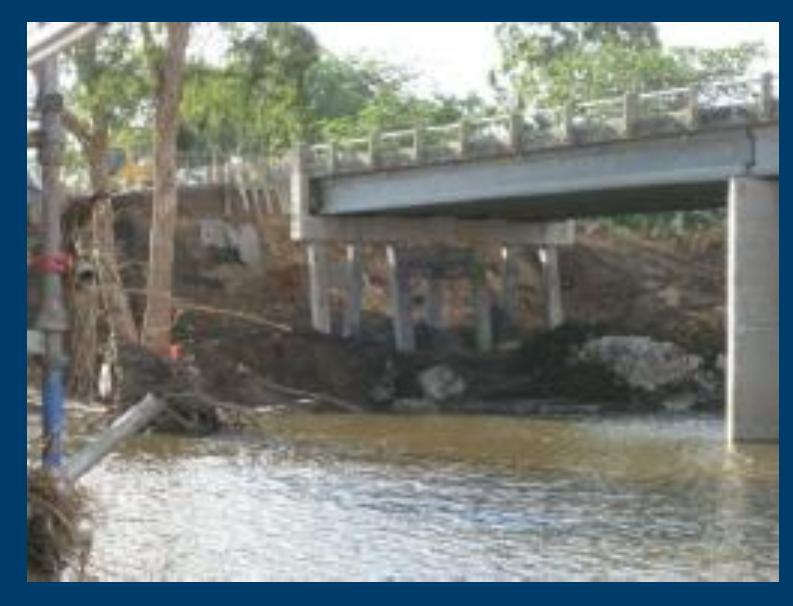
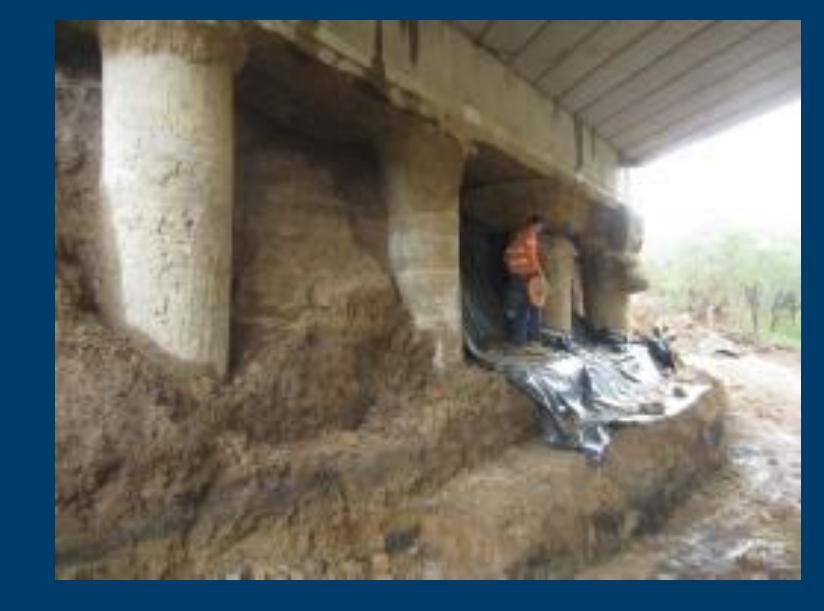
Neerkol Creek, near Rockhampton

Ex Tropical Cyclone Oswald January 2013

Double Creek, near Rockhampton

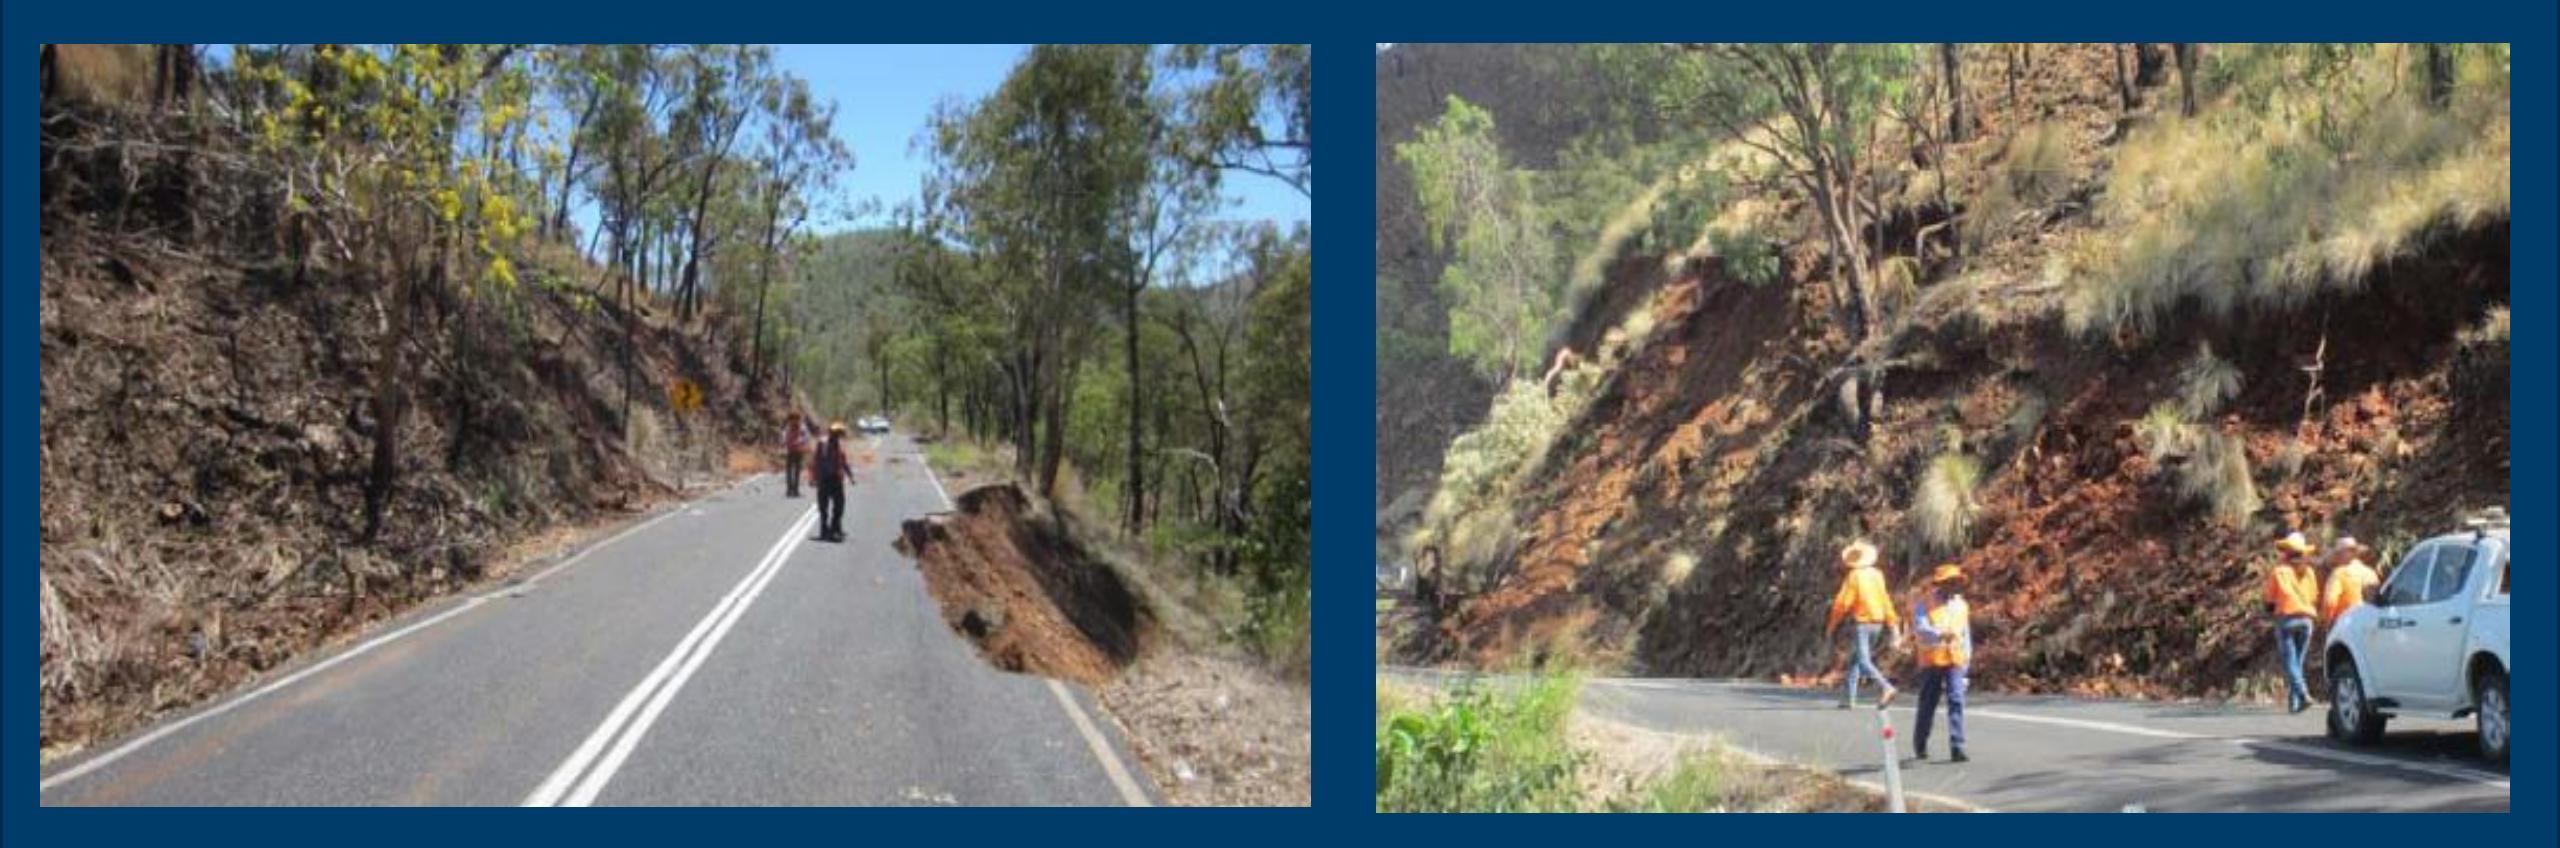
Mt. Morgan – Burnett Highway

Ex Tropical Cyclone Oswald – January 2013

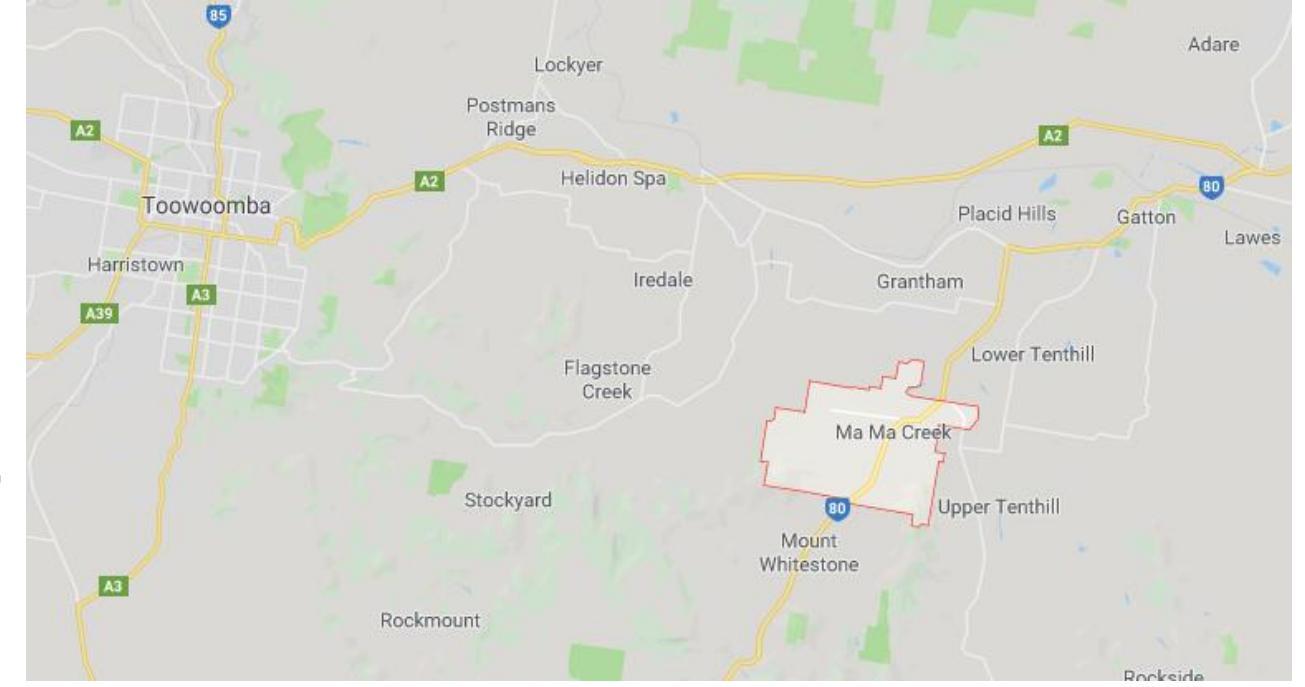
- Affected section located just outside the township of Gatton close to Ma Ma Creek.
- 30m effected between chainage 203.1 and 203.4km.
- Available road width is less than 6.1m, rural, narrow and winding.
- The geometry consists of up-slope cuttings and down-slope sidelong embankment fills.
- The down-slope batter continues into a ravine meeting Ma Ma Creek.

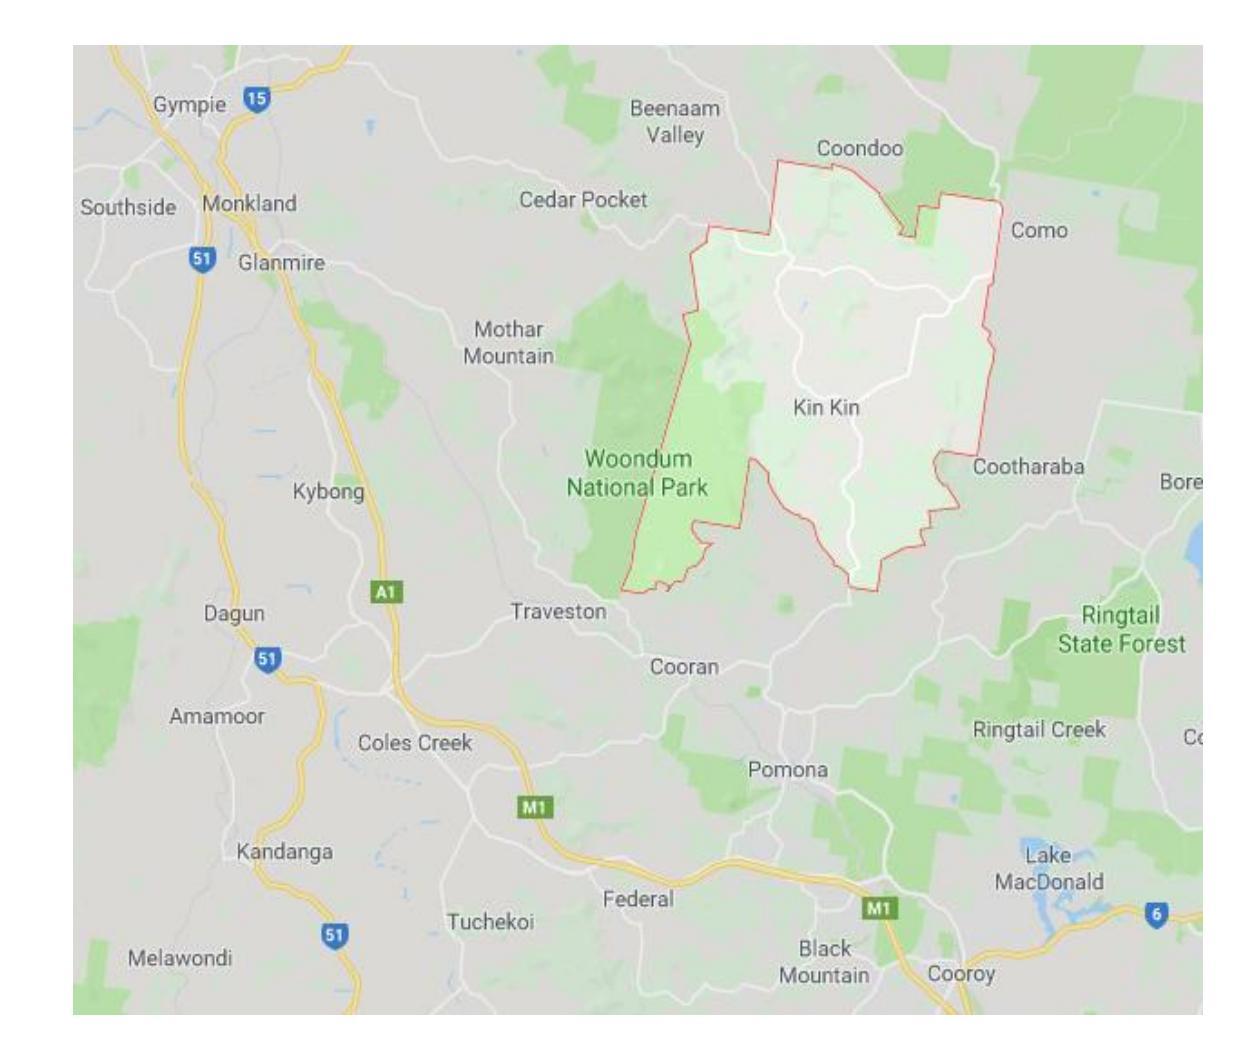
- About 1.3km south of Kin Kin town centre.
- 40m effected between chainage 35.93 to 35.97km.
- Average Annual Daily Traffic = 2921 vehicles per day.
- Two lane undivided rural road with a 6m width.
- The road consists of up-slope cuttings and down-slope sidelong embankment fills.
- The down-slope batter continues in to Kin Kin Creek.

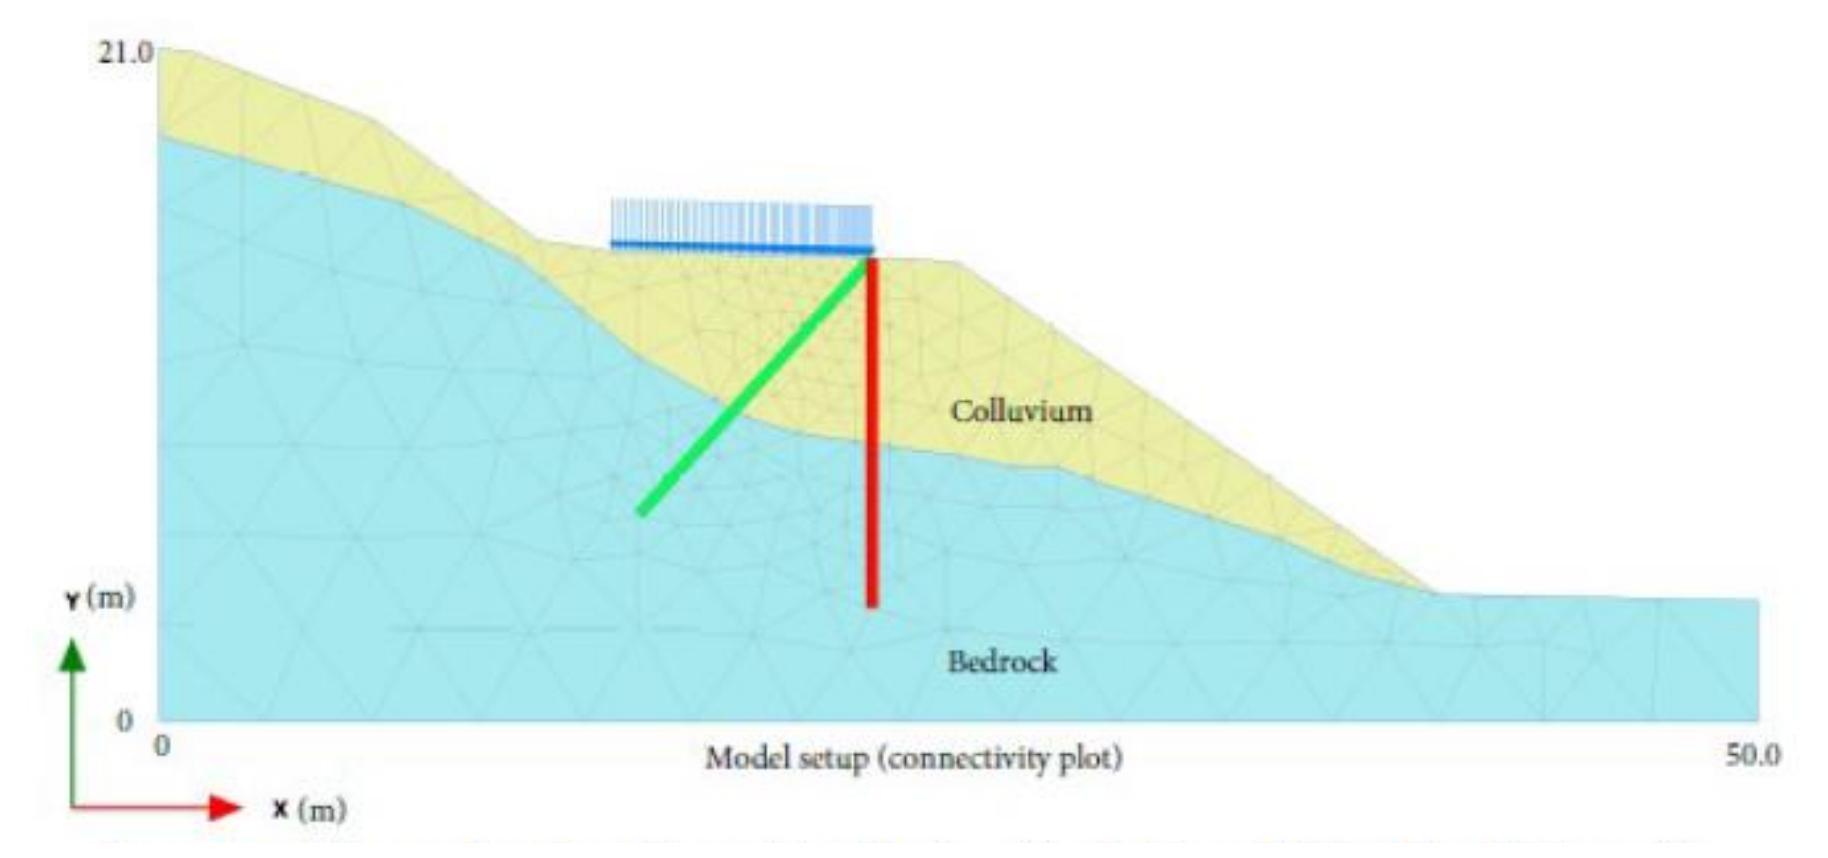
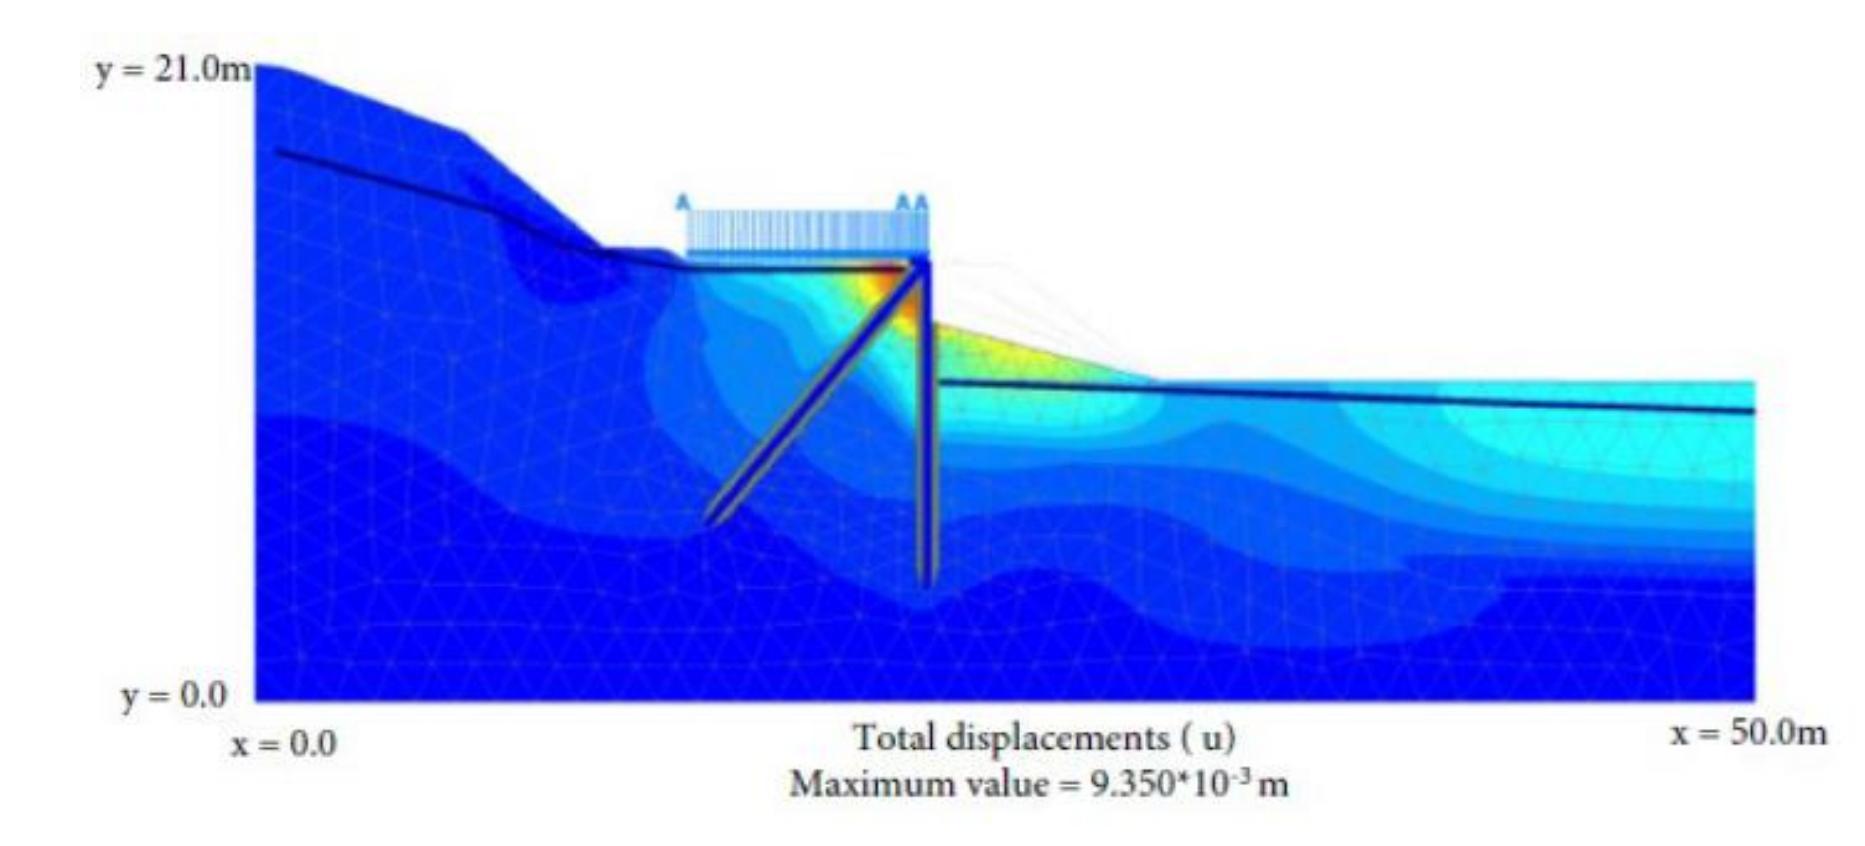
Geometry of the analysed problem at Section 6 on the Gatton-Clifton Road (Figure 3).

Computed lateral displacement at the ULS condition – up to 2m loss of soil in front of the pile wall and groundwater table at ground surface.

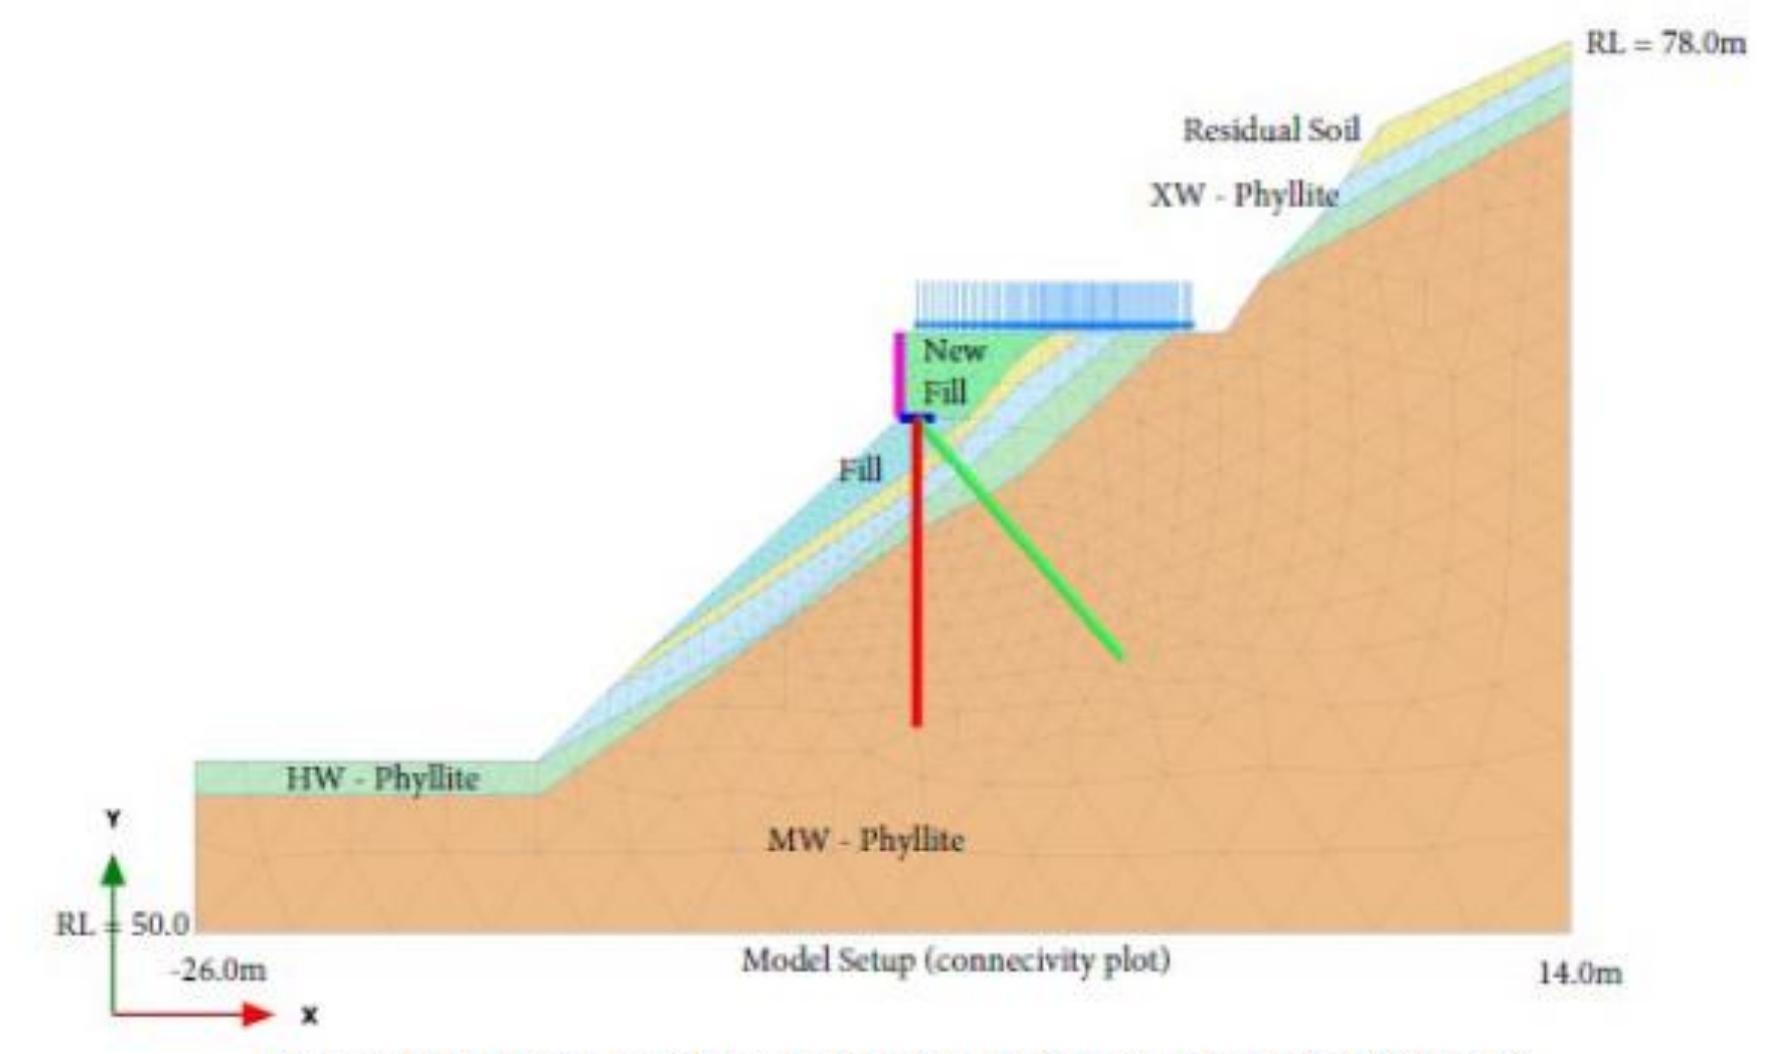
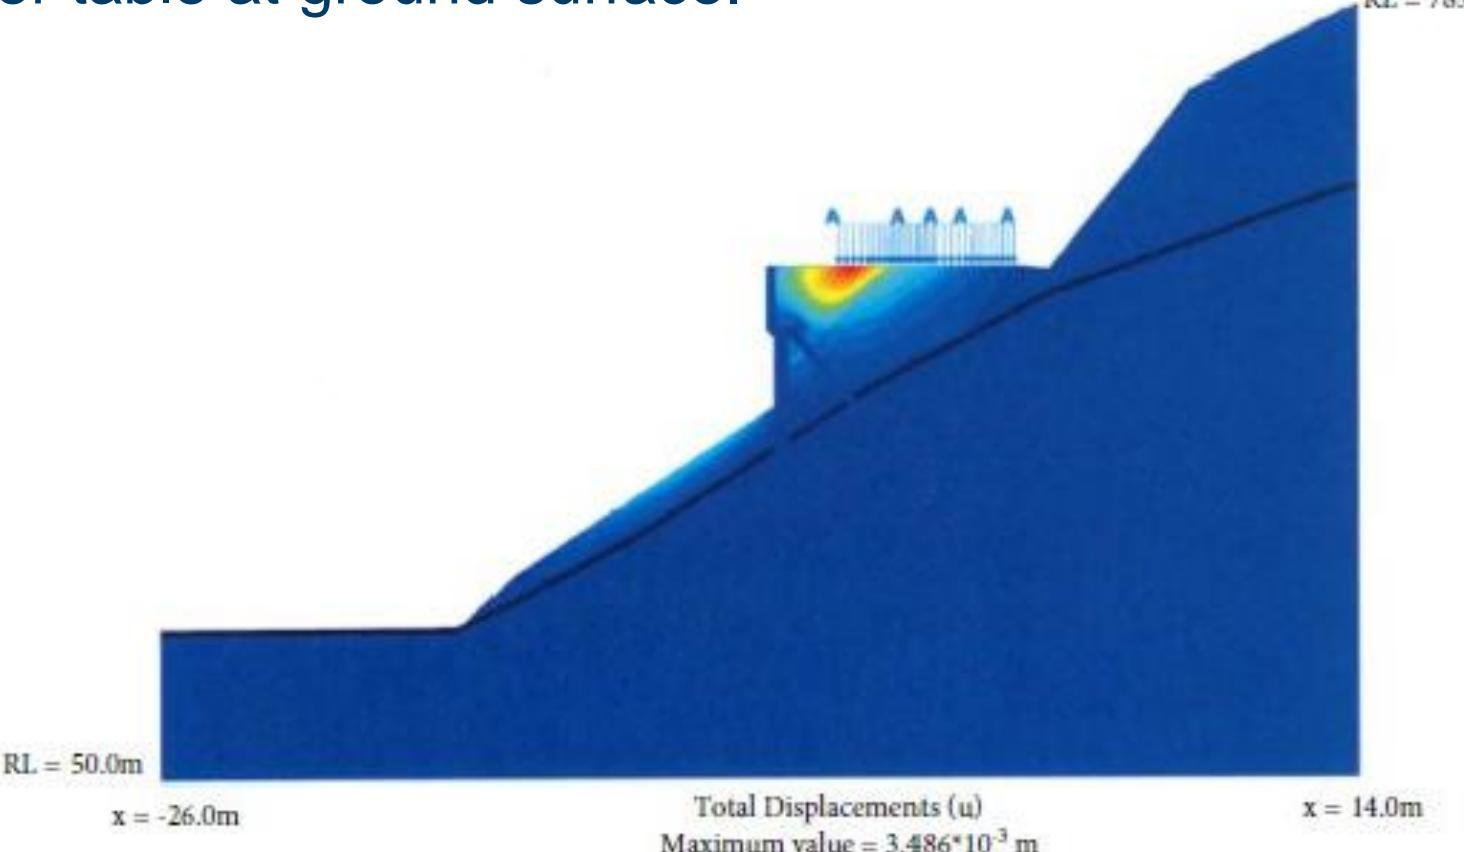
Geometry of the analysed problem at Kin Kin Road (Figure 5).

Computed lateral displacement at the ULS condition – Up to 2m of soil loss in front of the pile wall plus additional load due to retaining wall and groundwater table at ground surface.

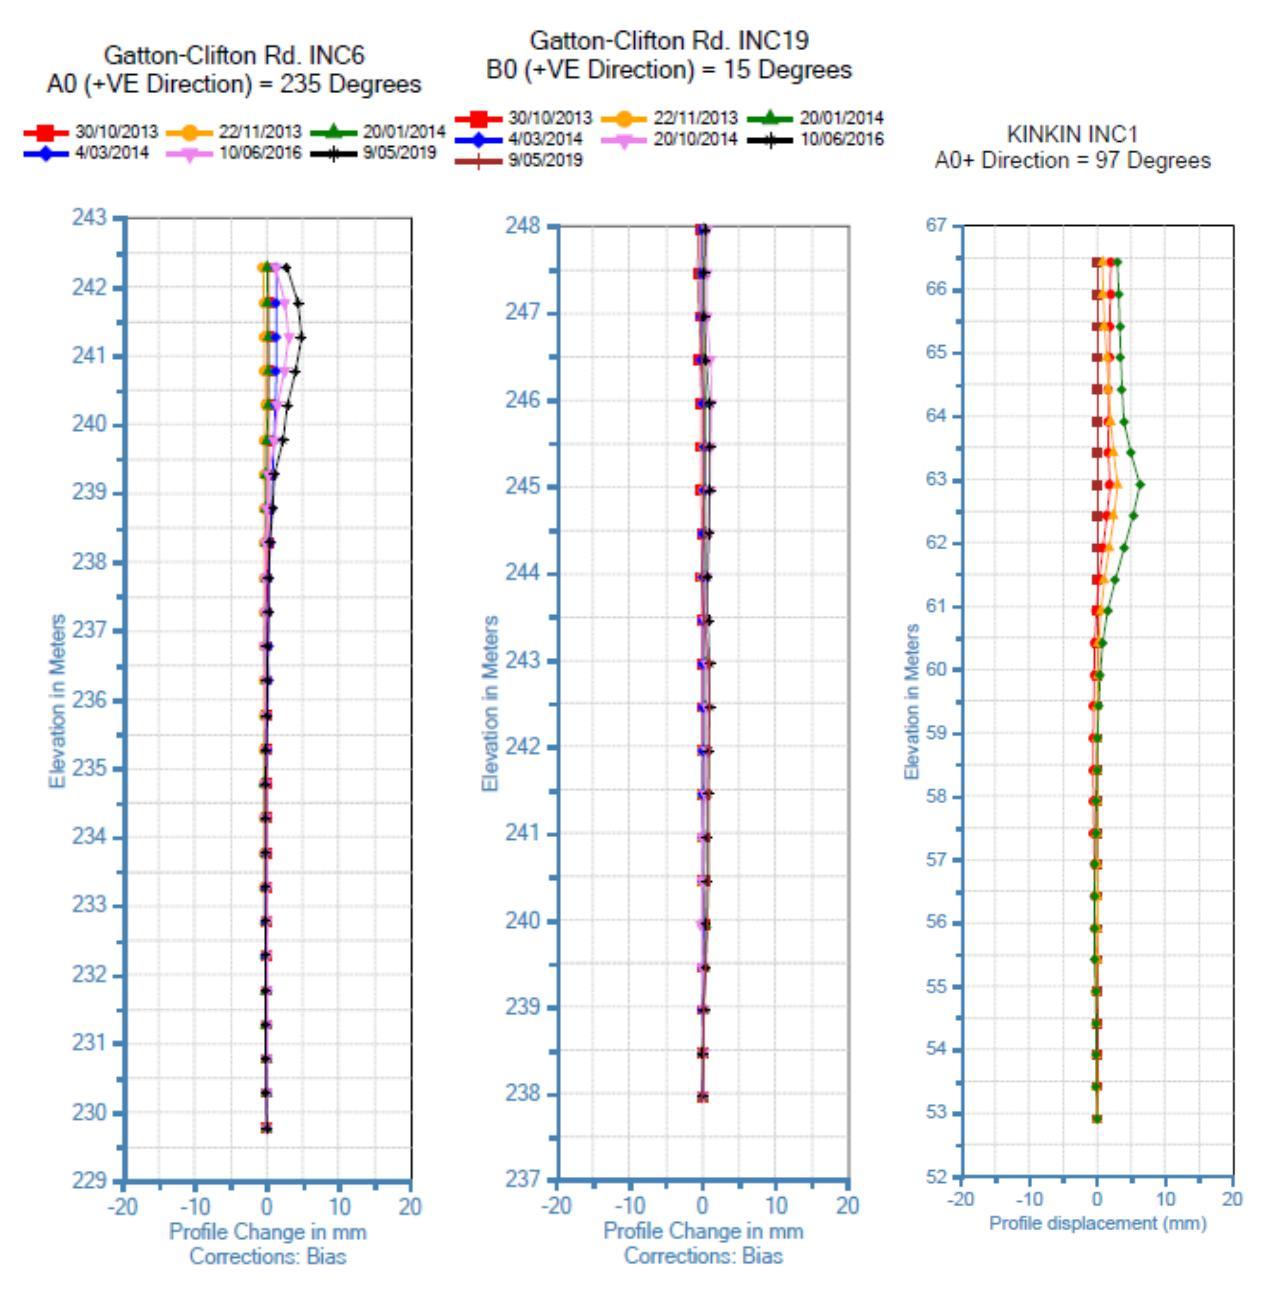
Plots of results of inclinometer monitoring

Project area	Inclinometer Number (INC)	Date installed (Date of current reading)	Maximum displacement (mm)	Location of maximum displacement	Comments
Gatton- Cliffton Road	INC 1	30/10/13 (9/05/19)	5.0	Within top 1.5m from ground surface	Locally referred to as INC 6 (installed in Bay 6 of works). No distinct pattern of movement.
	INC 2	30/10/13 (9/05/19)	4.0	Within top 1.5m from ground surface	Locally referred to as INC 19 (installed in Bay 19 of works). No distinct pattern of movement.
Kin Kin Road	INC 1	28/04/15 (14/05/19)	6.0	At 3.5m from ground surface	Movement locus at 3.5m from ground surface.

- Method used must follow the FHWA design manual, comply with the 12 steps and the extra 2 steps – loss of soil and additional loads.
- Minimal movements captured at the two trail sites.
- No loss of soil witnessed on the down-slope side of the piles promising results.
- TMR will continue to monitor the sites and make further recommendations moving forward.
