Micropile Bearing Plates:

Are they Necessary?

Presented by: Nadir Ansari, P.Eng.

Peter Sheffield & Associates Ltd.

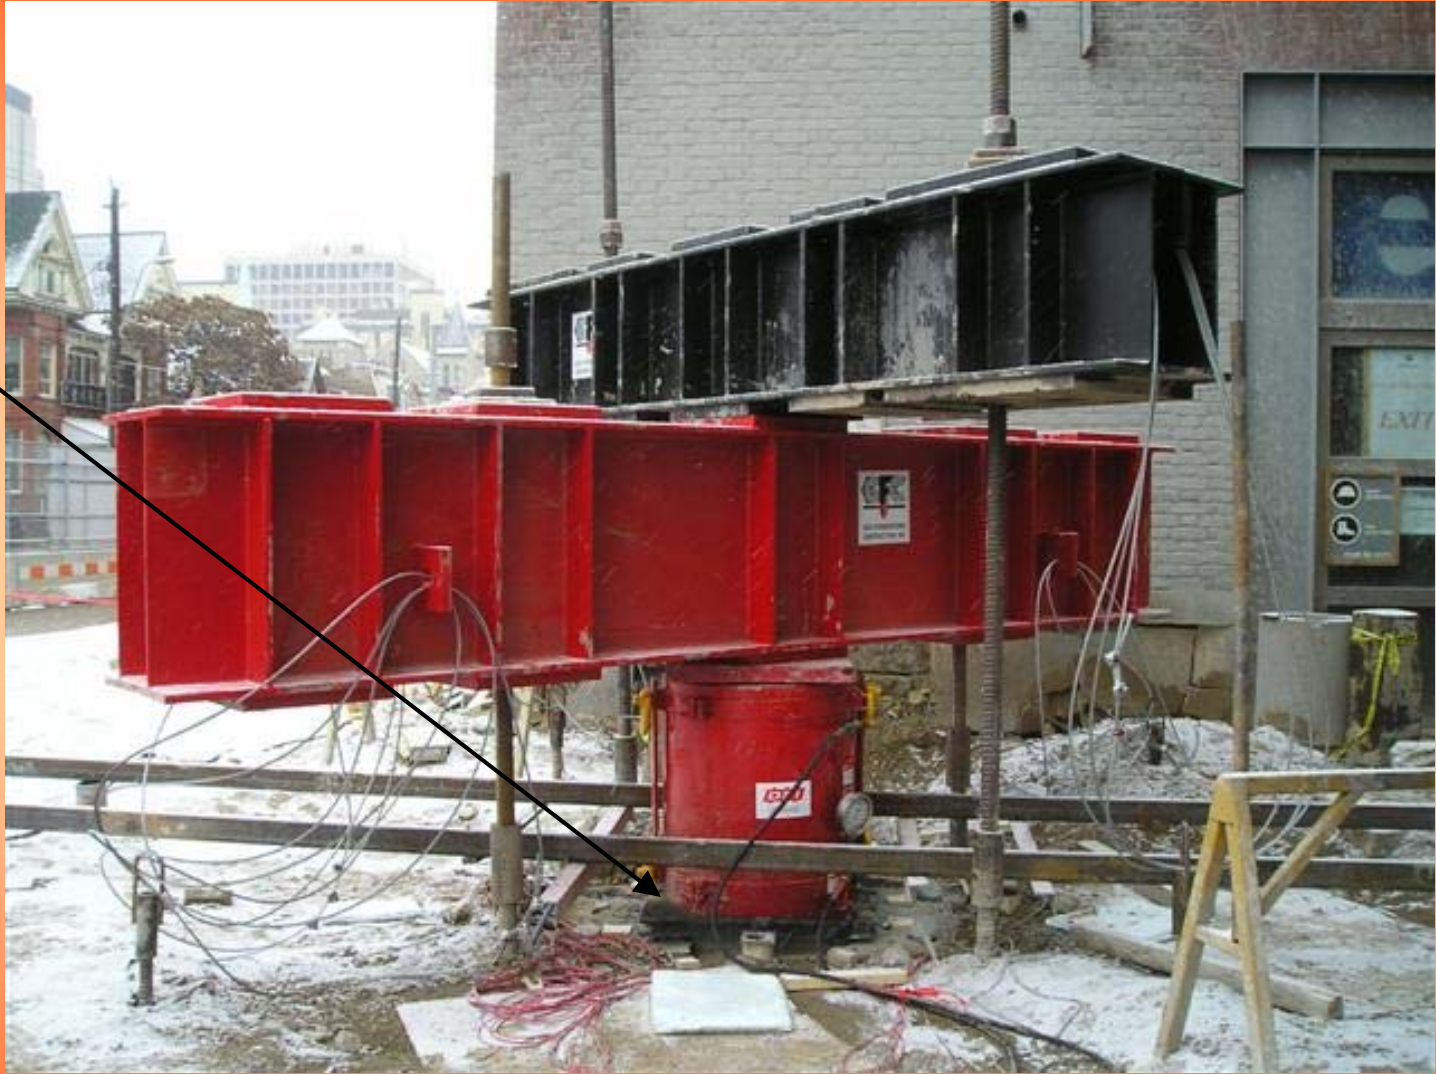
Test Set up

Dial
Gauges

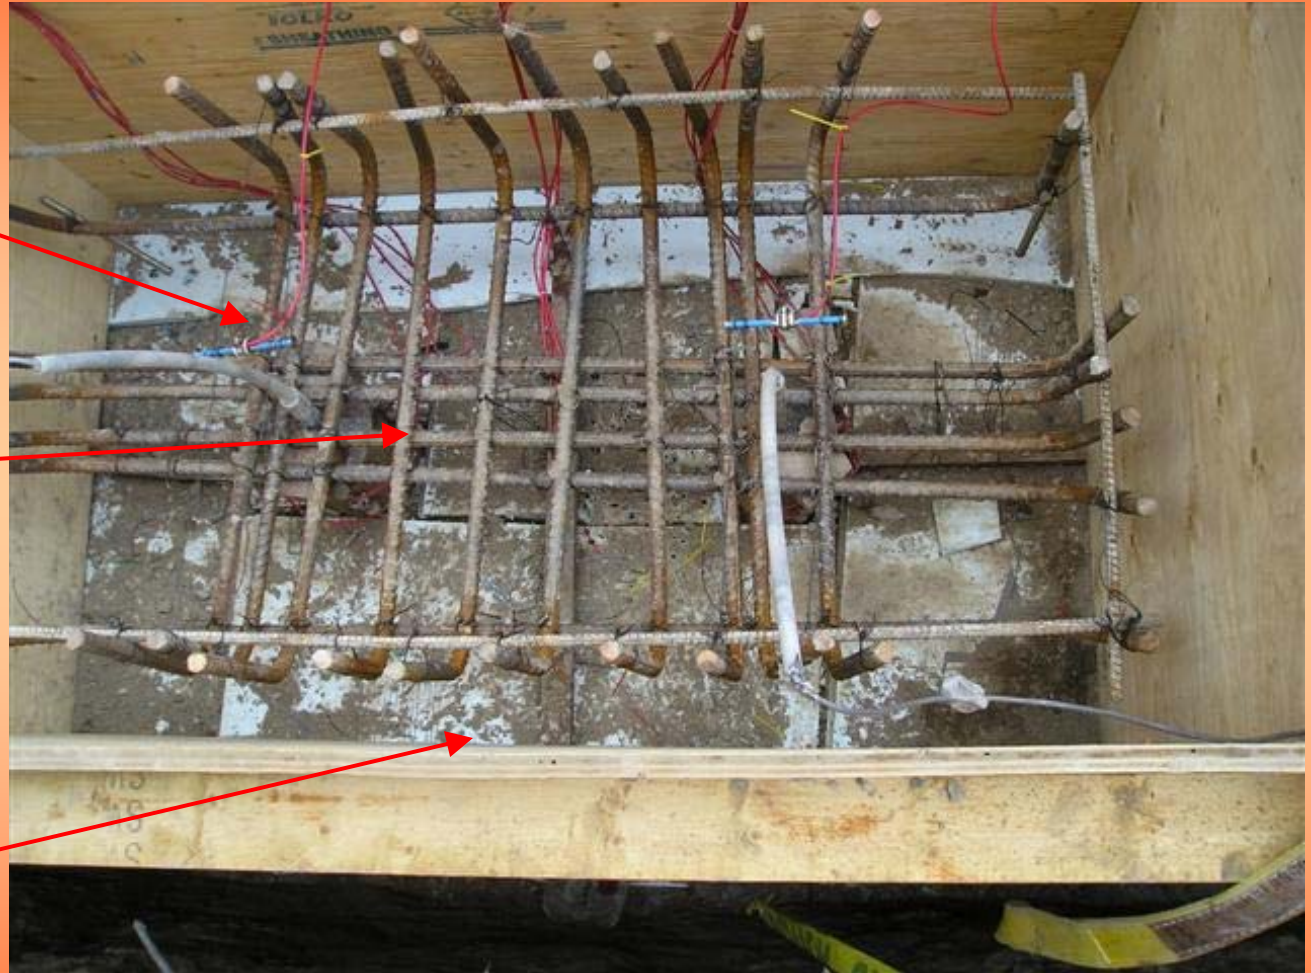
Test Set Up

Concrete Strain Gauge

Rebar with Strain Gauges

Compressible Material

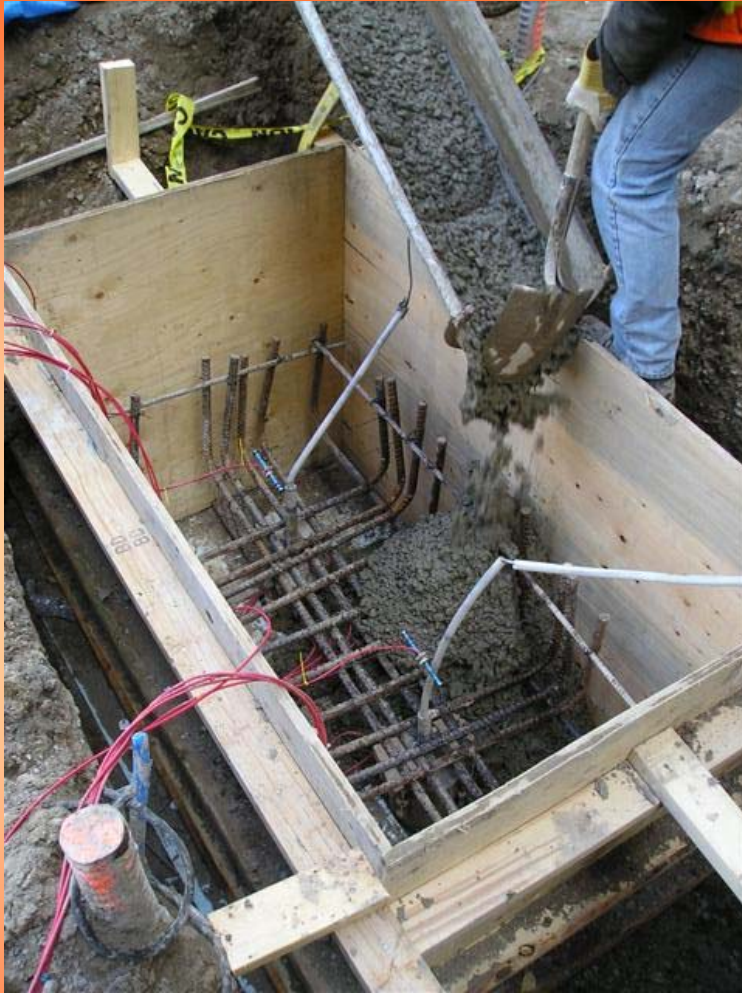
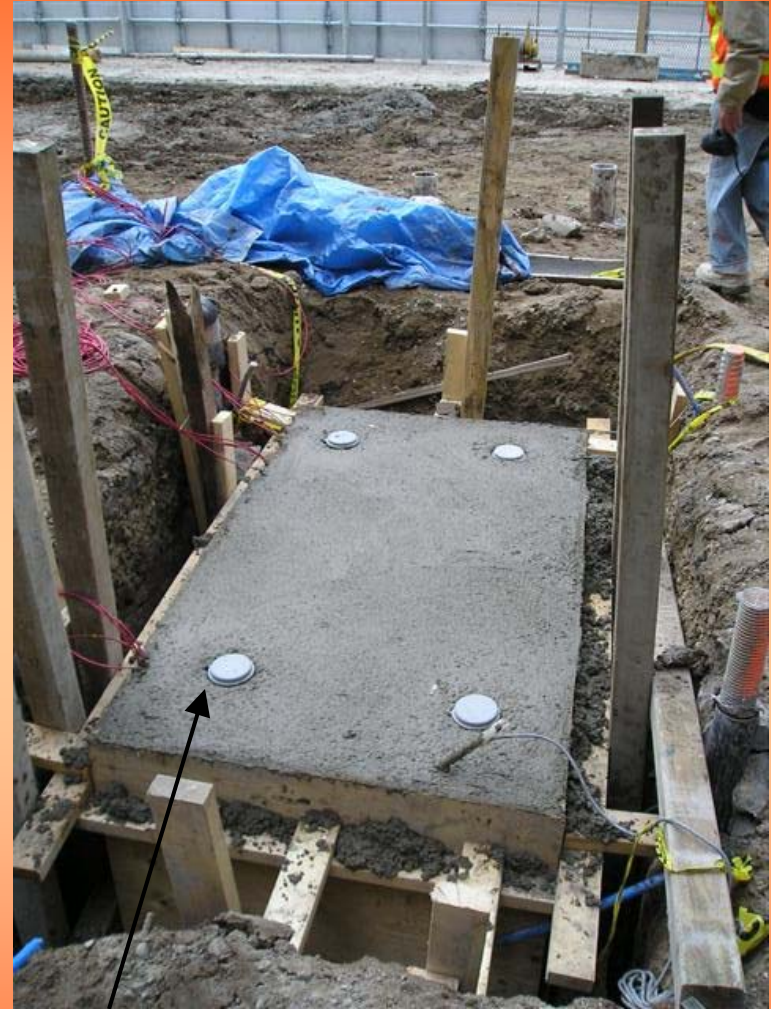
Test Set Up

30 MPa Concrete

Cylinders

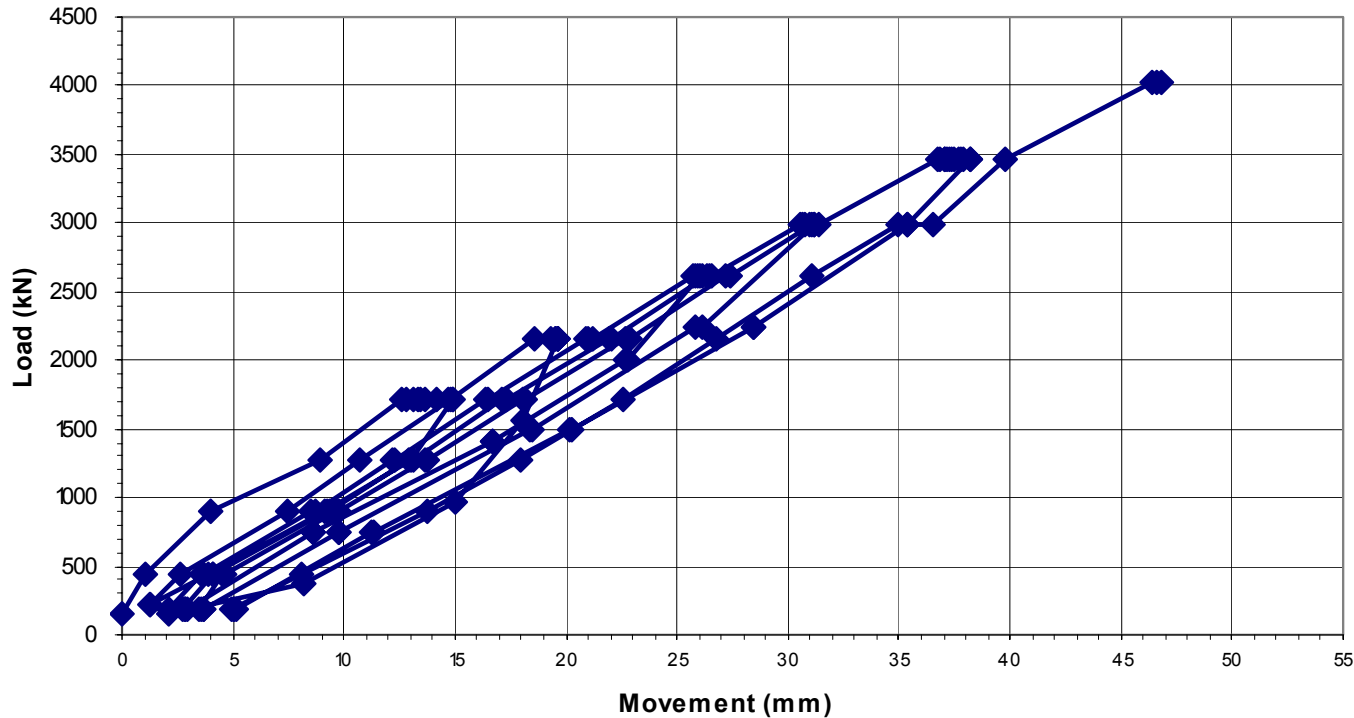
Cyclic Loading for One Micropile

LT1- Micropile Compression Test

-8050 kN ultimate load on cap

-50 mm movement

-136 MPa based on MP area

-2.33 Design Load

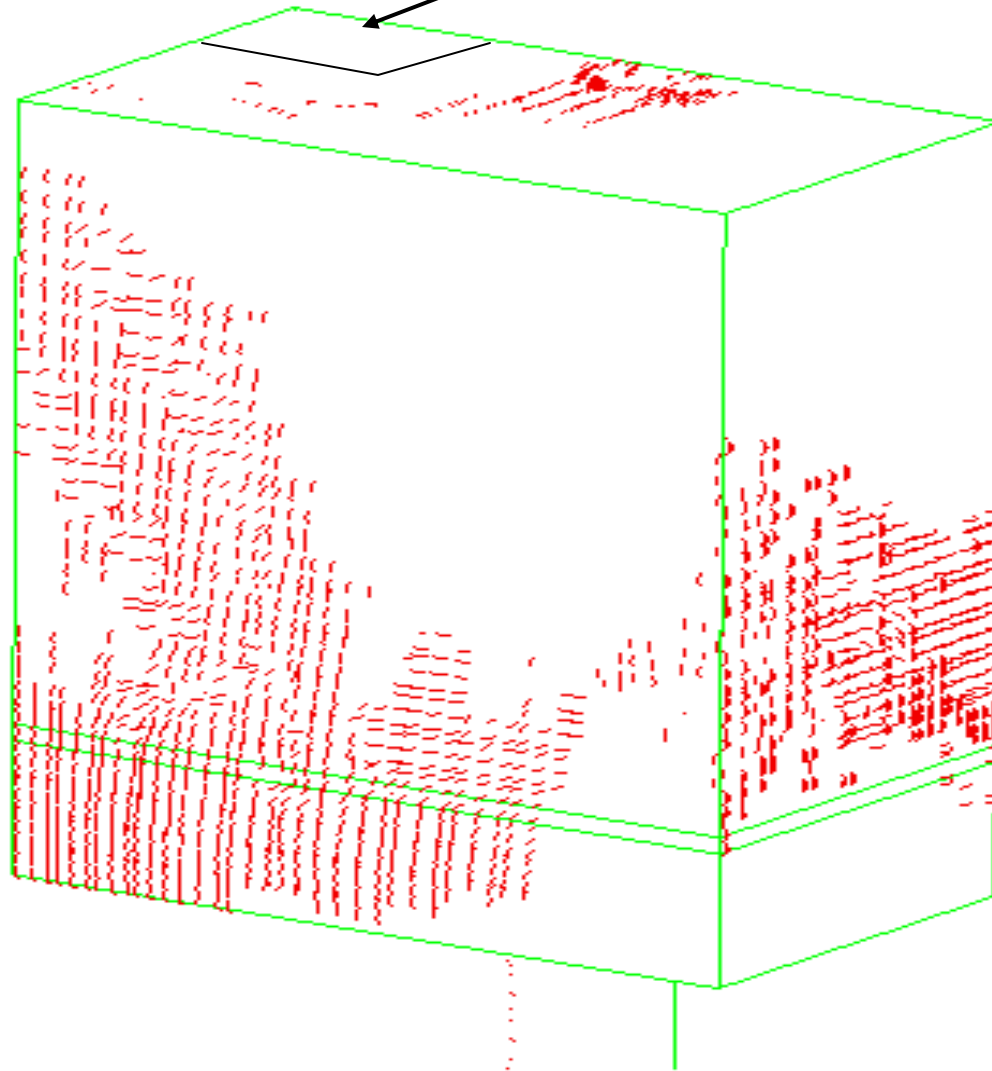
Column Base Plate

Cracking
Pattern in
one quarter
of the
cap
