Foundation improvement of historical buildings by micro piles Museum Island Berlin, St. Kolumba Cologne

Dipl.-Ing. Klaus Dietz

Dr.-Ing. André Schürmann

Dietz Geotechnik Consult GmbH, Hilden, Germany

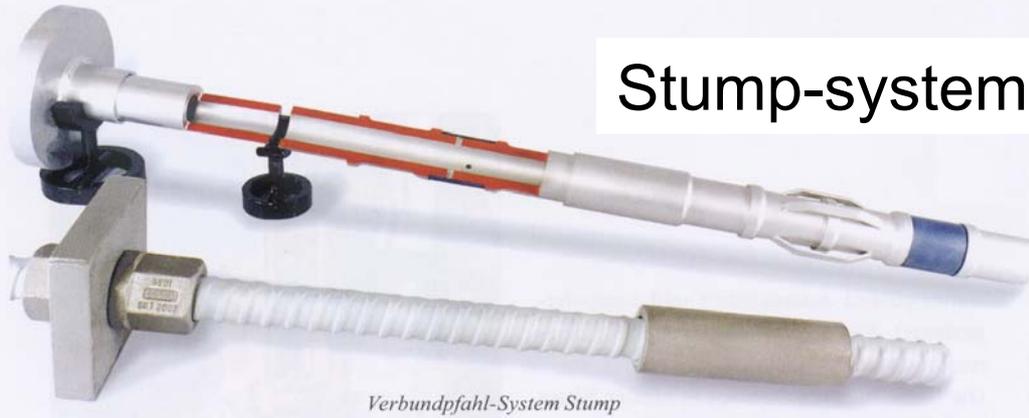
Stump-system steel-tube pile

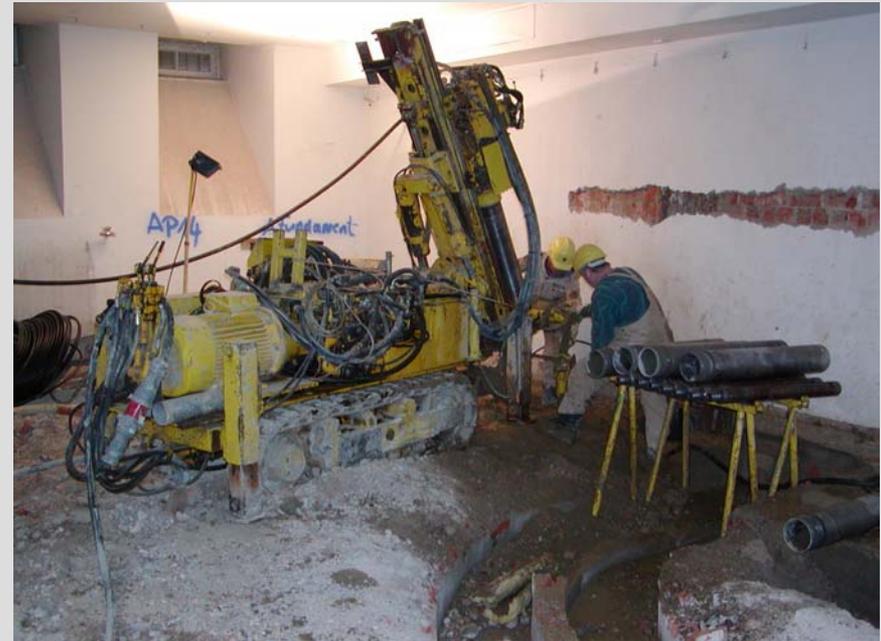
Stump-system composite pile

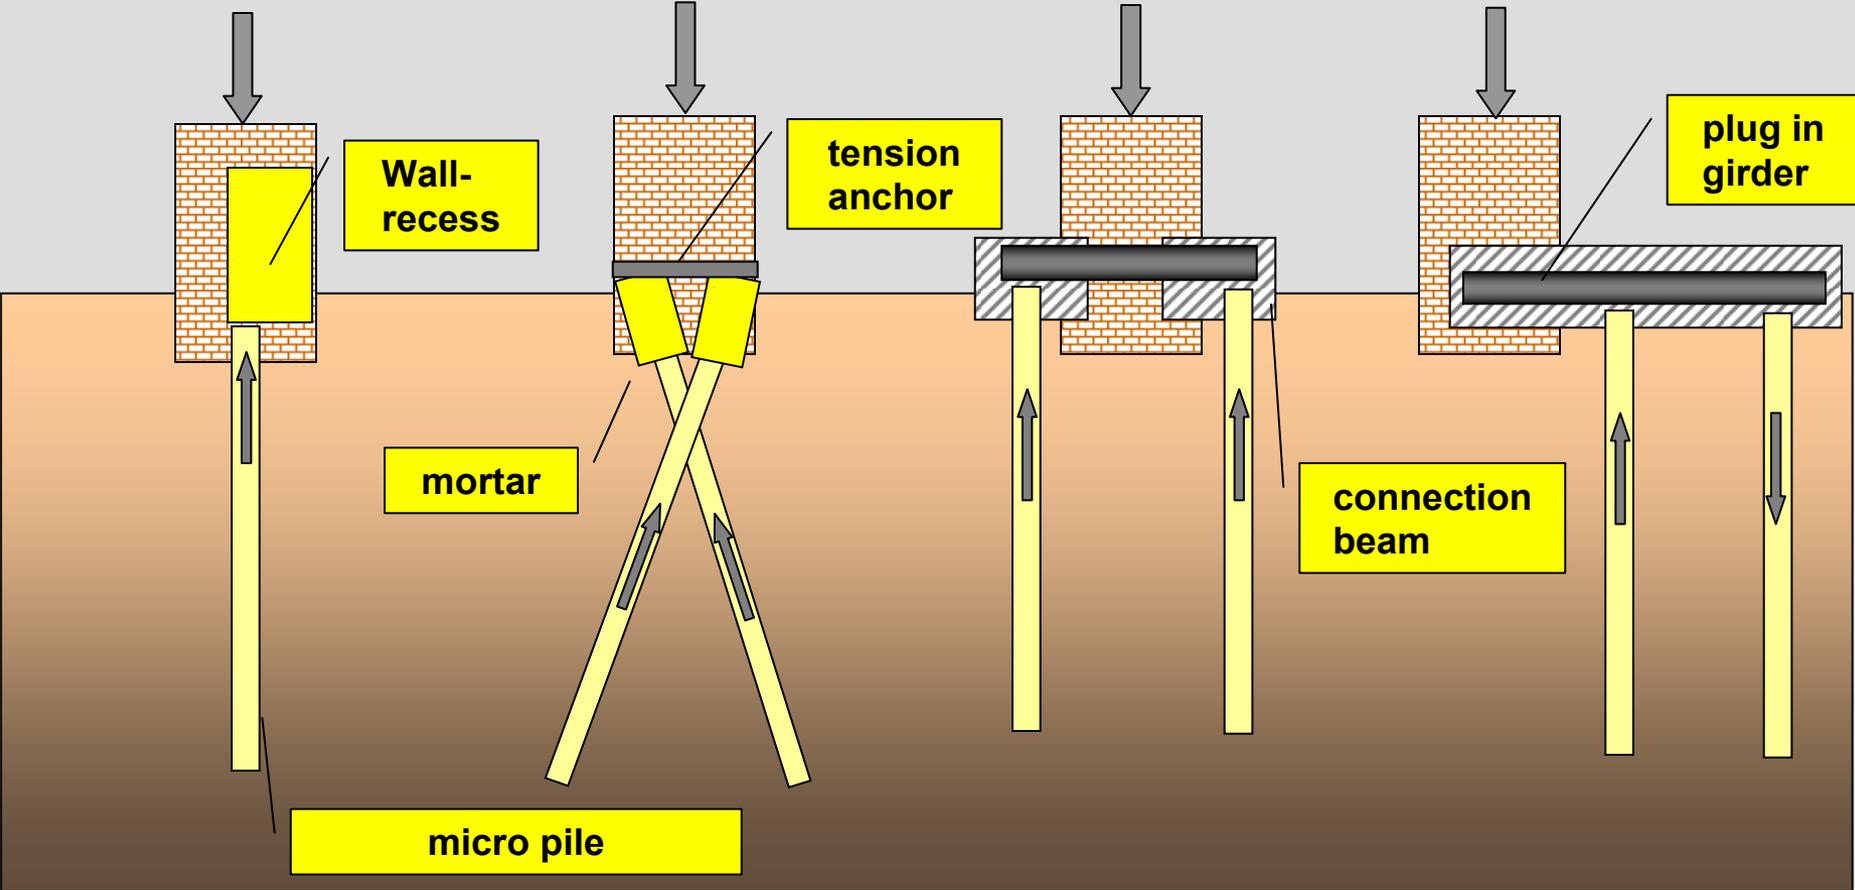
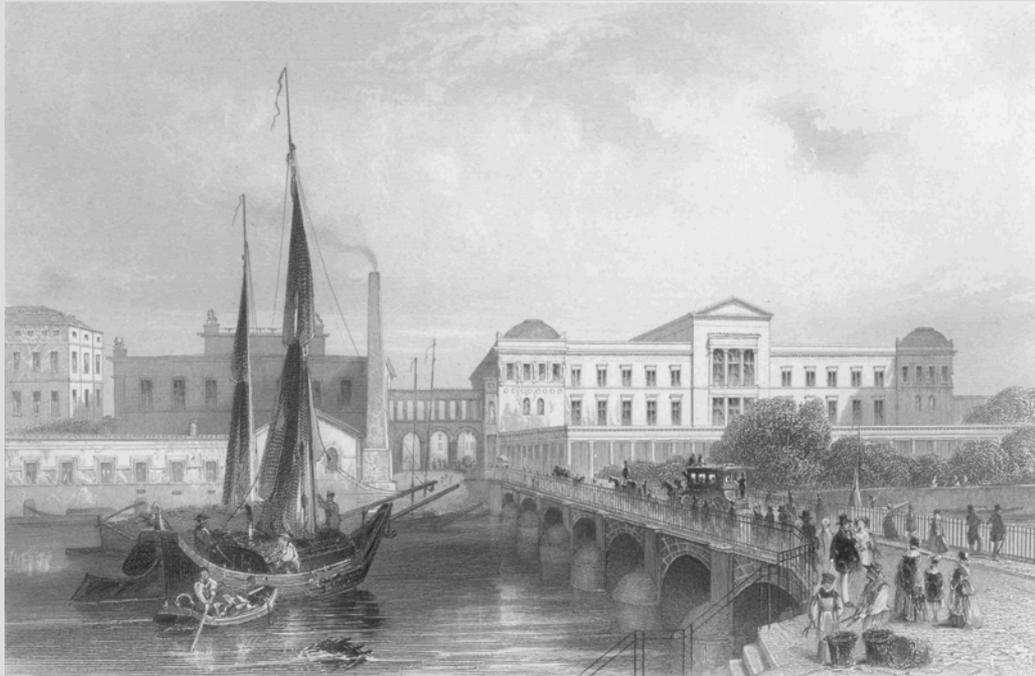
Load bearing systems and wall connections

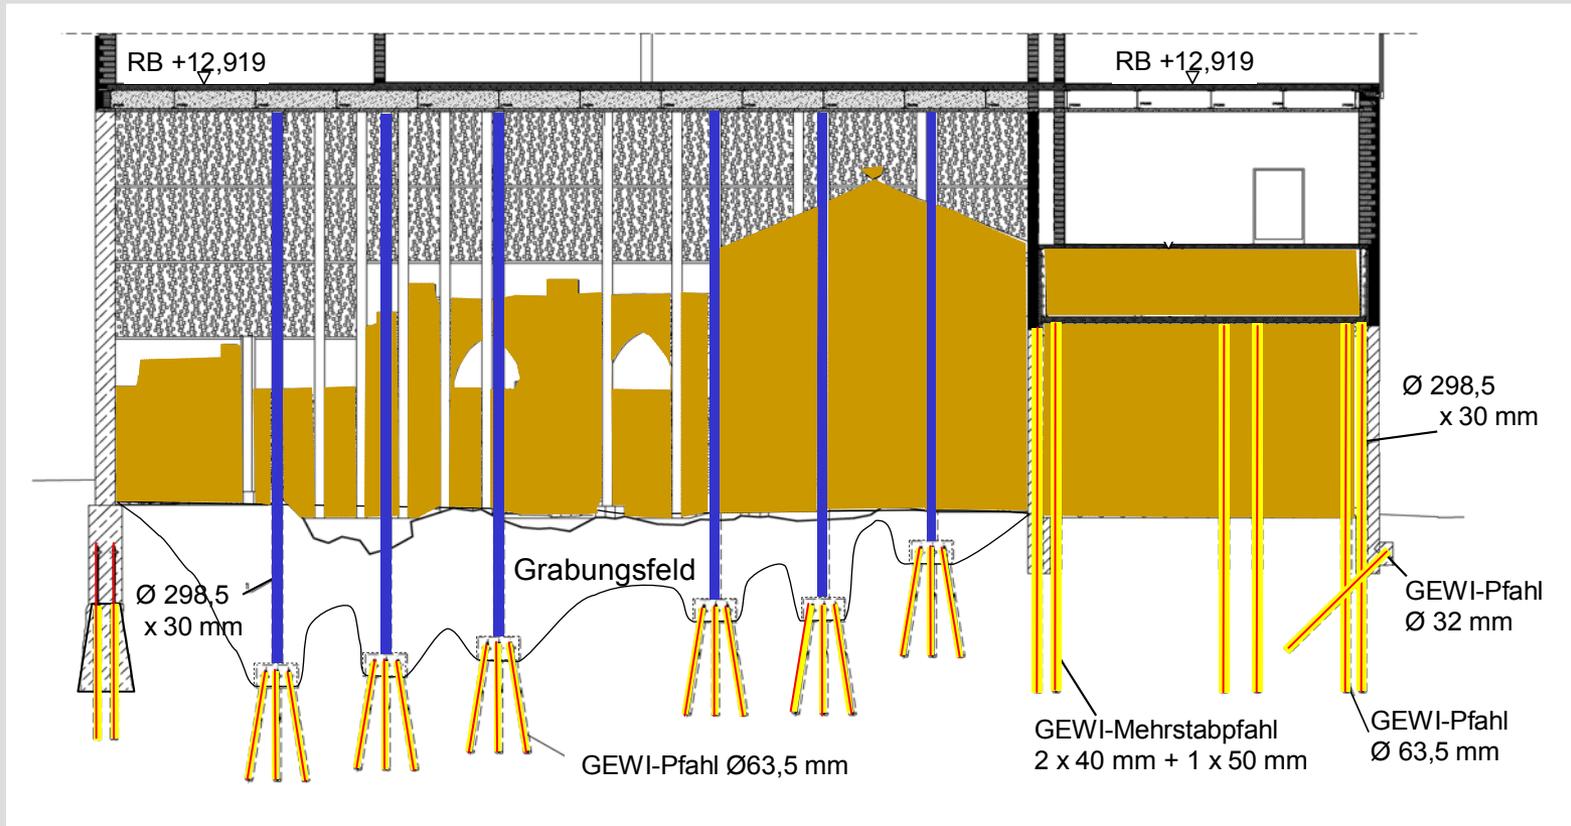
Foundation concept new Diözesanmuseum

cross section digging field

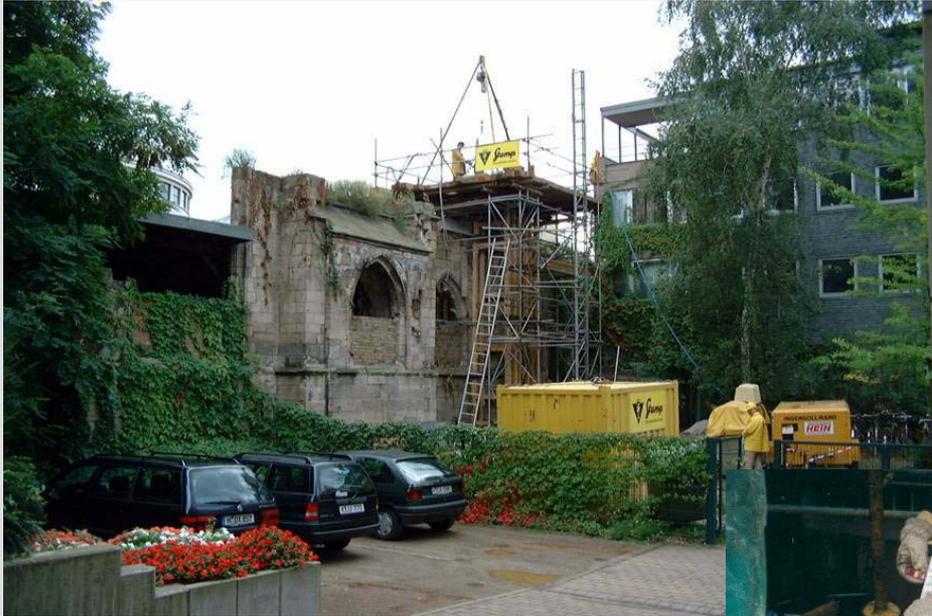
preparing investigations

test drilling

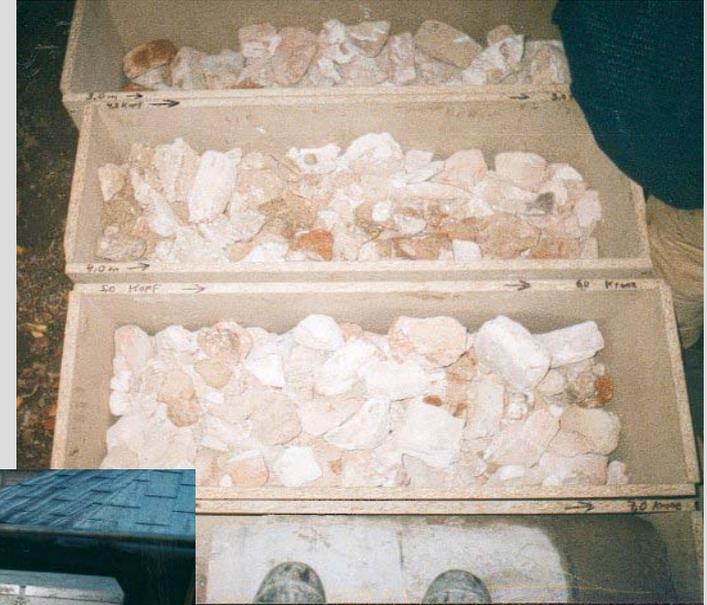
before

masonry core

after grouting

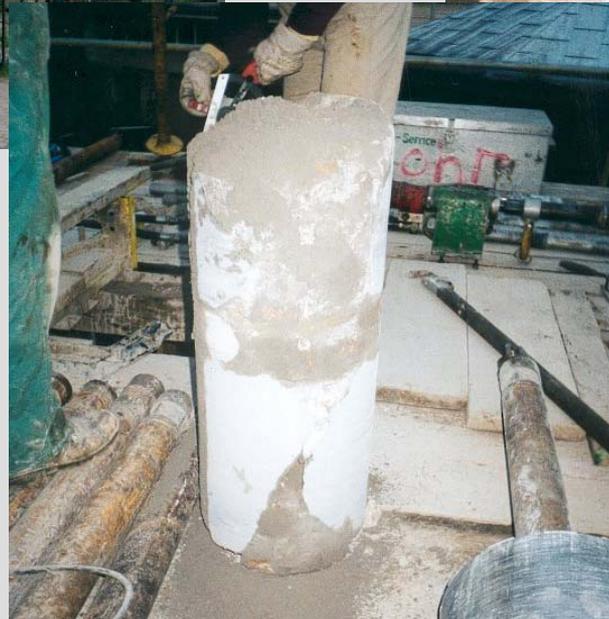
View arrangement of implants and nailcolumns

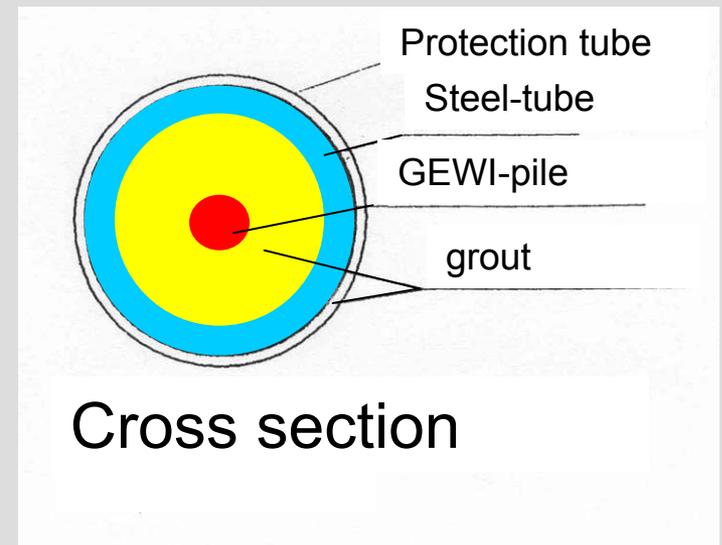
view masonry column and cross section implant

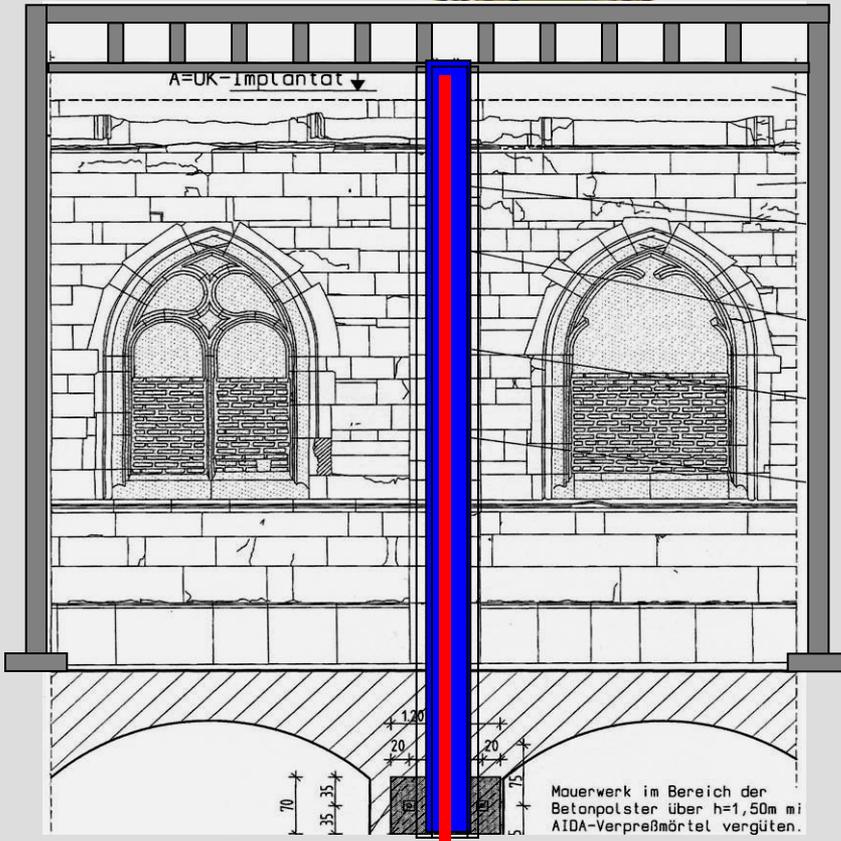
Pile production

1

installation drilling platform

2

core drilling 350 mm

3

implant tube 298,5 mm x 30 mm

4

GEWI-pile drilling 219 mm

5

GEWI-pile installation

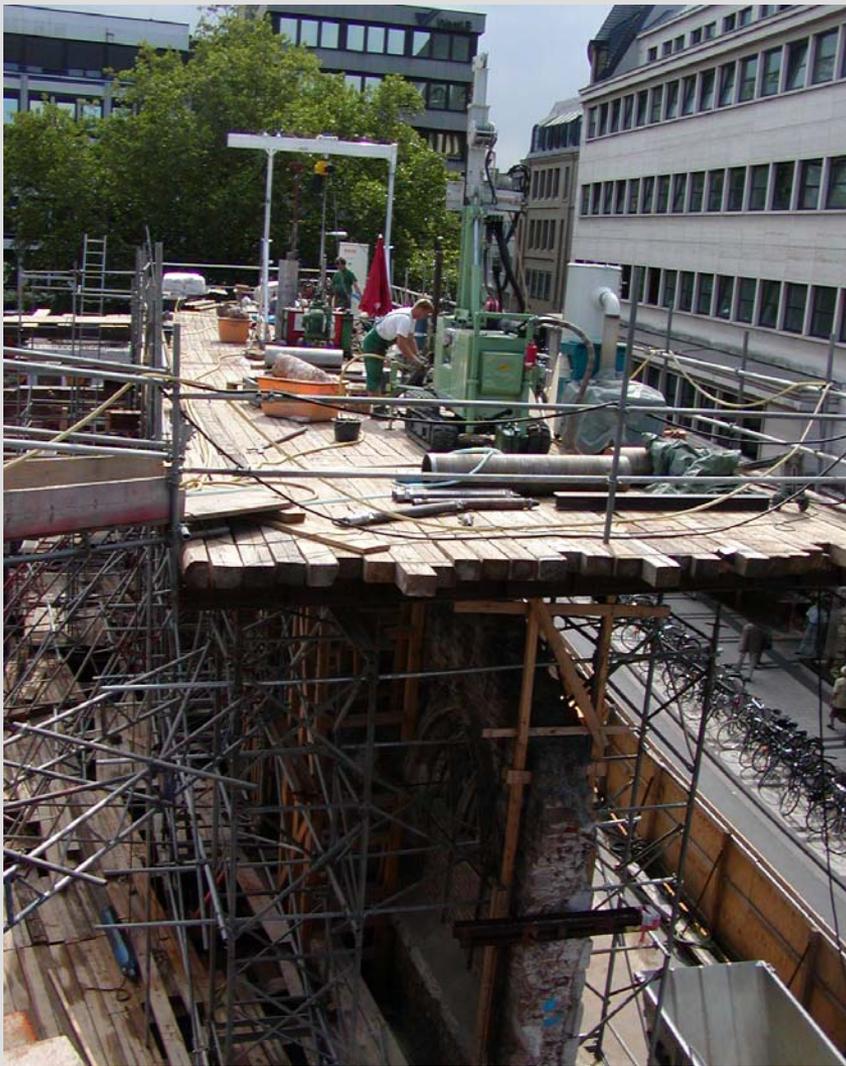
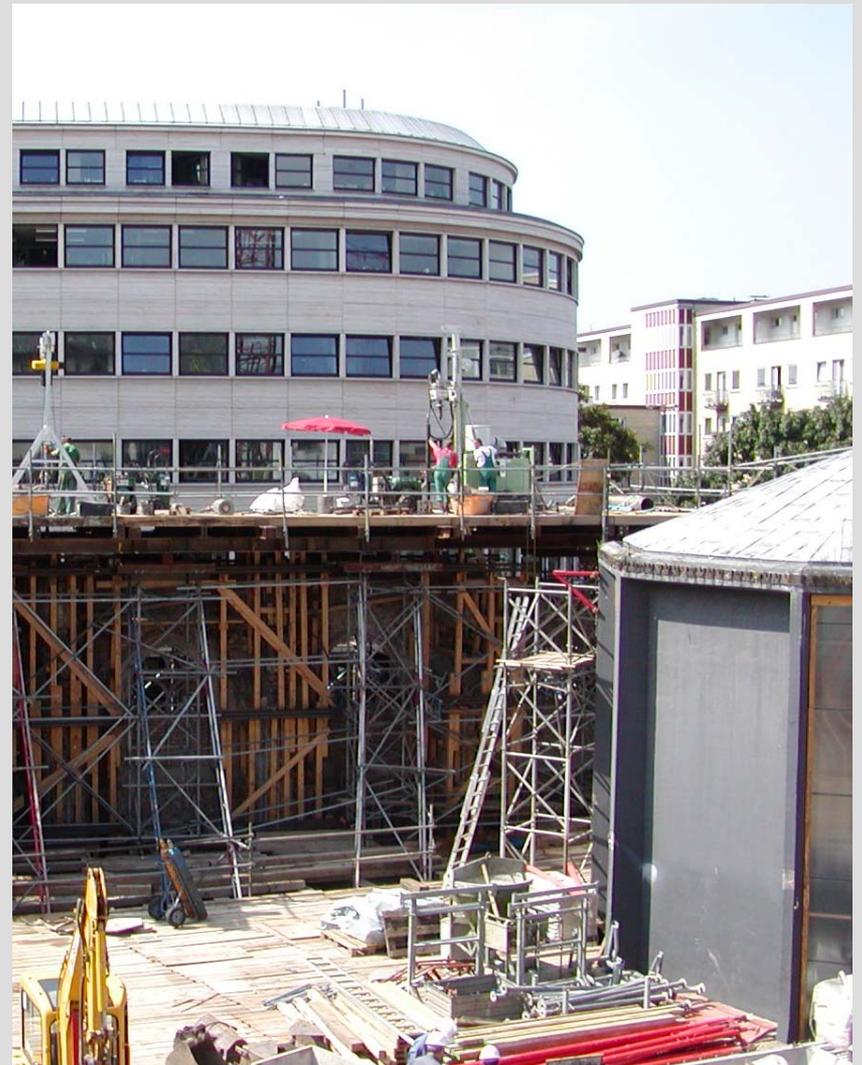
Core drilling through the old walls

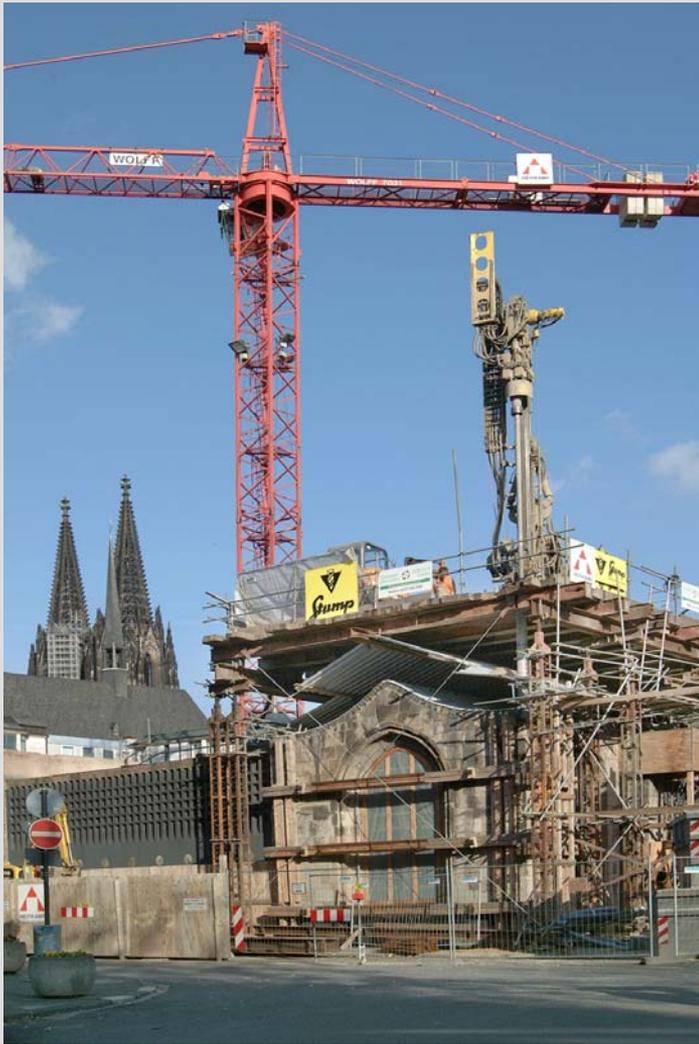
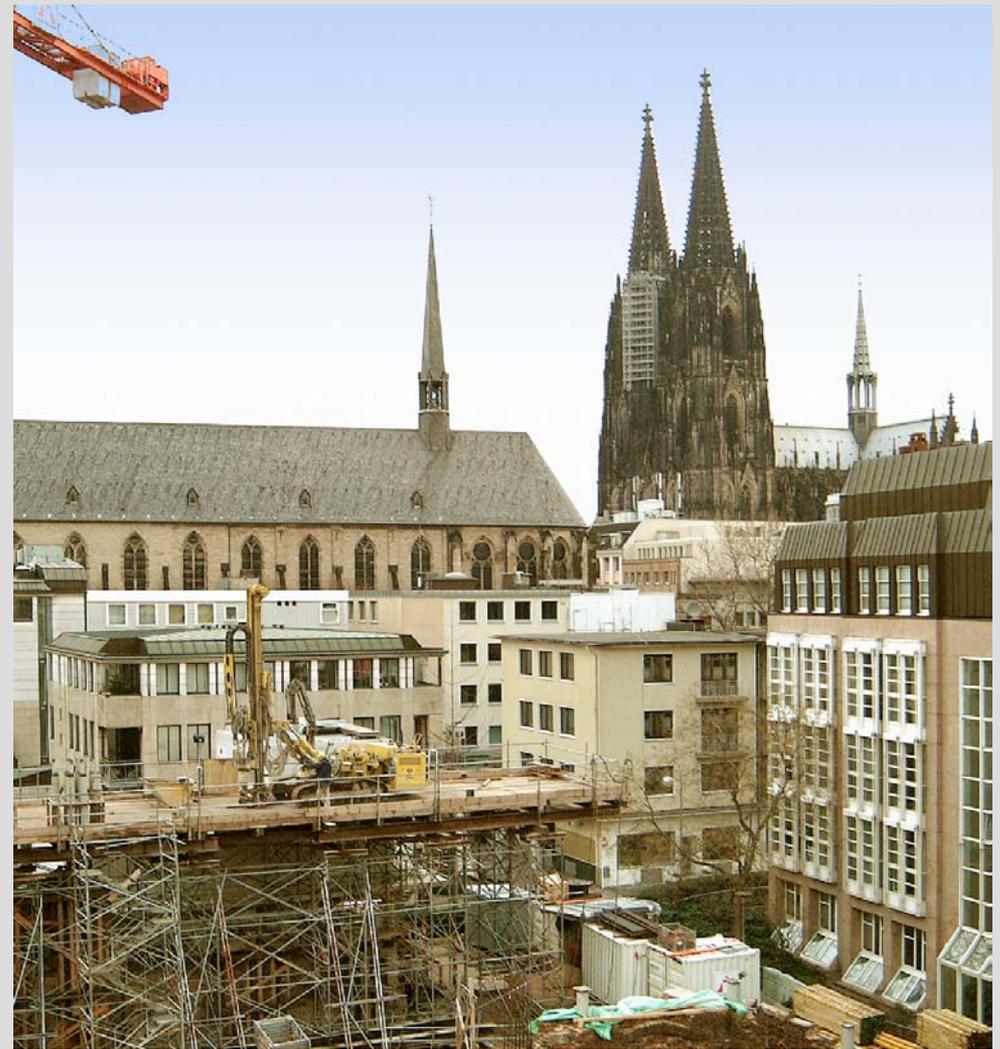
drilling for pile installation

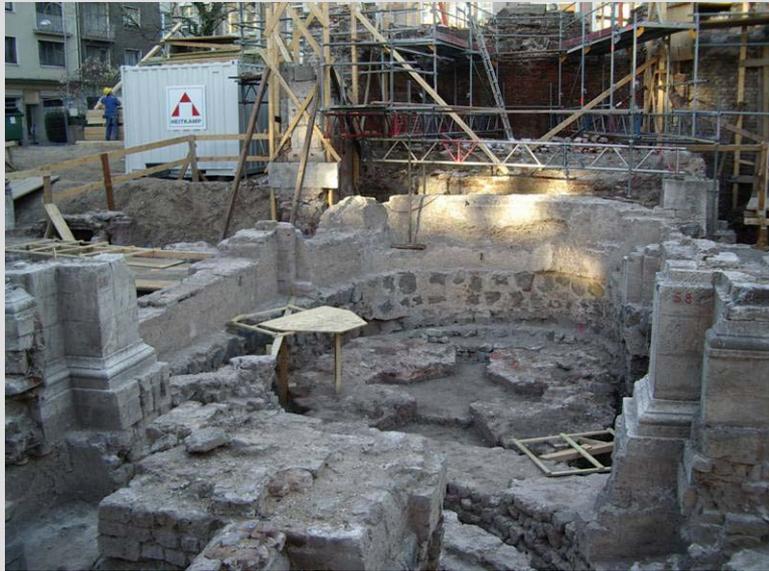
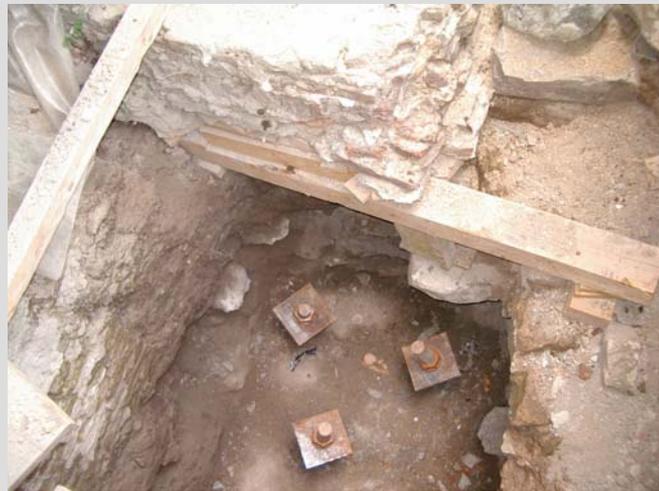
foundation
nailcolumns
digging field

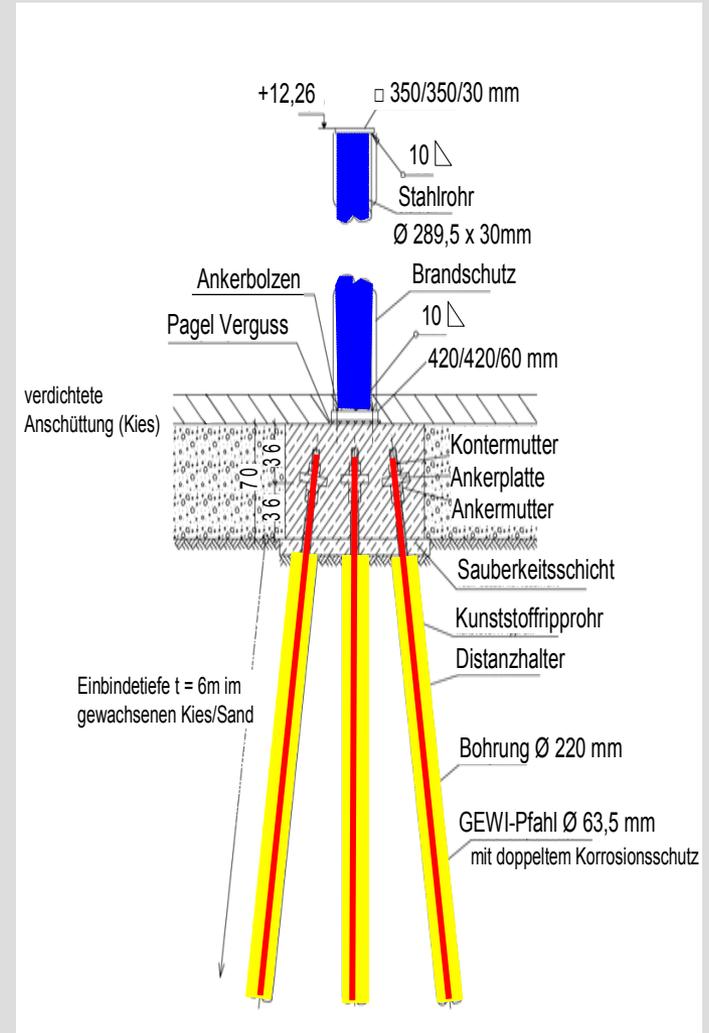
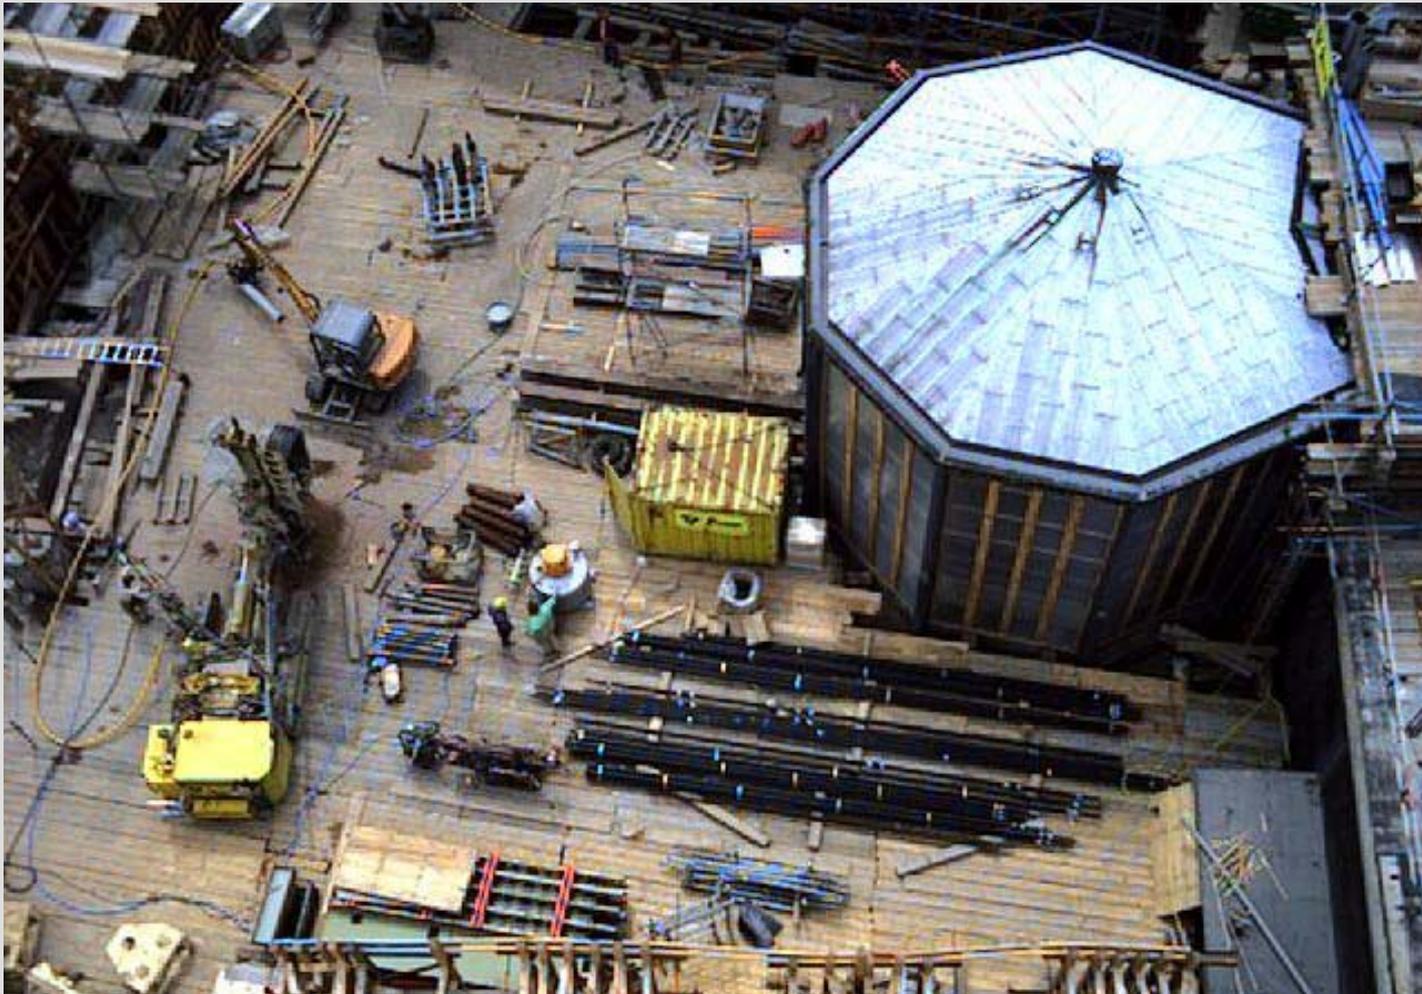
Drilling for micro piles at the chapel and on the digging field
