Observations From The Instrumentation of a Micropiled and Tied Back Reticulated Grid

Walter E. Vanderpool, P.E.
Senior Geotechnical Engineer
Terracon Consultants, Inc.

- Site: The C2K Theatre at the Palazzo
- 370 kN wall load at the crest of a 15.3 m excavation
- Theatre construction concurrent with excavation and tower construction

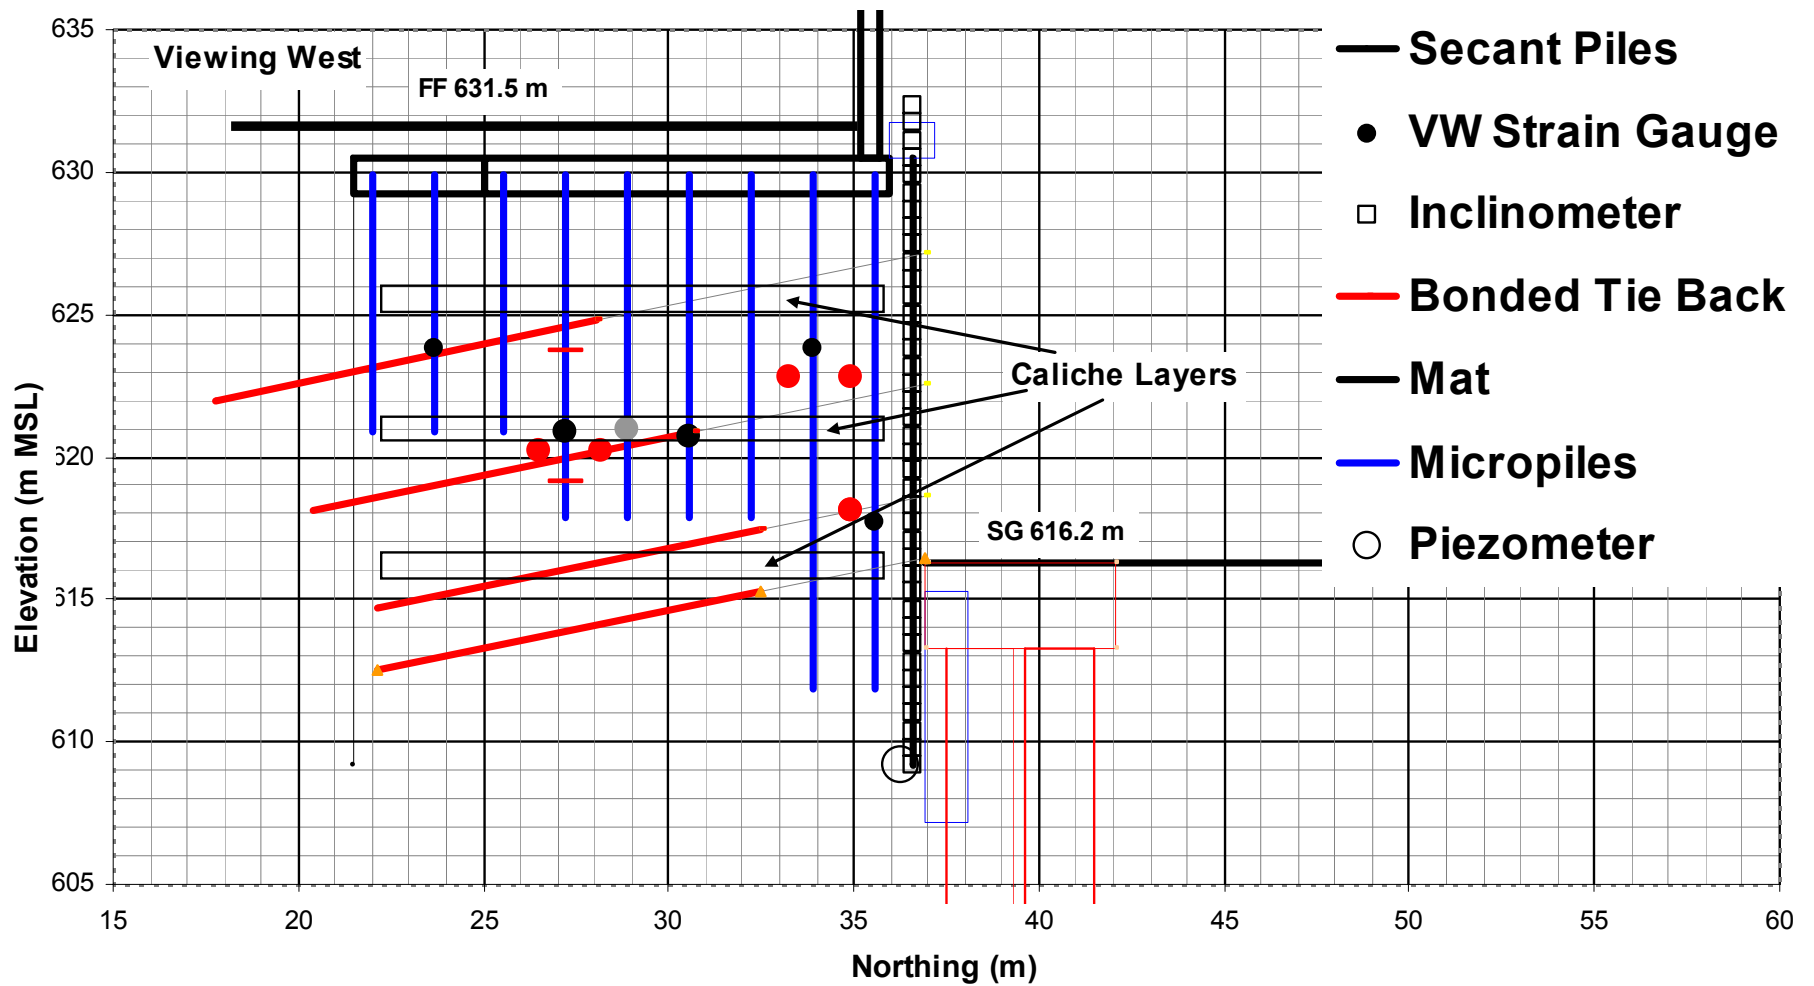
- Reticulated group profile
- VW gauge locations
- Micropile locations
- Tieback locations

- Reticulated tieback intersections
- Cemented beds
- Piezometer location

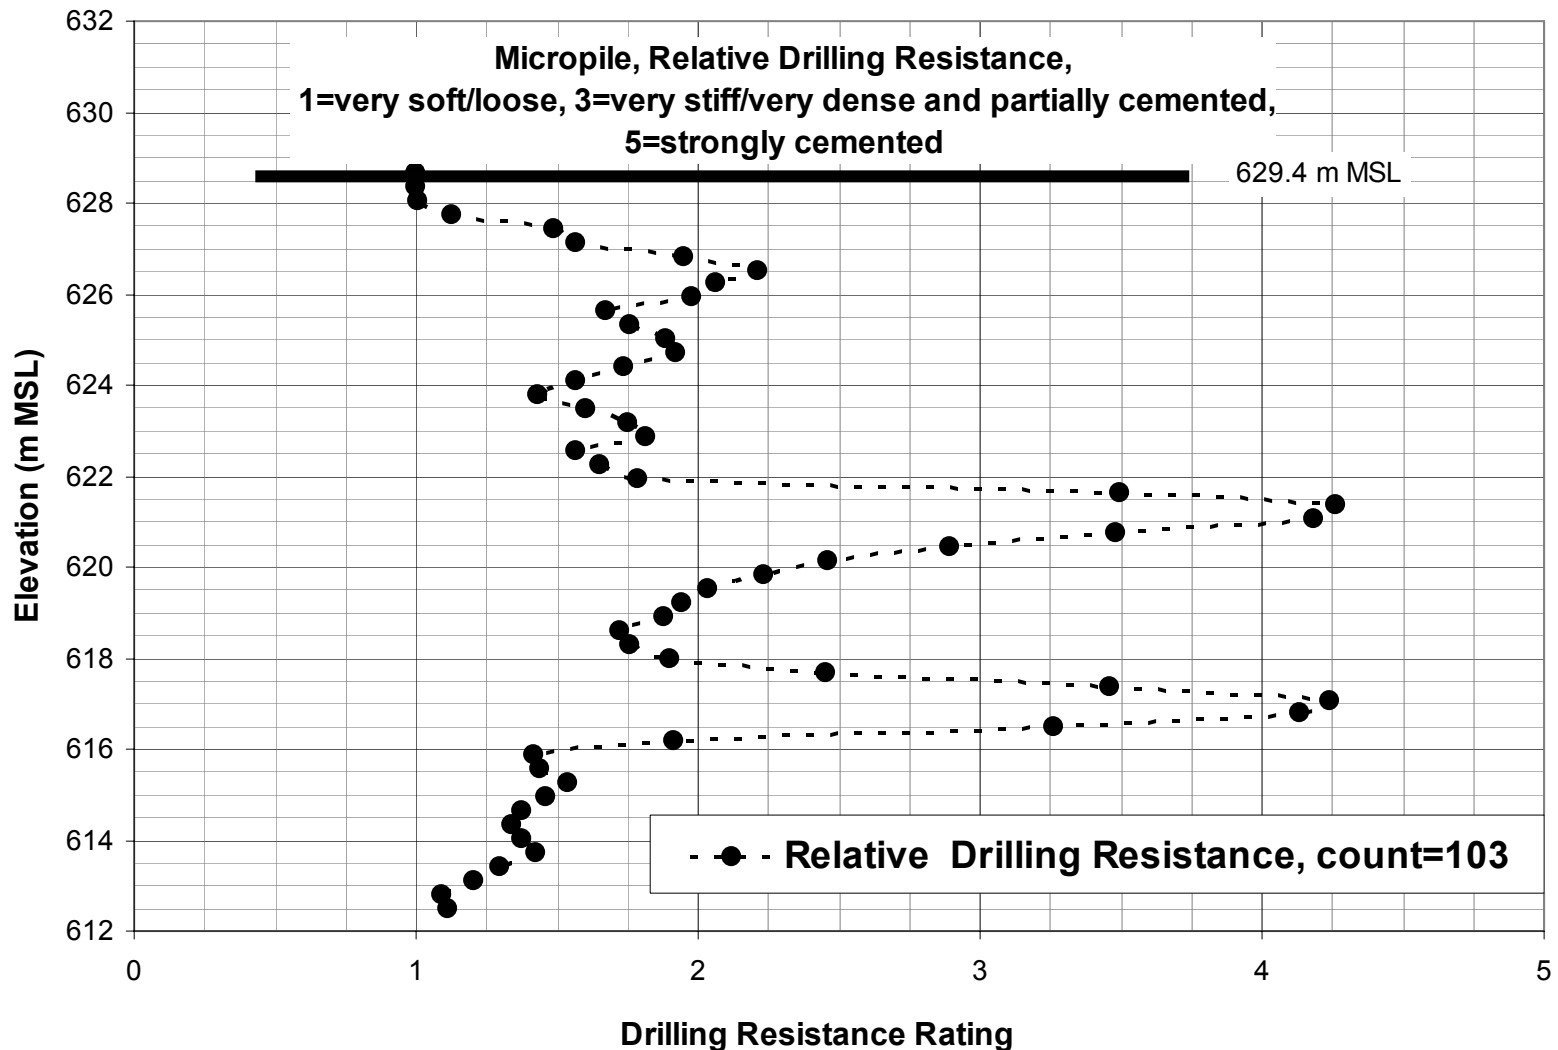
- Relative top-drive hammer drilling resistance
- Measured by rate of advance
- Subjectively interpreted relative to geotechnical logging

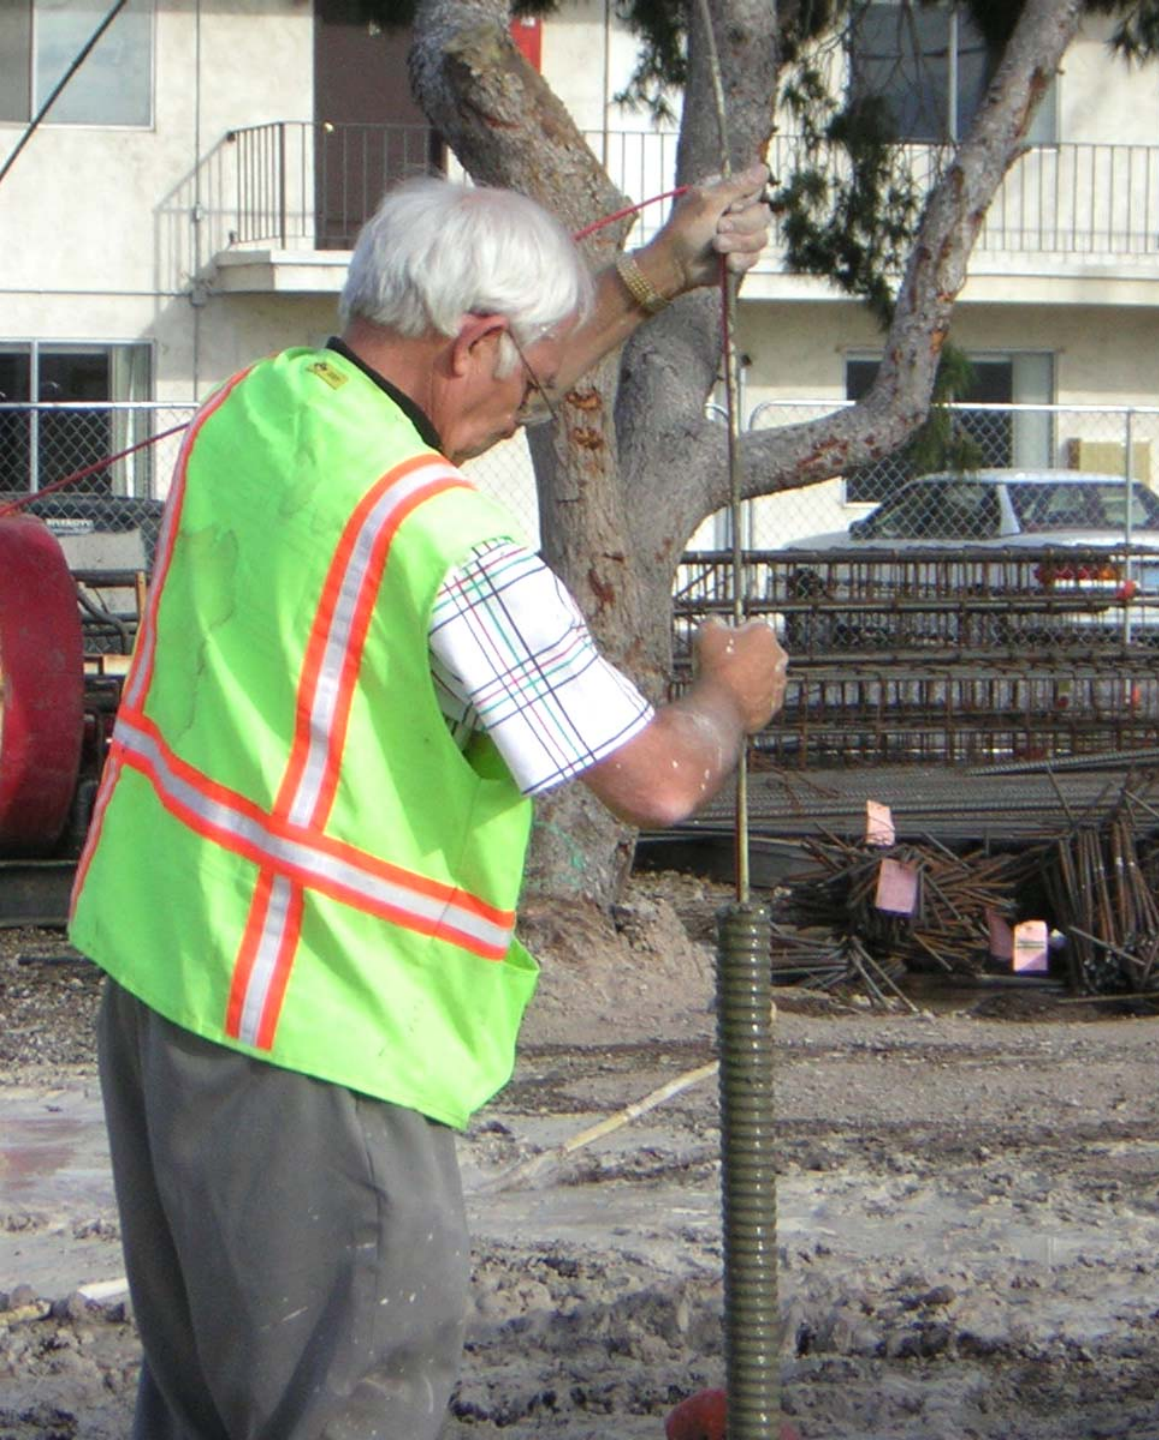
- Flush grout injection drilling
- VW strain gauge
- Insertion by fiberglass rod

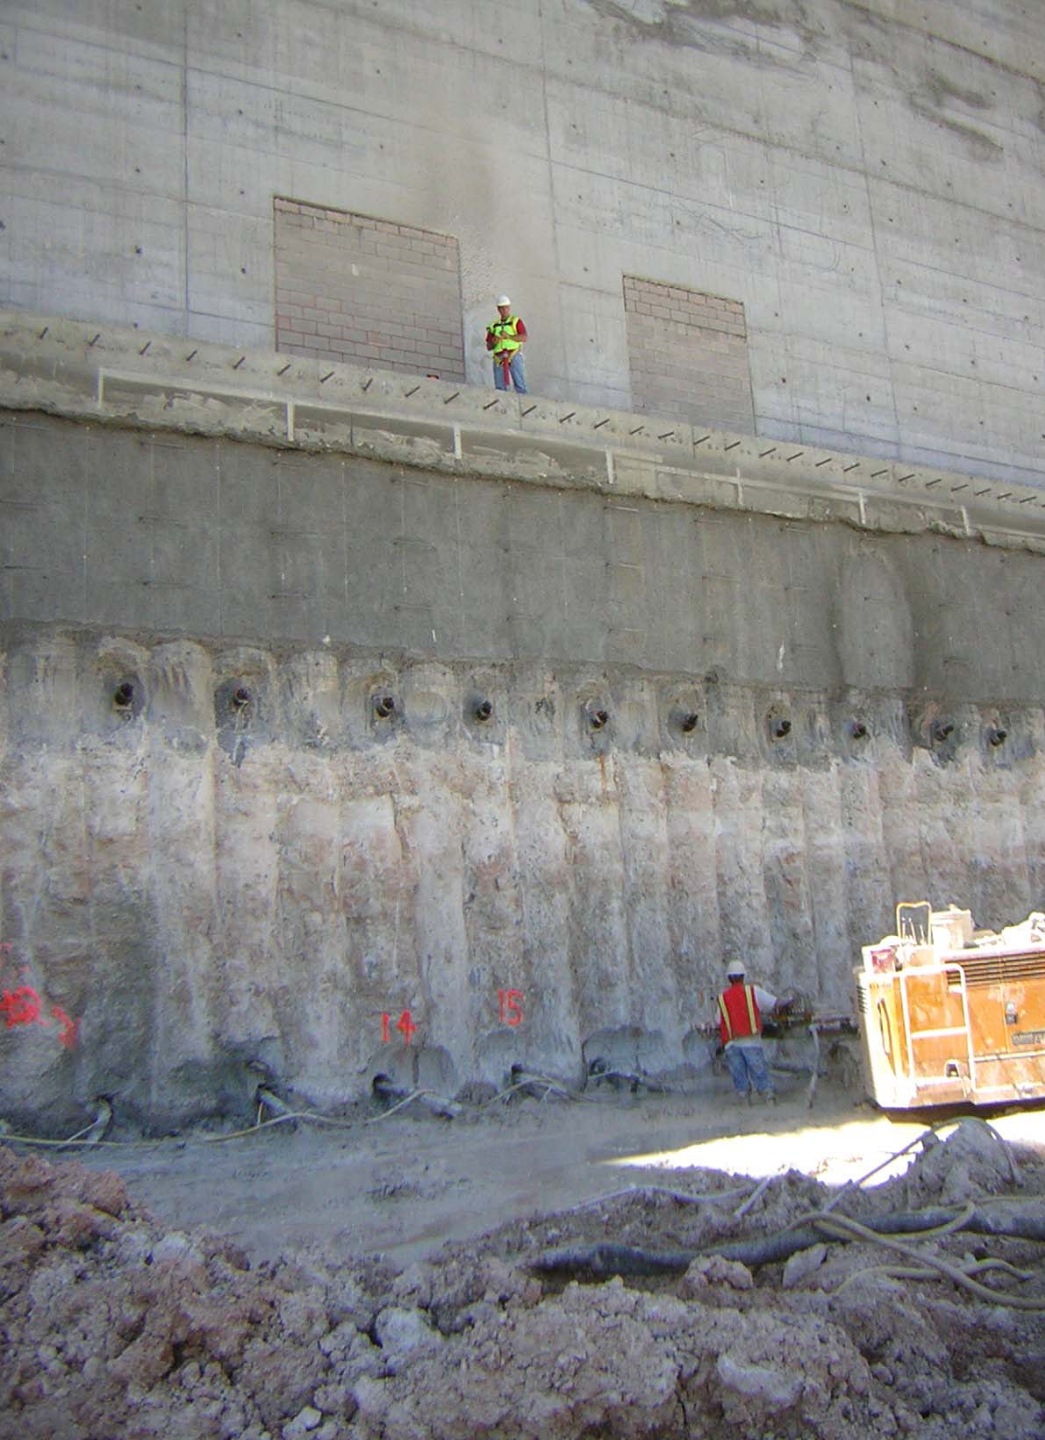
- Inclinator at P1-015NS
- Piezometer at P1-013S
- Cemented layer at approximately elevation 626.5 m to 625 m MSL

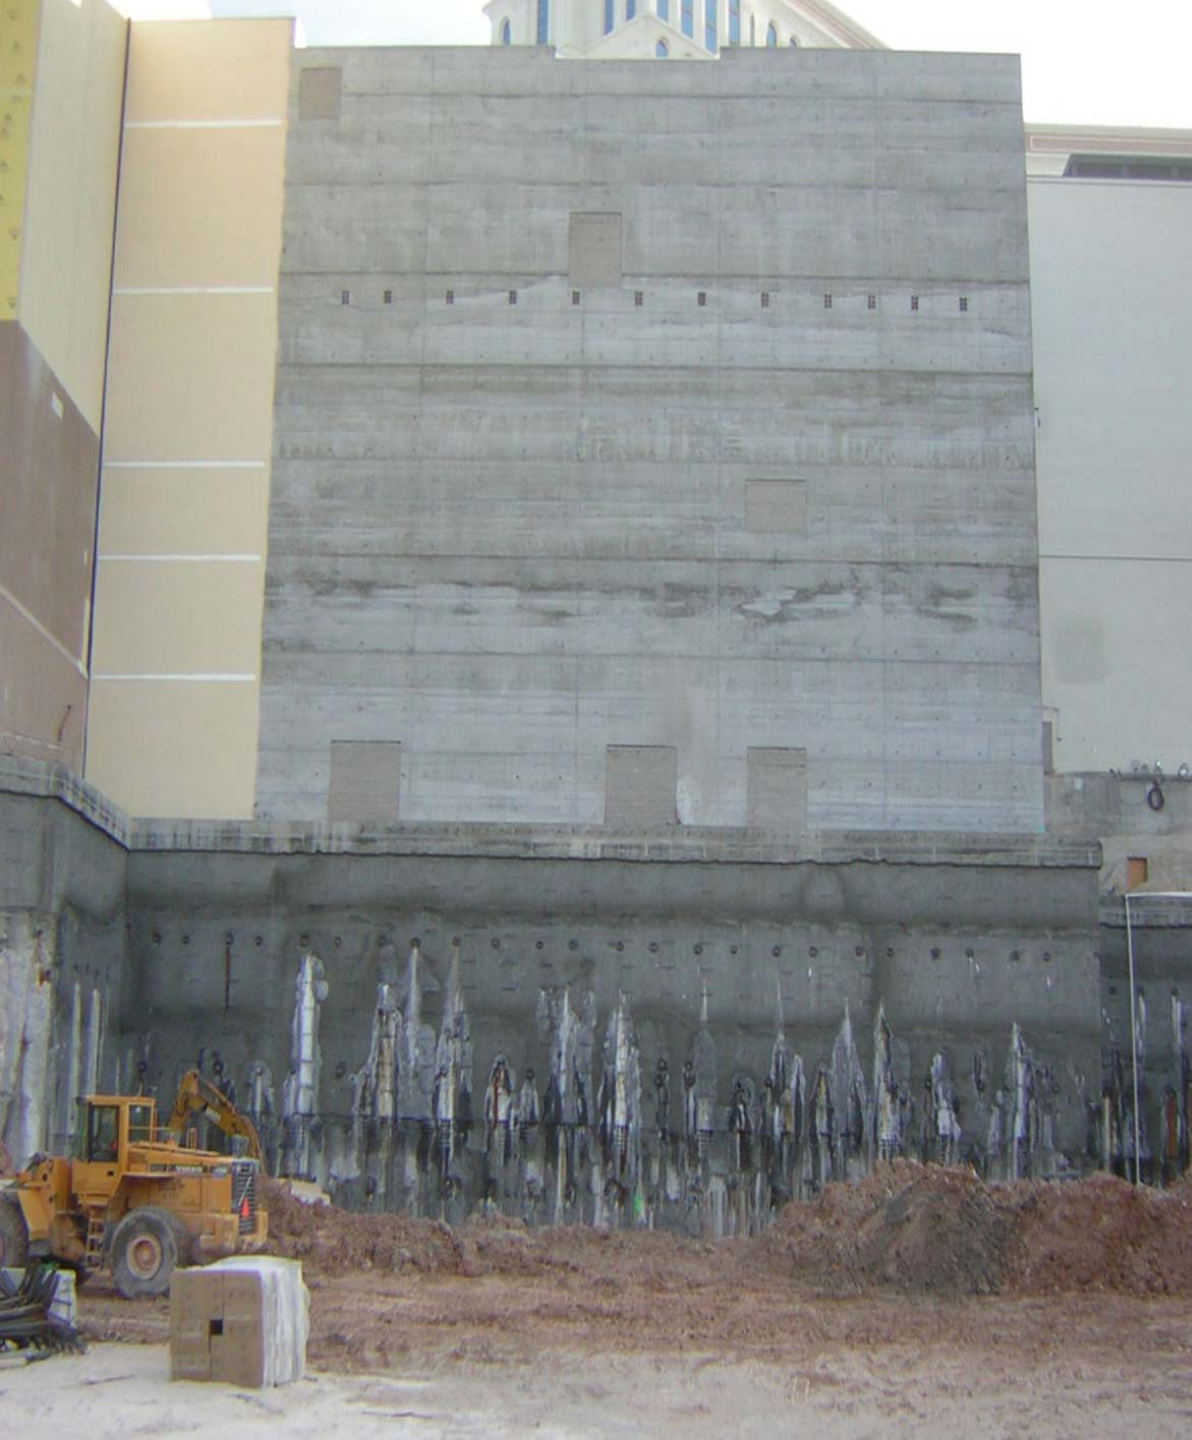
- Notch at tower cantilever
- Theatre wall
36.3 m - wide by
32 m - high by
457mm - thick
- Carbonate precipitate at tie-backs

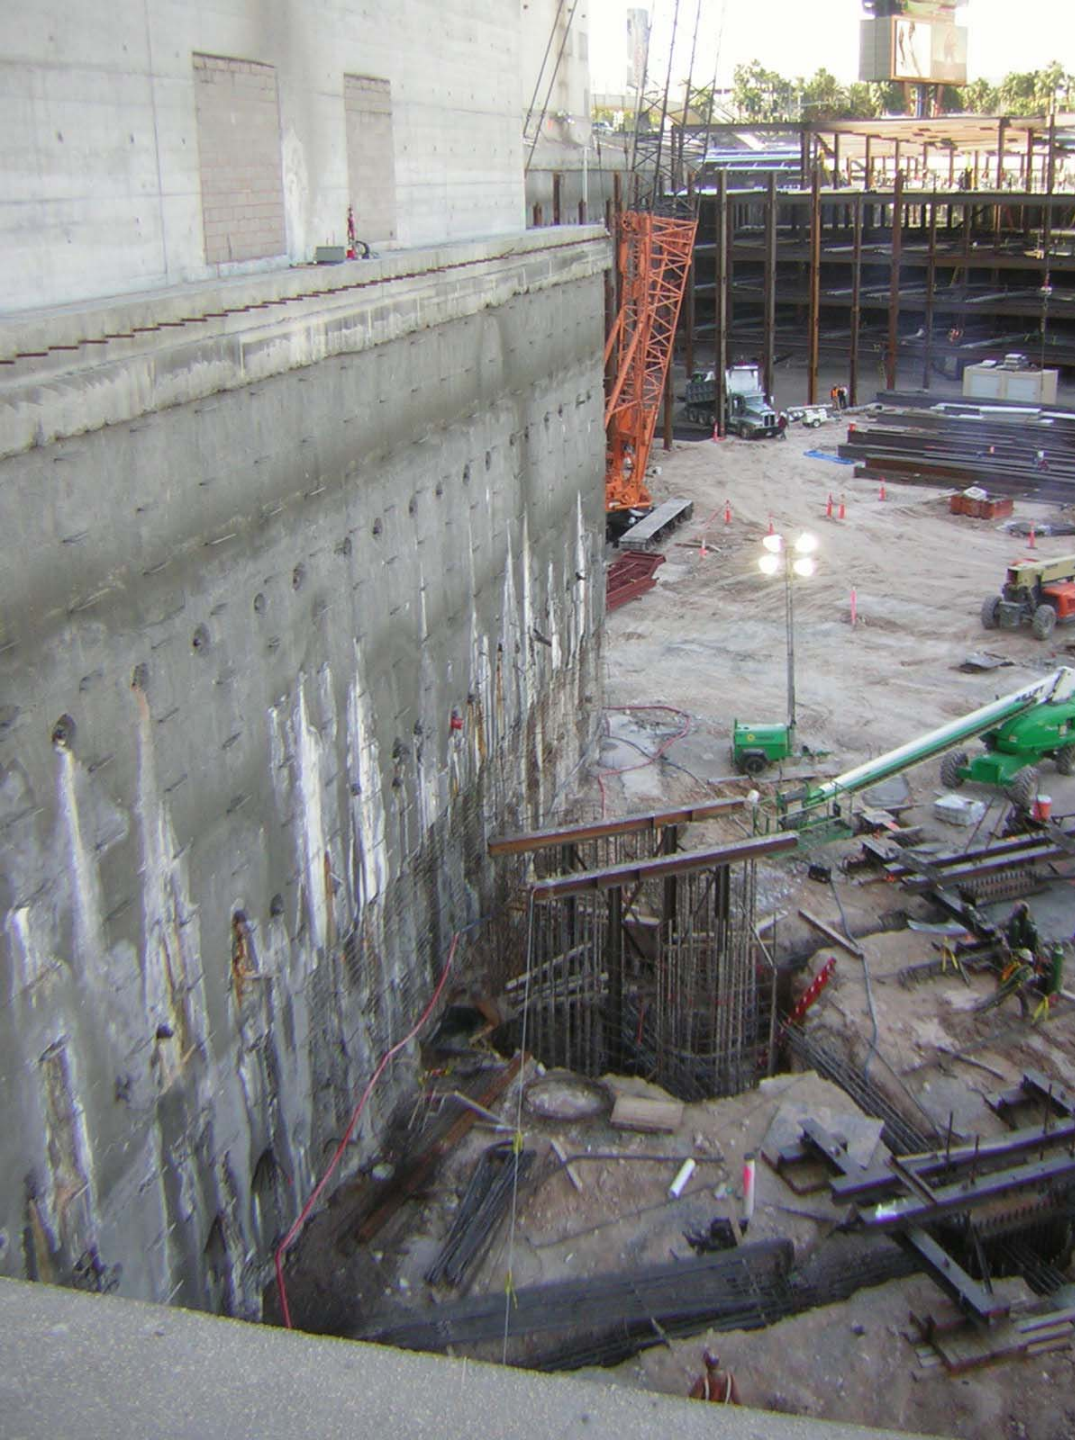
- Tower shaft group at cantilever

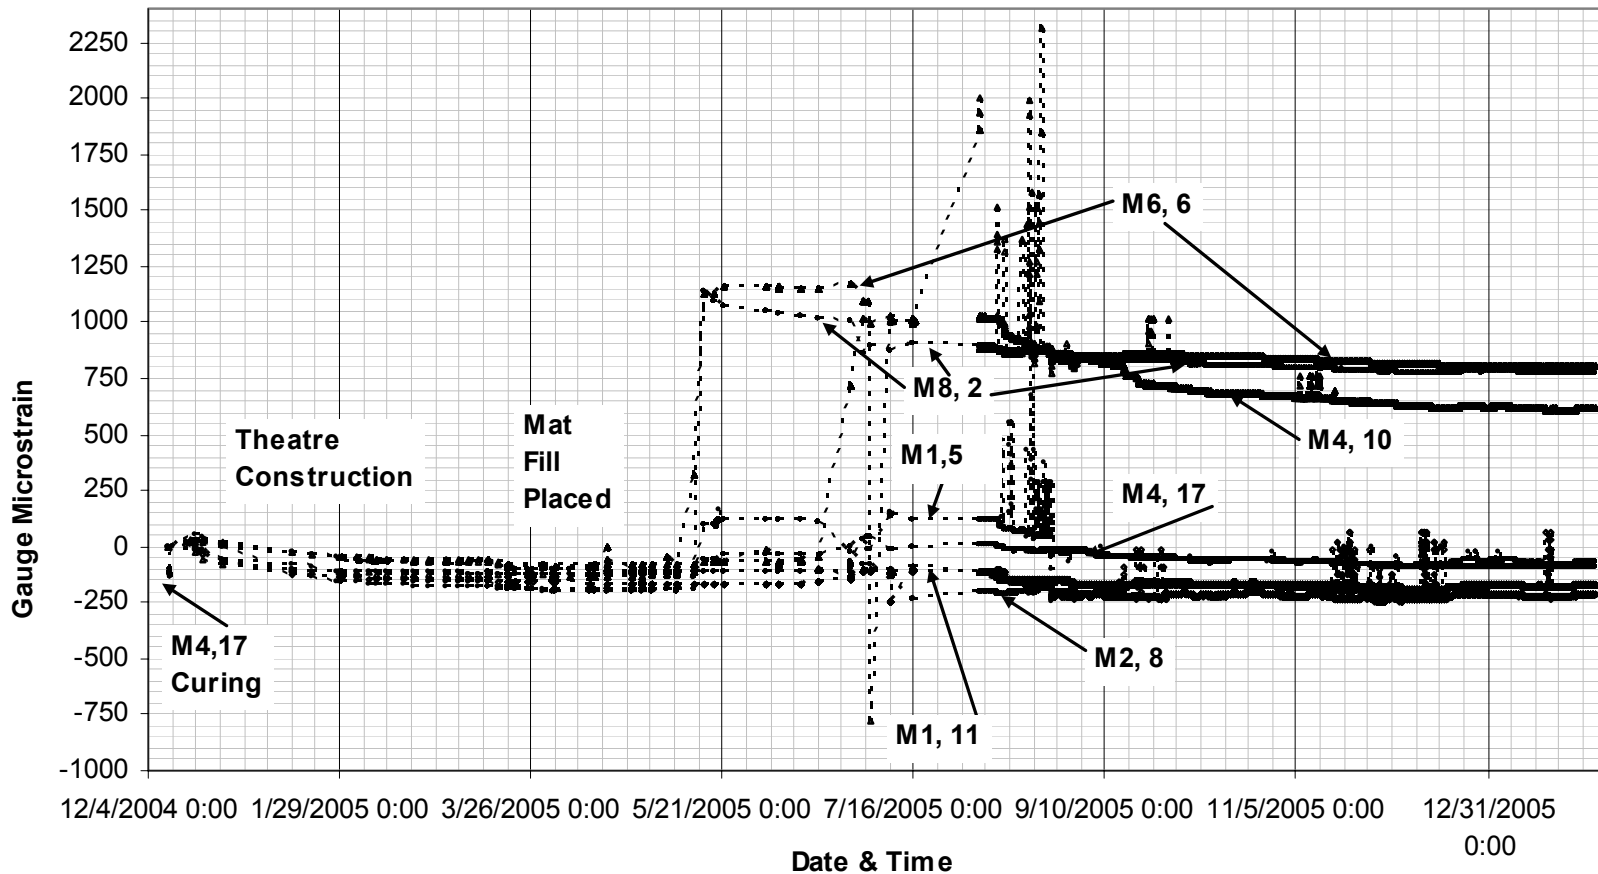
- Micropile strain history
- VW strain gauge data record
- Installation 12/04 through completion 1/06

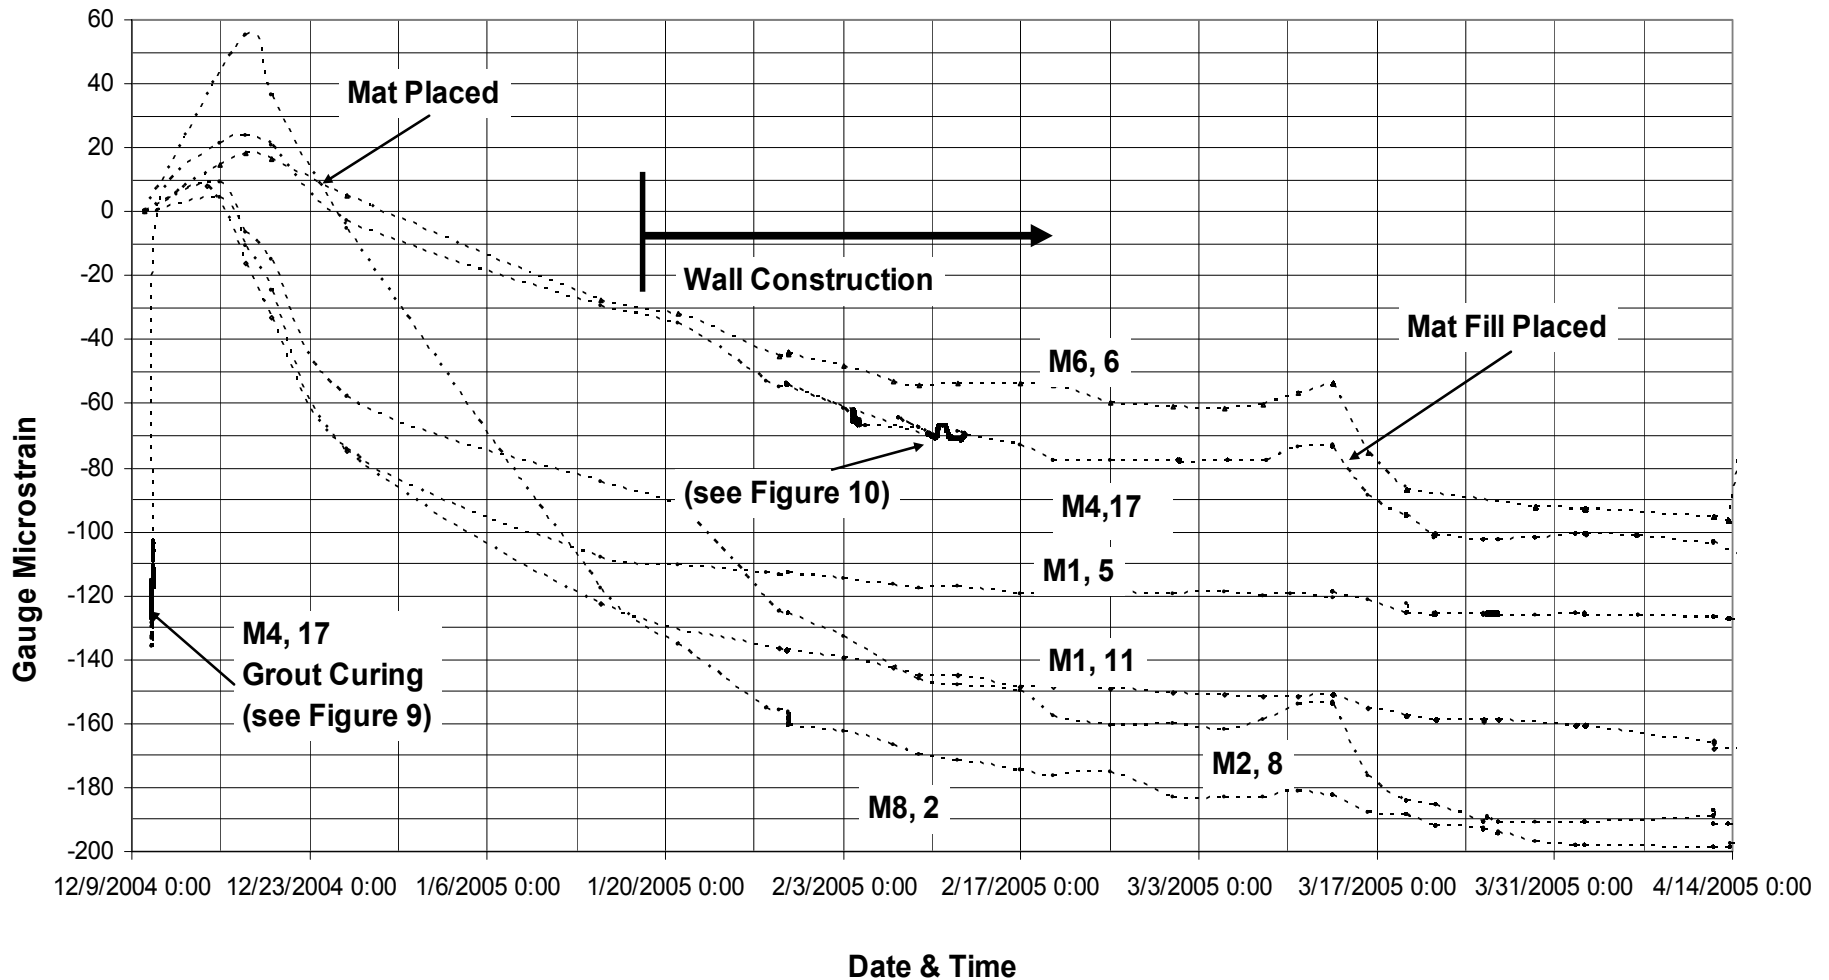
- Initial tension during curing and excavation to subgrade 12/11/04 – 12/18/04
- Mat placement 12/24
- Theatre construction 1/05 – 3/05
- Fill placement 3/14/05 – 3/20/05

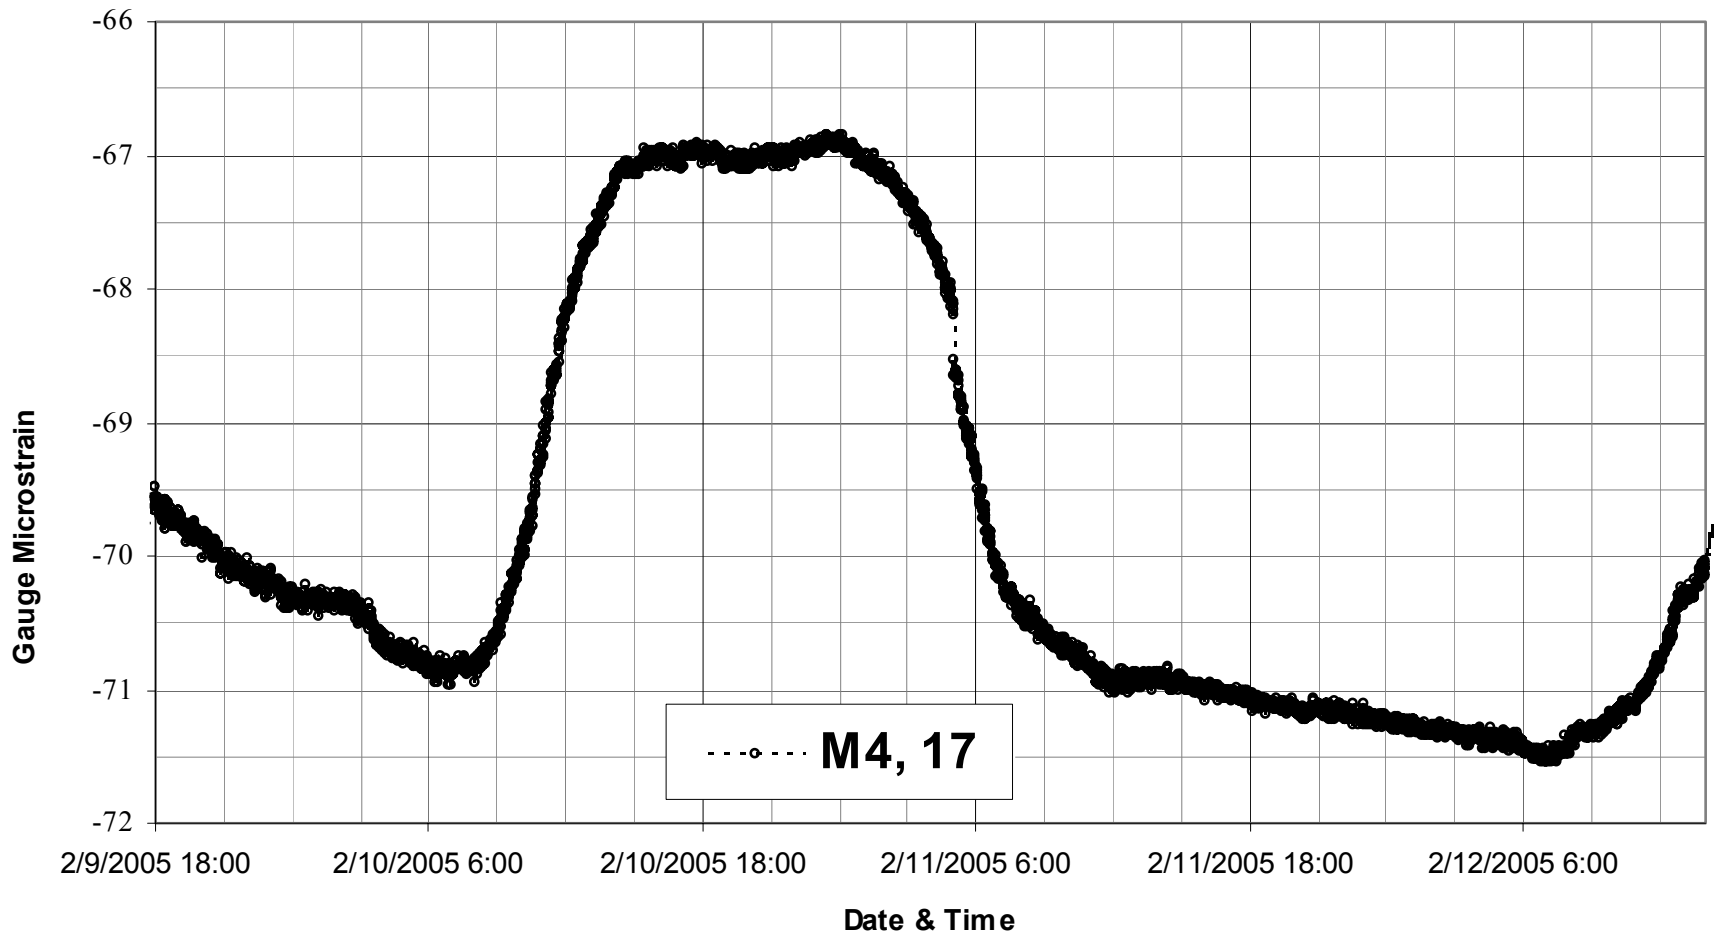
- Forming and concrete placement load/unload at interior location on mat

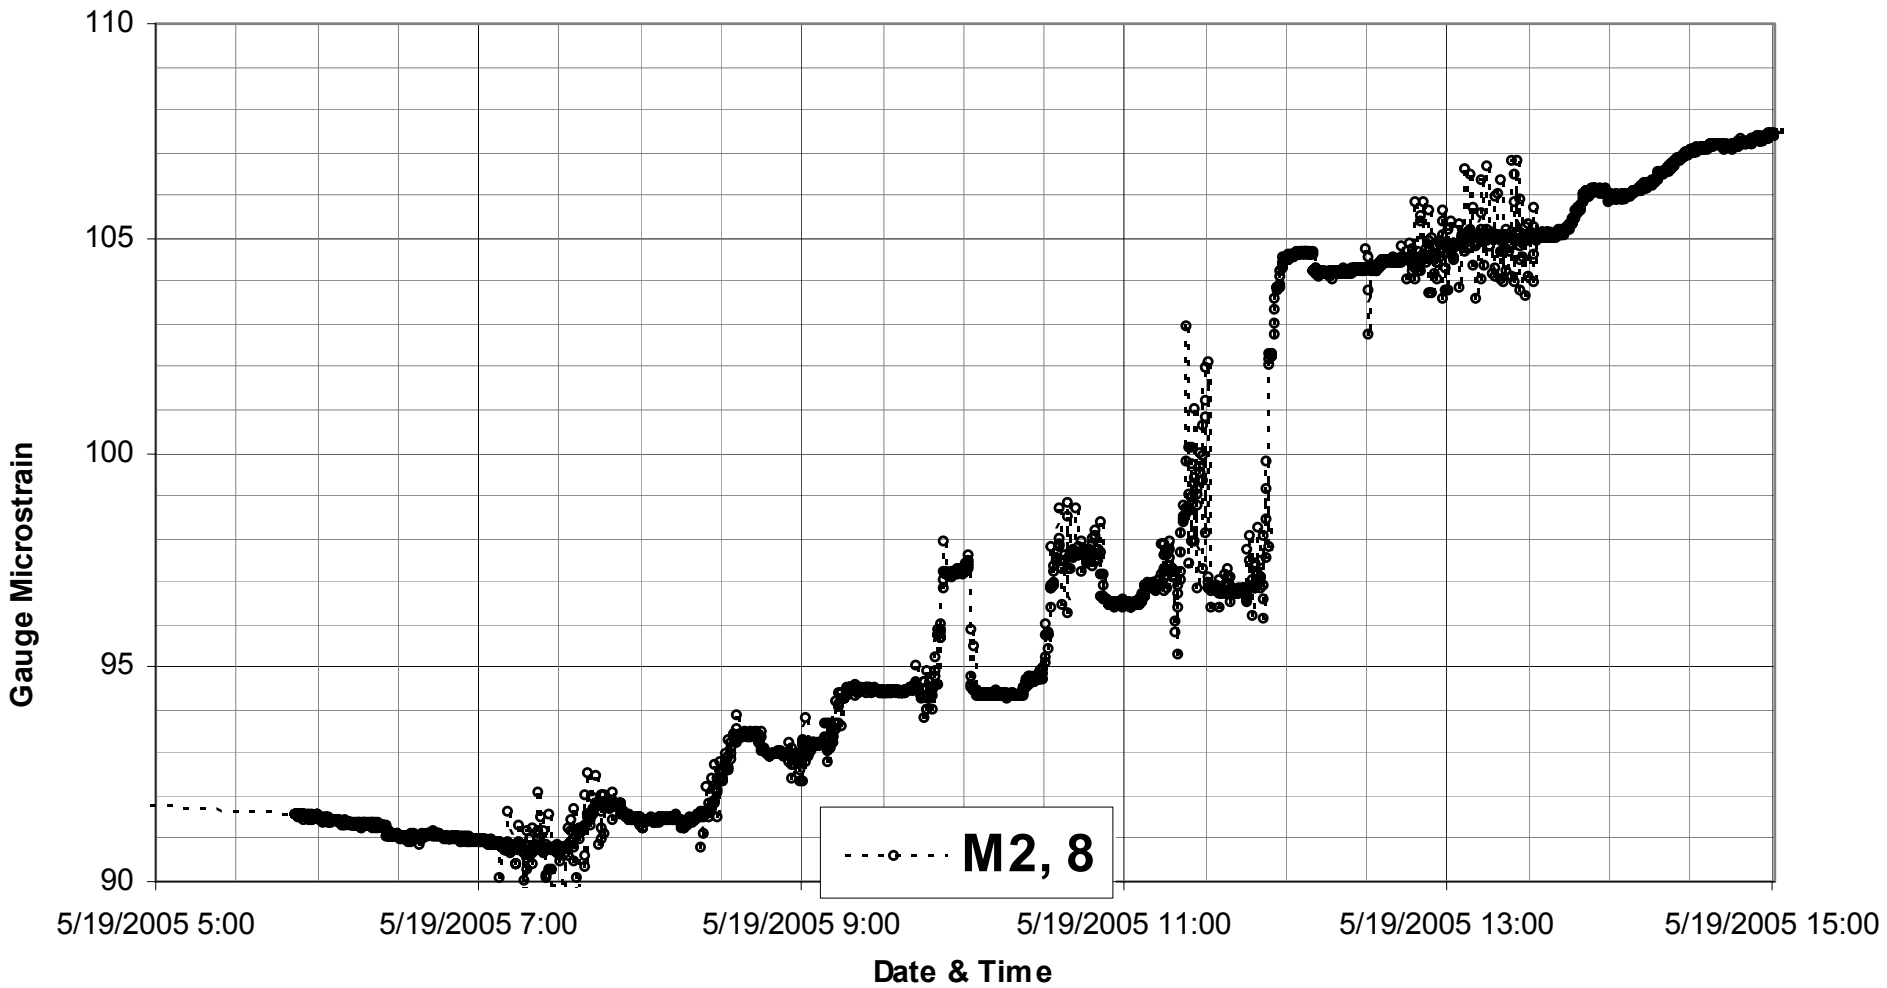
- Tieback stressing effects
- 15 Tiebacks at Level -1 stressed

- After tieback stressing
- 20.8% to 115.5% at perimeter
- 6.7% to 184% (tension) at 1st interior row
- 11.4% to 83.0% (tension) near middle of mat (row 4)
- 139.5% (tension) at back of mat (row 6)

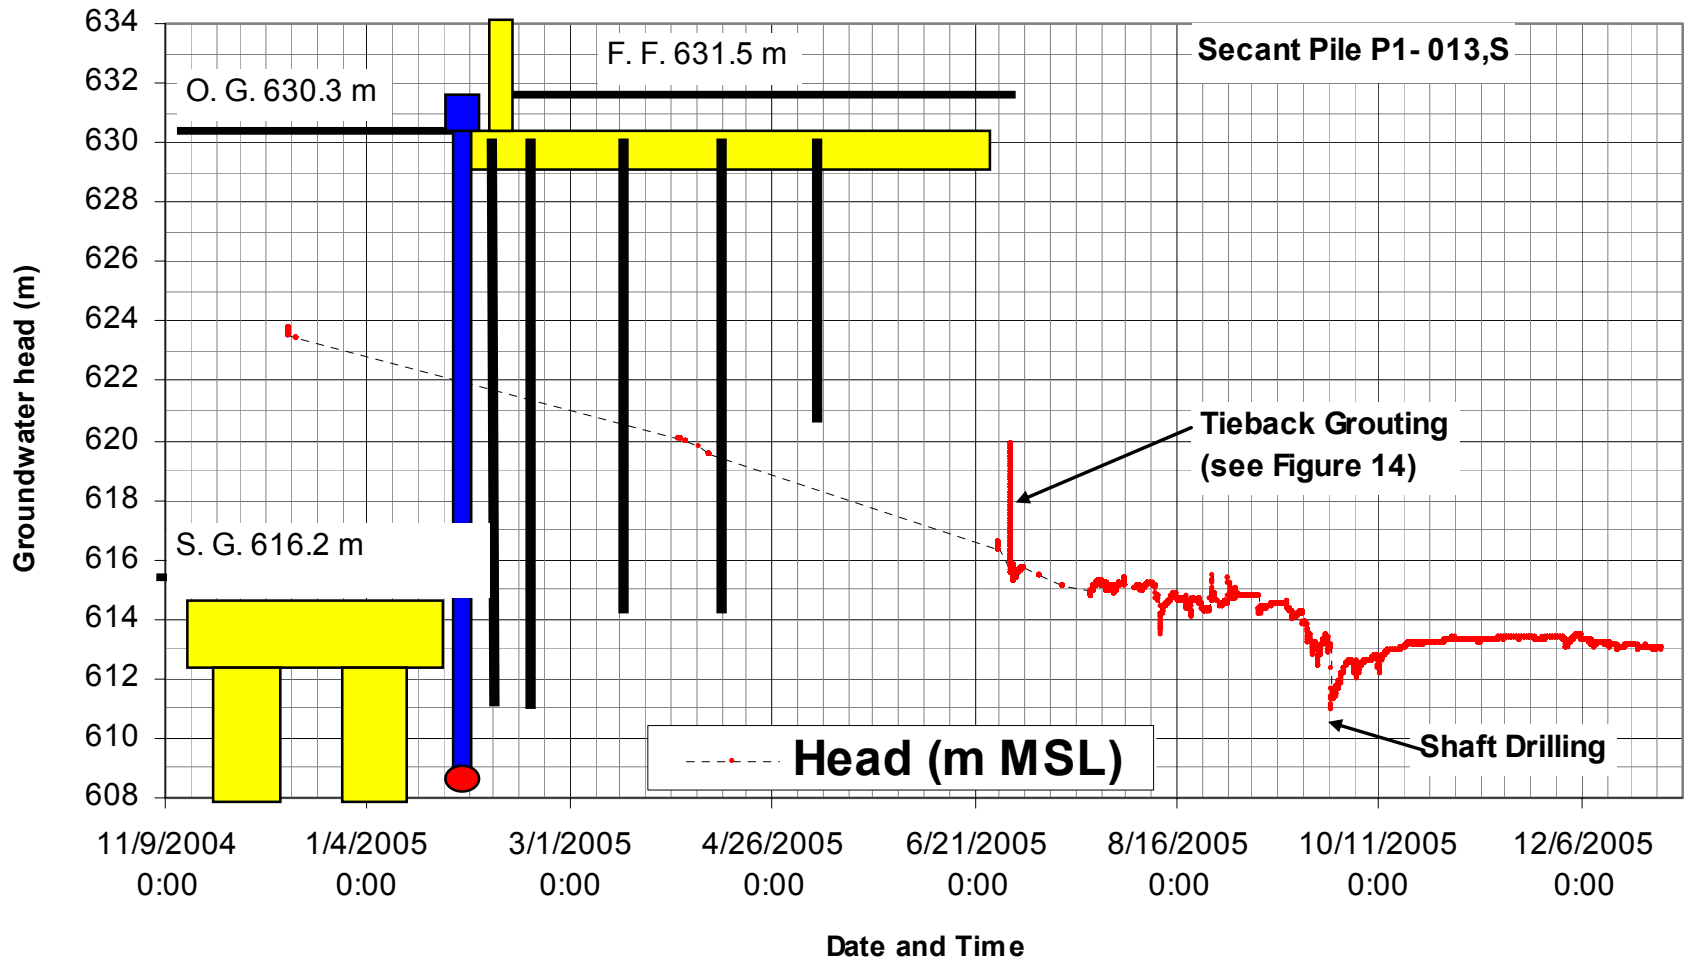
- Piezometer data record 12/04 – 1/06
- Head rise during tieback grouting
- Head drop during drilled shaft construction

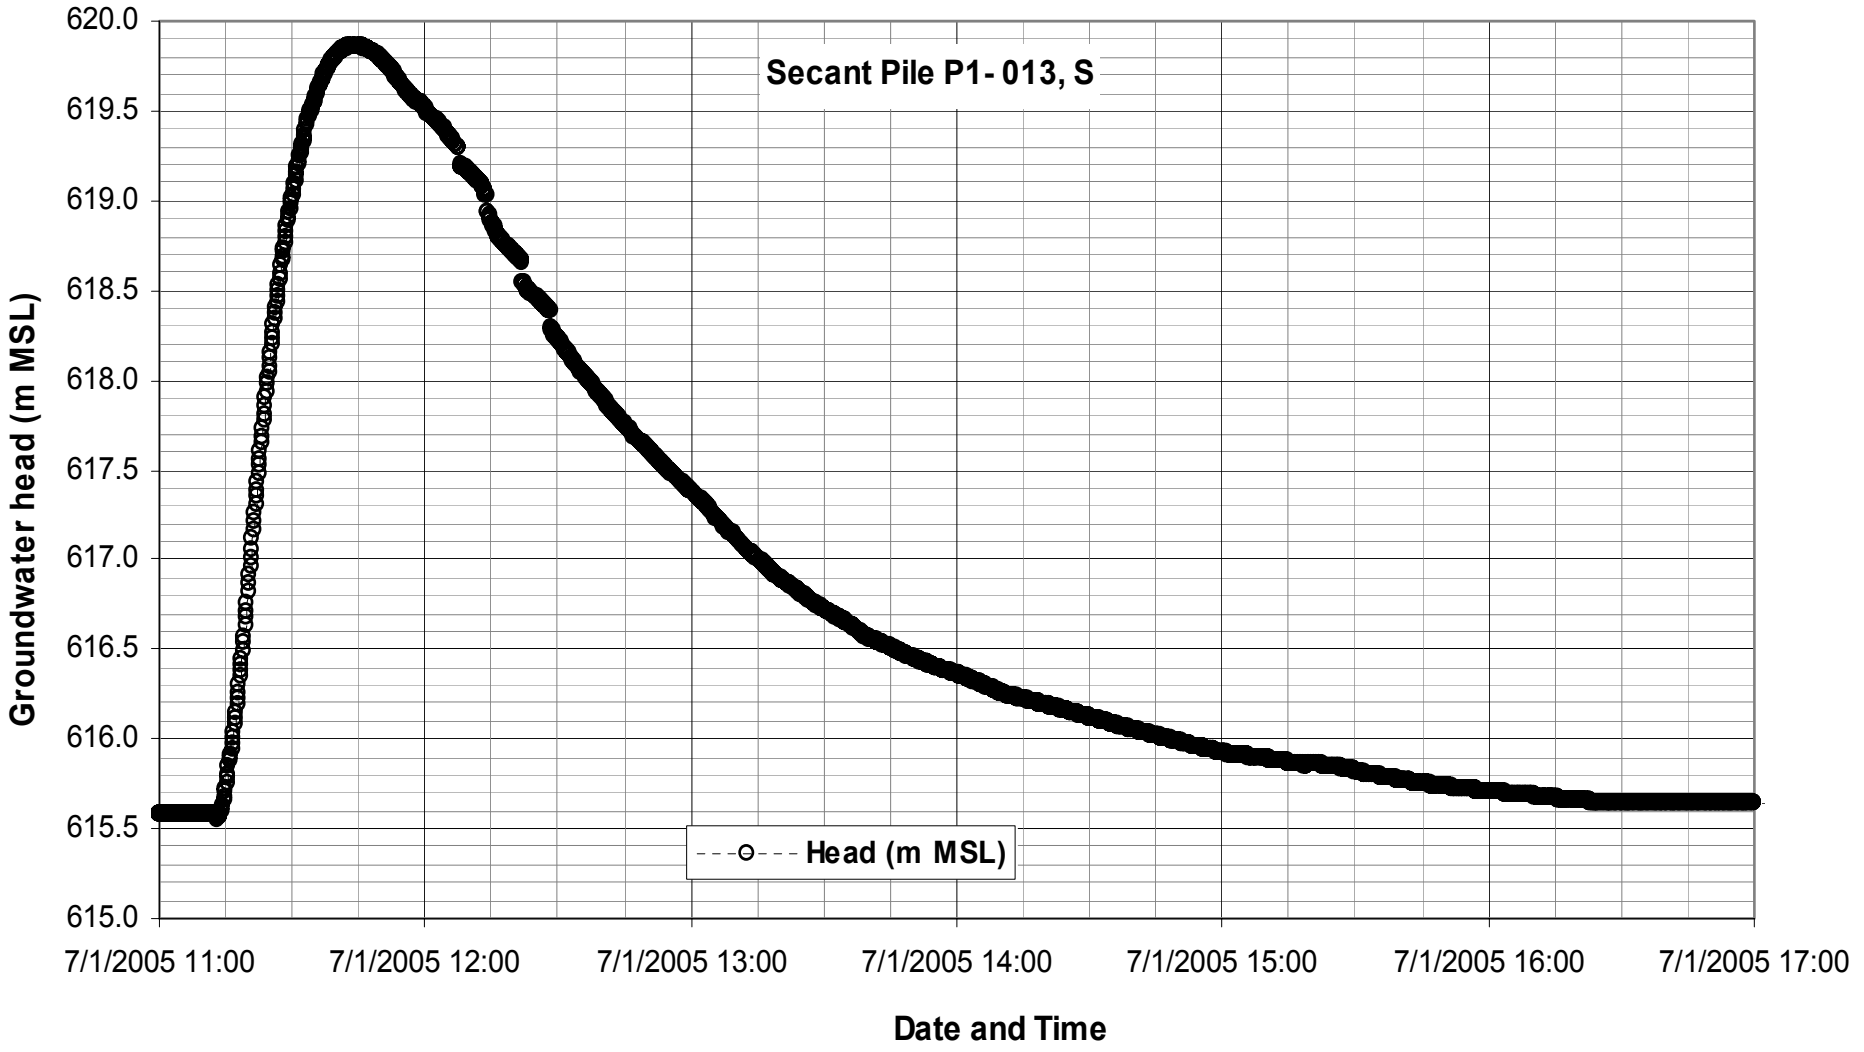
- Tieback grout placement at Level – 2

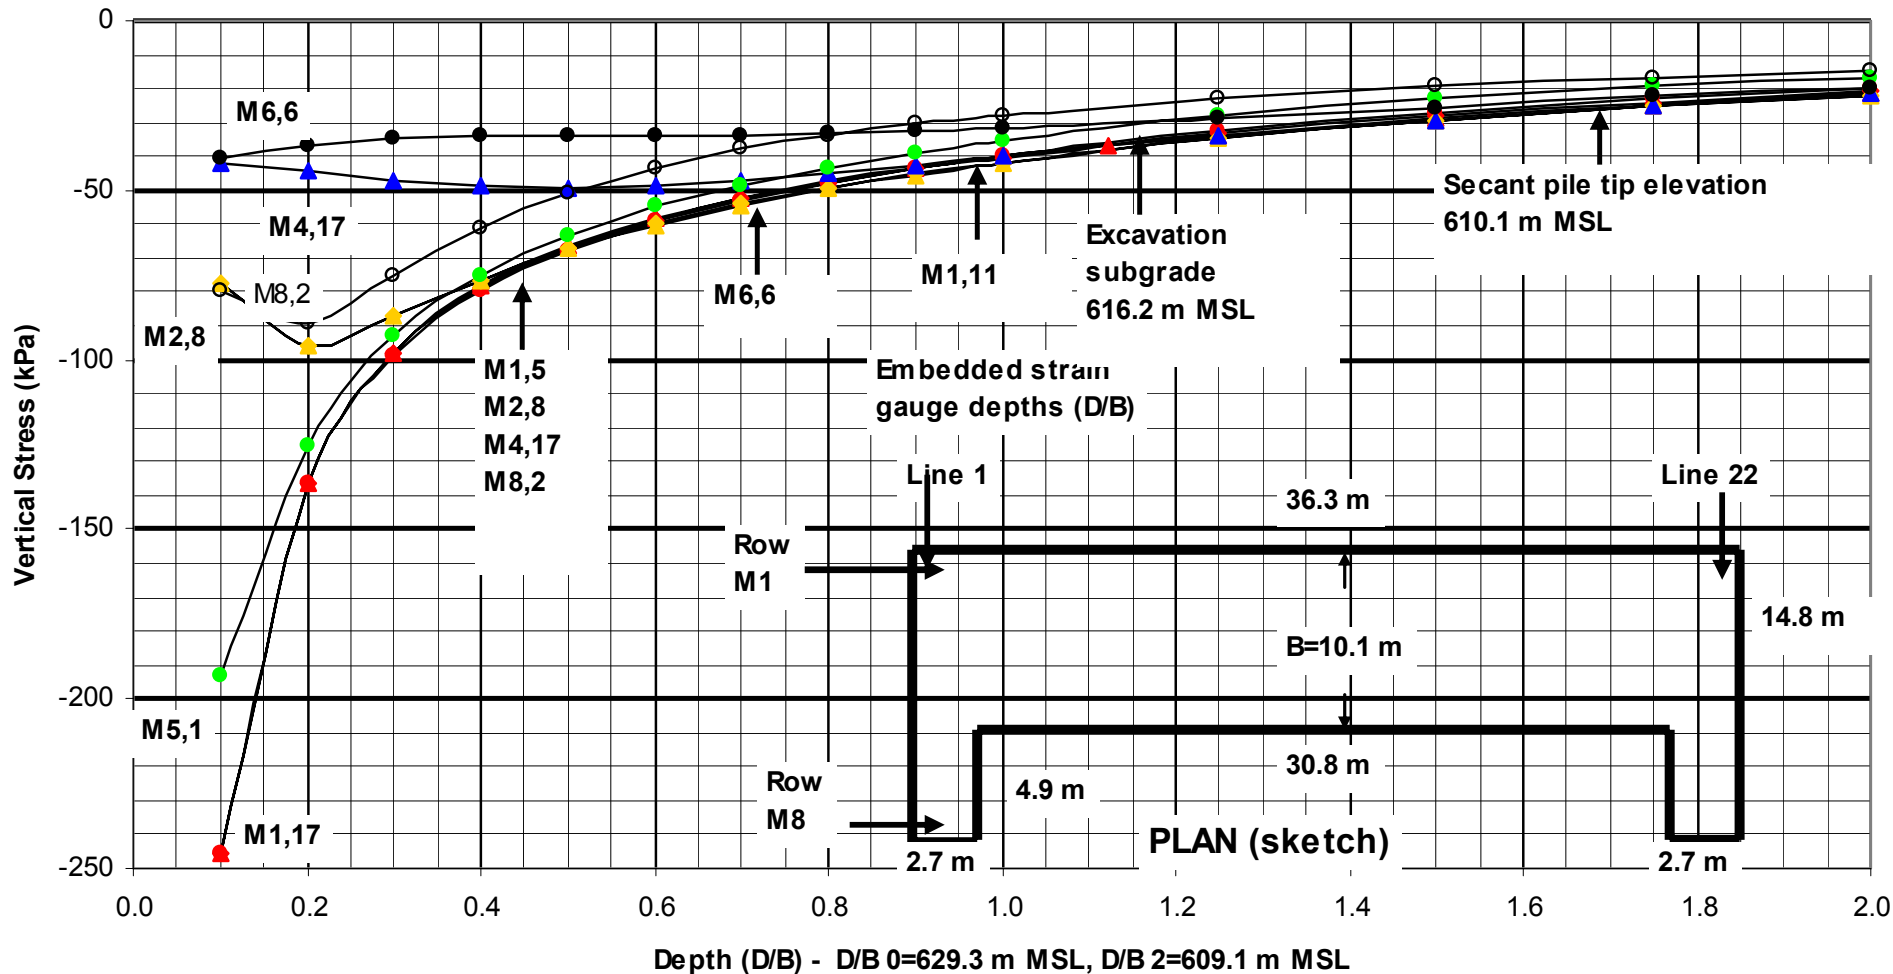
- Boussinesq elastic analyses by superposition
- Instrumented micropile locations and depths

- 37.6% to 88.3% at perimeter
- 5.6% to 73.2% at 1st interior row
- 10.9% to 11.8% near middle of mat (row 4)
- 17.1% at back edge of mat (row 6)
- Prior to stressing
