A Case Study of Micropiling in the Urban Environment

Jung-Hoon Lee, Ki-Hwan Lee, Hyun Cho (SsangYong Eng. & Const.)
Jaehyeung Jeoung, Changho Choi (KICT)

Apartment Remodeling Overview

Micropile Design

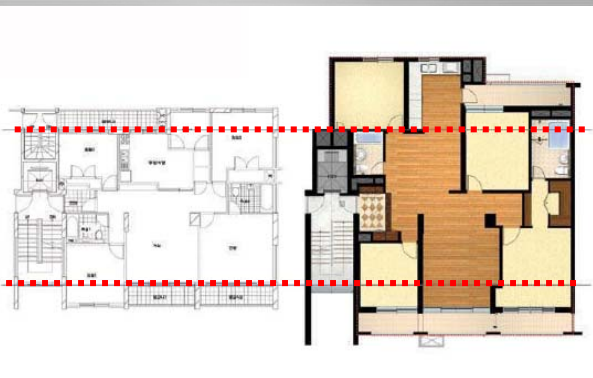
Building 1

Before (139 m²)

After (175 m²)

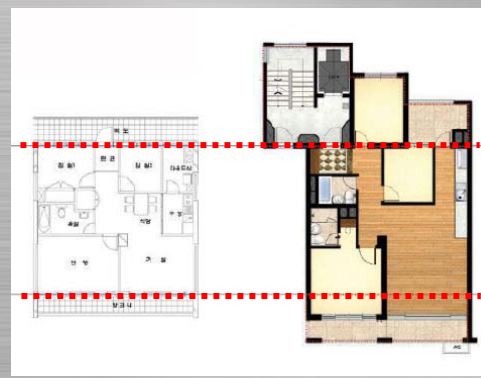
Building 2

Before (93 m²)

After (116 m²)

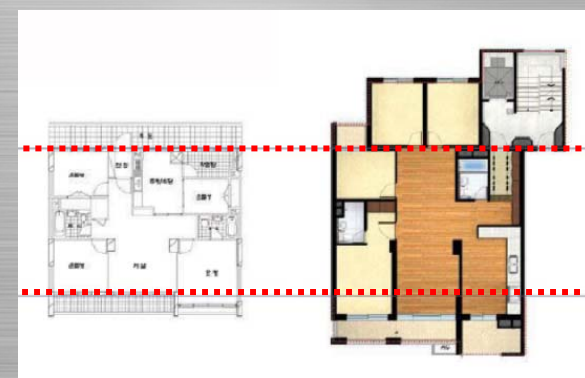
Building 3

Before (119 m²)

After (145 m²)

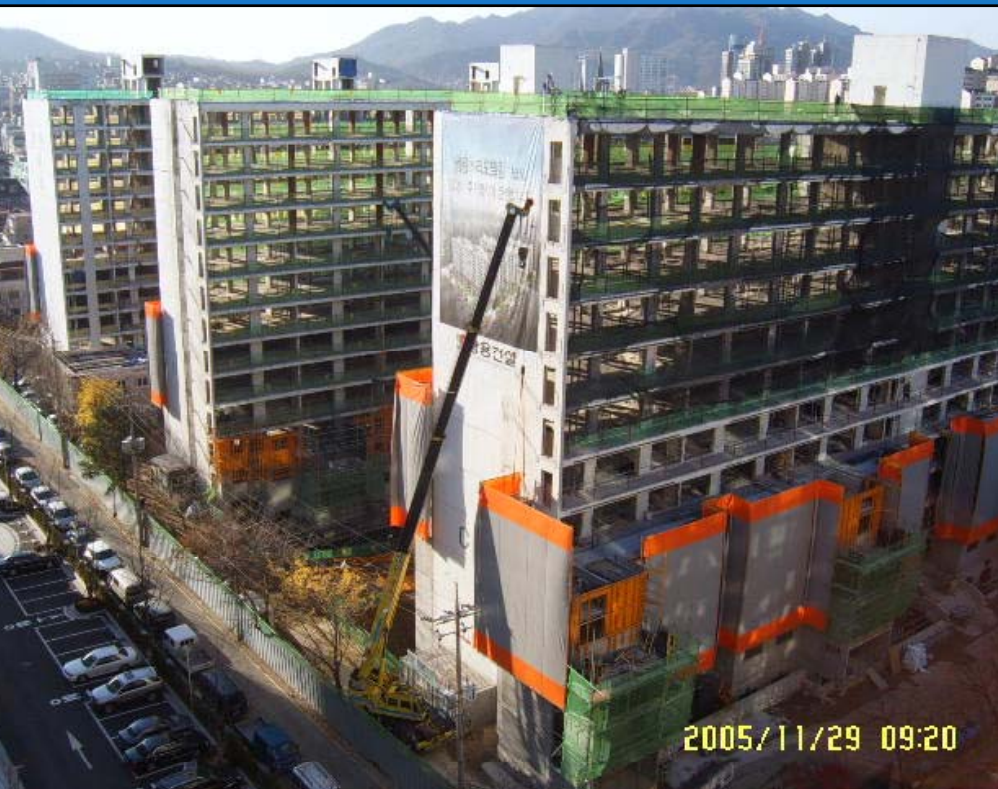
Horizontal Expansion of Space

Apartment spaces expanded horizontally

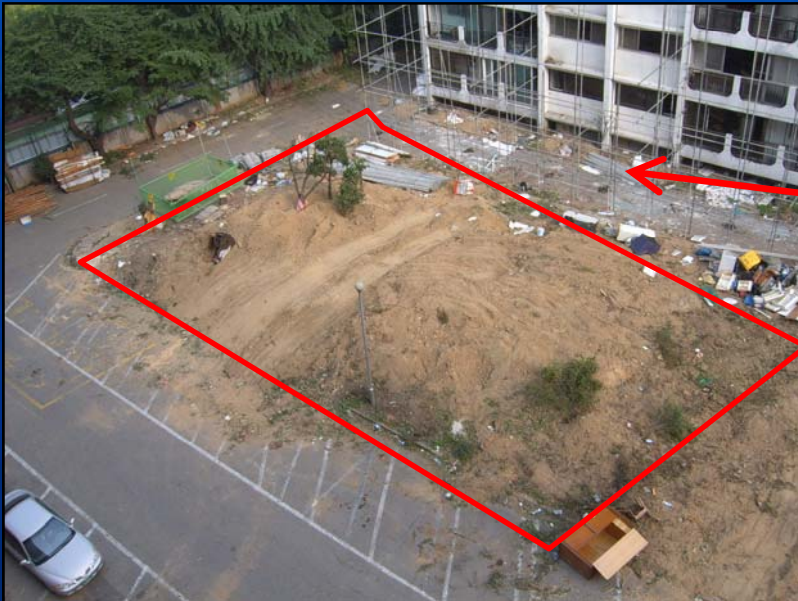
Construction of Basement Parking Area

- To connect new basement parking area and Building 1, **the elevators were extended downward with excavation of the bottom of existing foundation.**

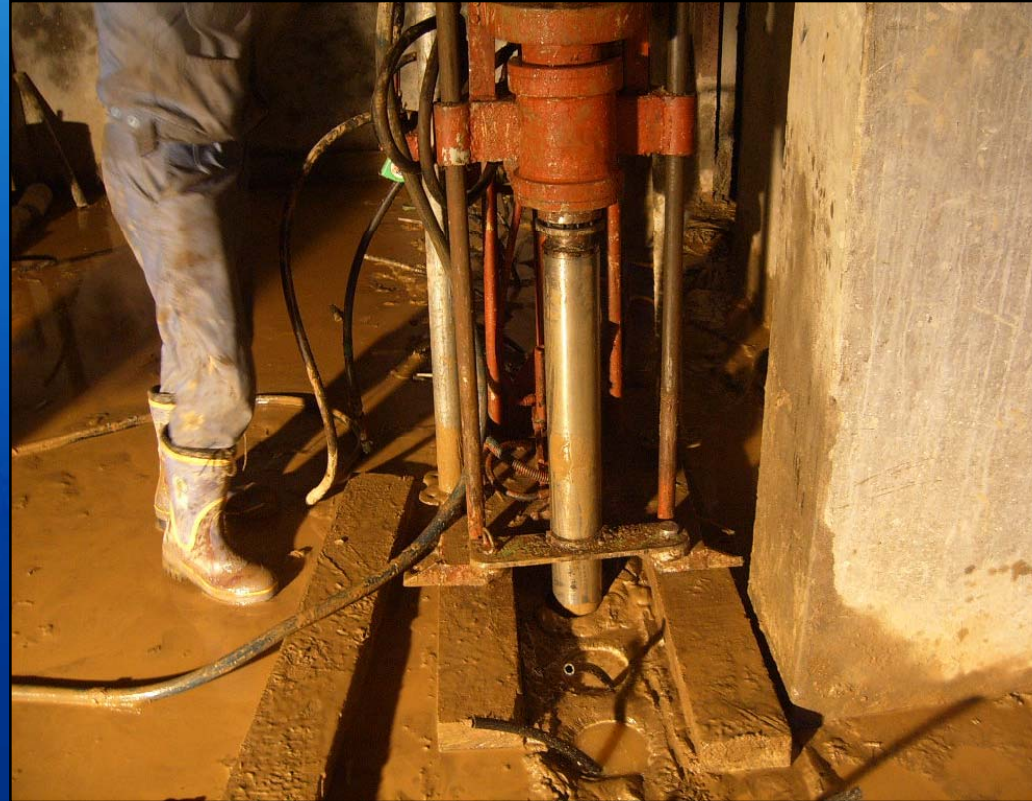
Step 2 : Shoring Installation

Shoring were installed to retain the side earth pressure due to the excavation of existing footing.

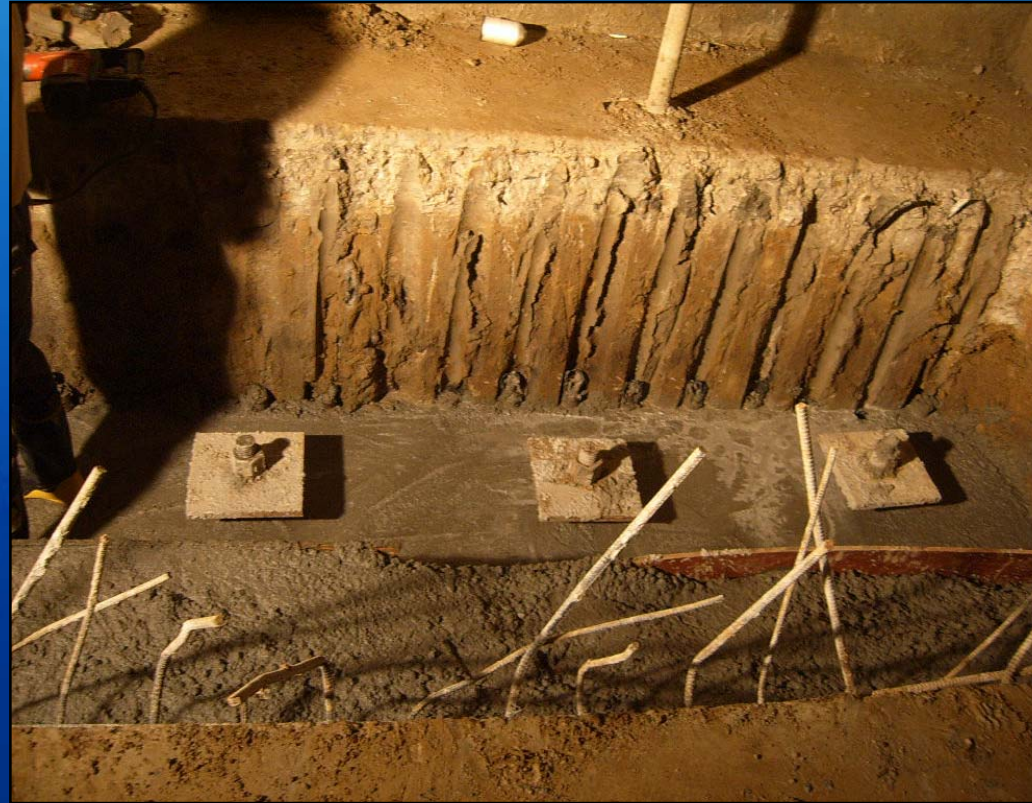
Step 3 : Micropile Bearing Plate Installation

Micropile Bearing Plate was installed for making new foundation.

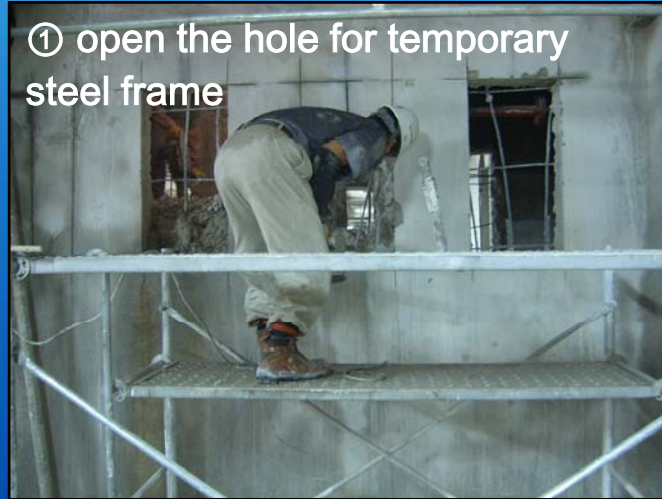
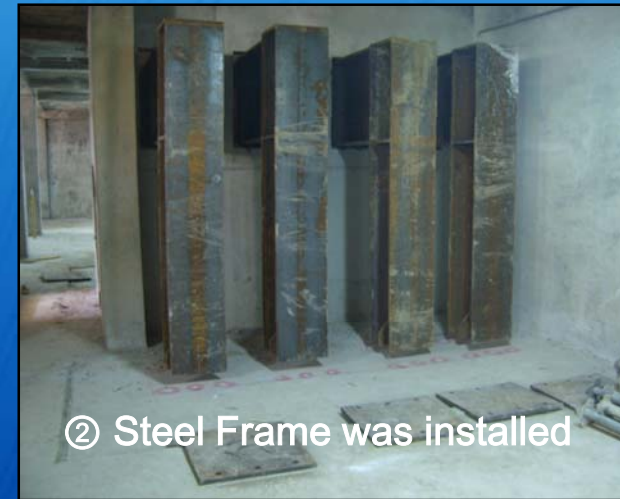
Step 5 : Temporary Steel Frames were installed using new foundation.

① open the hole for temporary steel frame

② Steel Frame was installed

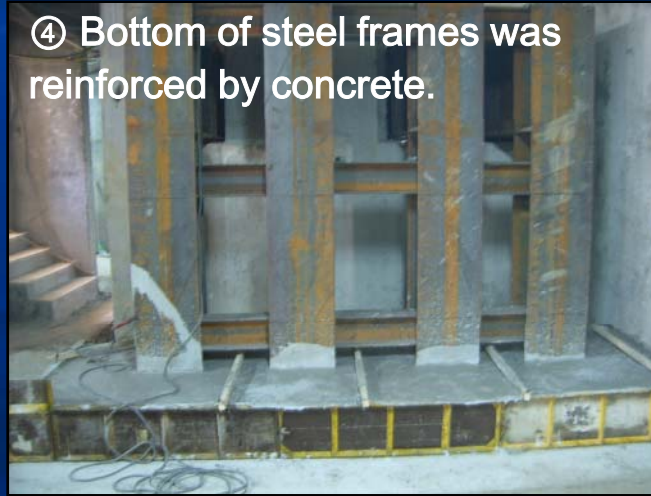
③ Bottom of steel frames was fixed by bolts.

④ Bottom of steel frames was reinforced by concrete.

⑤ The gap between steel frames and ceiling was filled using epoxy grout.

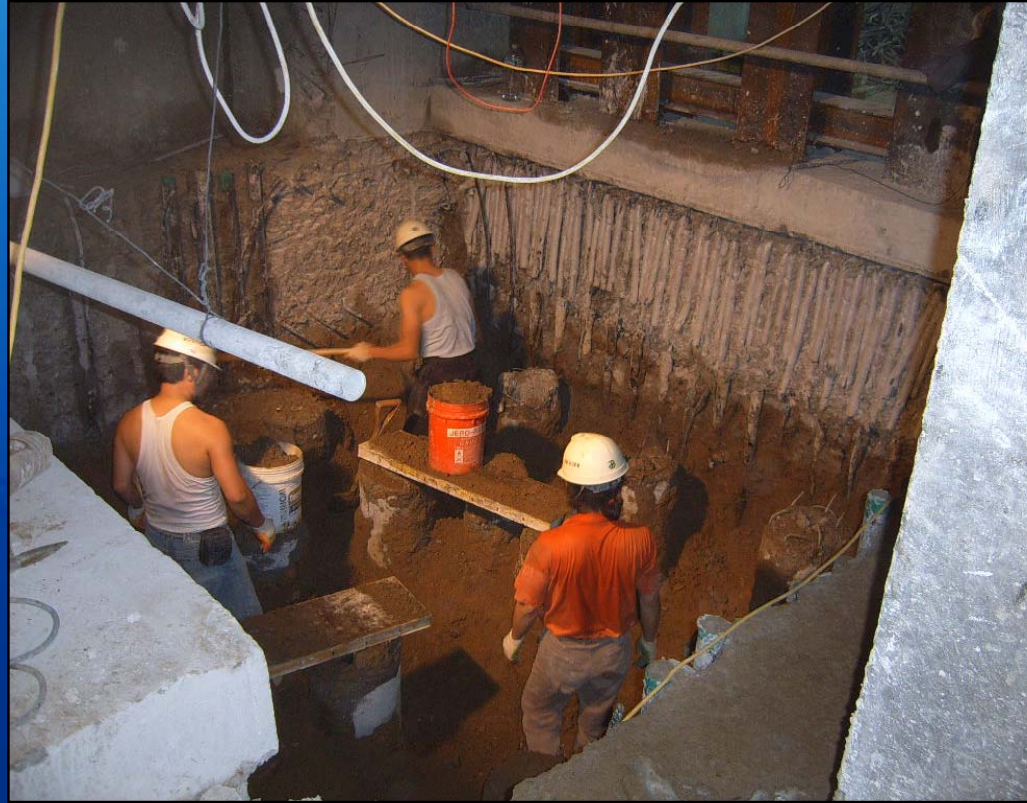
Step 7 : Excavation and Removal of Existing PC pile

Existing PC piles were removed for making the space of elevator PIT.

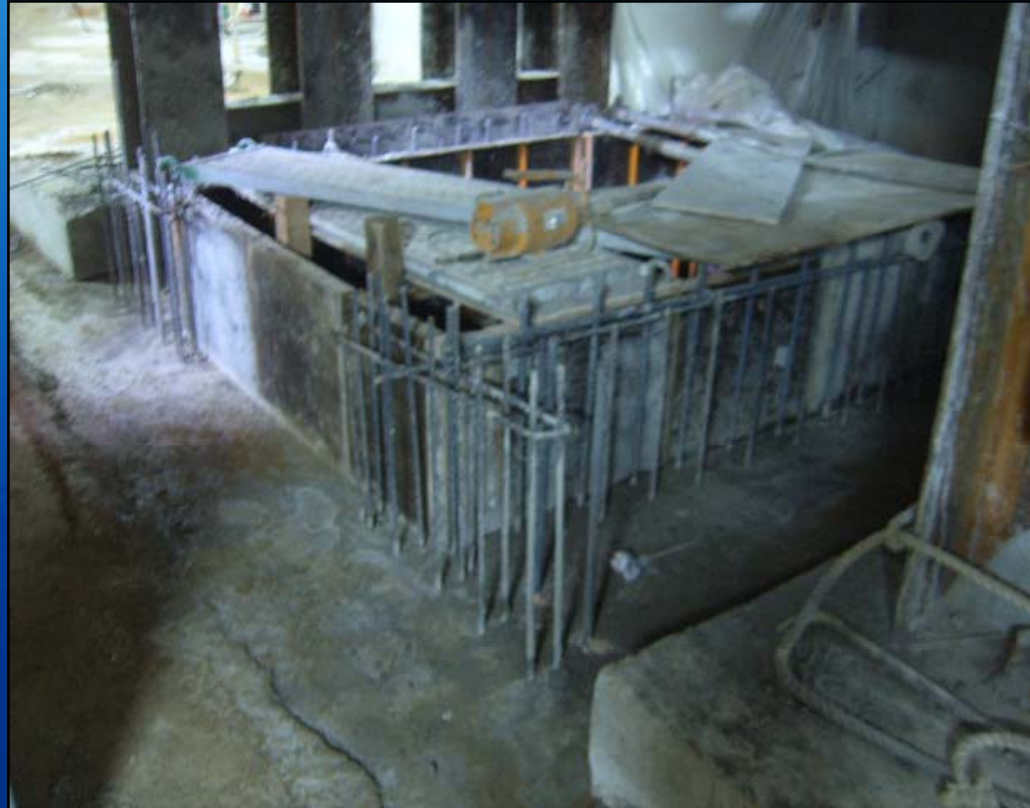
Step 8 : Construction of New PIT Wall

New PIT wall was constructed.

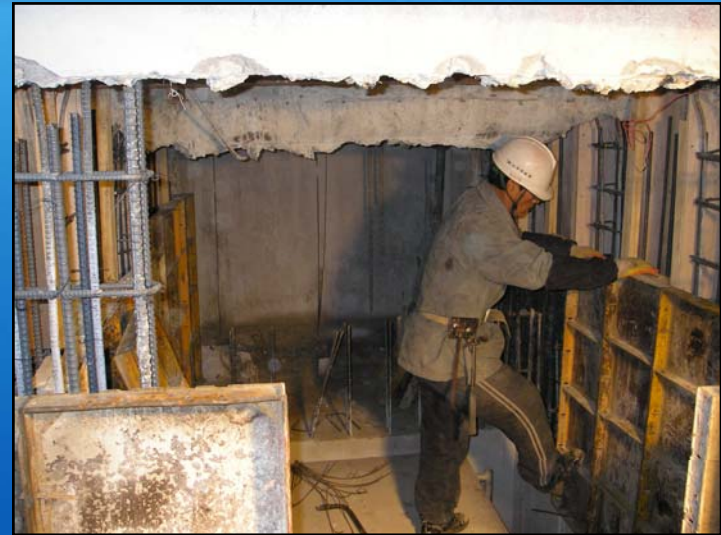
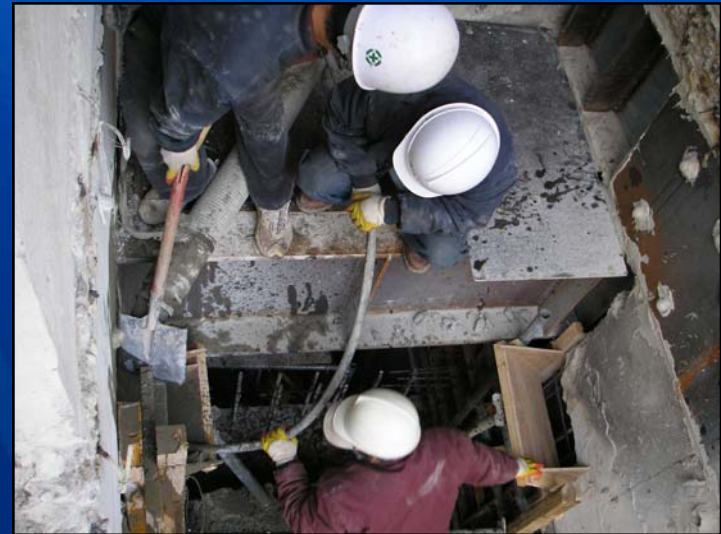
Step 9 : Construction of New Shaft Wall

① Assembling Steel Mold

② Filling Concrete

New Shaft wall was constructed by assembling steel mold and filling concrete.
