HIGH CAPACITY MICROPILES IN WEAK DOLOMITIC LIMESTONE FOR CRANE FOUNDATION SUPPORT

A Case History in Temporary Foundations

12th International Workshop on Micropiles

Terence P. Holman, Ph.D., P.E.

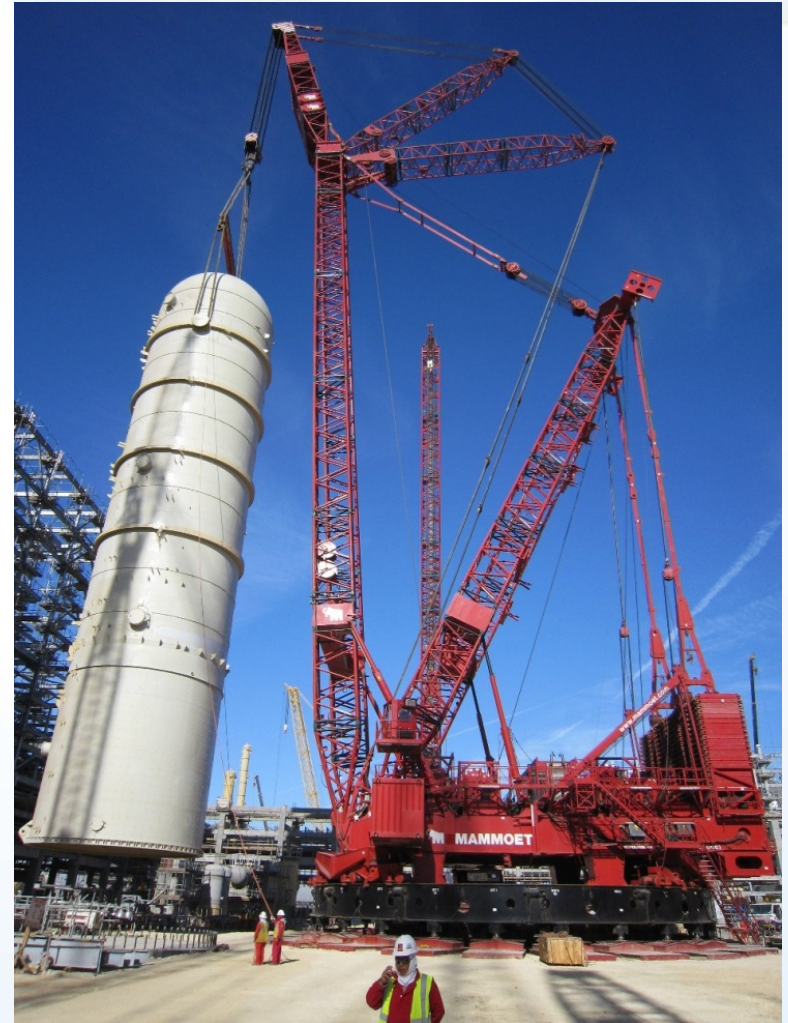
Photo of typical usage and setup for a Mammoet PTC35 ring crane (photo courtesy of Mammoet)

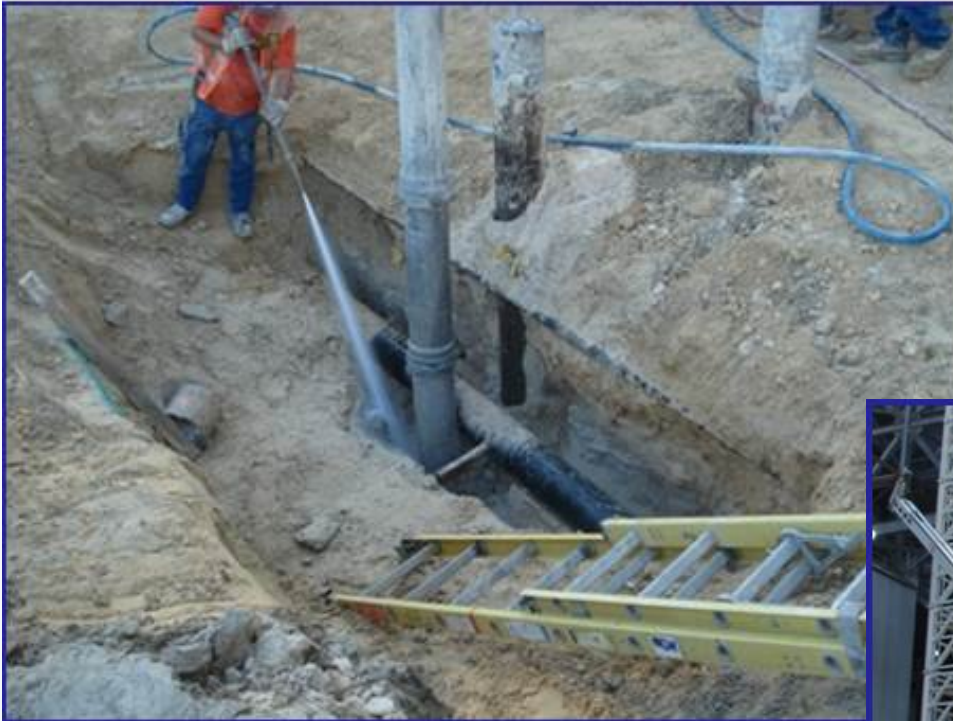
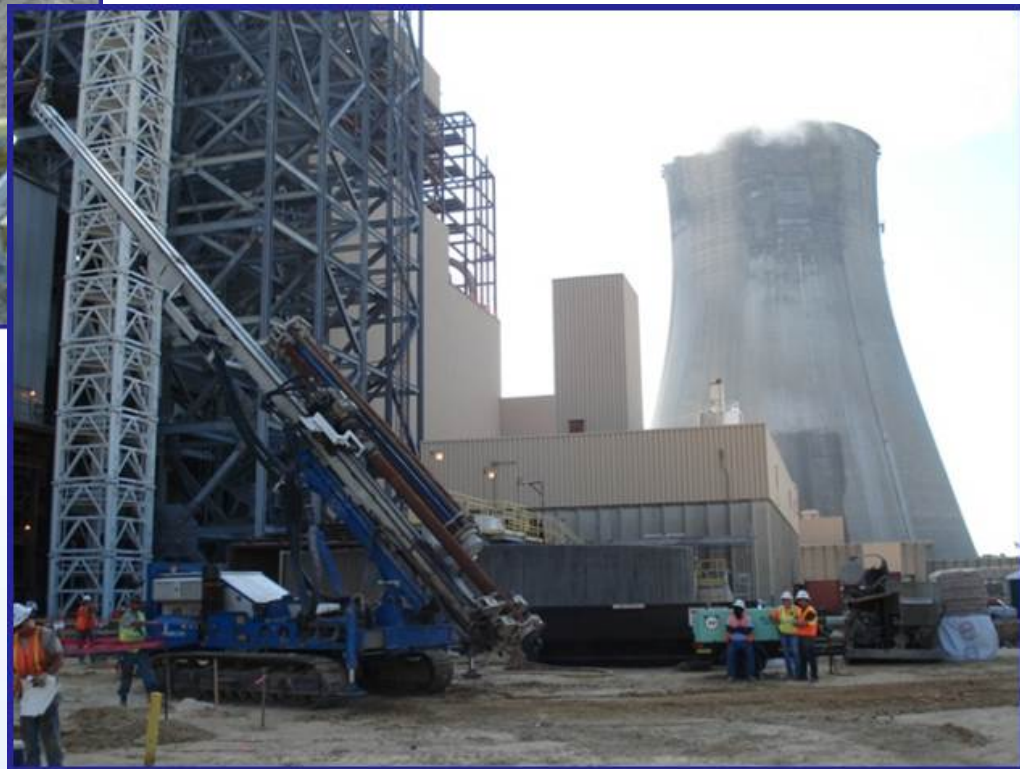
Production Pile Installation & Challenges – Utilities and Access

- 72 piles eventually installed due to utilities
- Local overstressing expected due to as-built pile configuration
 - Some additional reinforcement
 - 22% overstress in SE quadrant

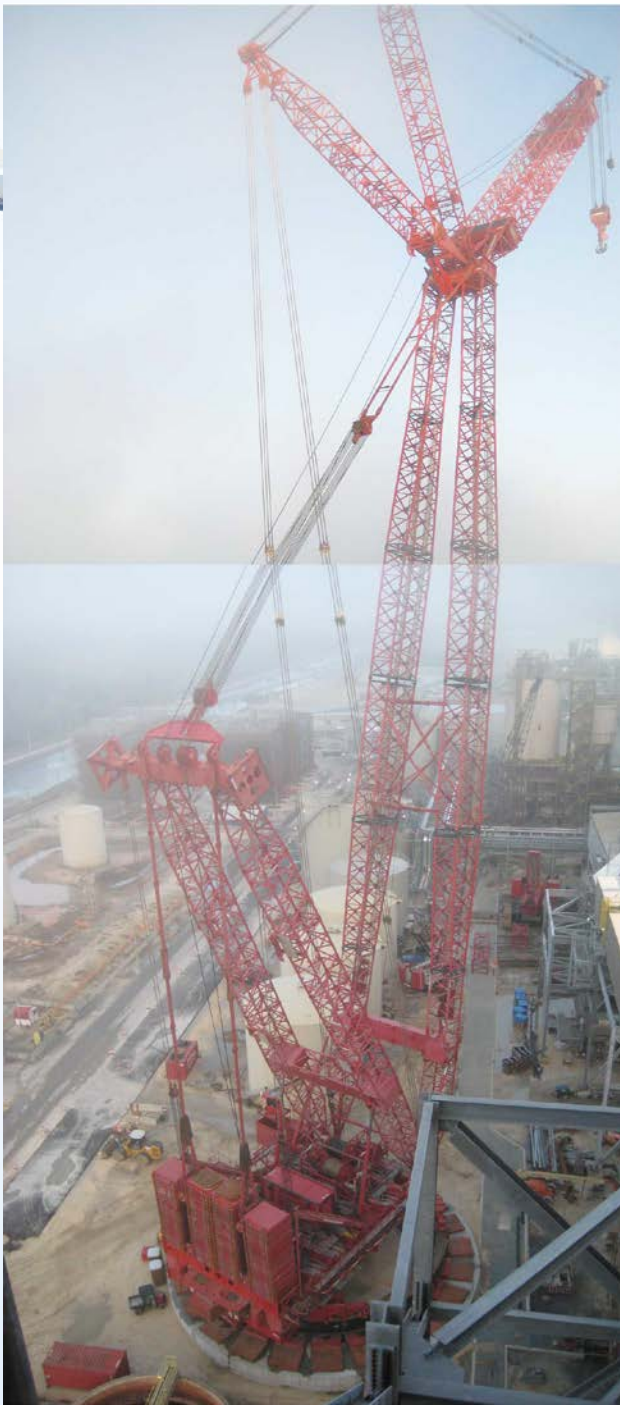
- Total micropile and cap construction took 44 calendar days
- Mammoet 1800 metric tonne ring crane was assembled during December 2009 and January 2010
- Active crane use began in February 2010 and continued until late May 2010
- No performance metrics out of crane operation bounds by on-board measurement
