APPLICATION OF MICROPILES TO THE STABILIZATION OF A DEFLECTED OLD TENEMENT HOUSE

The old tenement house in a city of Upper Silesia (Poland) is deflected as a result of non-uniform settlement on the compressible ground. Low bearing capacity of the ground has been exceeded several times. The mining activity in the area has also contributed to the total settlement of the building.

In order to stabilize the building and protect it from further tilting, underpinning of the foundations has been designed. Due to the dense urban building and difficulties in accessing the foundations three technologies have been proposed: drilled micropiles, jacked micropiles, and jet-grouting columns. The design has been made which is currently under execution. Finally, all three technologies have been substituted by drilled jet-grouted micropiles.

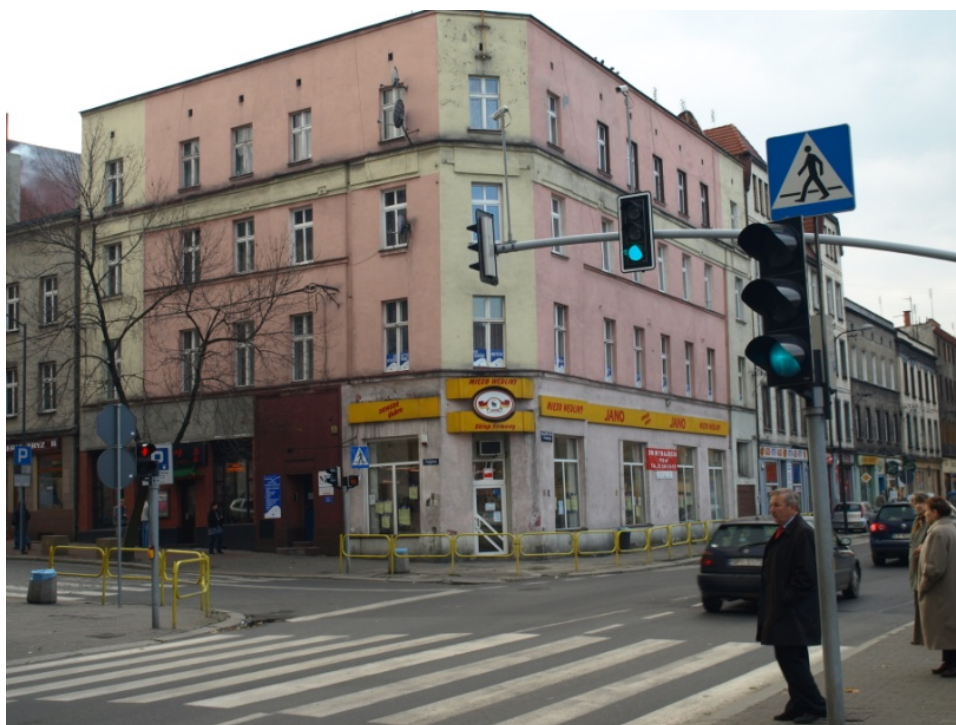
The tenement house was built as a single block masonry structure without dilatation. It is a four-storey building with a basement (Fig. 1). The floors above the basement are made of steel I-beams and arched vaults made of bricks. Basement

Fig. 1. View of the façade of the tenement house

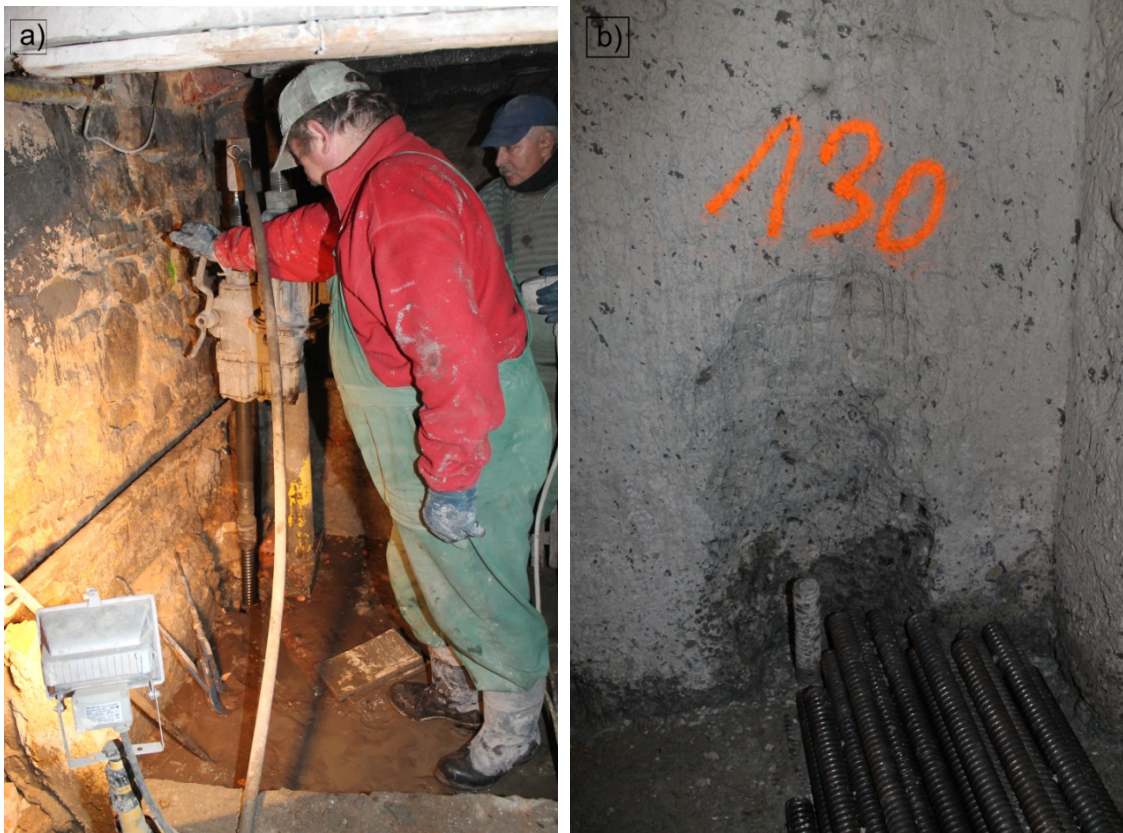
Fig. 8. Drilling of micropiles in the basement

Underpinning works started at the end October 2013. Titan bars were introduced into the subsoil through the foundation walls at the inclination of 2°-5°.

Drilling was preceded by cutting niches in walls. After installation of micropiles the niches were filled with concrete.

Due to confined space drilling was performed by a manual operated drill mounted on a stand (Fig. 8a). Grout was delivered by a conduit from a mixer situated in the courtyard of the building. Micropiles were drilled with 1 m sections of Titan bars. The niche with the head of a micropile is presented in Fig. 8b.
