MICROPILE FOUNDATION FOR SUSPENSION BRIDGE IN HIGH ALPINE

Dipl.-Ing, Andreas Brandner, IB-Brandner, Karl-Schoenherr-Strasse 8, A-6020 Innsbruck – Austria, Phone +43 512 563 3320, Fax +43 512 563 3324, Email office@ib-brandner.com

ABSTRACT

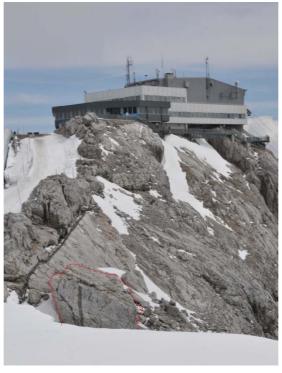
Figure 4 - Situation of eastern abutment

North of the ridge the Dachstein Glacier covers the rock line and the crevasses and holes are filled with ice in this height. As it is shown, the eastern abutment of the bridge is situated on a huge bloc lying on a steep falling rockslope - sloping in southern direction.

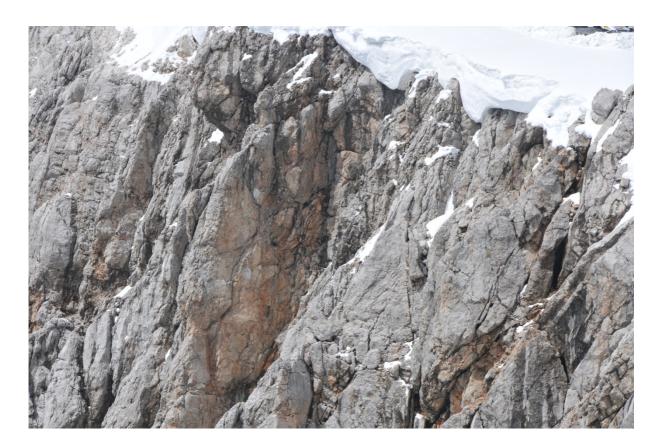
Figure 5 - Situation of western abutment

The western abutment as well as the western access is situated in a vertical rock wall.

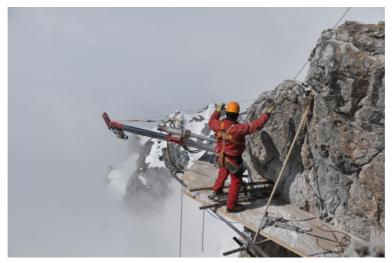
Figure 7 - Drilling works of access path

After the winter break site works started in April 2013 with the access from the tunnel to the western abutment and the securing works of the bloc of the eastern abutment. Drilling was a hard job in the mostly vertical rock wall. Cracks and holes of the Karst made it even worse and caused some adaption of the design. Although we had a detailed survey of the site it proved not to be accurate and therefore design had to be corrected – coordinates of drilling points on rock surface, pile orientation at the rockwall edge and also length of piles. All drilling had to be done with lightweight equipment, which had to be fixed and secured by steel ropes anchored to the wall. To meet the requirements of health and safety laws we evaluated the whole erection process and only special equipped and trained workers were allowed on site. Also the designer and the site manager approve the construction procedures.
