A Review of Micropiles Beneficial Aspects through a Case History near False Creek, Canada

M. Deriszadeh, M.Sc., Ph.D.¹ and M. J. Kokan, M.A.Sc., P.Eng.²

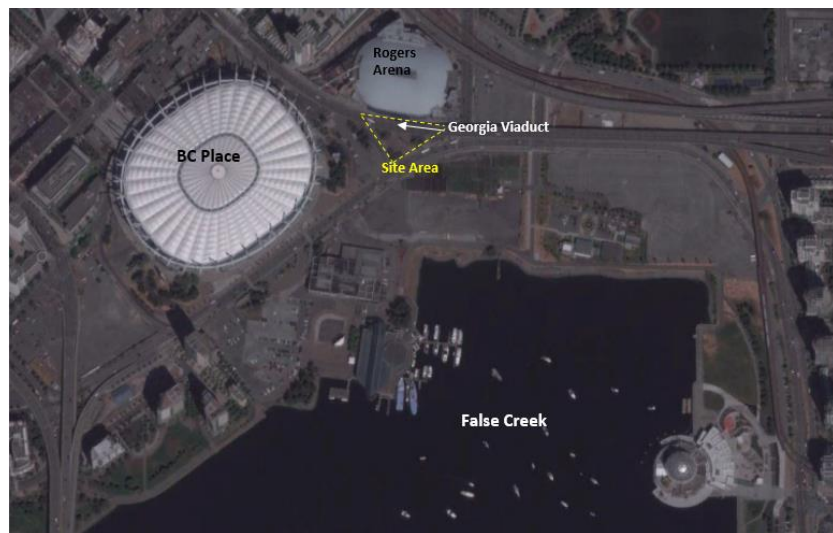
Figure 1. Site area in relation to surrounding developments/features (Google Image, 2014)

Micropiles were first introduced to the geotechnical engineering practice in early 1950's in Italy and mainly used for underpinning the historic structures with settling foundations (Shong and Chung, 2003). Micropiles have recently gained increased acceptance in geotechnical engineering practice and have been utilized for seismic retrofitting, resisting uplift loads, control of settlements and underpinning of existing foundations. This paper presents a construction case history of the application of micropiles in controlling settlement of an existing highly sensitive foundation system supporting a viaduct. The project included a residential tower (South Tower) with five levels of underground parking, located about 150 m to the north of False Creek, in Vancouver, Canada. Figure 1 shows the construction site area in relation to the surrounding structures and features.

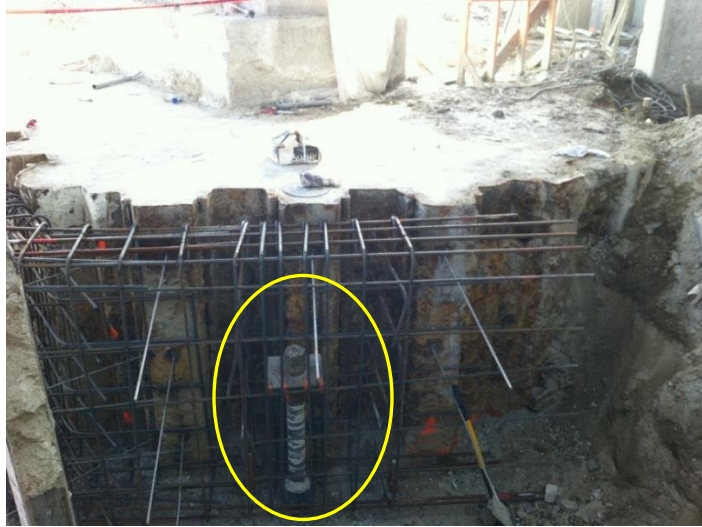
Figure 8. A view of an installed underpinning micropile on the north side of pier G-18 prior to pilecap expansion

A typical section view of the micropiles, designed for underpinning the viaduct pier foundations is shown in Figure 7 and a view of an installed micropile in the field (prior to pilecap expansion) is shown in Figure 8. Each micropile was designed for a service load of 850 kN. The bonded length of the micropile, in contact with glacial till, was computed using a bond strength of 150 kPa, in both tension and compression. Given the maximum service load of 850 kN and the micropile diameter of 200 mm, a minimum bonded length of 9.1 m was considered in the design. Each micropile included a high-grade steel thread
