USE OF HIGH CAPACITY MICROPILES TO RESIST SEISMIC OVERTURNING OF COLUMNS

Peter Speier, P.E.

ABSTRACT

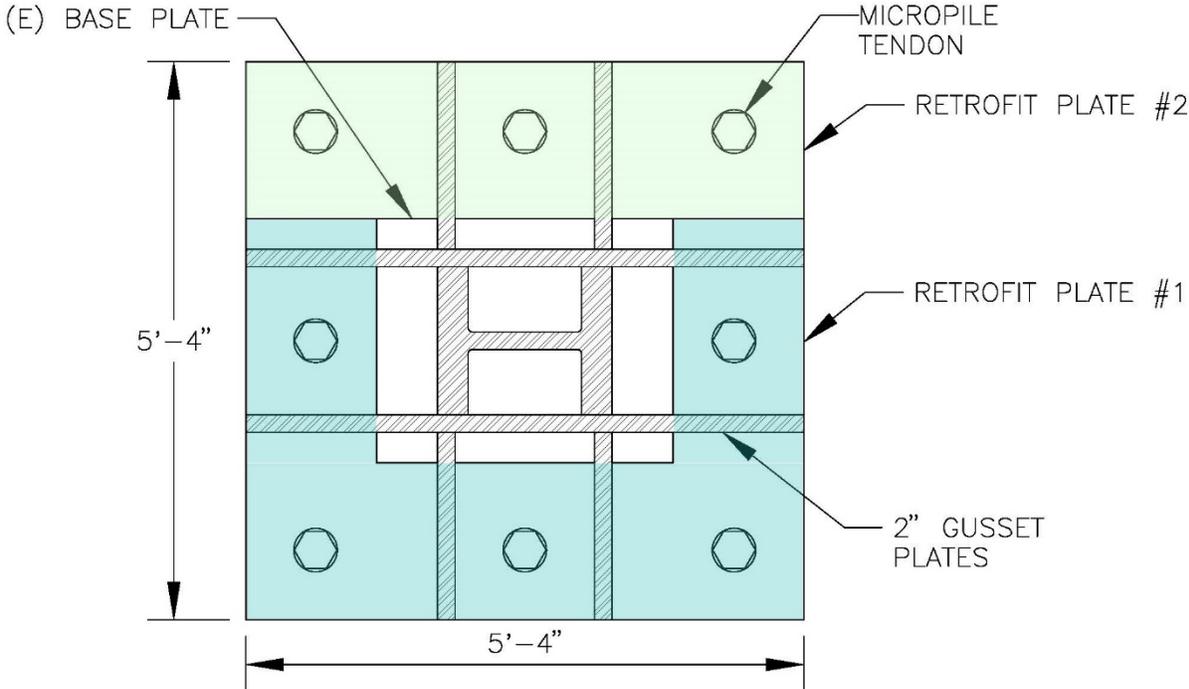
Figure 1: Typical Layout of Column and Retrofitted Base Plate

One of the more unique aspects to the design was to anchor the micropiles directly to retrofitted column base plates rather than to the existing concrete footing or a new cast in place footing extension. The existing column base plates were too small and could not supply the required fixity to the base of the steel columns. The retrofitted base plates consisted of a 2-piece arrangement that allowed installation around the existing base plate after the micropiles were installed. One of the plates was "U" shaped, while the other was rectangular. To tie them into the existing column, gusset plates were welded to the base plates and the existing column. A sketch showing this arrangement can be seen in Figure 1, and a CAD rendering is shown in Figure 2. This solution resulted in very close spacing for the micropiles that were as little as 0.6 m (2 feet).

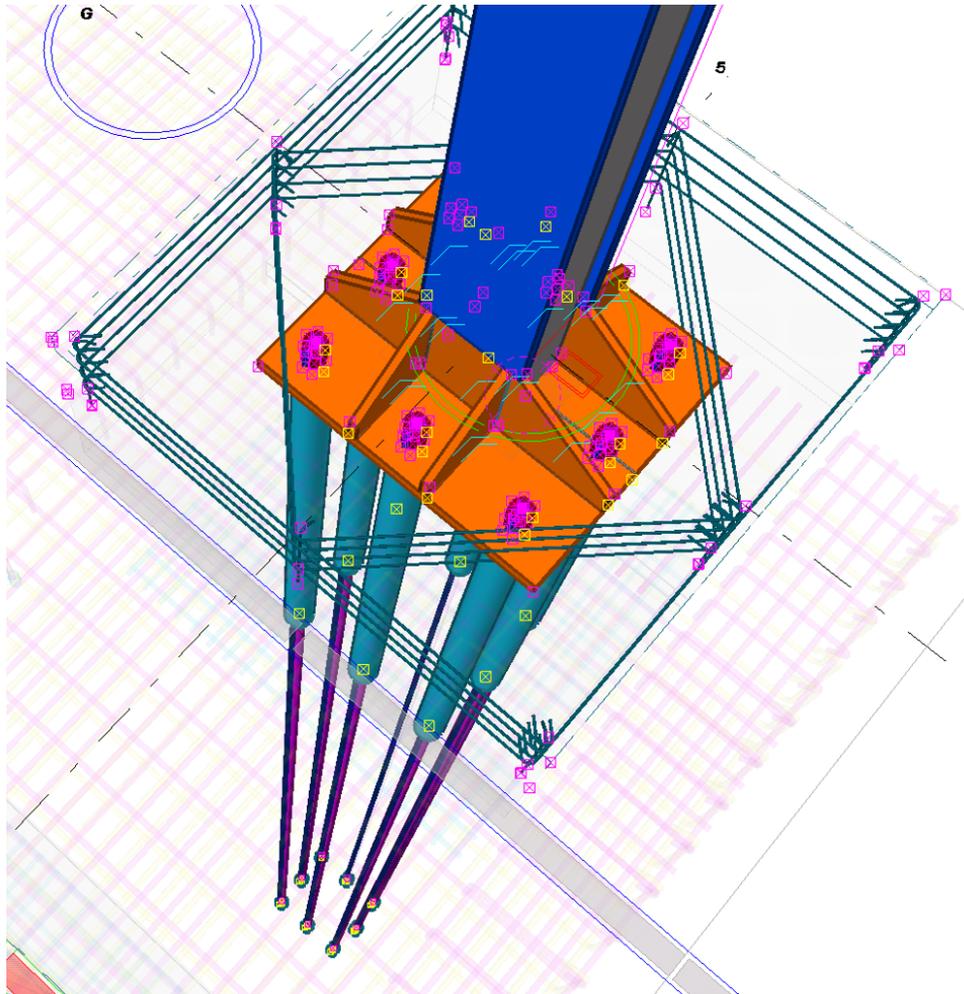
Figure 2: CAD rendering of retrofitted column

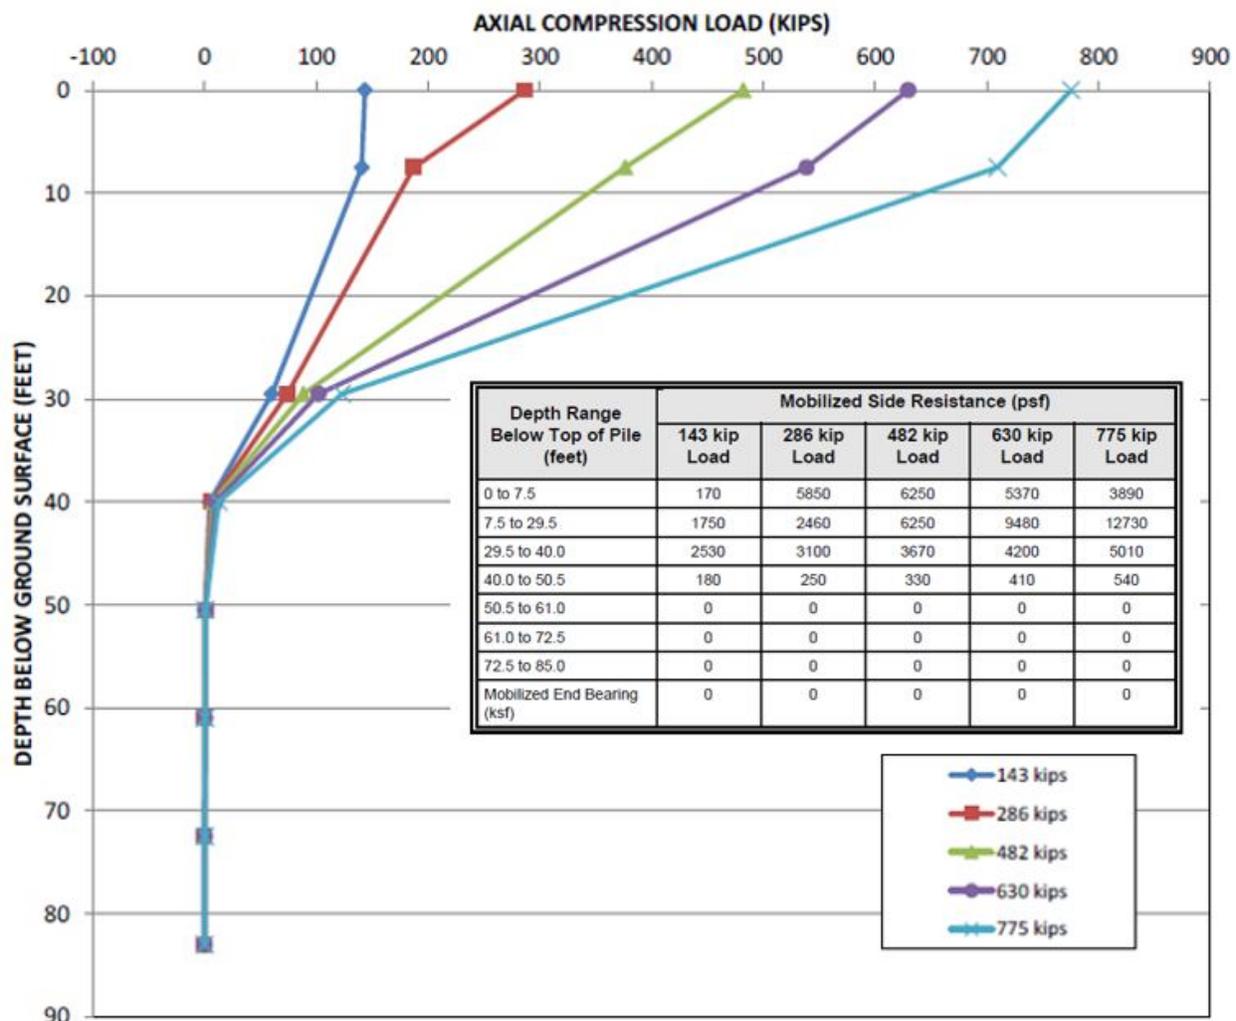
Figure 3a: Graphical Results of Strain Gauge Readings for Compression Loads with inset showing average bond stress within various depth ranges for specific load increments

Additionally, strain gauges were installed on the test pile tendon that were used to calculate the stress in the tendon at various depths of the pile throughout the test. Reaction piles on each side of the test pile were installed for the compression testing. All three piles were 200 mm (8 inch) diameter and drilled to a depth of 25.9 m (85 feet). The test pile was bored out to 225 mm (9 inches) in the top 4.25 m (14 feet), and an 220 mm (8-5/8 inch) OD casing was set in the top portion of the pile. The piles were reinforced with 75mm (3 inch) diameter 1034 MPa (150 ksi) Williams Threadbar, and grouted with Portland Cement and water grout.

The data obtained from the strain gauges (Figure 3a and 3b) showed that nearly the entire compression and tension test loads of 3,444 kN (775 kips) were transferred through the top 12.2 m (40 feet) of the pile. This data was used to economize the design by establishing bond stresses much higher than would have been assumed without instrumentation of the testing. The increased bond stresses allowed the production micropiles to be reduced to 18.3 m (60 feet), which put the pile tip well above the groundwater elevation. This simplified installation tremendously since all drilling was done from inside the existing hospital lobby. The final micropile design utilized 65 mm (2-1/2 inch) diameter 1034 MPa (150 ksi) Williams Multiple Corrosion Protected (MCP) Threadbar tendons as reinforcement.

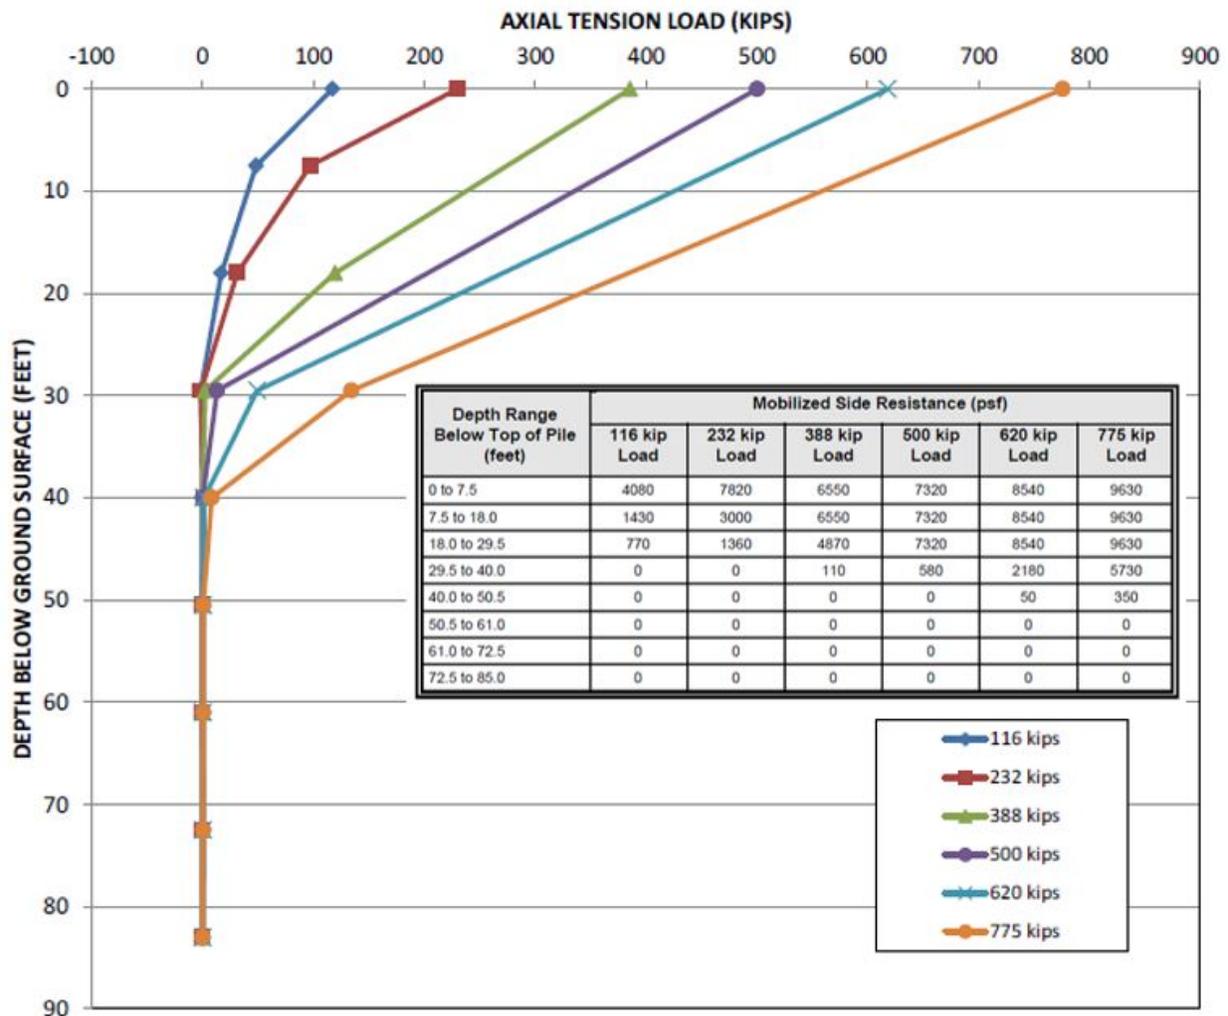
Figure 3b: Graphical Results of Strain Gauge Readings for Tension Loads with inset showing average bond stress within various depth ranges for specific load increments

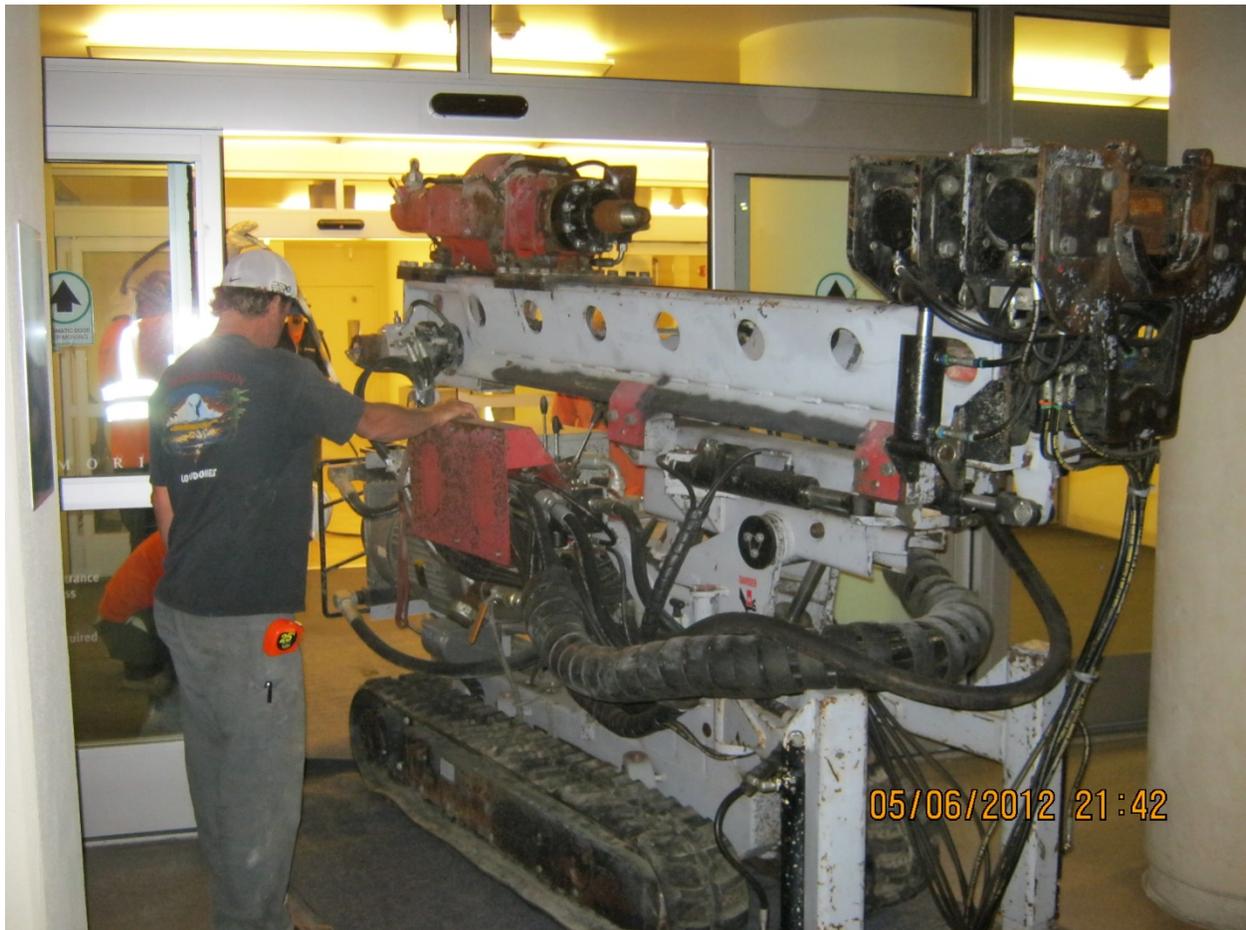
Figure 4: Micropile Drill entering hospital

A TEI TD75 drill with a single rotary and duplex setup was used to drill the micropiles. This compact rig was able to drill up to a 250 mm (10 inch) diameter hole, and track into the work area through a standard size doorway (Fig 4). The holes were advanced inside the casing using a 125 mm (5 inch) down-the-hole hammer. While casing was not needed to stabilize the drill holes, it was used to facilitate containment of the drill spoils. By fabricating a spoil swivel attached to the casing flushing bell, drill spoils were transported through a vacuum duct to a sealed separation tank, and removed from the work area when full.

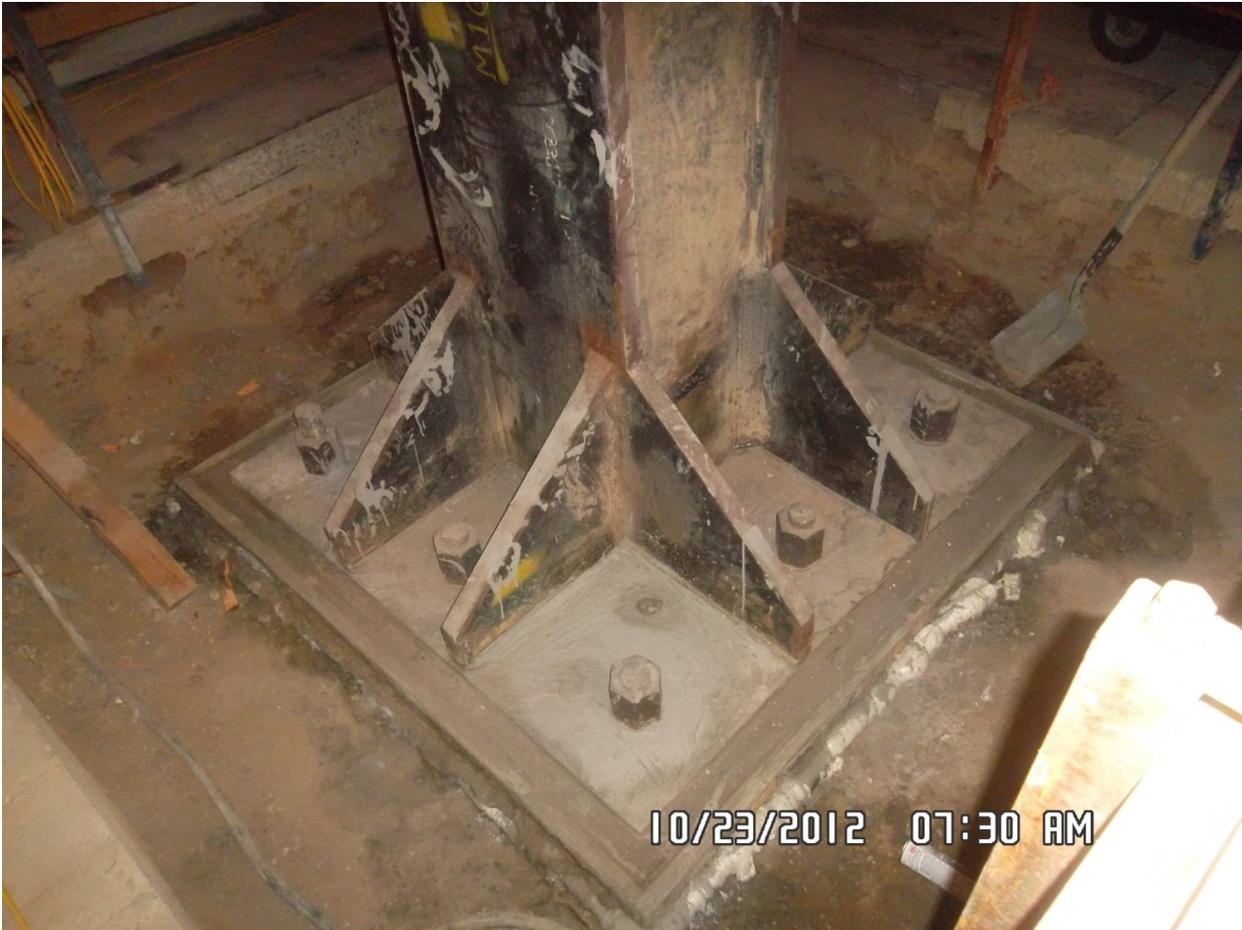
Figure 5: Completed retrofitted column

After all micropiles for a given column were complete, the retrofitted base plates were installed (See Fig 5). To facilitate transfer of both compression and tension loads, hex nuts were installed above and below the base plates. Finally, the slab cutout was poured back with concrete to cover the base plate, and micropile tendons to complete the work.
