MICROPILE QA/QC TESTING USING THERMAL PROFILING

ABSTRACT

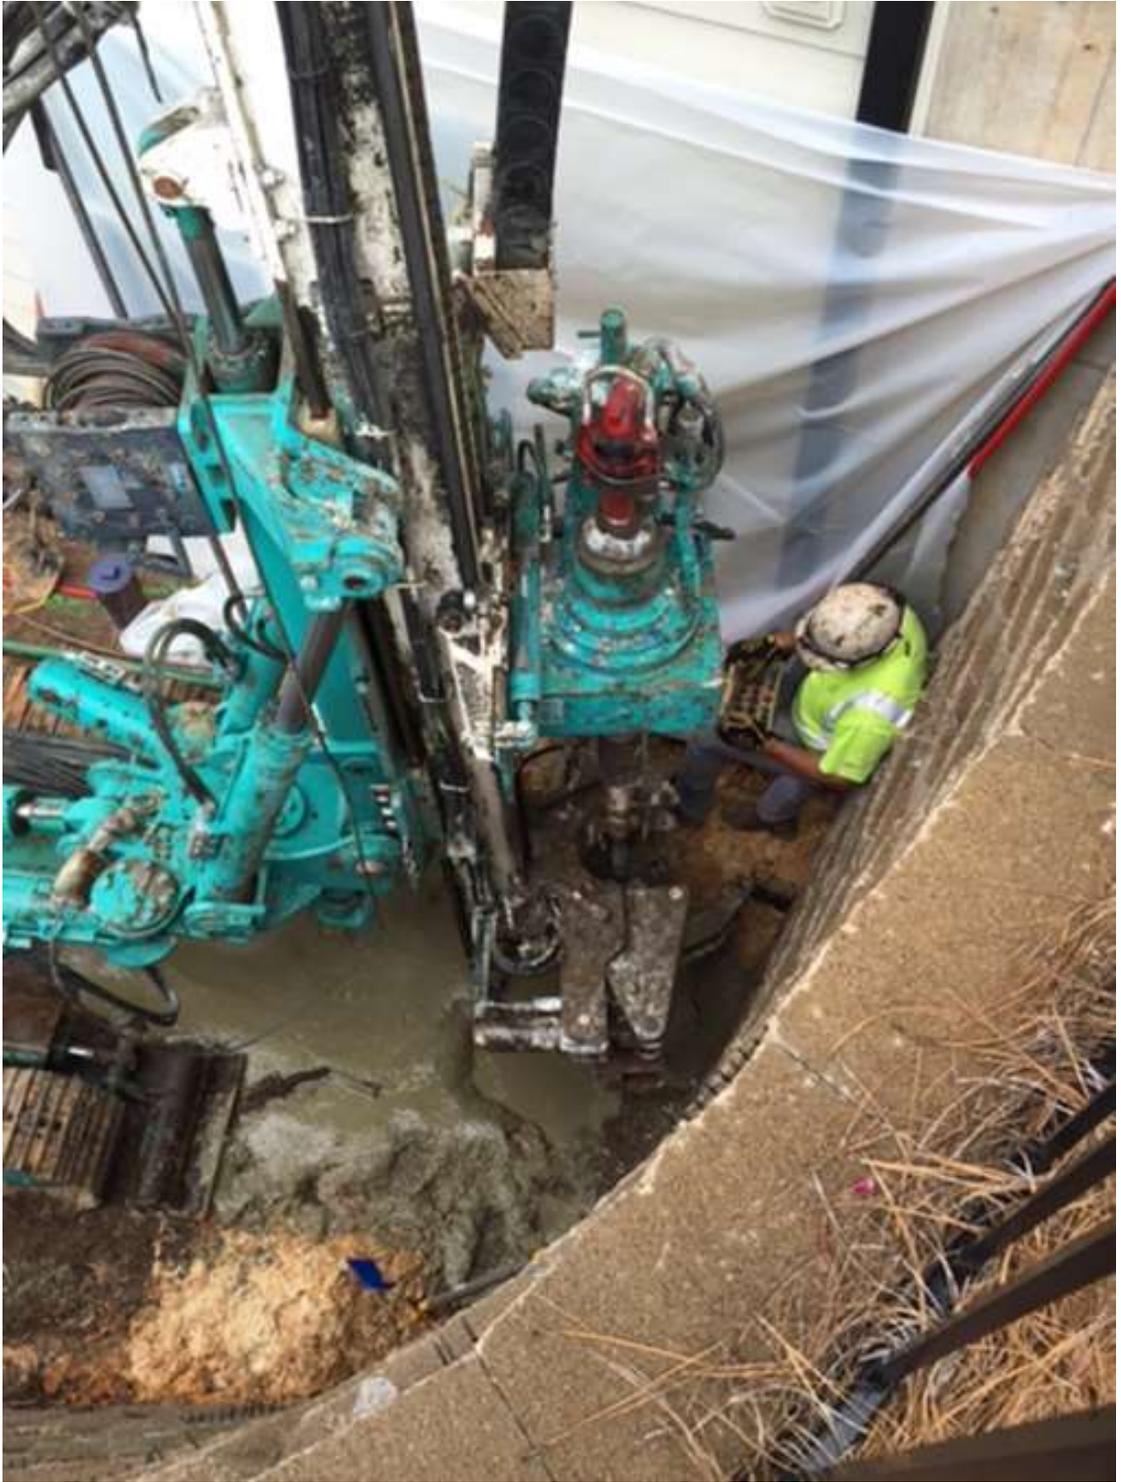
Figure 1. Viewing down from the top of the adjacent retaining wall, the installation of one of the micro-piles can be seen.

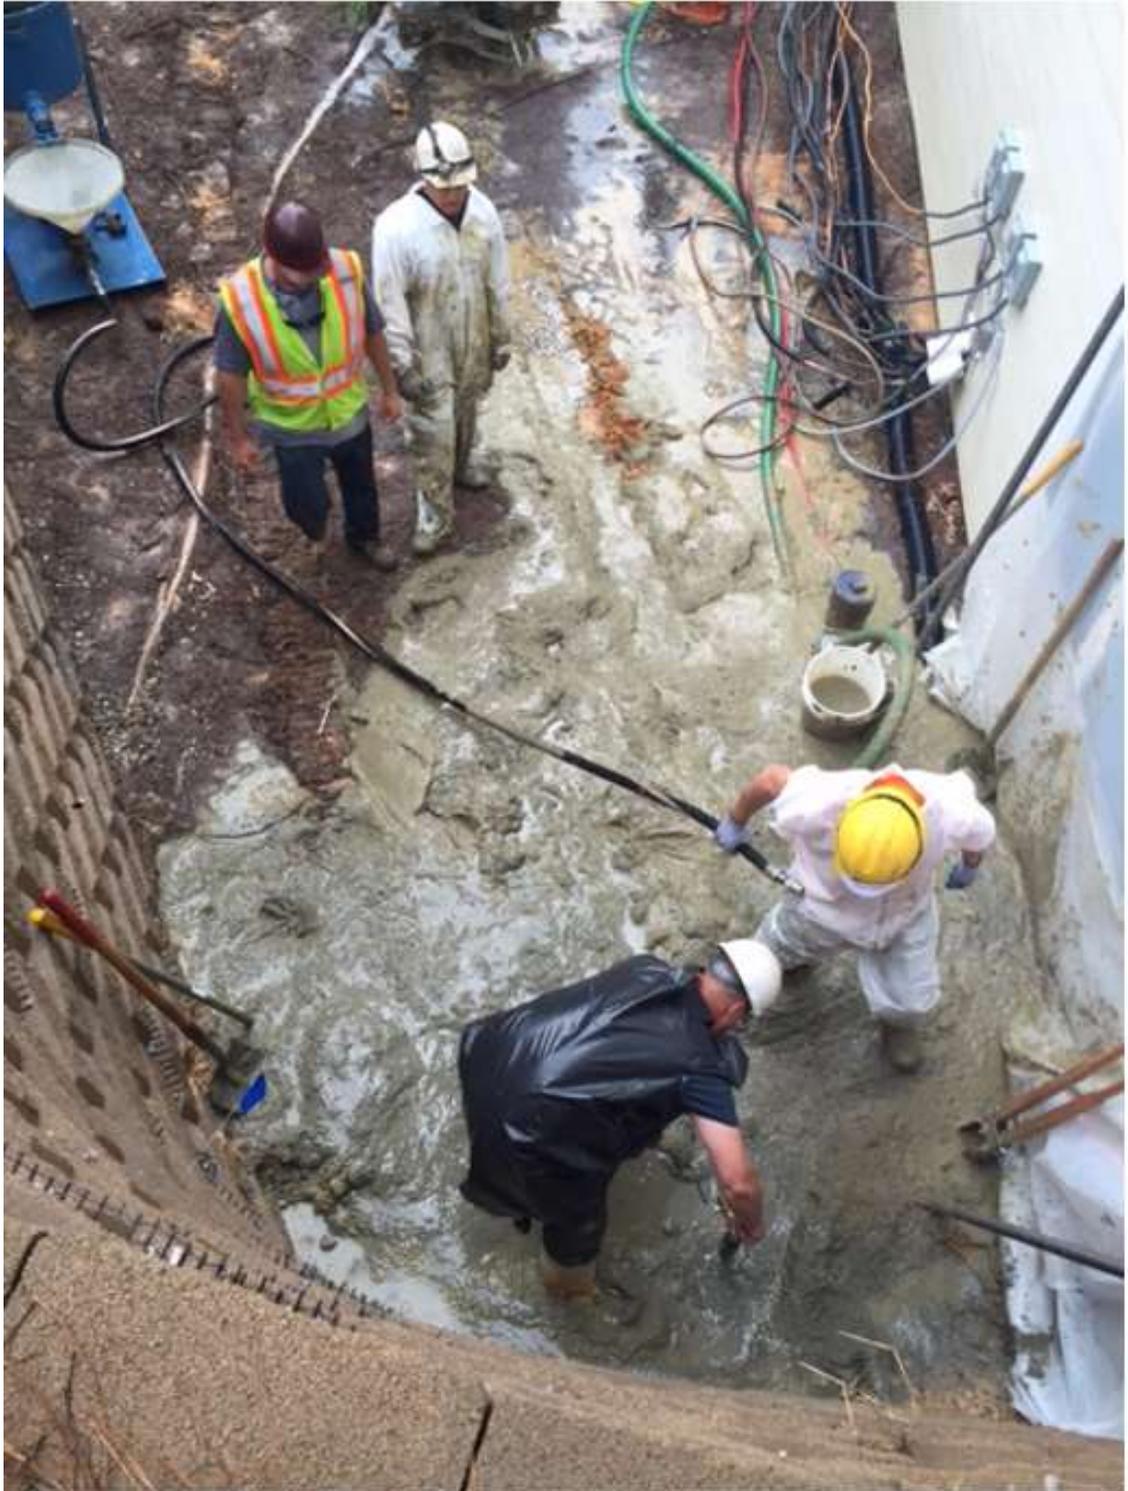
Figure 2. After drilling, the grout is pumped from the center of the bar.

We utilized a single strand of sensors inserted into the water filled hollow bar after completion of micropile installation. Since the hollow center of the bar is used to inject grout into the bottom of the micropile, the grout first had to be removed to allow the thermal sensors to be inserted. This was accomplished by inserting a spherical sponge into the top of the hollow bar, and attaching a pump to the top of the rod. The known volume of grout within the hollow core of the rod was exchanged with water by pumping. This allowed the hollow core to be cleared without diluting the structural grout at the bottom of the micropile with water. Of the 12 micropiles tested, we had difficulty clearing the core of 3 micropiles. Figures 1, 2 and 3 are from the installation of one of the micropiles. Once the thermal sensors were inserted, a data logger recorded the grout temperature over a 24 to 36 hour period as heat was generated during the exothermic hydration reaction. Processing software then used the temperatures recorded to generate a plot of temperature versus depth (see Figures 5 & 8), a plot of radius vs. depth (see Figures 6 & 9) and a 3-dimensional model of the micropile (see Figures 7 & 10). These models allow the viewing of variation of the micropile diameter with depth, which could not be accomplished using typical methods discussed in the 2015 IBC.

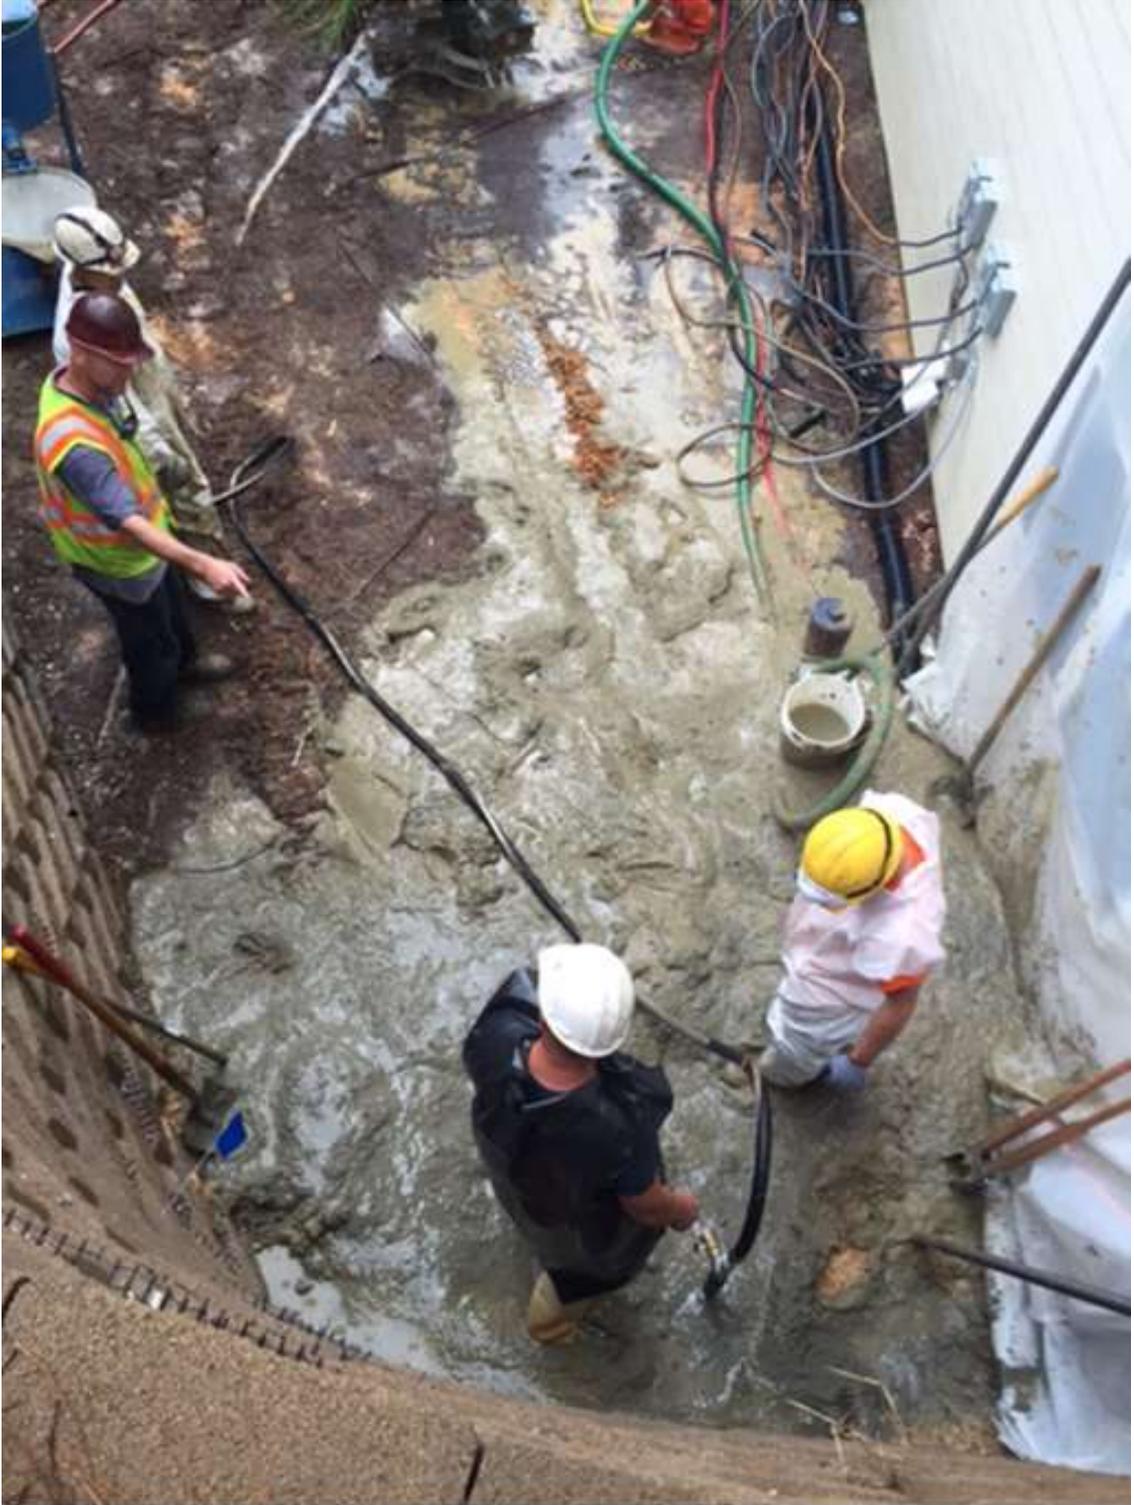
Figure 3. Pumping grout from the center bar of the installed pile.

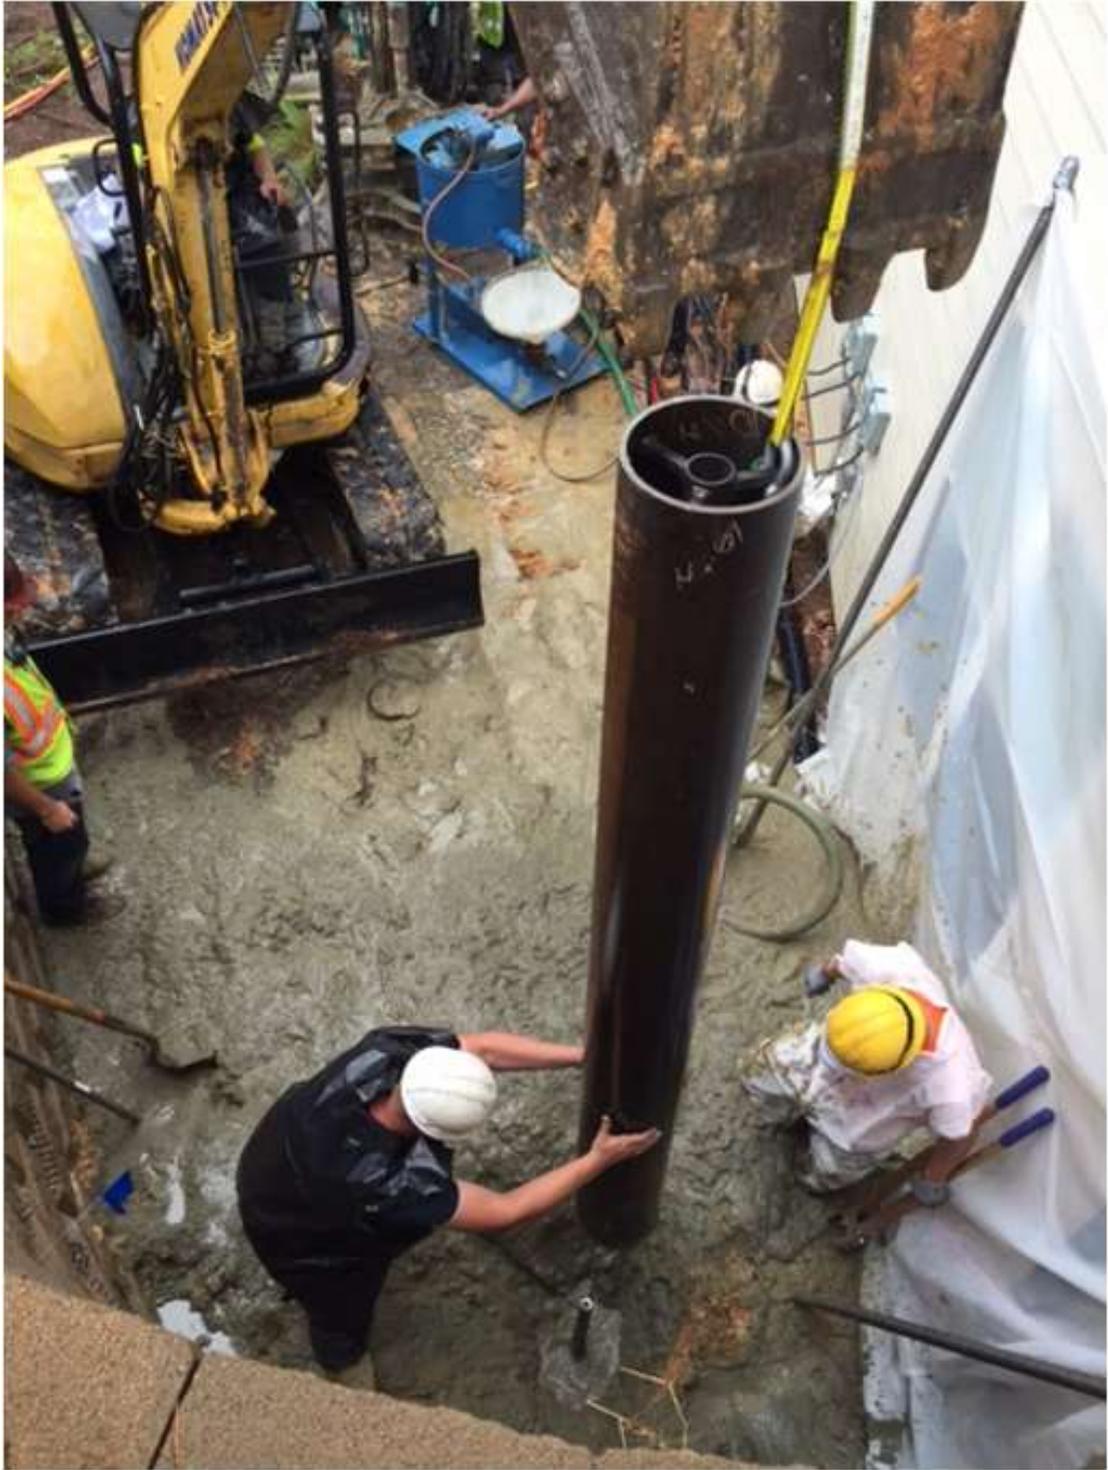
Figure 4. A cased section is lowered into the drilled and grouted hole. The casing is aligned along the center bar with a series of collars within the casing.

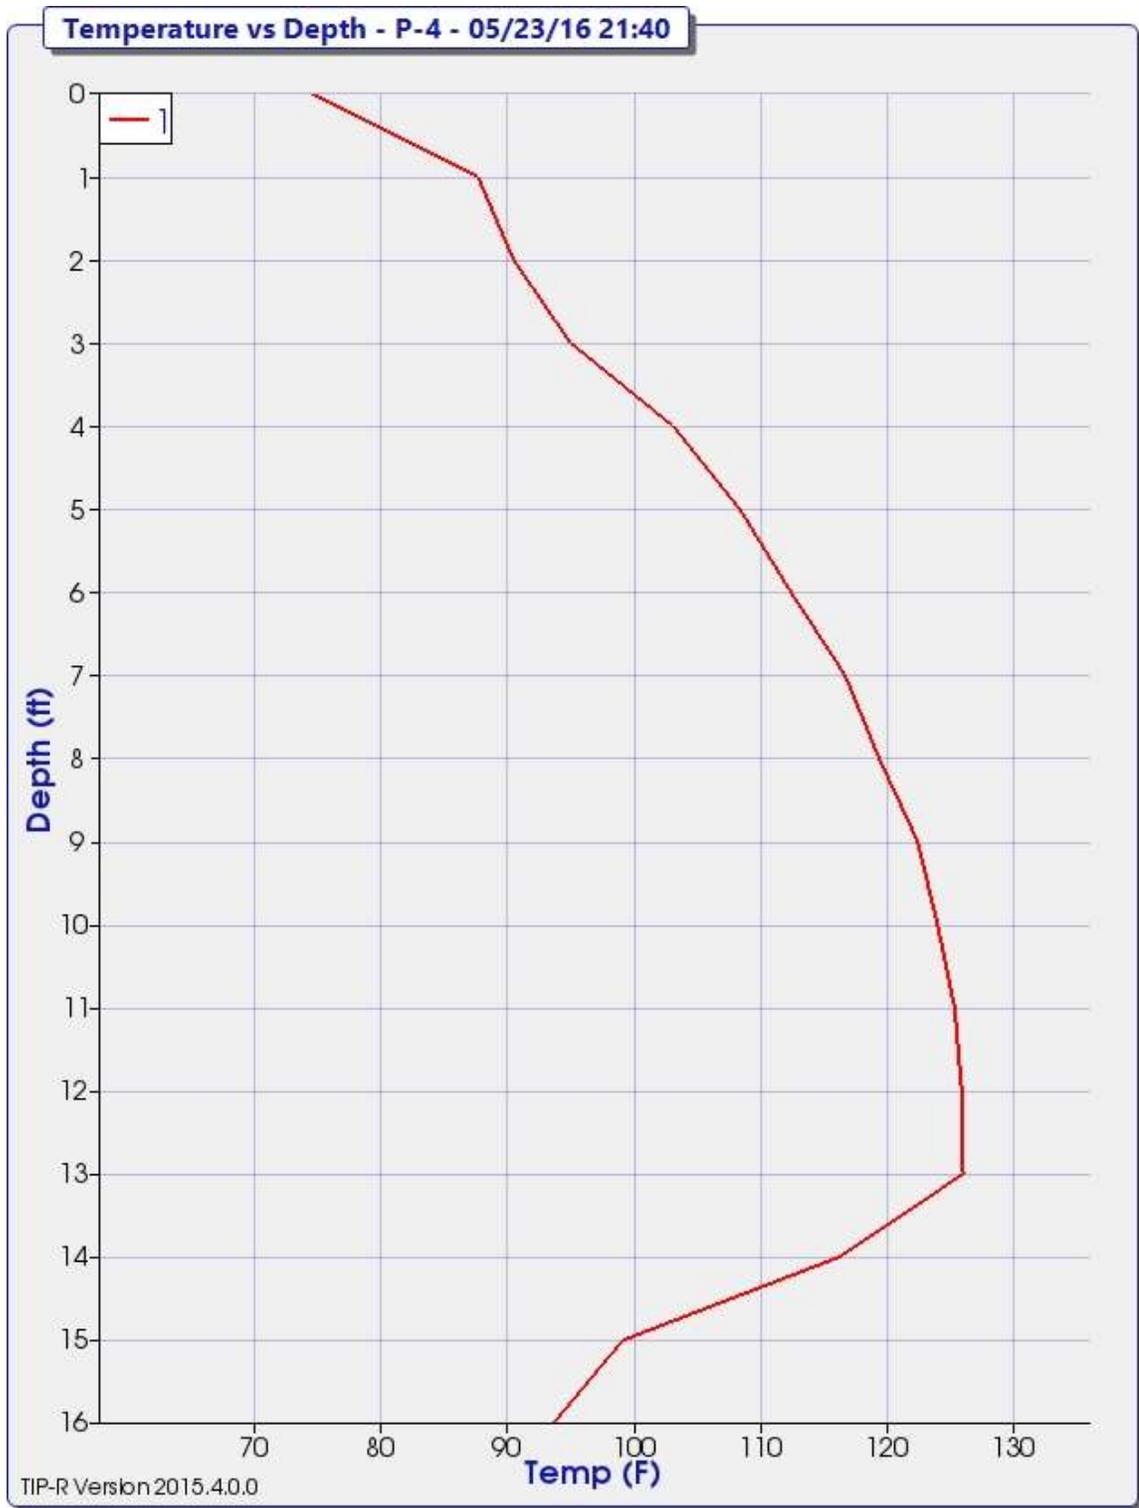
Figure 5. Temperature vs Depth plot for Pile #4.

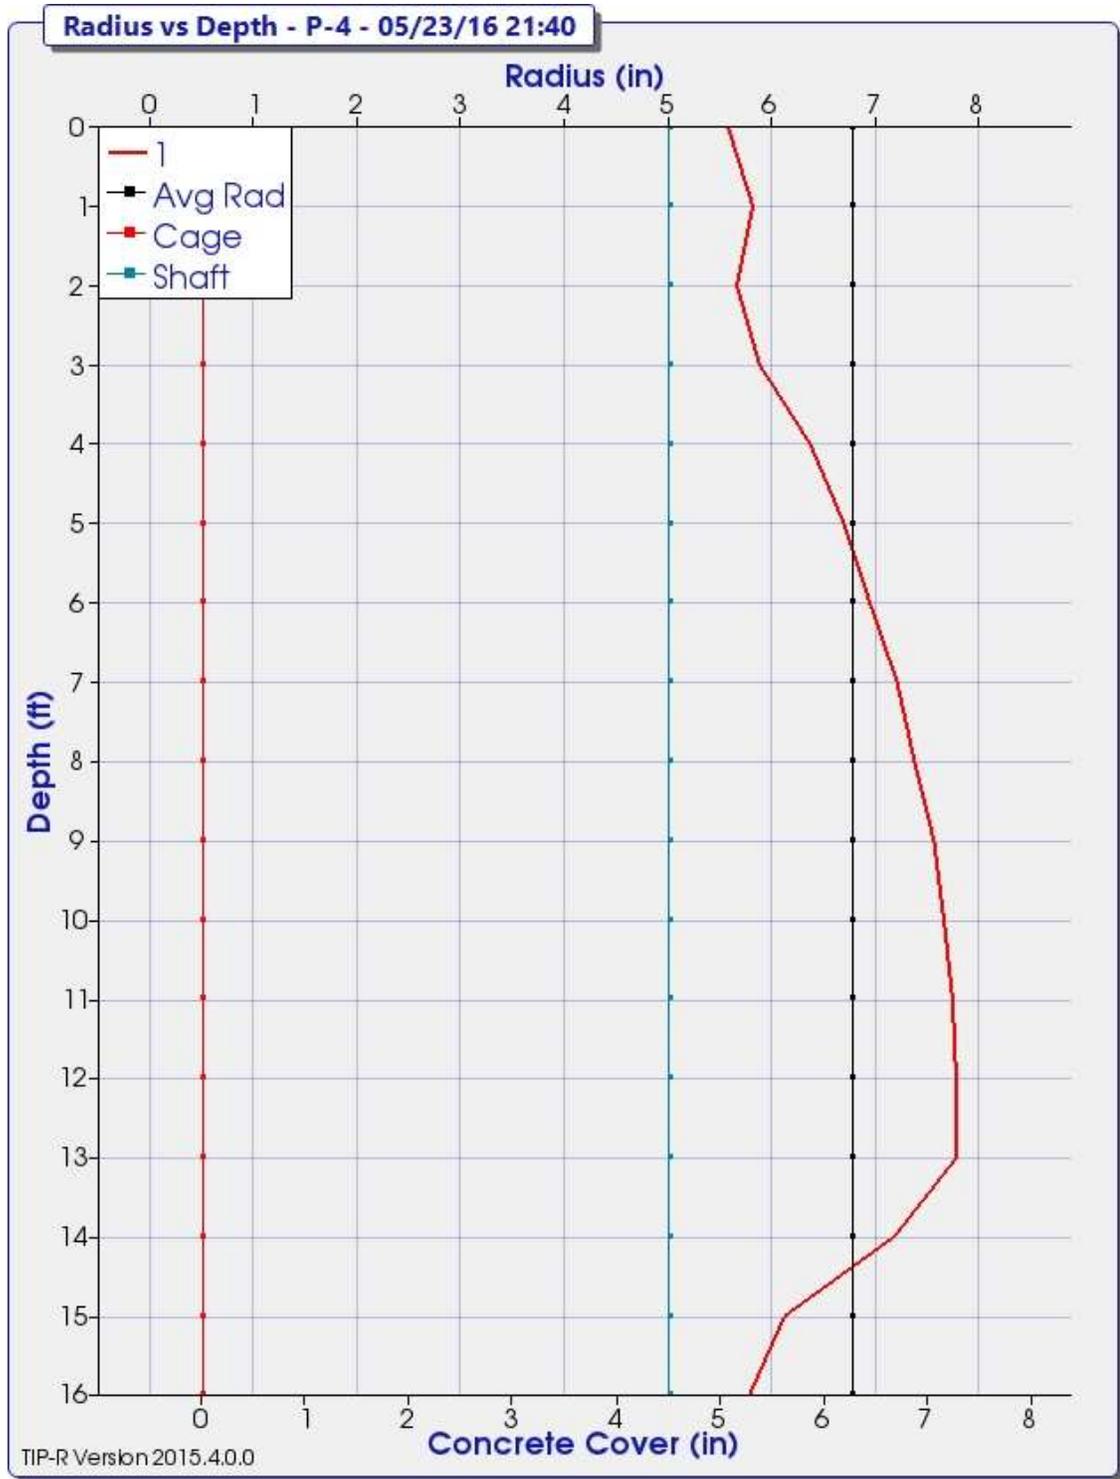
Figure 6. Using the temperature data and measured grout volumes from Pile #4, calculations of the pile’s radius can be made. The dashed red vertical line is the center bar, the dashed purple line is the design radius of the pile. The dashed vertical black line is the average radius of the pile. The red line is the calculated radius base on the temperature data.

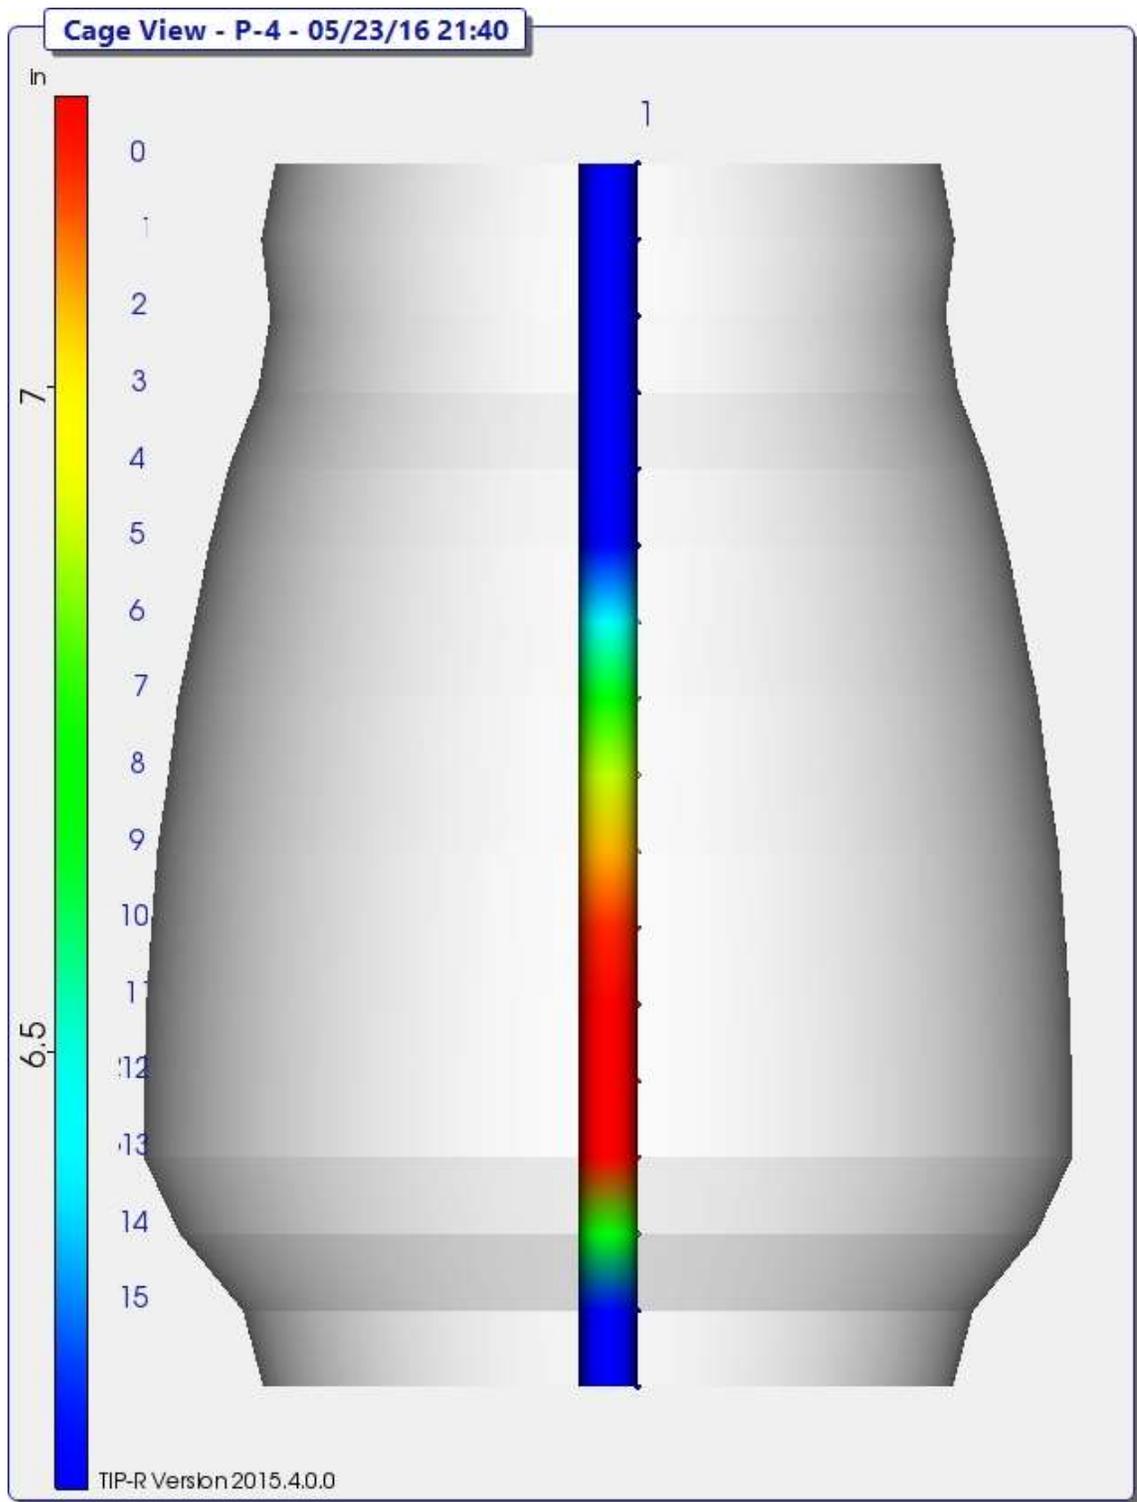
Figure 7. Using the analysis software, a 3D model of Pile #4 can be developed. The center colors correspond to the radius of the pile.

As seen in Table 1, the TIP testing results agree with the expected micropile diameters. While the average diameter is useful information, it does not guarantee that necking or narrower portions of the pile are not present. As seen in Figure 7 and Figure 10, the diameter determined by TIP testing can vary with depth. TIP testing allows for a more detailed view of the pile profile and can alert the project team to potential issues

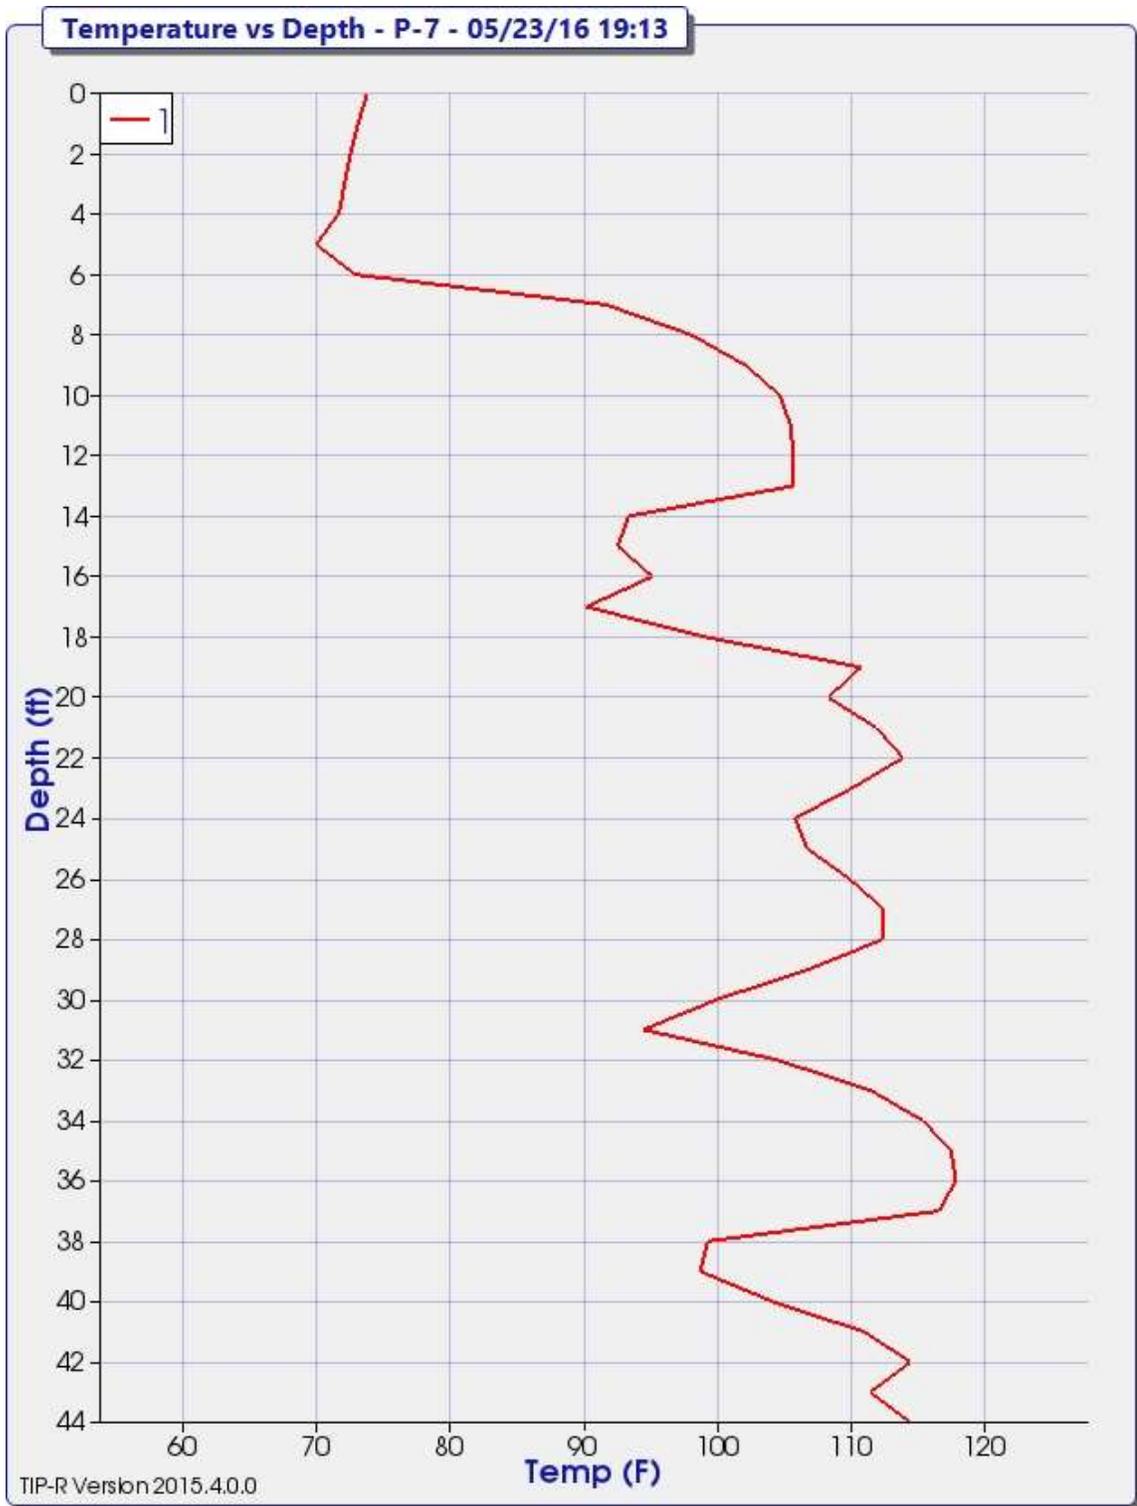
Figure 8. Temperature vs Depth plot for Pile #7.

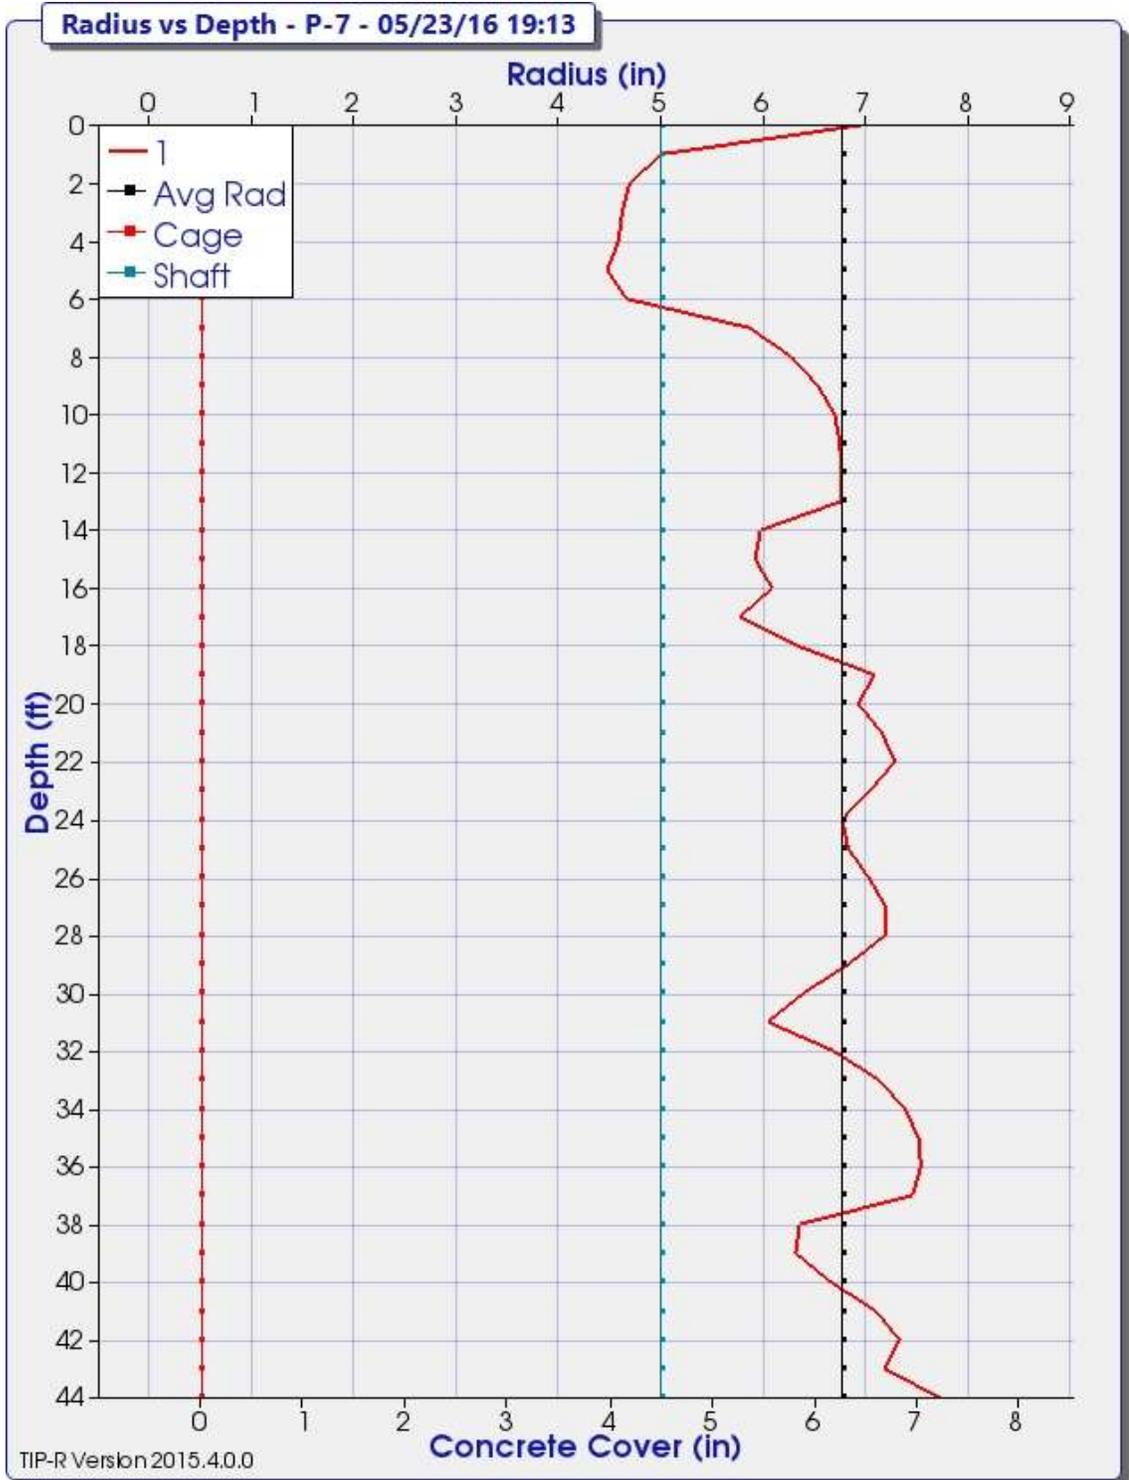
Figure 9. Using the temperature data and measured grout volumes from Pile #7, calculations of the pile's radius can be made. The dashed red vertical line is the center bar, the dashed purple line is the design radius of the pile. The dashed vertical black line is the average radius of the pile. The red line is the calculated radius base on the temperature data.

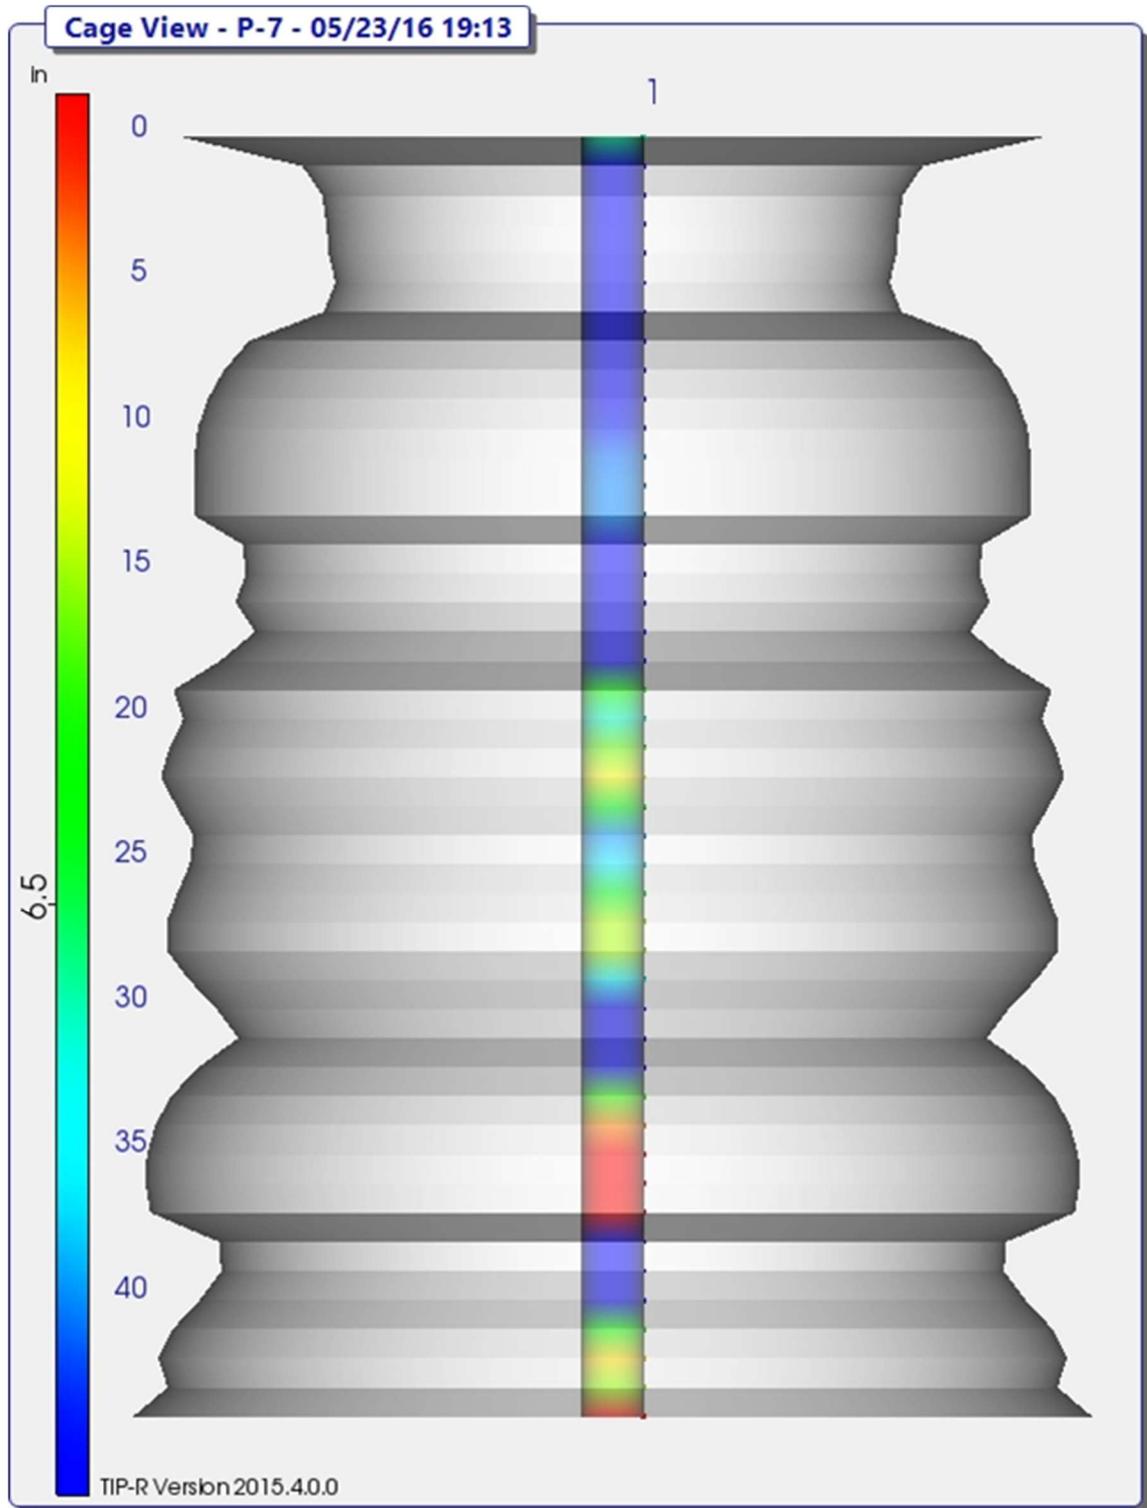
Figure 10. Using the analysis software, a 3D model of Pile #7 can be developed. The center colors correspond to the radius of the pile.
