# **SESSION 1**

# The Earthquake Strengthening Construction Case of the Pier Foundation by Using the Micropile.

Affiliated Researcher, Public Works Institute, Ministry of Construction  
MASAHIRO MORIWAKI

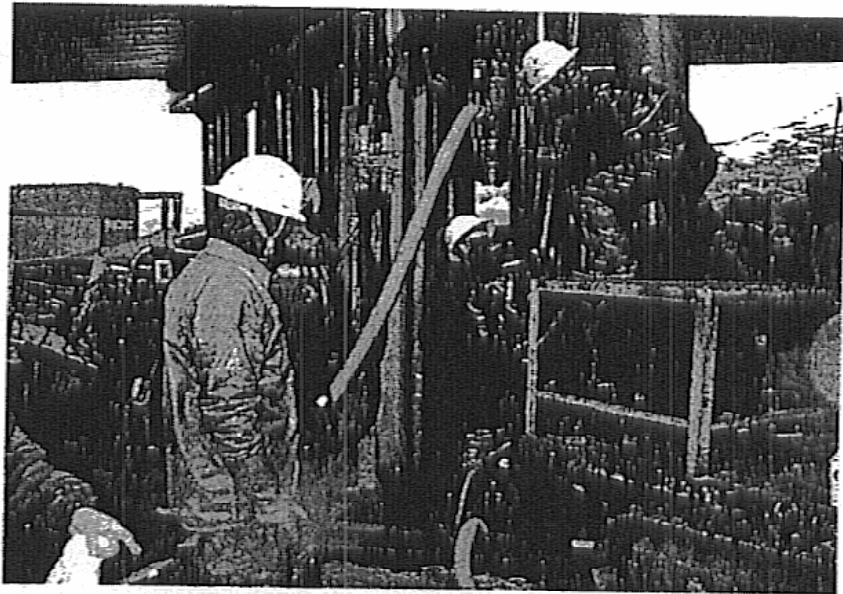
Photo-2 The Construction Situation  
(the steel pipe set)

placed. The pile length is 18m, with grouting length of 3 m.

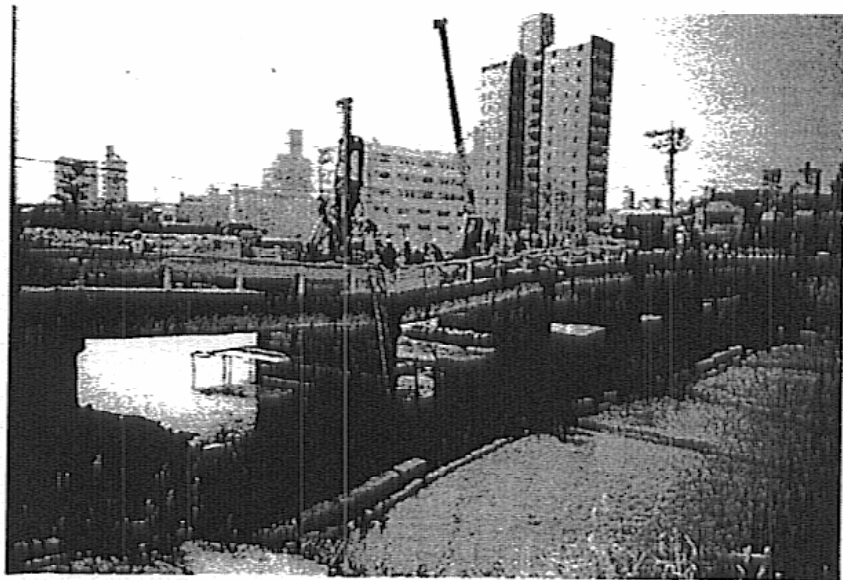
Photo-3 The Construction Situation

By emptying the hole in the slab, the construction was carried out on the bridge.
