LIZZI'S PHILOSOPHY. CONCEPTS TO PRACTICE.

James A. Mason, PE

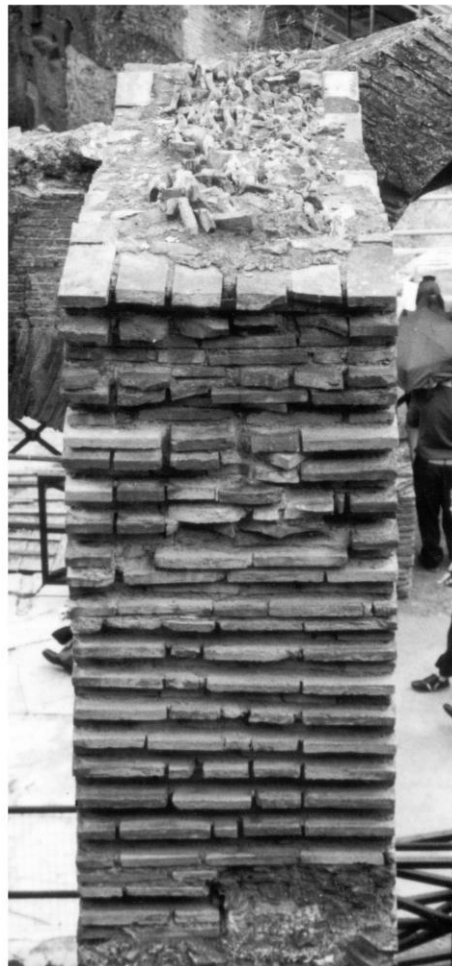
filled with cementitious dust or mortar. The wall width was empirically determined for assumed gravity loads. The composite action of the wall necessarily depends of the adhesion and interlock of the block elements and rubble in-fill to provide shear and bending resistance, minimal adhesion being provided by mortar, and interlock due to geometric interference of adjacent block. The weak or non-existent tensile capacity of the mortar bed gluing the components together forces the resistance of shear, bending, or torsion to wall component interlock. Figure 1 is a photo of a rubble in-fill wall in the Colosseum, Rome. The perimeter of regular block masonry surrounds the randomly placed in-fill material.

Figure 1. Rubble In-fill Wall. Colosseum. Rome.

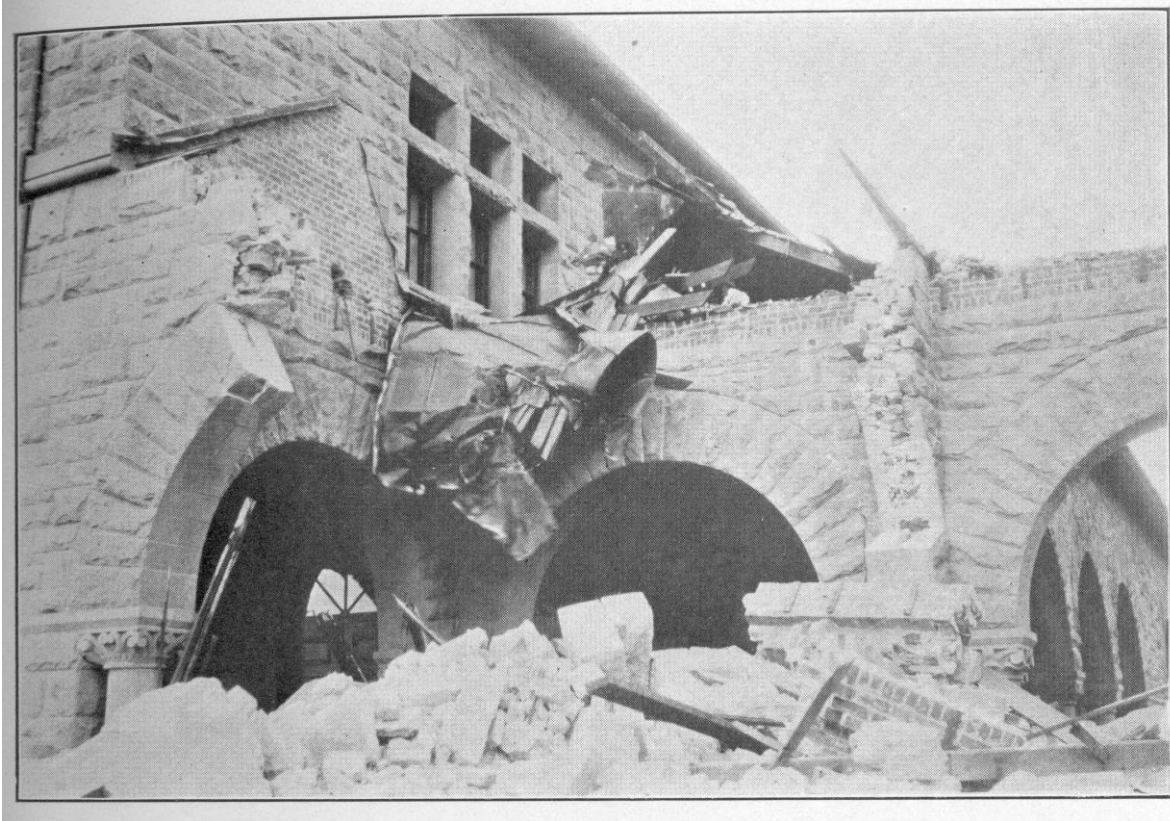
Arches are vulnerable to lateral displacement which could dislodge the keystone, thus altering the inherent compressive stability of the arch. This could be both a static and a dynamic failure mode. The static case is due to lateral movement caused by subsidence (consolidation or erosion) of the foundation soils, or possibly, the deterioration of the arch abutment, within the wall, due to weathering. The dynamic earthquake displacements allow the arch to open with elements dropping vertically due to gravity, providing hinge points for bending failure of the arch. Figure 2 is the failure of unreinforced stone arches on the Stanford University campus due to the 1906 San Francisco Earthquake. The spandrels were constructed with regular exterior block with random infill.

Figure 2. Stanford University. 1906 Earthquake Damage to URS Arch².

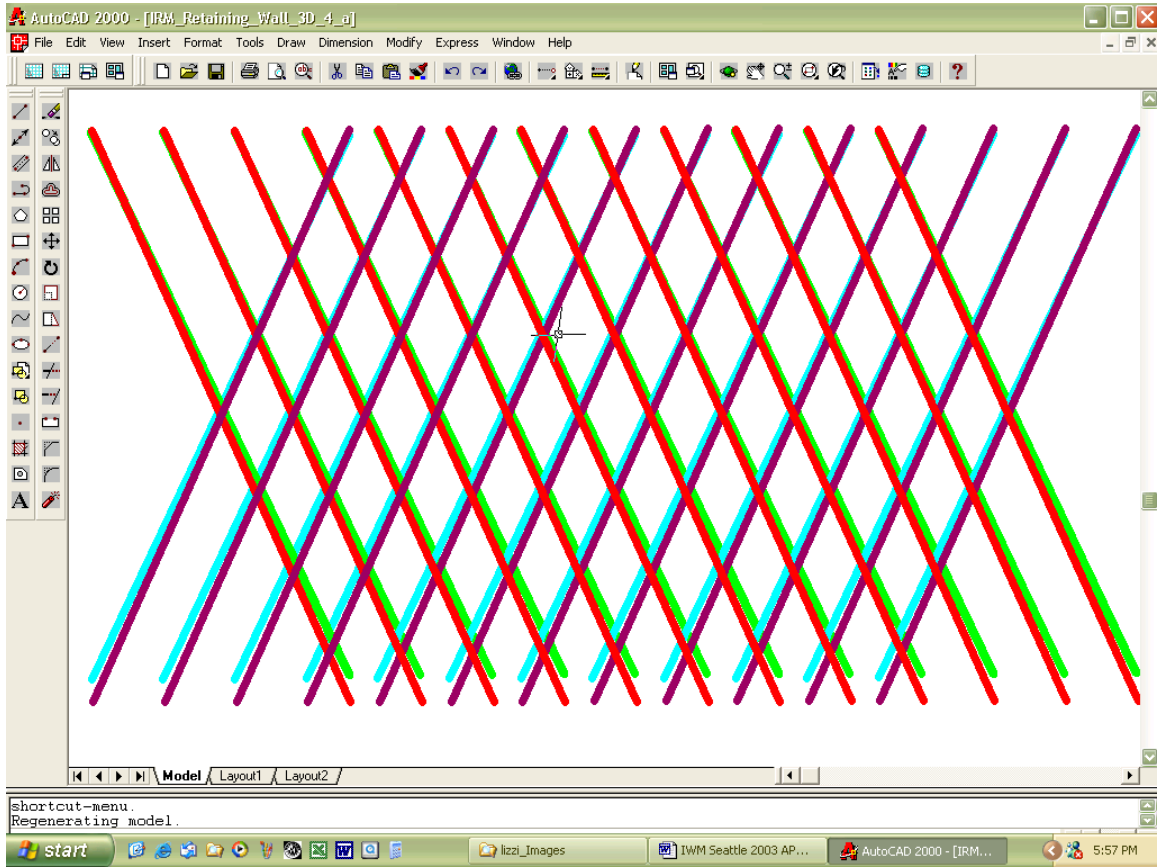
Figures 10 to 12 were generated with AutoCAD to show the three-dimensional nature of a RRP retaining wall. Figure 10 is shown as a cross-section of the wall system, in a similar fashion to Figure 9. Figure 11 is an image of the wall rotated approximately 30°. The typical diamond pattern of the RRP geometry is shown in this figure. Figure 12 is a front view of the leading (front) wall of the RRP retaining wall. The similarity to Figure 8 is seen in this figure.

Figure 12. Reticulated Micropile Retaining Wall.

Front View of Leading Wall.

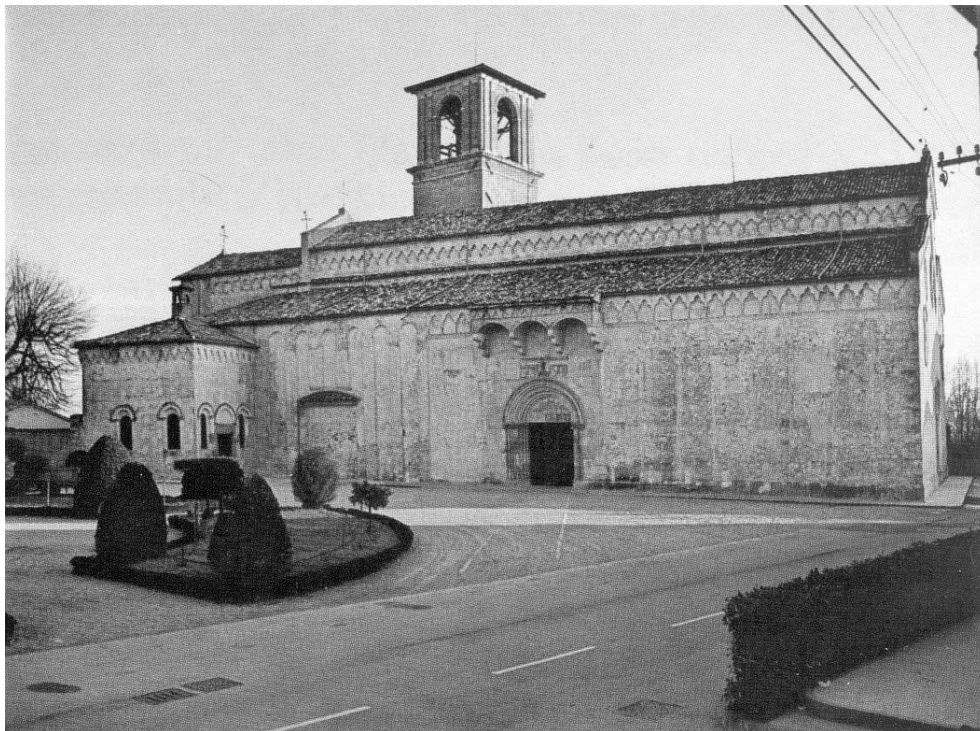
Figure 19. Spilimbergo Cathedral. Retrofitted Structure ².

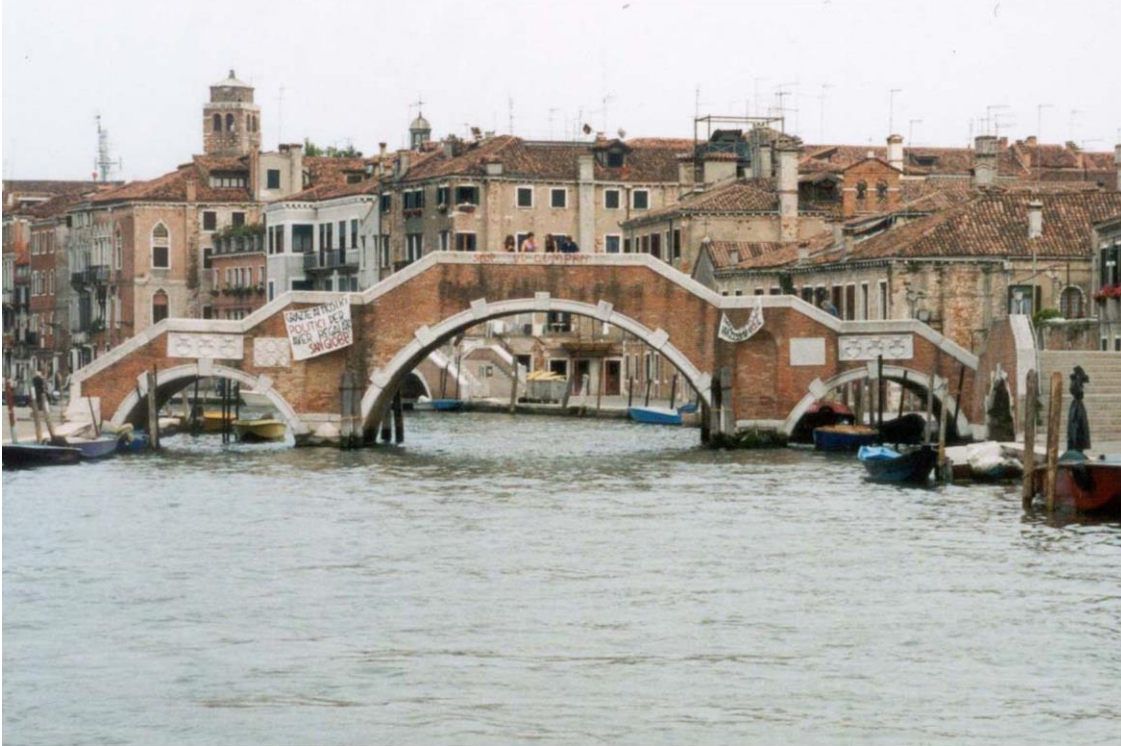
The “Three Arches Bridge” was constructed on the Rio di Cannaregio Canal in Venice, Italy in 1688, see Figure 20. The bridge was designed by Antonio Tirali¹³, and was the winner of a design competition with six other competitors¹⁴. It was constructed of “solid clay brick masonry in the same location of a previous timber bridge. As usual in Venice, the bridge had no parapets; two very stiff parapets were added during the first restoration in 1794; this fact modified completely the structural behavior of the monument, and the parapet acted as a stiff diaphragm”¹⁵. It is the only three arch bridge in Venice today.

FIGURE 20. Three Arches Bridge. Venice, Italy
