Micropiles and the FHWA 30 Years of Implementation

**International Workshop on Micropiles
Schrobenhausen, Germany
6 May 2006**

**Barry D. Siel, P.E.
Senior Geotechnical Engineer
FHWA-Resource Center**

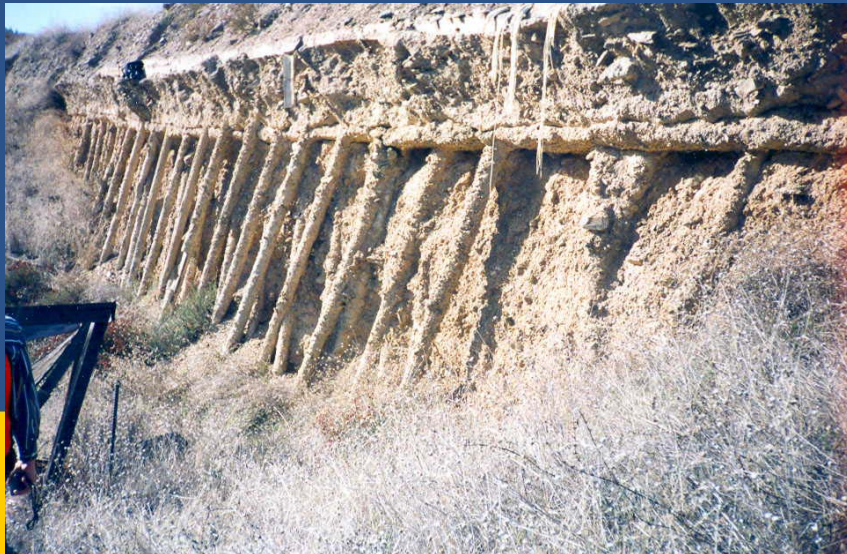
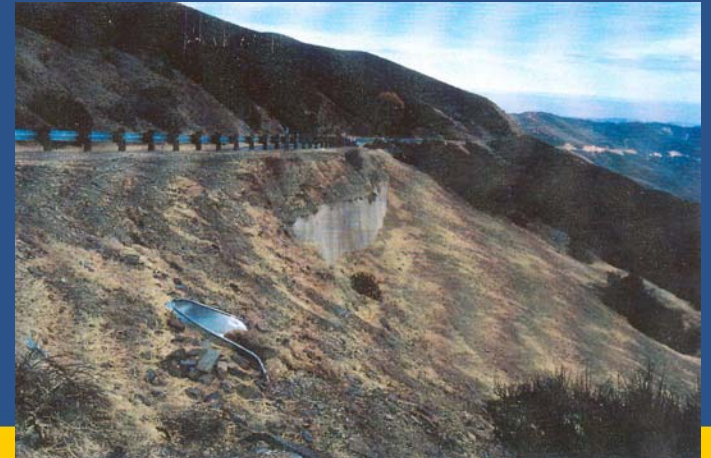
Mendocino Pass, 1978

Pali Radice

- 721 127 mm piles, 15 to 24 m long
- 8.25 piles per meter
- Wall designed for shear, piles in compression
- Slide in 1990s revealed wall, which still performed well

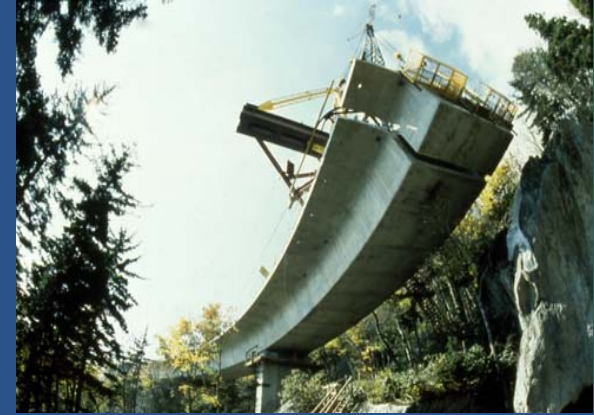
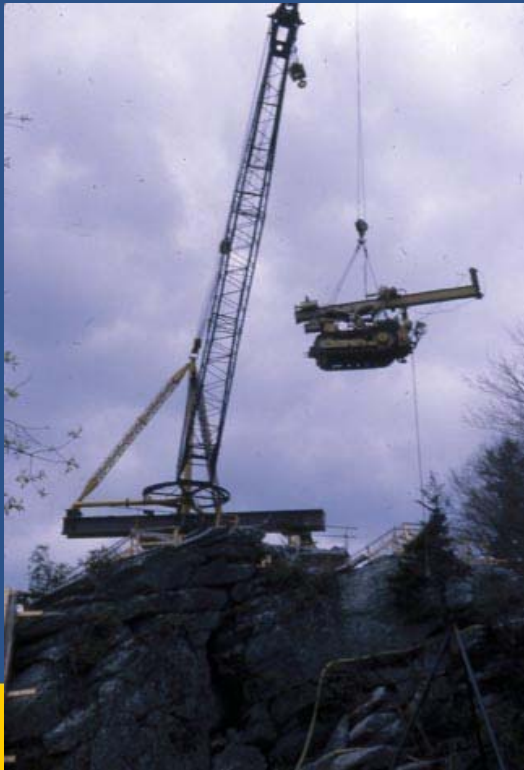
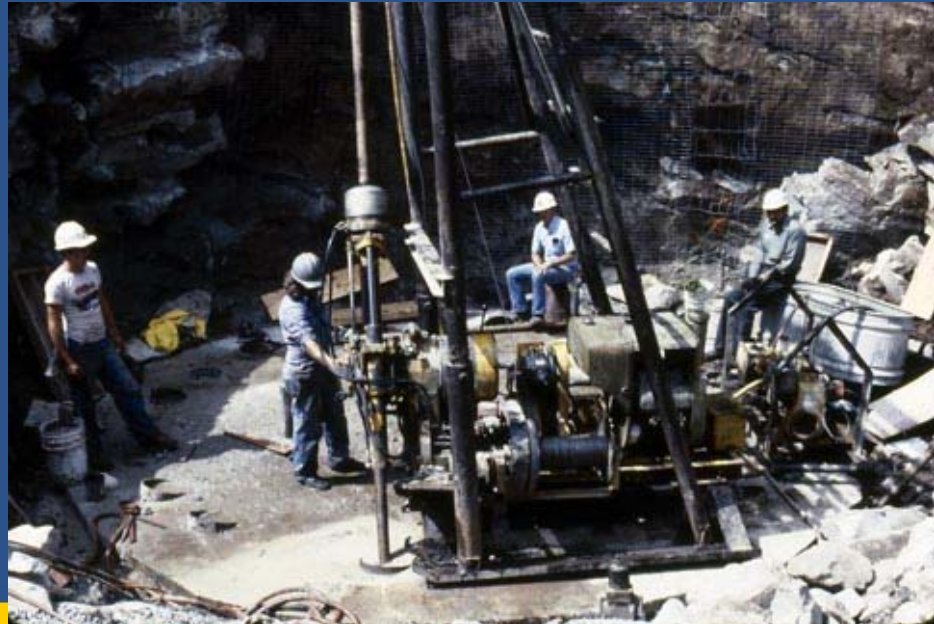
Linn Cove Viaduct

Deliver the Project 'Top-down'

Limited exploration

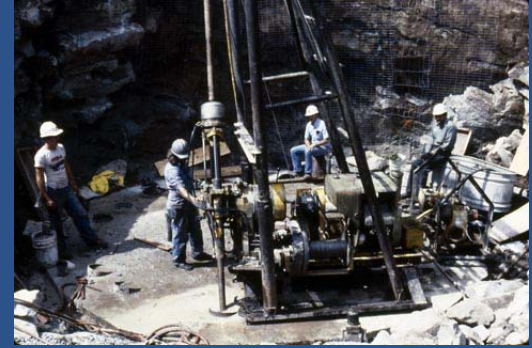
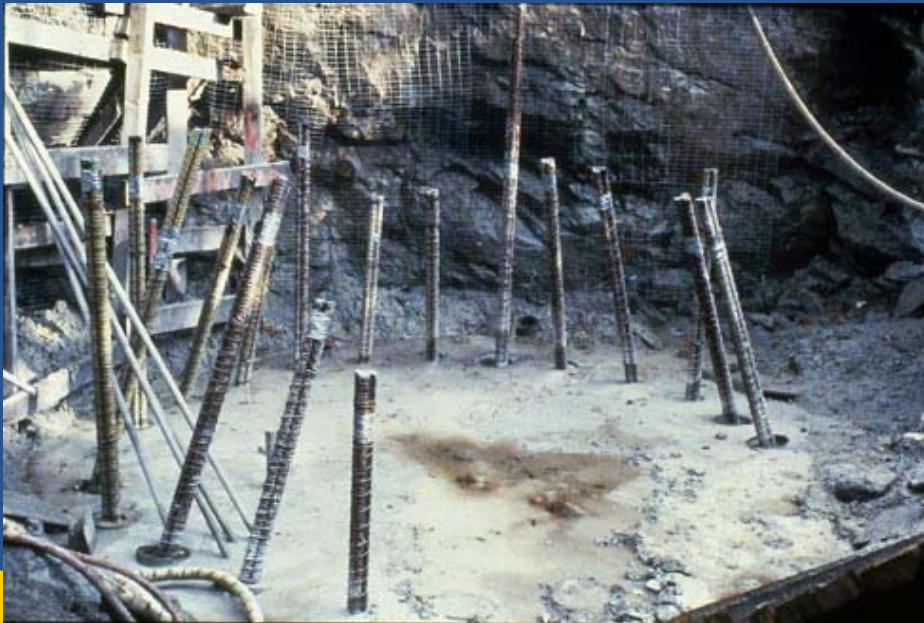
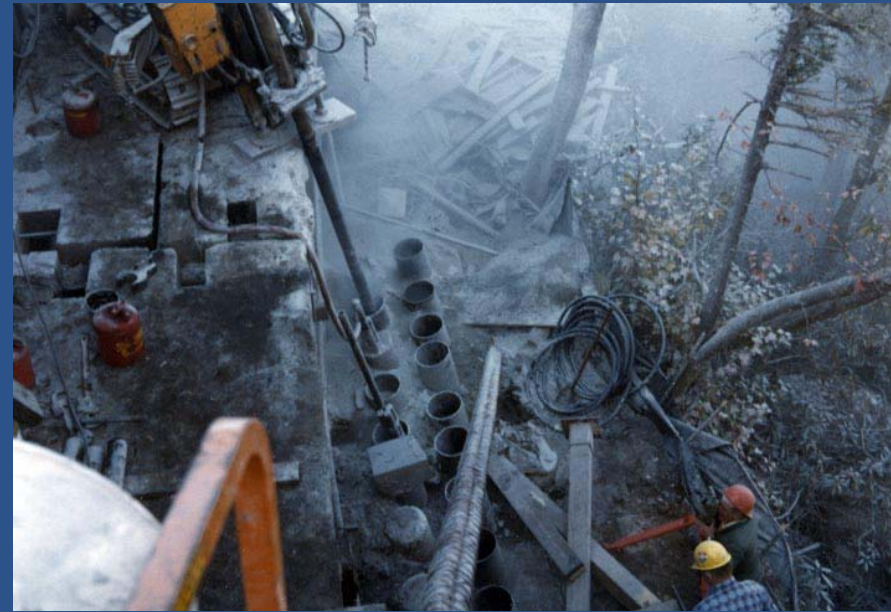
Linn Cove Viaduct

Two uses for 'Microshafts'

- Pier foundations
- Sliding resistance

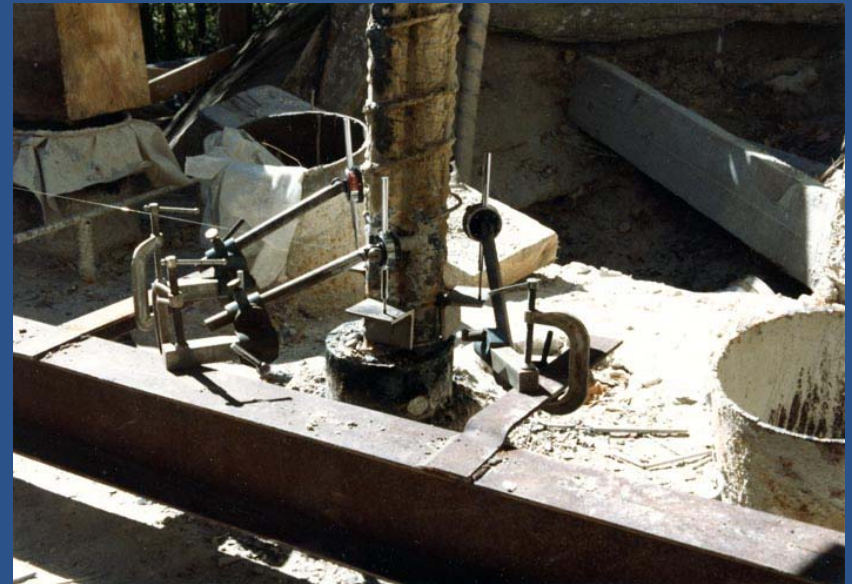
Linn Cove Viaduct

Load testing

- Design load of 130 tons compression, 50 tons tension
- Tested simultaneously to approx. 200% DL

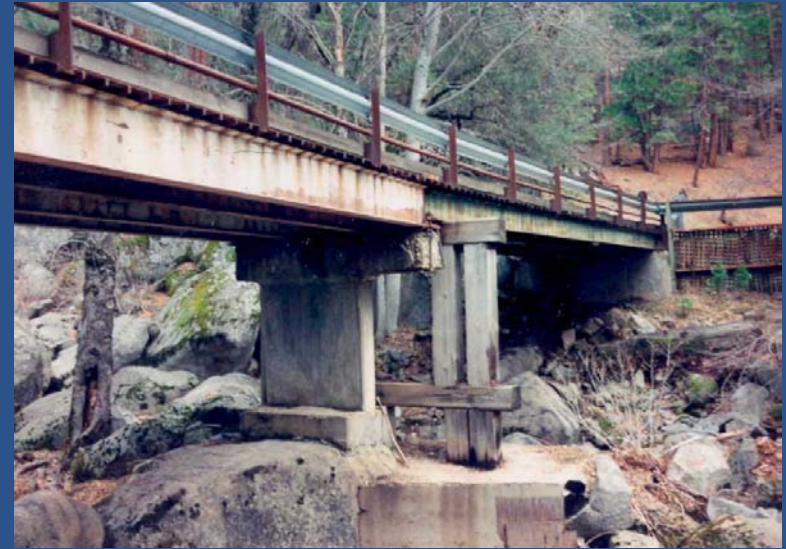
Chilnualna Bridge, Yosemite NP

15 years after Linn Cove
Follows Marble Fork Bridge,
Sequoia NP

– Contractor design

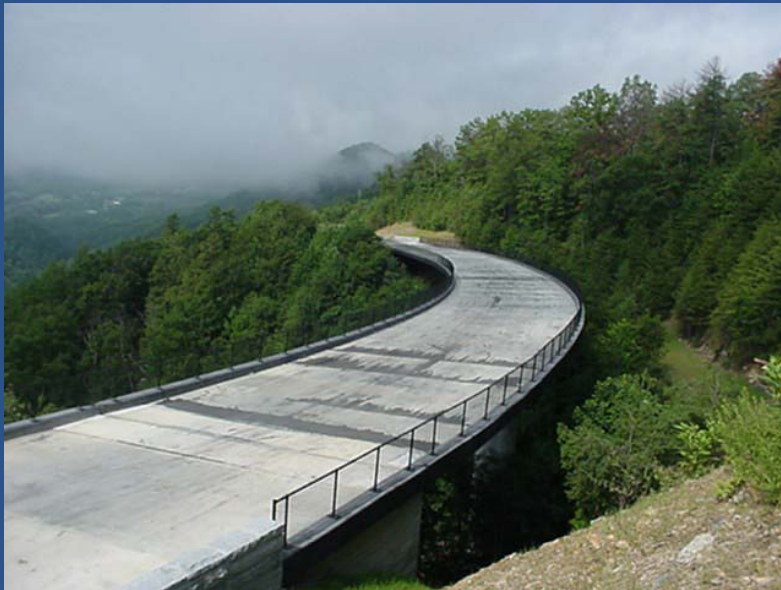
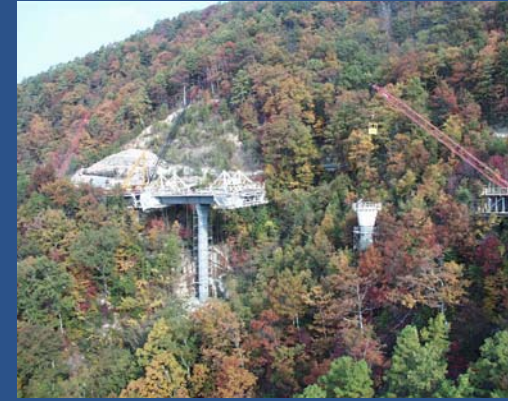
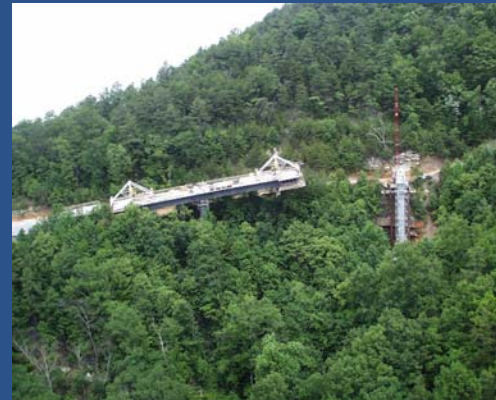
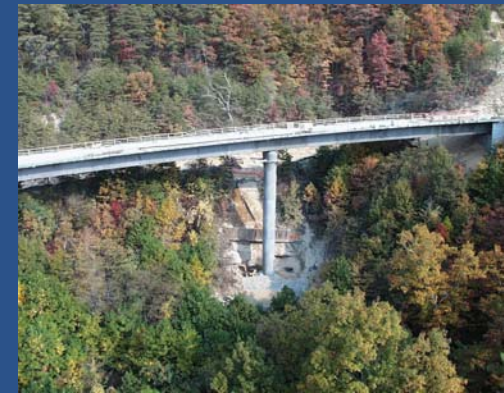
Foothills Parkway, GSMNP

Late 1990s

Similar to Linn Cove

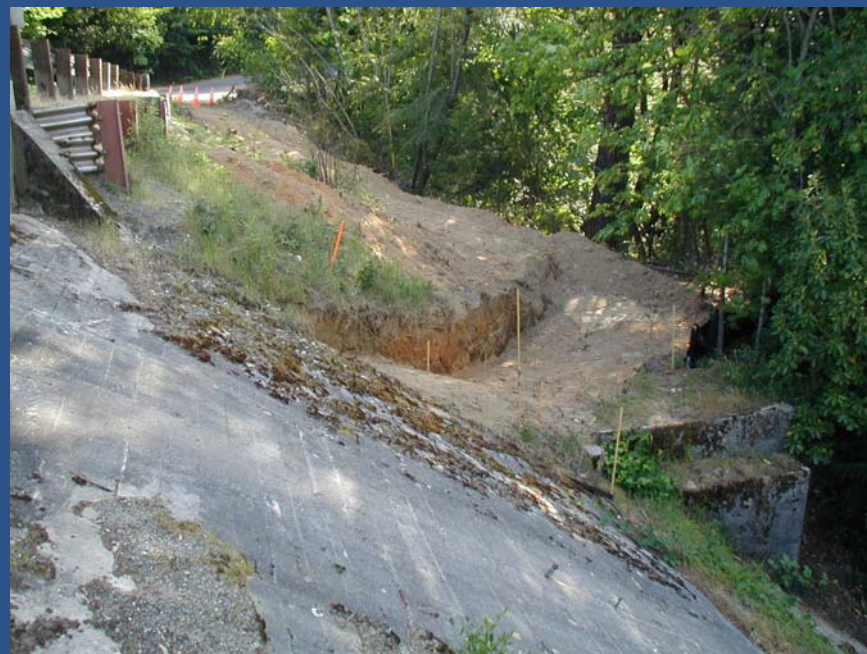
Madrone Lake Dam

New retaining wall on 75-year old,
marginally stable dam

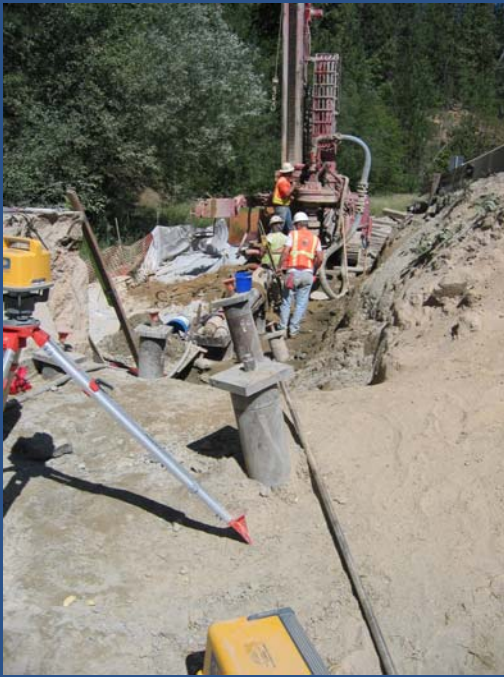
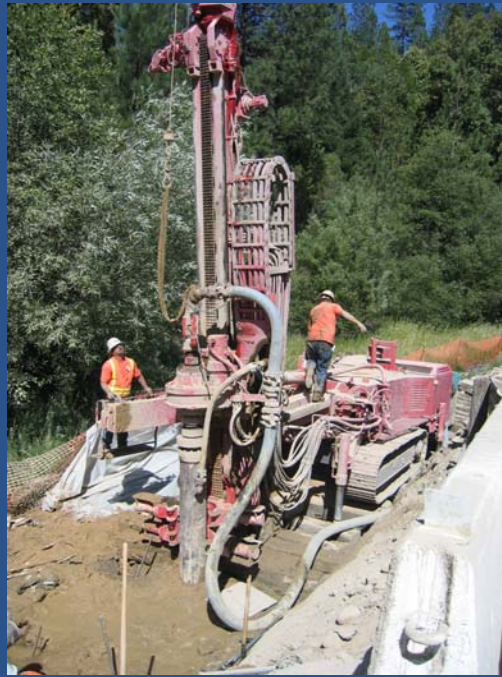
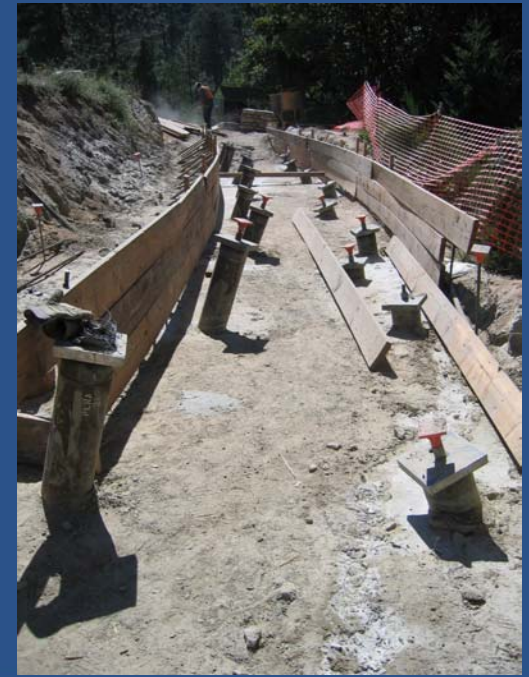
Madrone Lake Dam

Battered piles

No testing

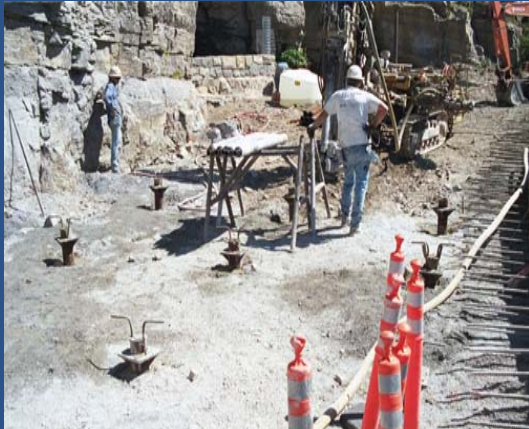
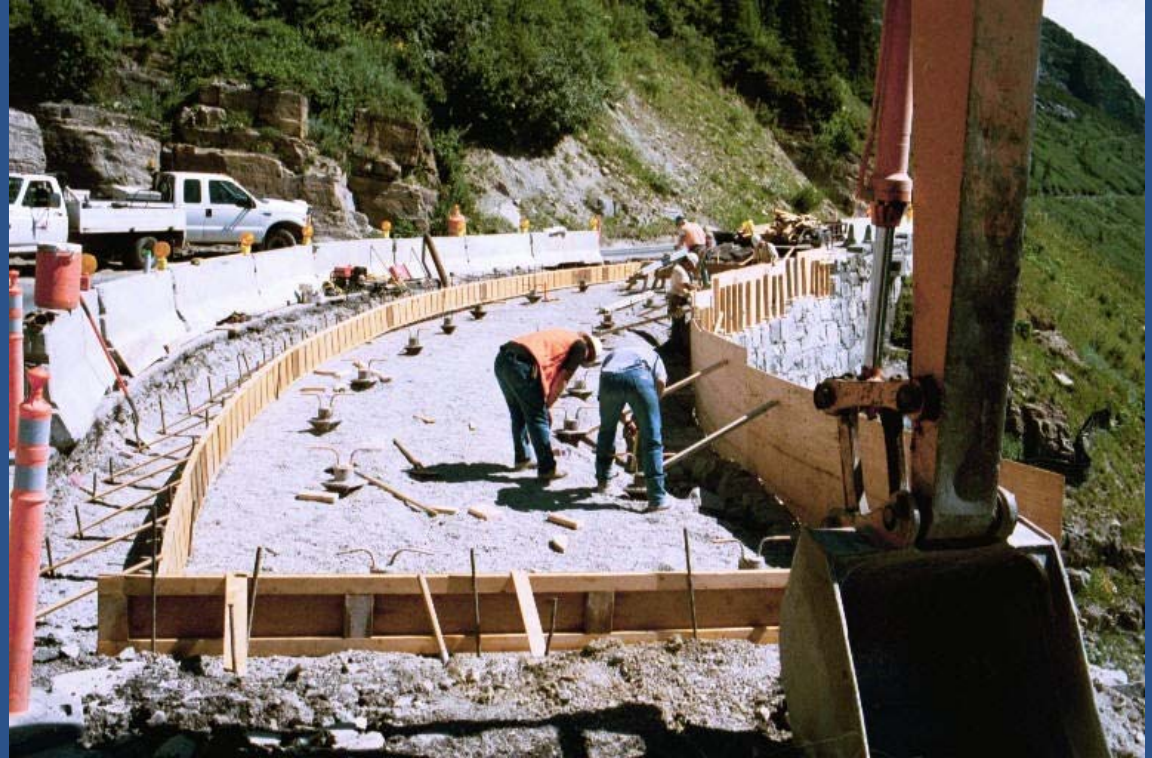
Going to the Sun, Glacier NP

Avalanche Resistant Wall

Install micro-piles

Form work

Masonry work

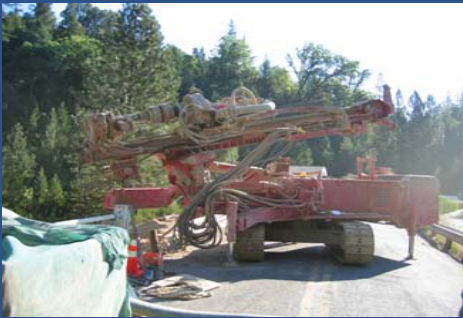
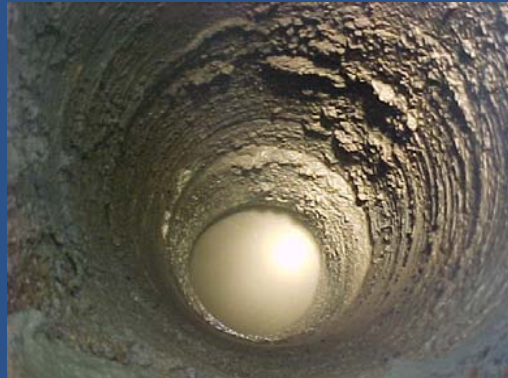
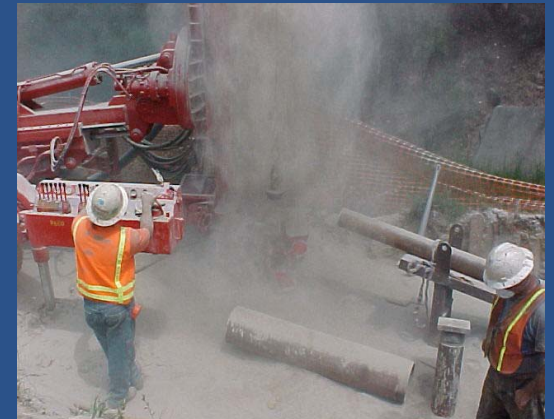
Deer Canyon Bridge, California

Changed site conditions, bedrock lower than anticipated

Boulders preclude drilled shafts

Differential settlement preclude spread footing

Change order design for micropiles

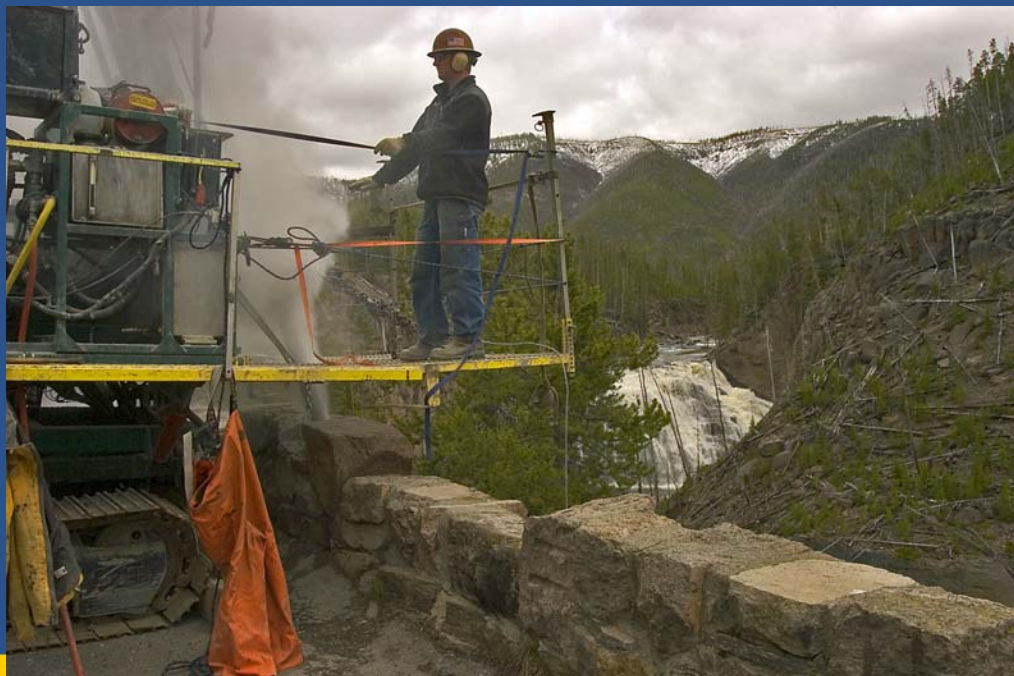
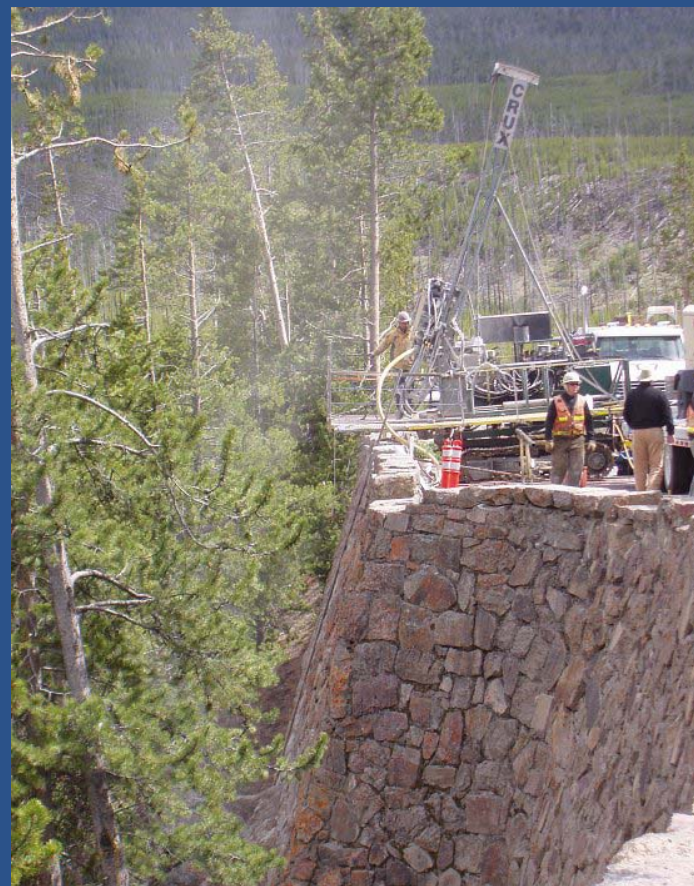
Gibbon Falls, Yellowstone NP

Historic wall stabilization
Extension of guardwall
