The use of micropiles to reinforce old walls and stabilize steep slopes in Quedlinburg, Germany

Presented by Heinz Staudt

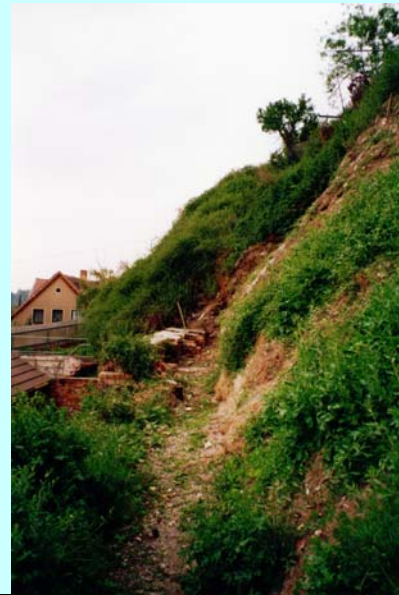
and of the steepness of the slopes.

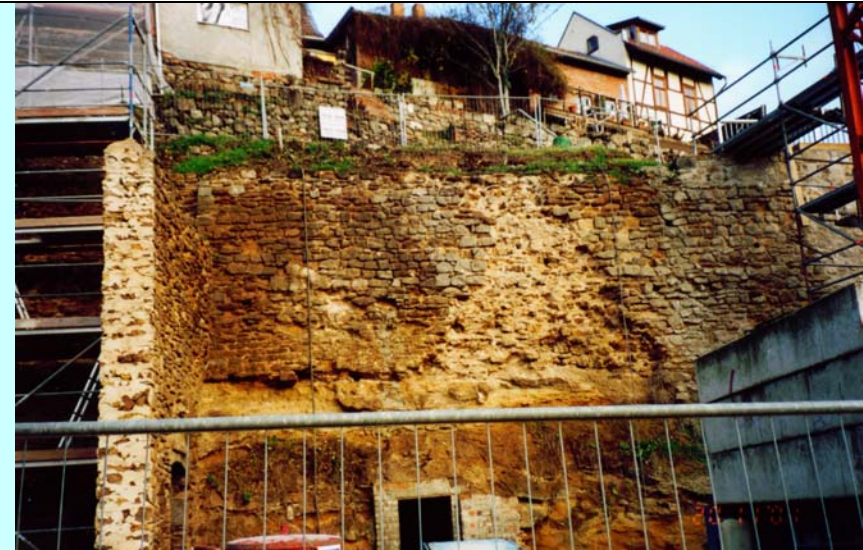
The deterioration and decay of the old walls was basically due to the following reasons:

- Load increase due to increased height of slopes / embankments or new / additional traffic loads.
- As the back of the walls was not waterproofed, surface water seeped or diffused through the wall section resulting in “flushing out“ or “washing out“ the binding agent, which in turn caused the internal bond of the walls to approach zero.

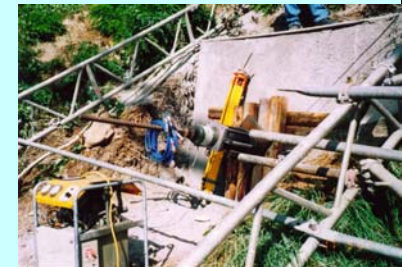
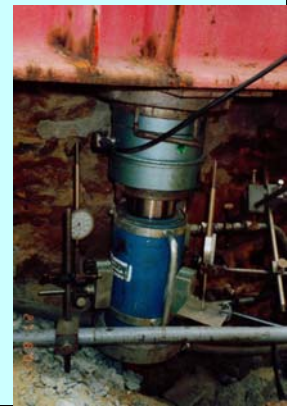
Static load tests

It goes without saying that we carried out static load tests (in both tension and compression) on each site in advance of the main works.

Tension + compression

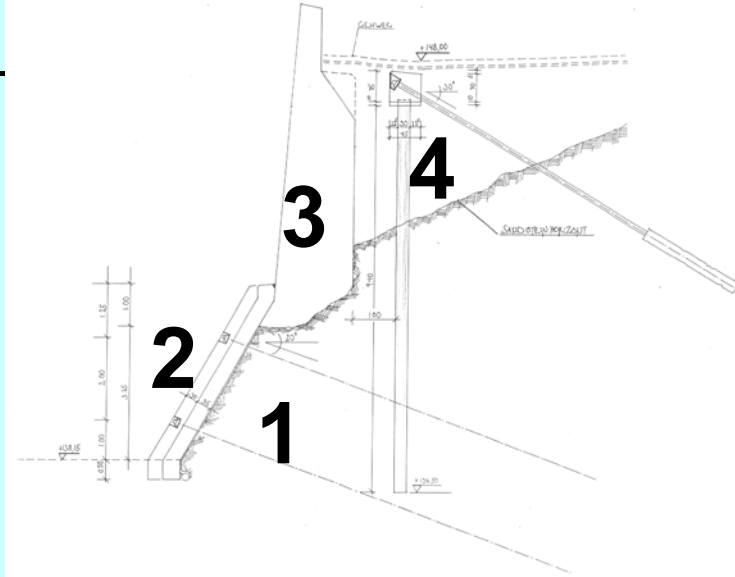
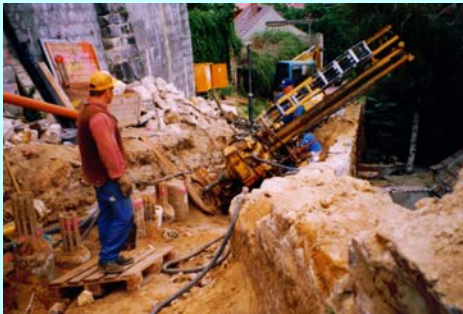
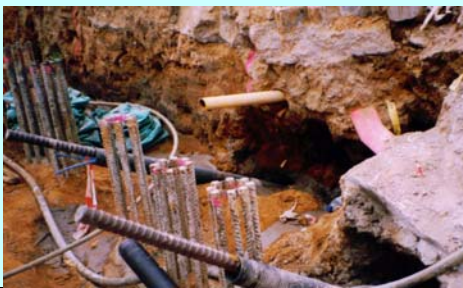
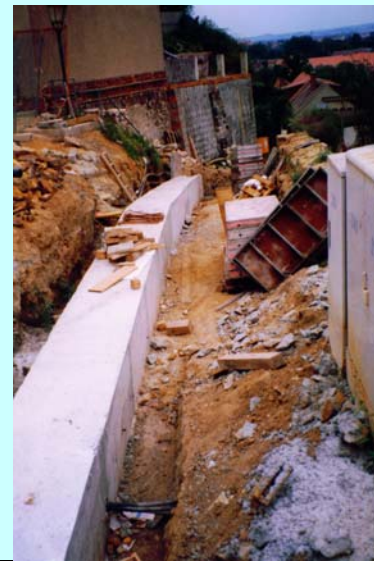
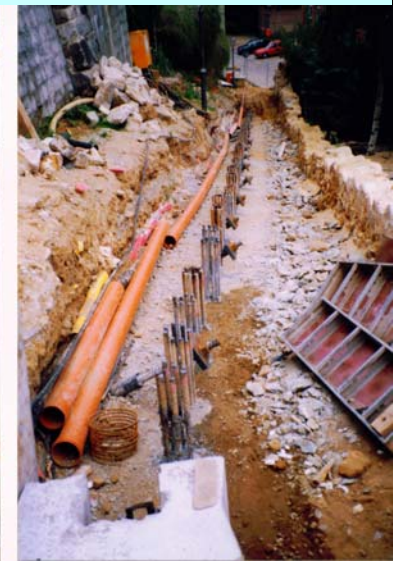
We adopted the following working sequence:

- 1 Injection of binder in the sandstone.
- 2 Stabilisation of the base of the wall. To that end we used prestressed anchors (the only time at the Münzenberg) because of the limitations on deformation.
- 3 Strengthening of the brick wall (grouting, dowelling).
- 4 Installation of a piled wall with micropile tie-back anchors.

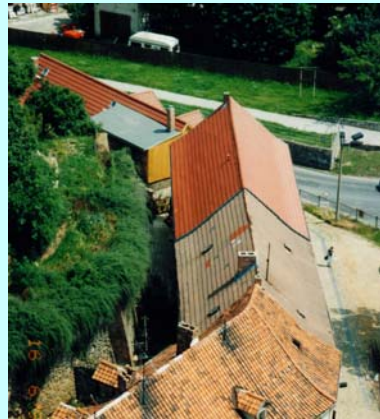
1 The original brick facing wall (rear part of cross-section) initially extended a little above the original ground level (as facing wall).

2 Over the years, the terrain was gradually built up with the "cultural layer" ("Kulturschutt").

3 One has increased the height of the initial facing wall and then constructed a further facing wall (with bricks) in front of the existing wall with its extension.

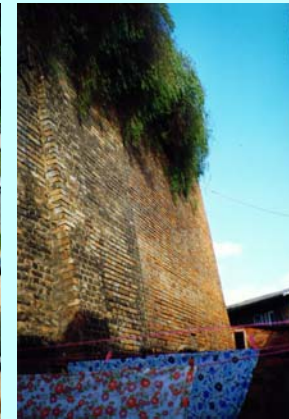
Front view

This enlarged cross-section of the wall was, however, totally unable to carry the earth pressure resulting from the fill.

Between the back of the wall and the sandstone, water flowing down on top of the "hard" sandstone layers had washed out or cut out large cavities.

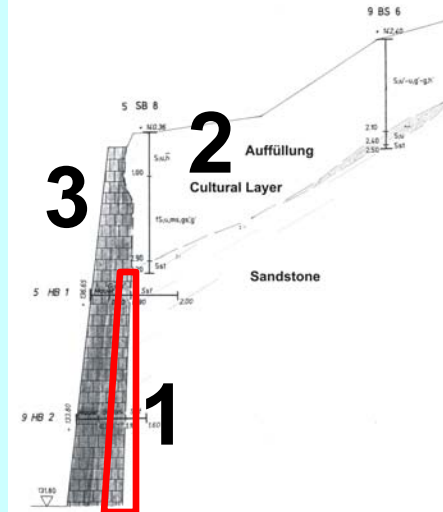
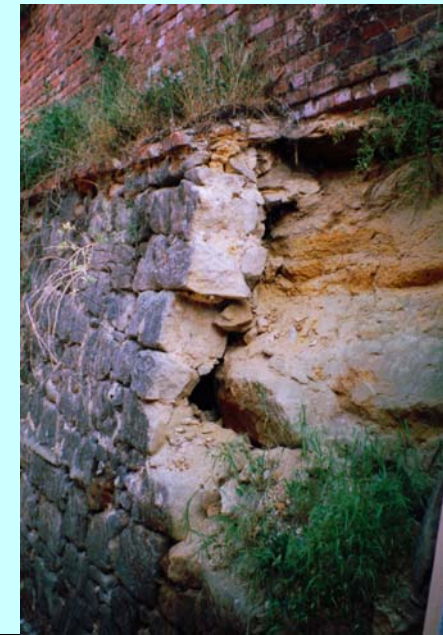
Site investigation

On the basis of the available results of the soil investigation, the entire bank had become unstable.

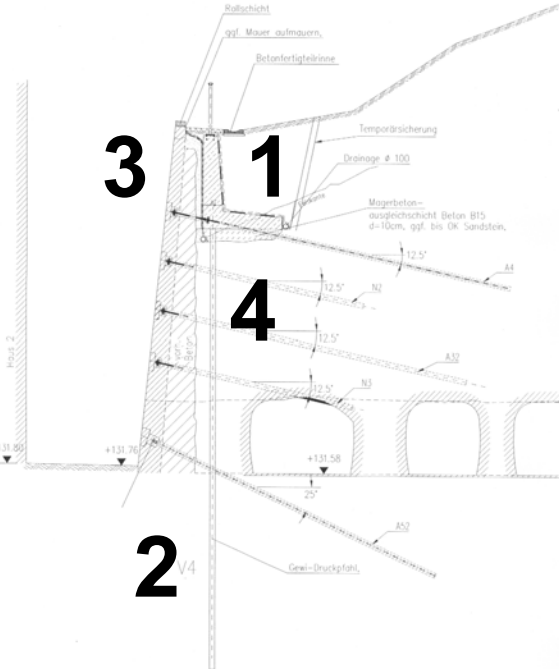
We adopted the following working sequence:

- 1 Construction of an excavation pit to top of "bedrock" at the top of the wall under the protection of a tied-back cover of shotcrete.
- 2 Installation of compression piles to carry the vertical loads from a concrete cantilever wall (as the sandstone was unable to sustain the foundation pressure applied at the front edge of the cantilever wall).
- 3 Installation of the top anchors to carry the horizontal loads from the concrete cantilever wall.
- 4 Construction of the cantilever, followed by backfilling
- 5 Stabilisation of the bank and wall with micropiles as tendons. The micropile heads were fitted with concrete pads to facilitate load distribution. These were faces with bricks.

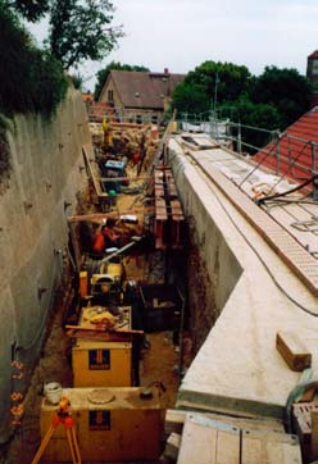
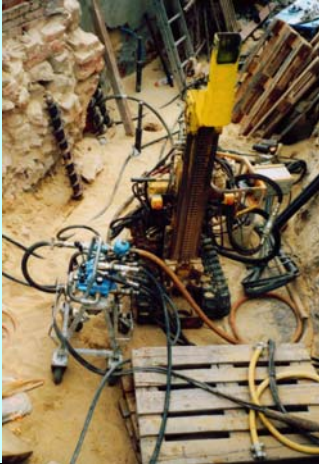
Temporary retention system, Pile drill, vertical
 Vertical GEWI pile test

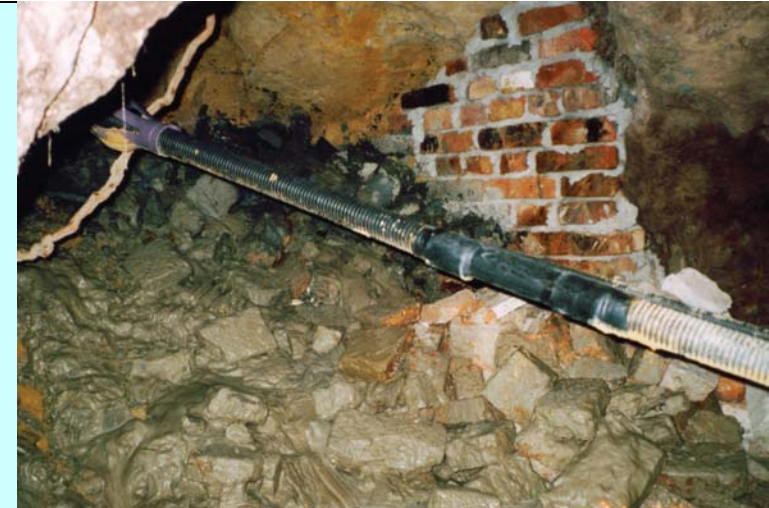
Former owners of the hillside had dug out caves as a substitute for cellars, the precise dimensions of which were not known. As a result, caves were drilled into, which had to be taken into account in the anchor design.

We bricked the caves up and bulk-filled them with grout.

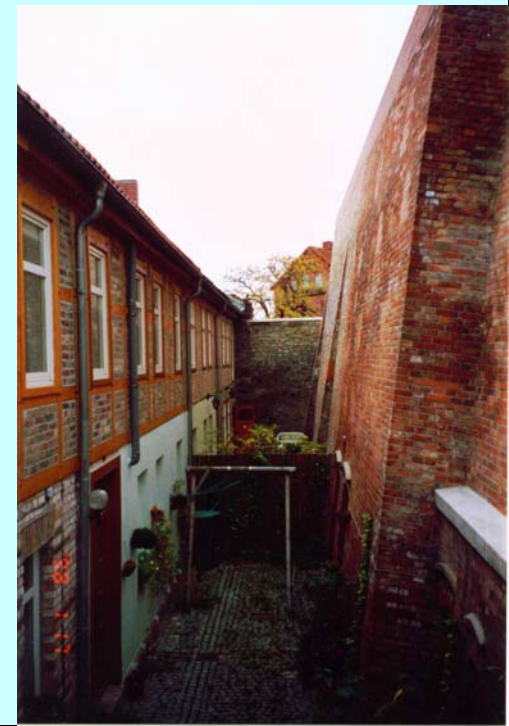
General view of the strengthened wall

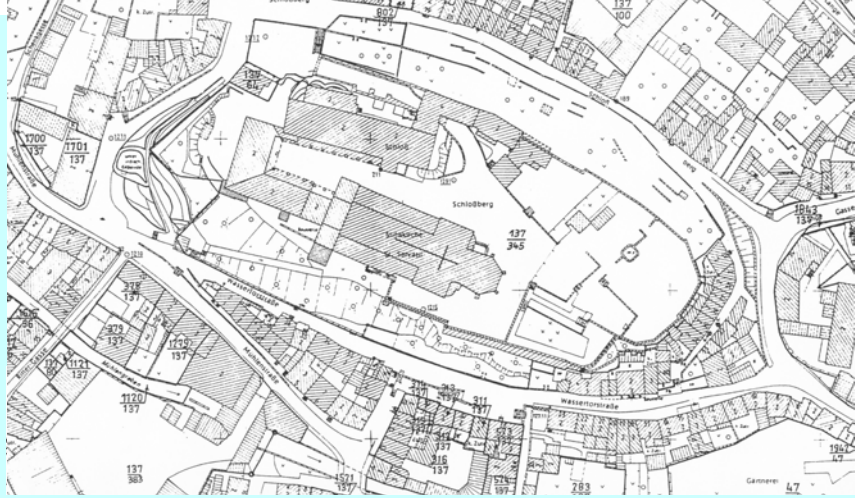
3.Replacement of a failing wall

This roughly 9.6 m high wall stepped at 7.7 m had developed a very severe bulge which had been hidden for many years behind the houses along this stretch of the road.

In addition, the sandstone blocks of the outer wall were very severely damaged.

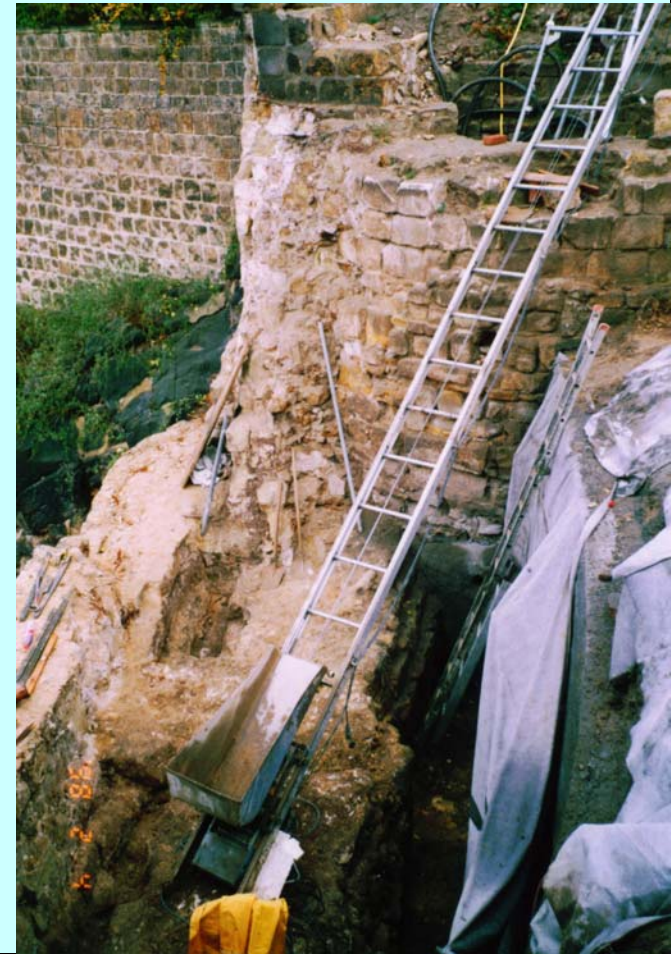
During the process of dismantling the wall we discovered (as a partial explanation for the stability of the old wall) a Baroque wall and the apsis of the oldest chapel of Quedlinburg. Neither of them had been recorded in any of the documents.

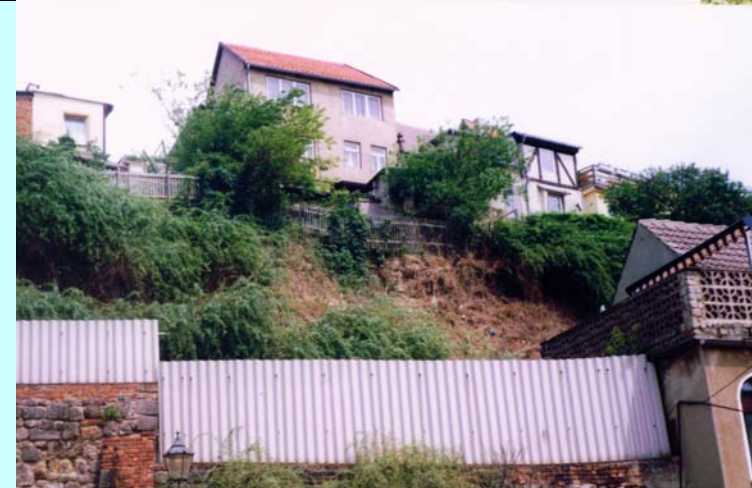
We have improved these slopes by a phased construction of wall panels built into the slope similar to the soil nailing technique. The wall panels are tied back with tension anchors, the vertical loads are either carried directly by the sandstone or transferred to compression piles.

Here one example

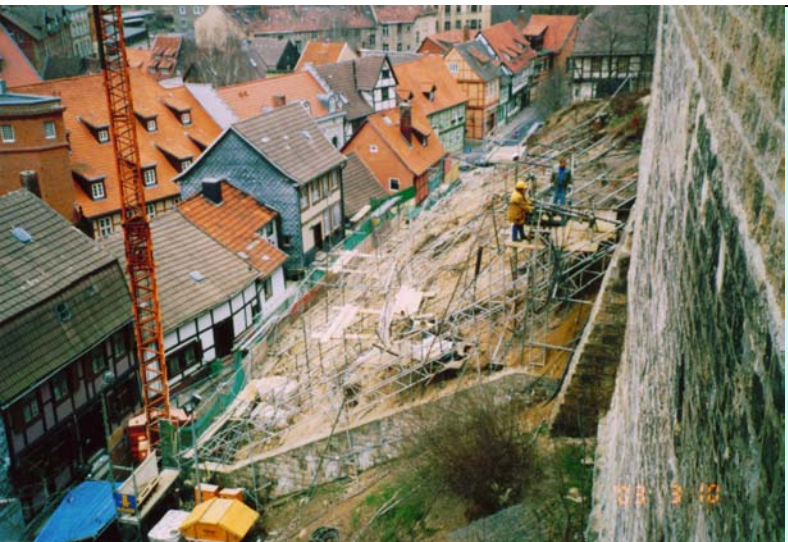
Installation of anchors from a light scaffolding platform

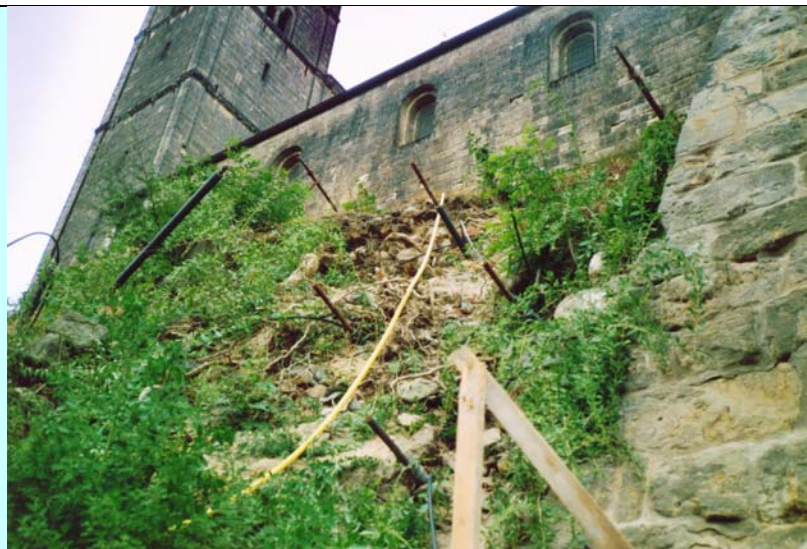
Anchor in the slope

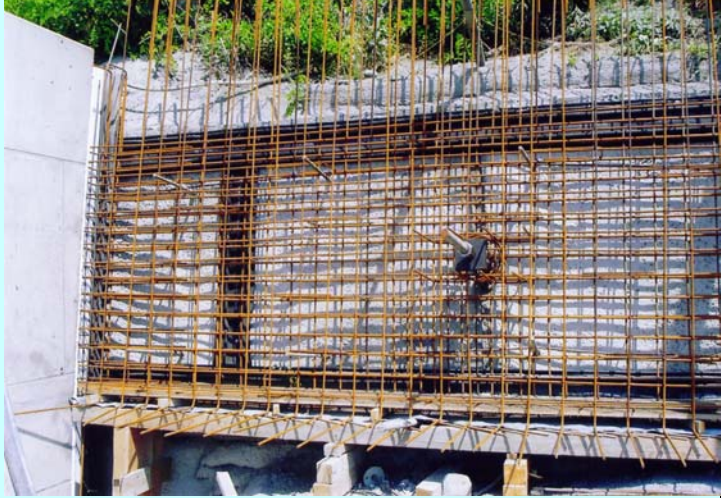
Installation of reinforcement and anchor heads

Spraying of wall

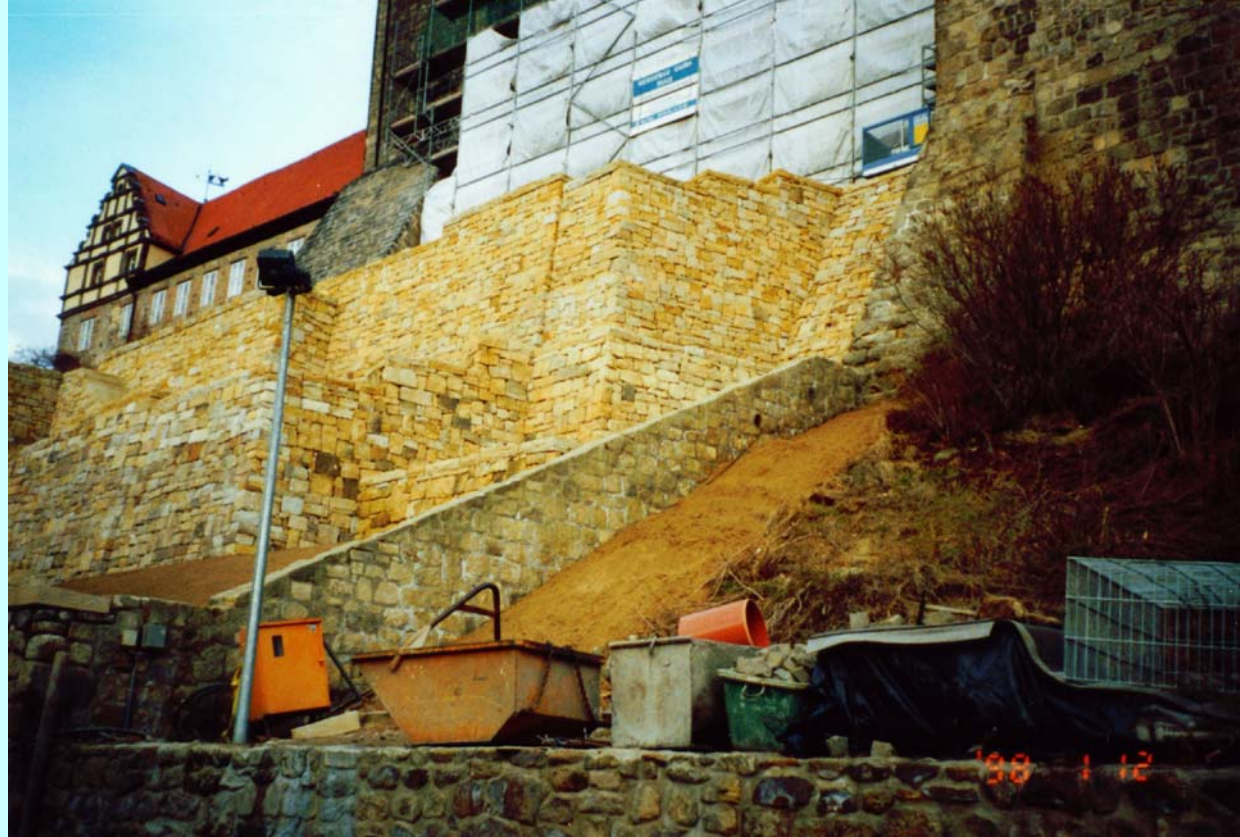
Front view of completed fully faced wall section
