Severn River Bluff Stabilization

Dr. Jesús Gómez, P.E., D.GE

- Description of site
- Geotechnical issues
- Stability analyses and design concept
- Construction and monitoring
- Closure

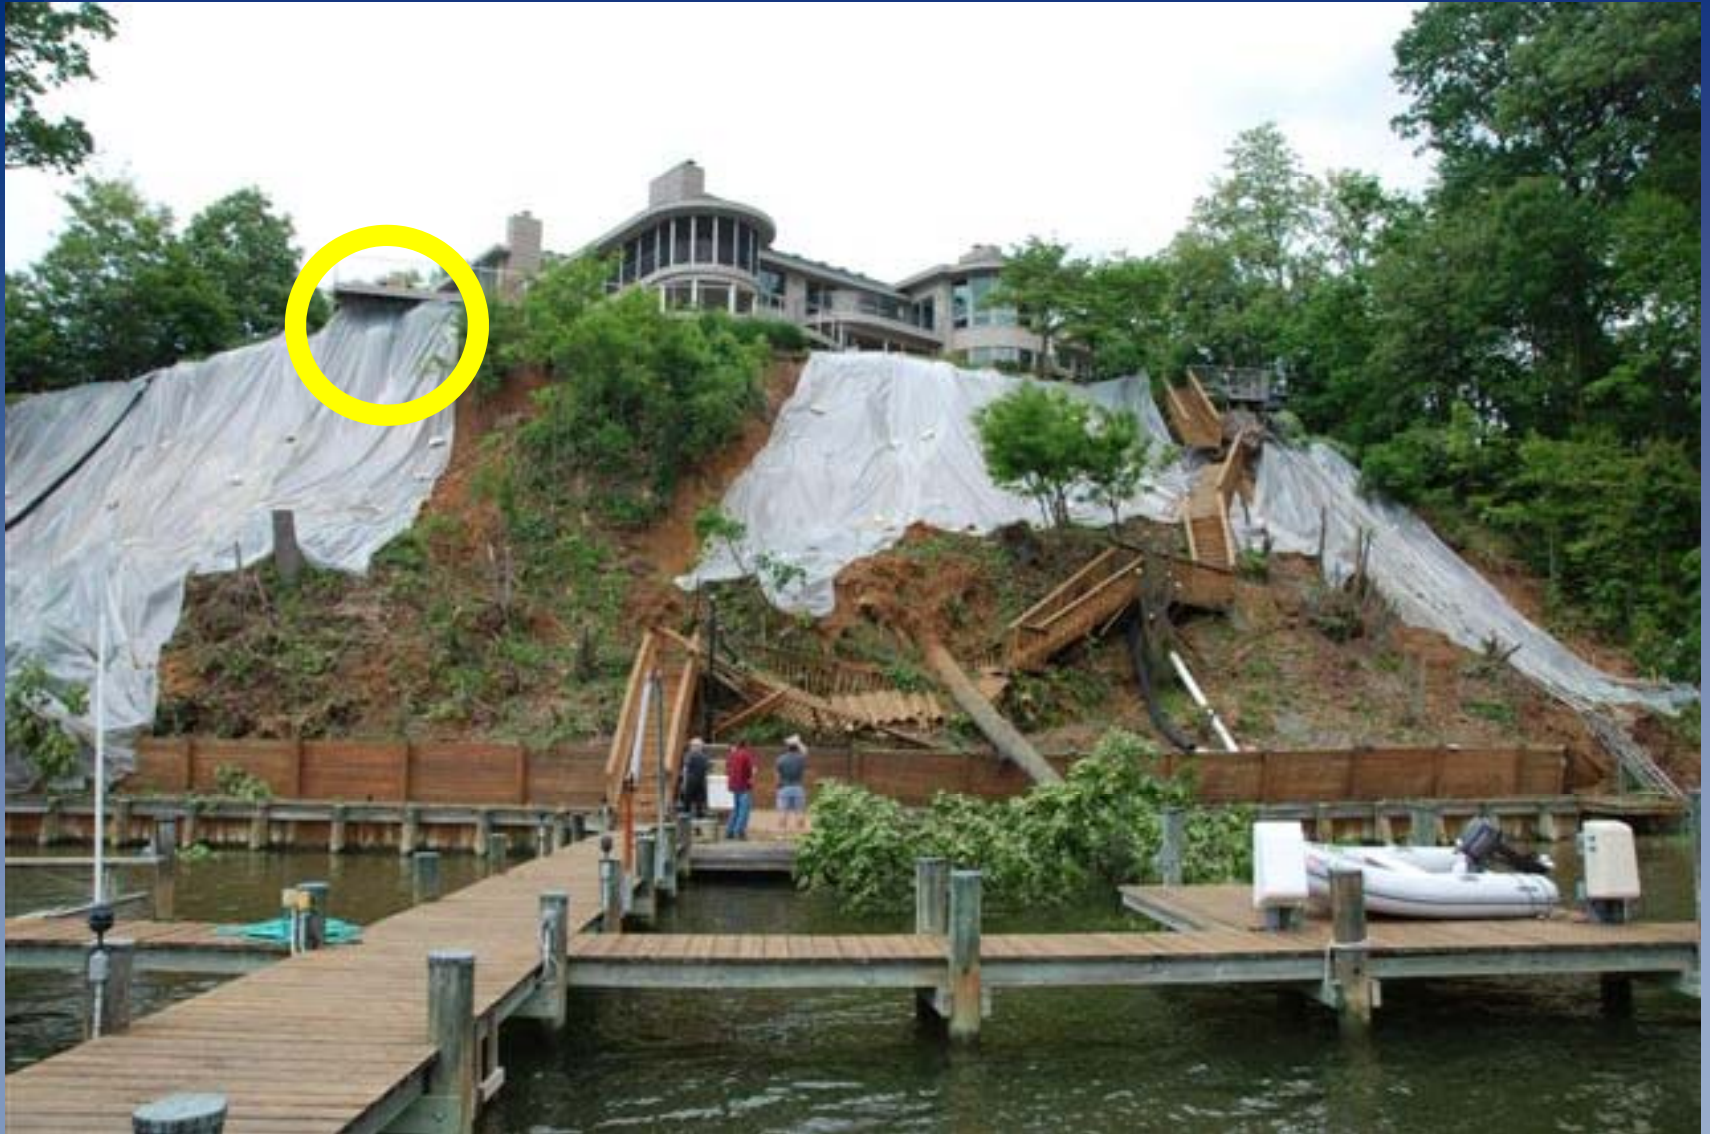
Geotechnical Issues

- Landslide affecting entire slope
- Overturned trees
- Damaged timber wall and pier
- Collapsed staircase and trolley
- Undermined deck
- Total loss of access to pier

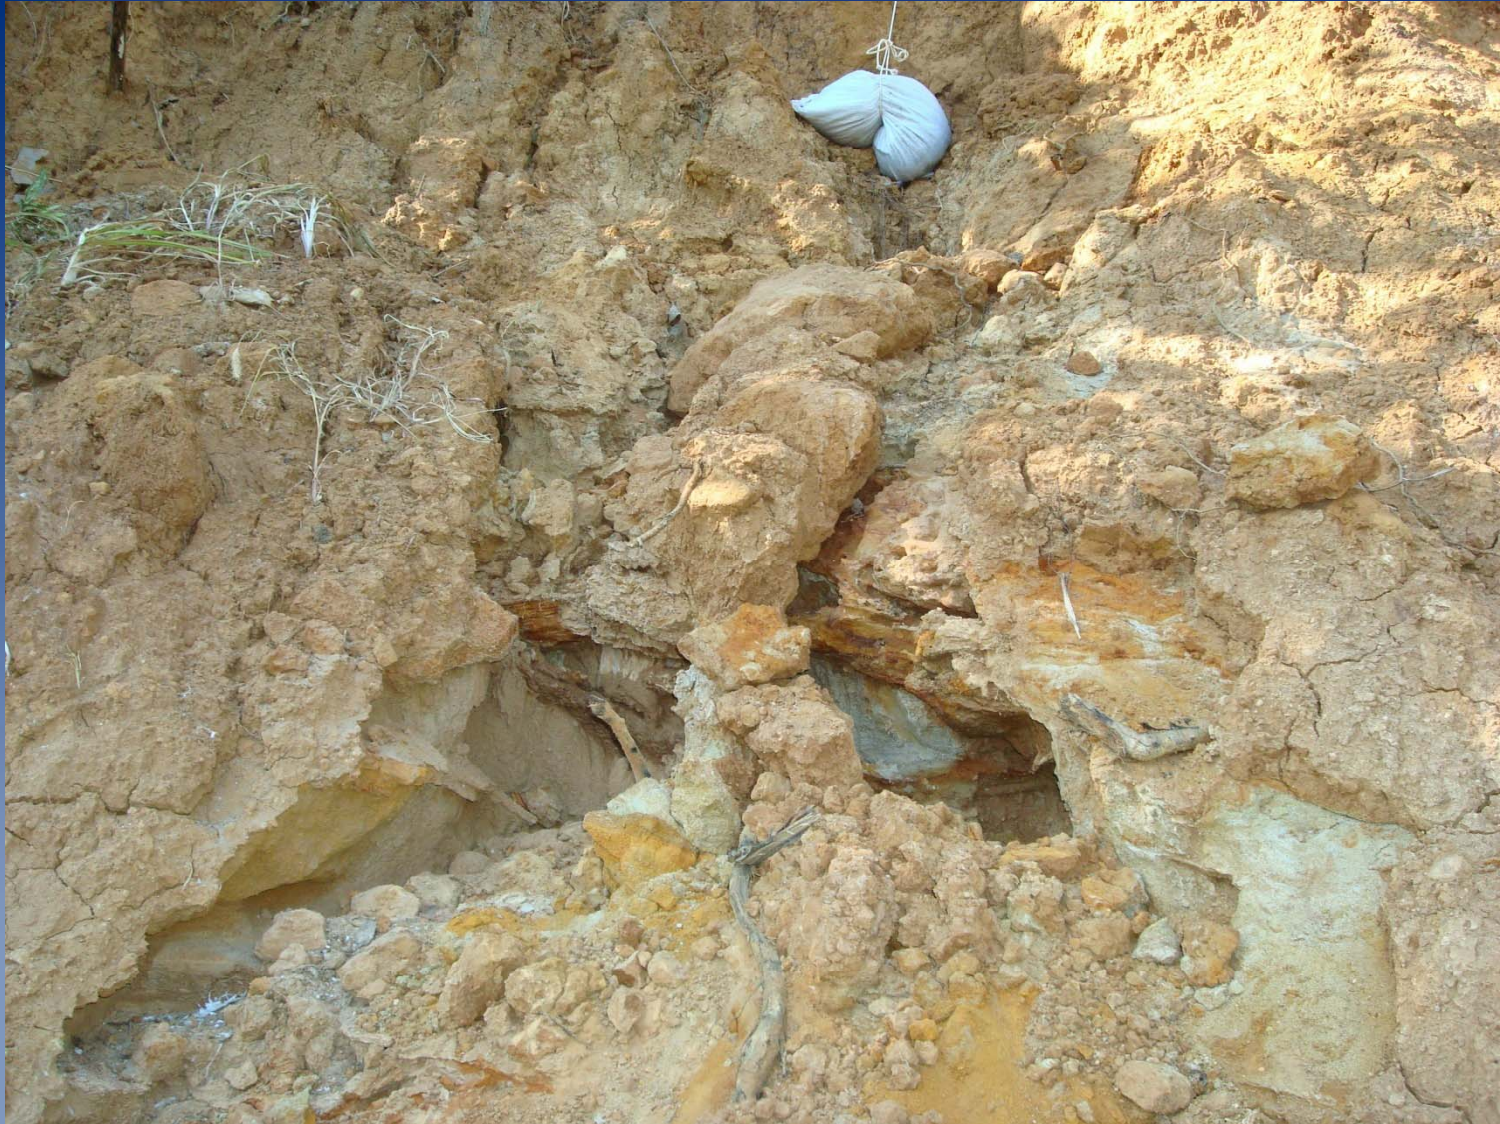
Geotechnical Issues

- Soils are sands and silty sands
- Lightly cemented
- Very susceptible to erosion
- Old roots acted as water conduits
- Very loose near surface due to disturbance
- High groundwater table

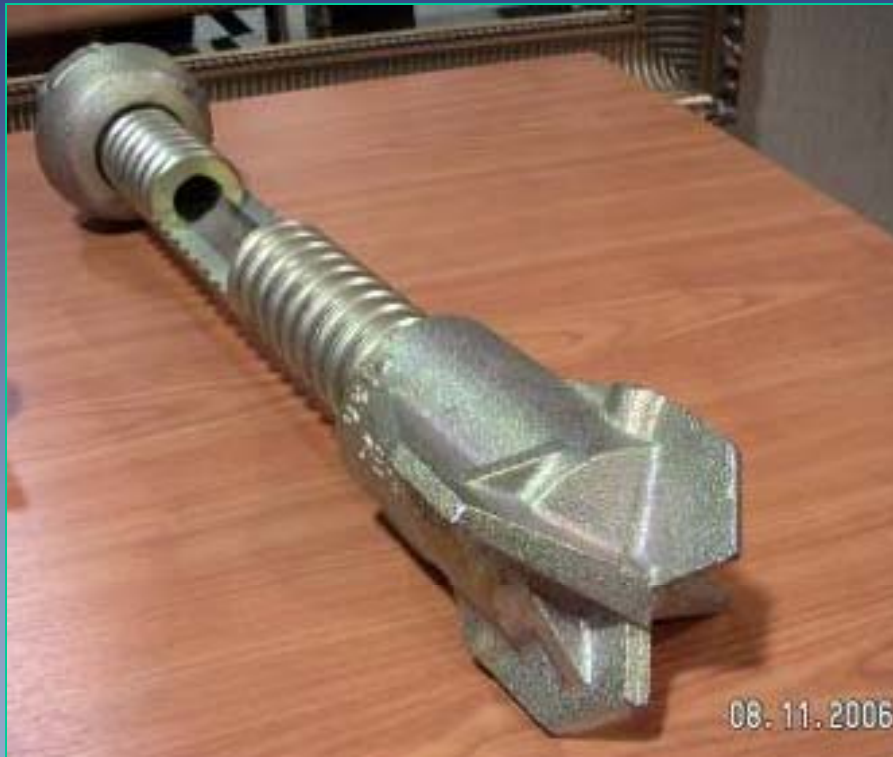
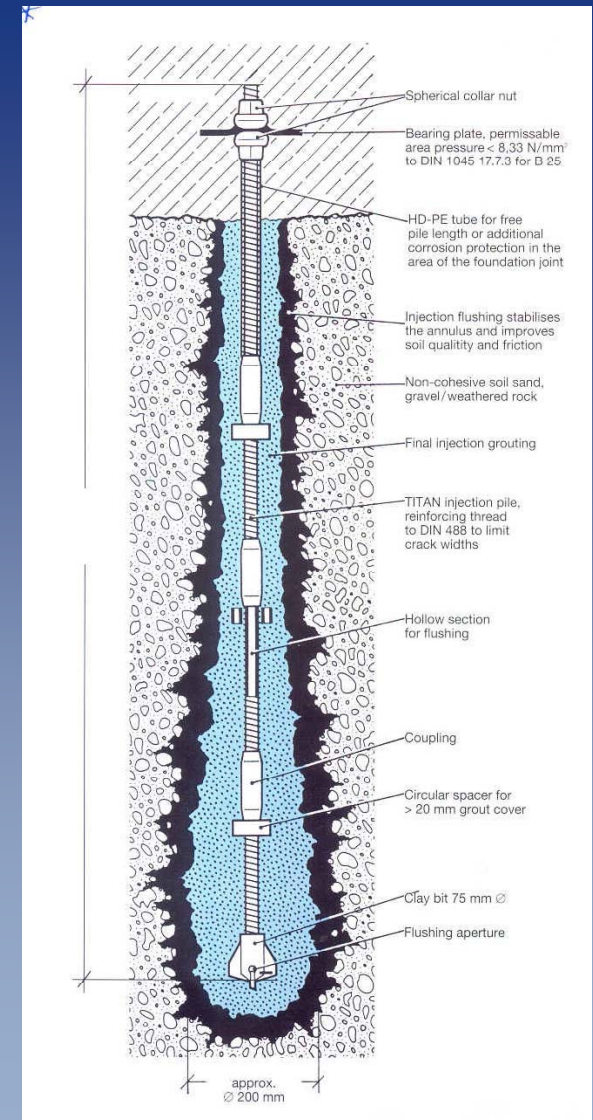
Hollow Core Bars

- No access from surface
- Drilling operations:
 - ◆ Most drilling using drill mast suspended from crane
 - ◆ Crane on barge or toe of slope
- Used hollow core bars for micropiles, tiebacks, and soil nails
- Faster!
- Large Capacity!
- Exerted tight control of spoils

- Inclinometers show no movement since stabilization
- Use of hollow core bars was fundamental to speed and safety
- Limited disturbance to soils

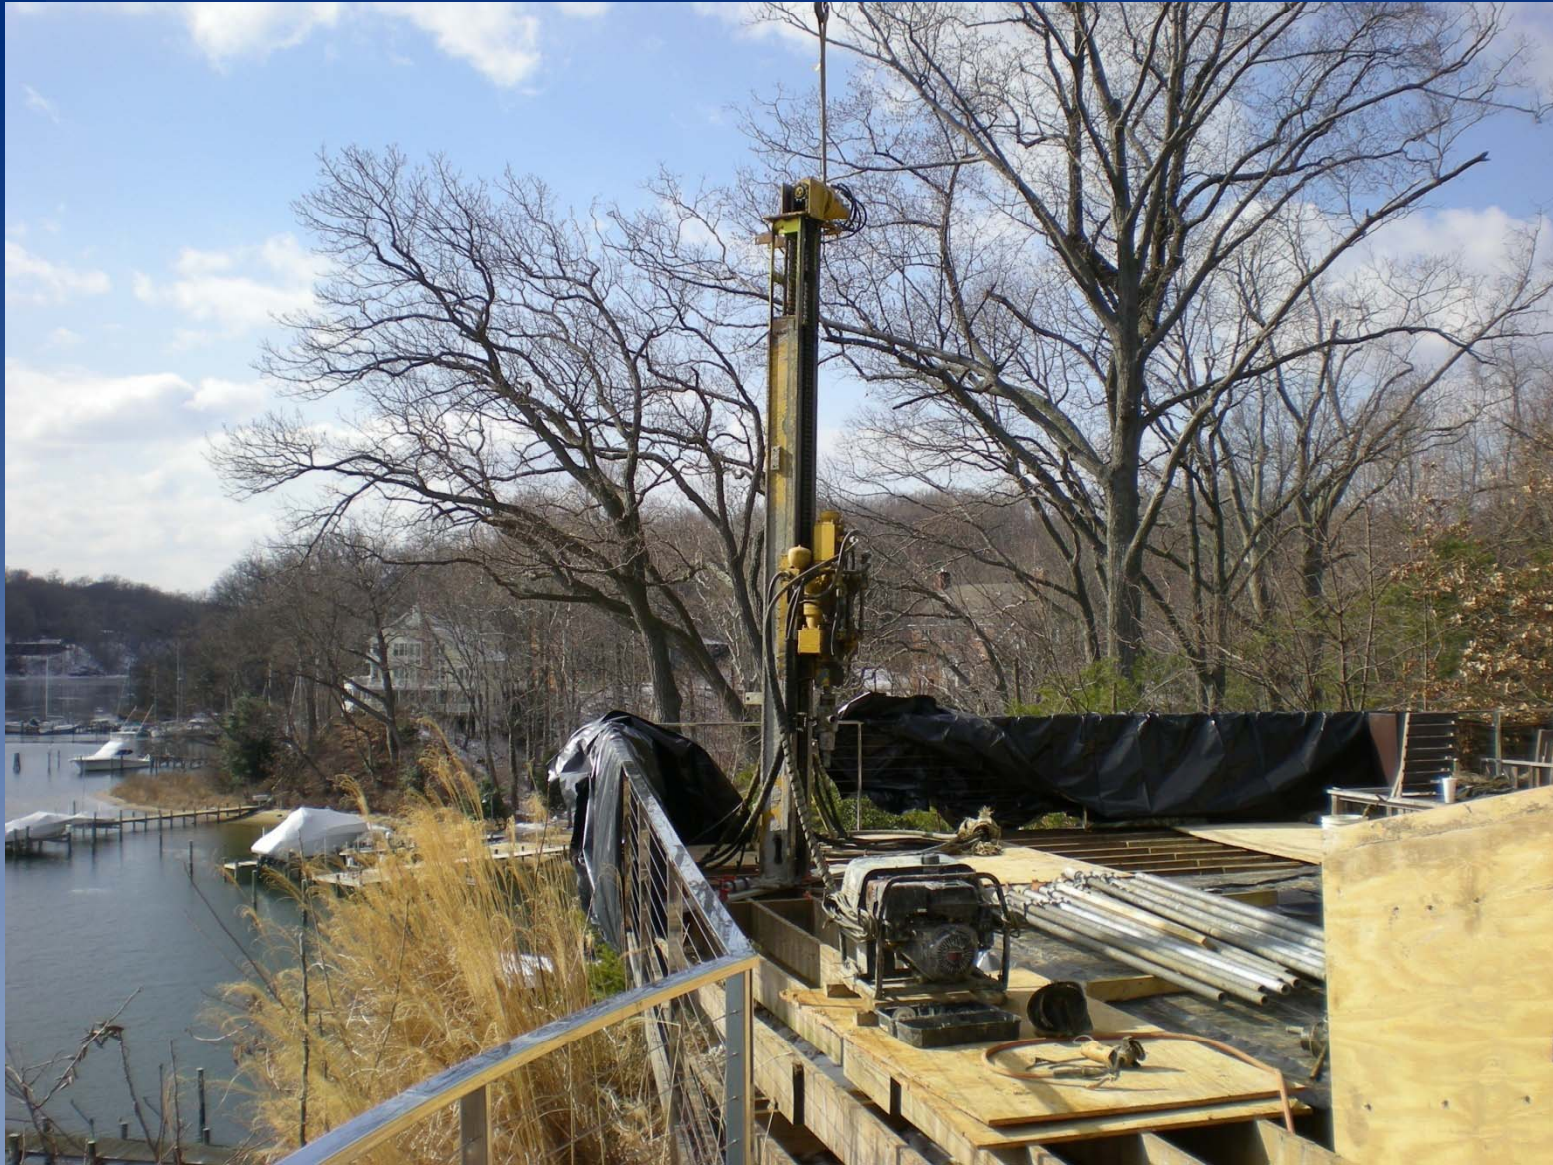
Construction

- Micropiles also used to underpin undermined deck
- “Surgical” procedure carefully removing wood floor boards and replacing them
- Connected to deck using steel needle beams encased in concrete
- Increased density of soil nails immediately below deck to prevent lateral movement

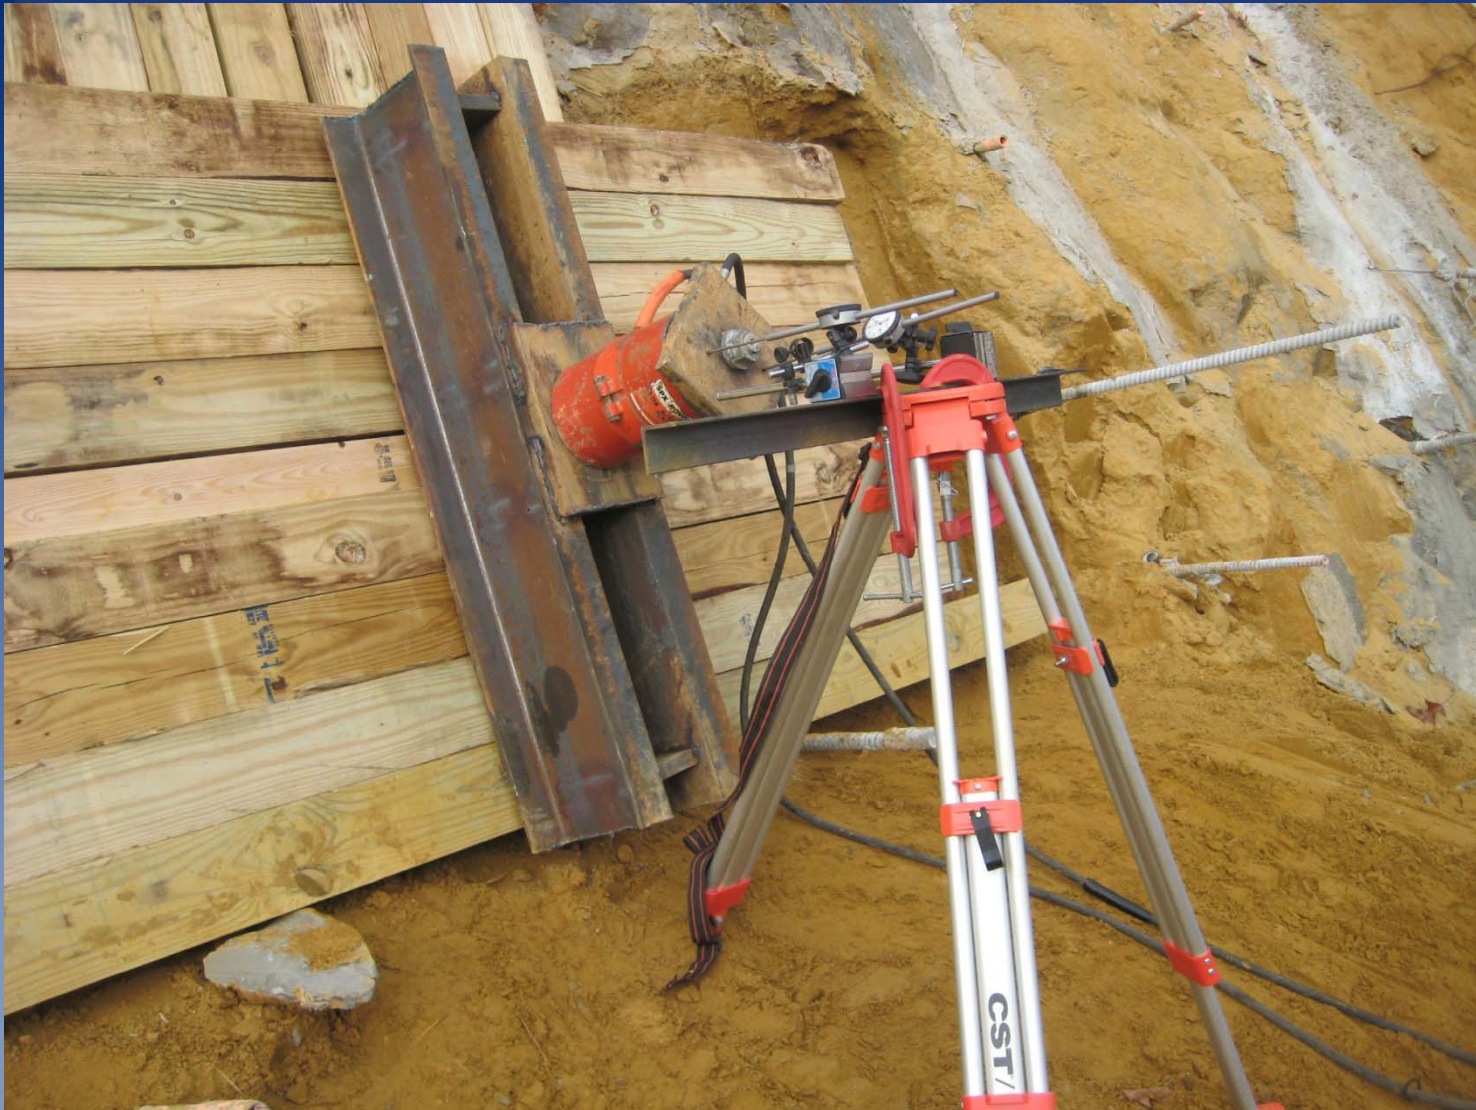
Construction

- Micropile design bond strength verified through load tests on soil nails and tiebacks
- Maximum mobilized bond stress about 42 psi in average during tests
- Most tests did not fail
