# **Micropile Performance and Durability**

**A fifteen year record of monitored micropile  
response to sustained static load**

# ISM 2014 Krakow, Poland

Walter E. Vanderpool  
P.E.

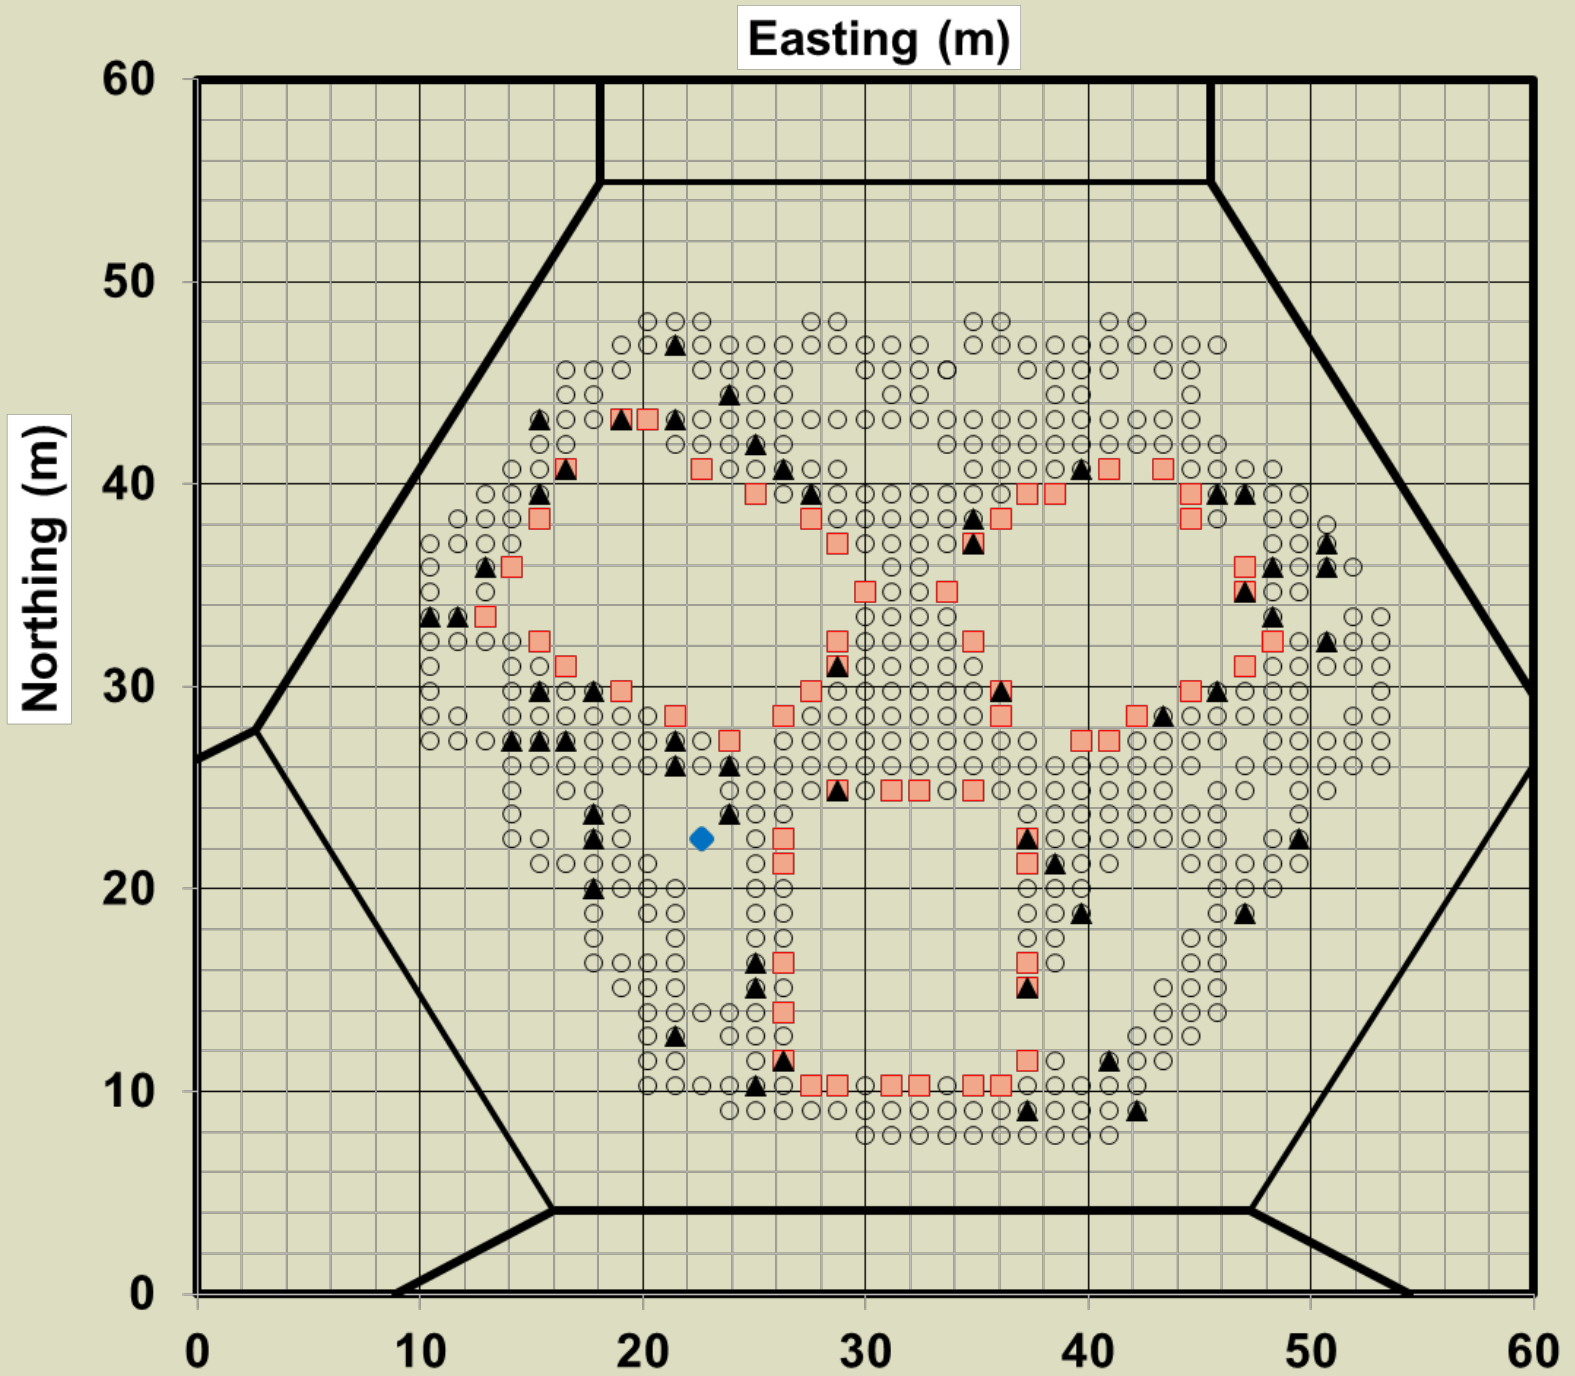
- Micropile locations
- 60 micropile test group
- ▲ 55 micropile SBSM group
- ◆ 94 point Sondex (K22)

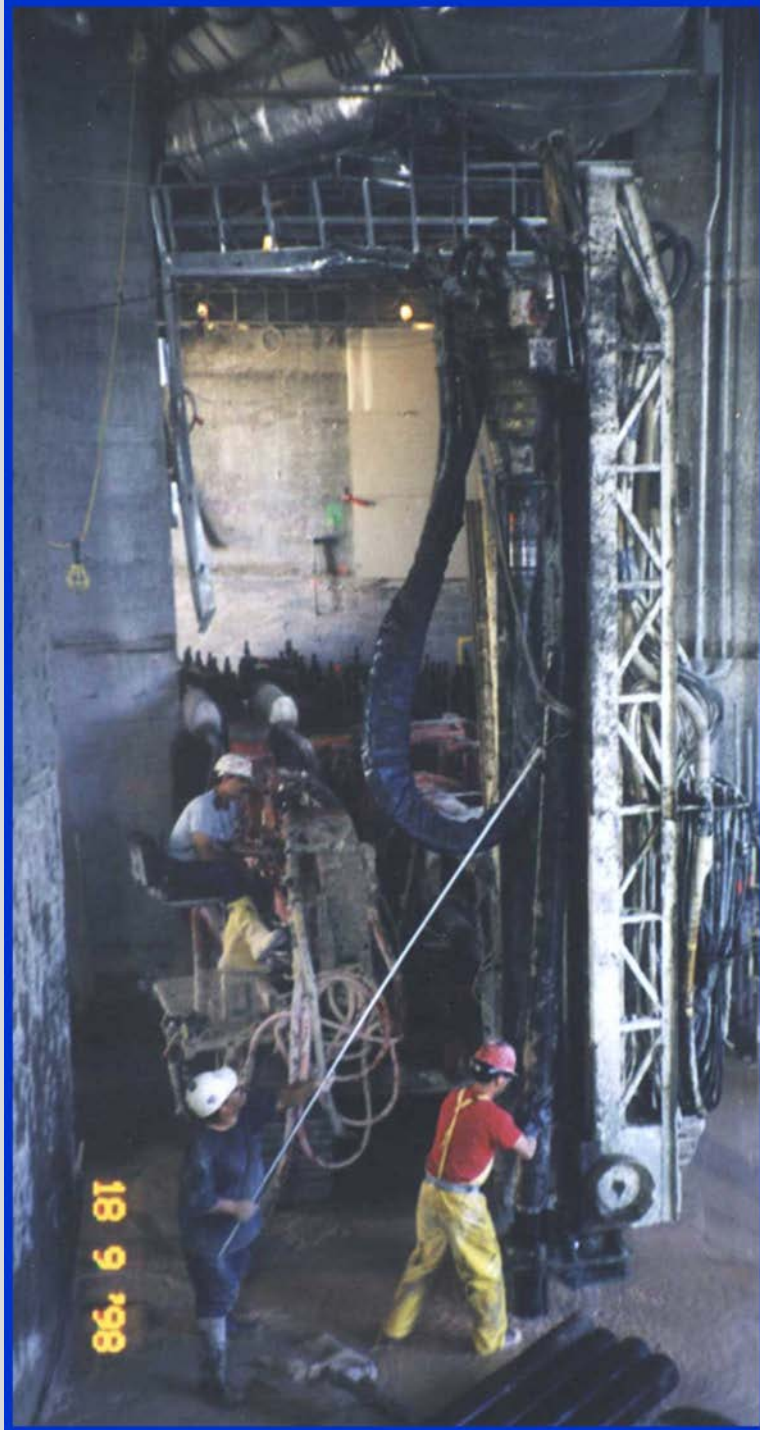
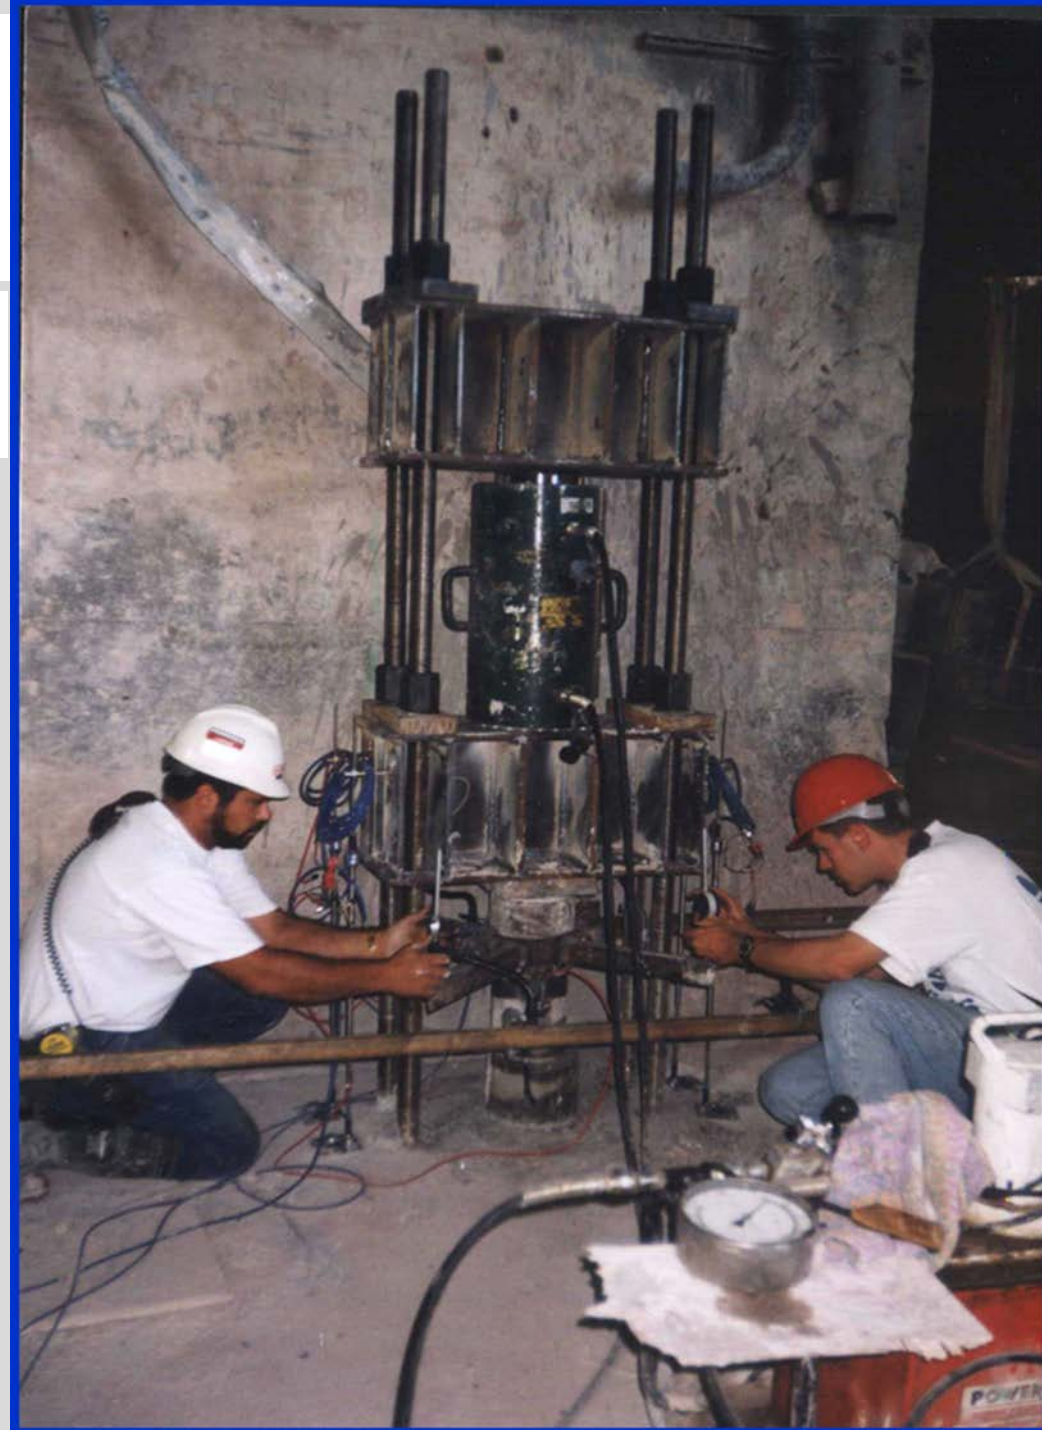
- Installation @  
MP C19, Sept.18, 1998

- Load test @ MP BB7  
August 11, 1998

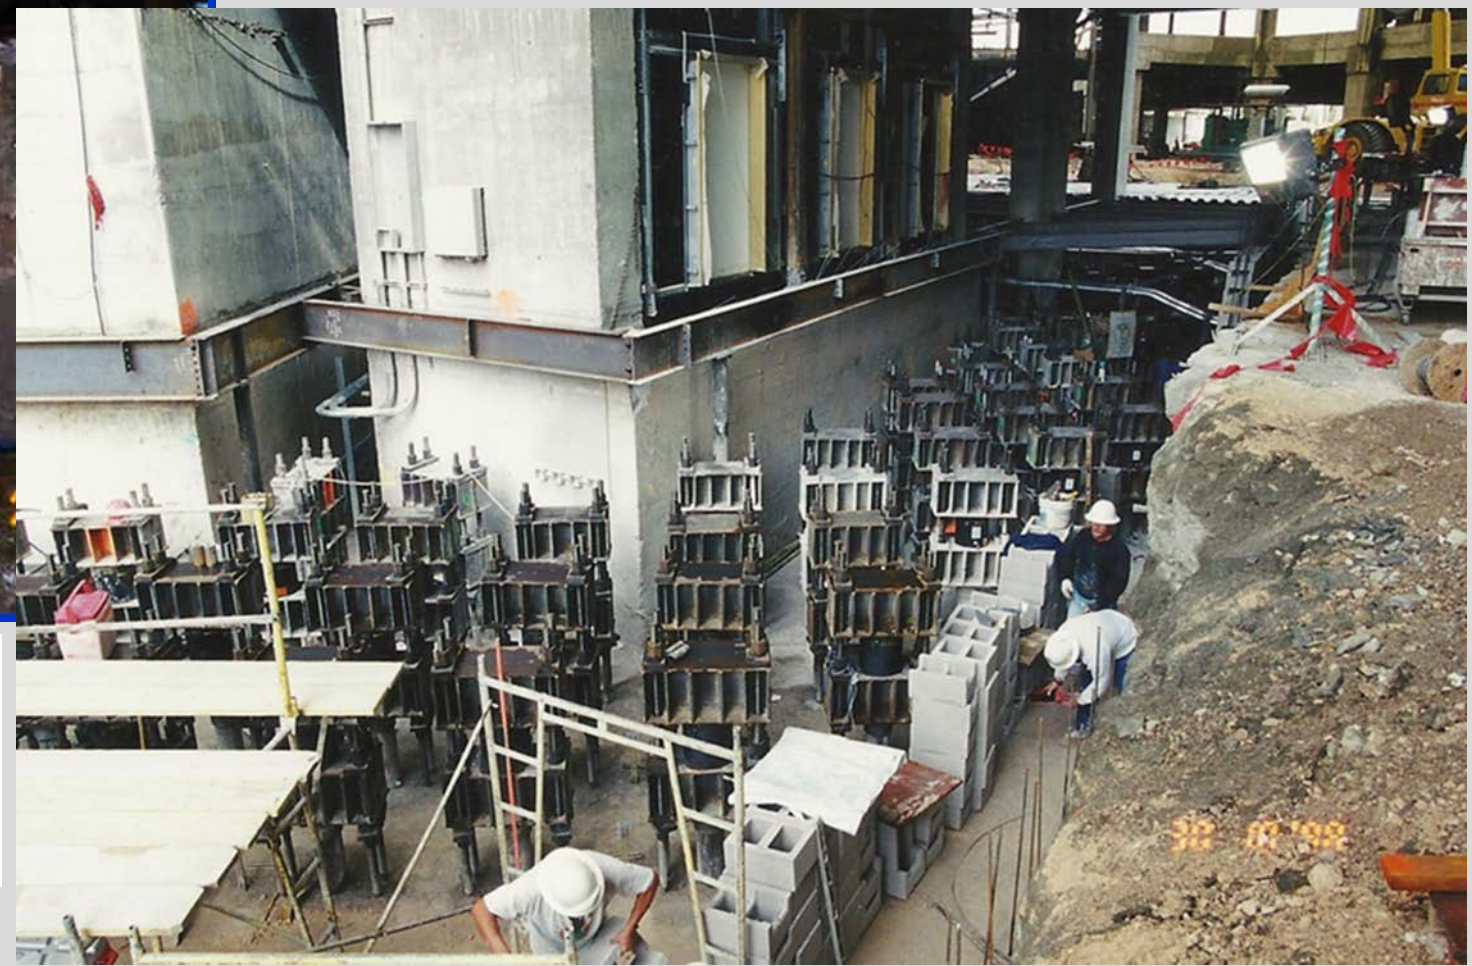
- Micropile L18  
8/27/1998

- Installation complete  
10/30/1998

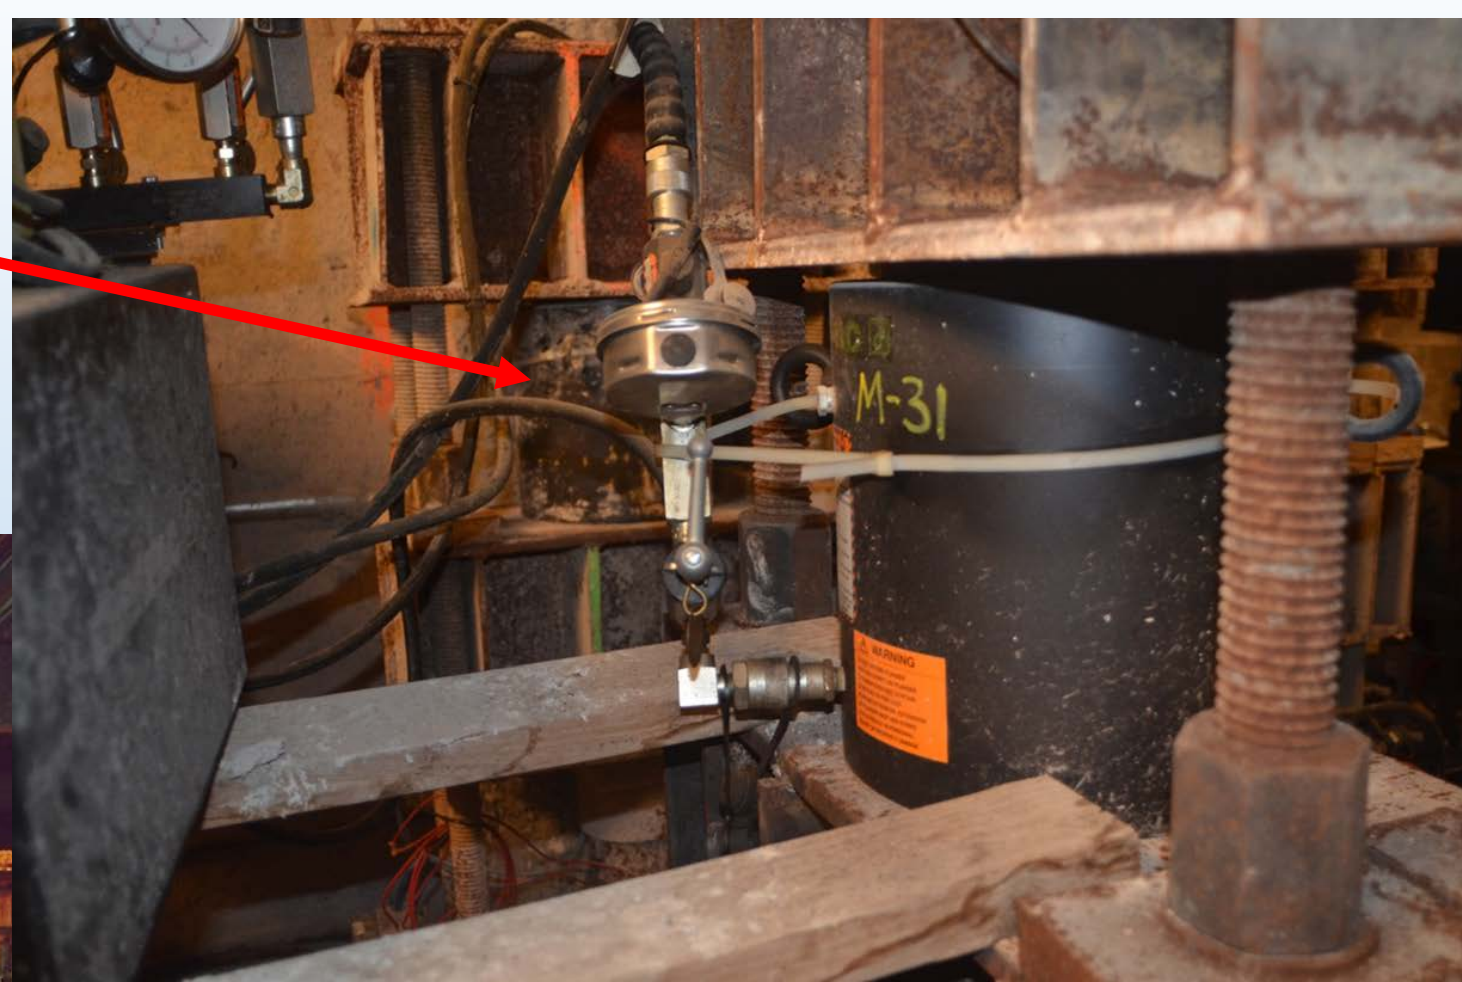
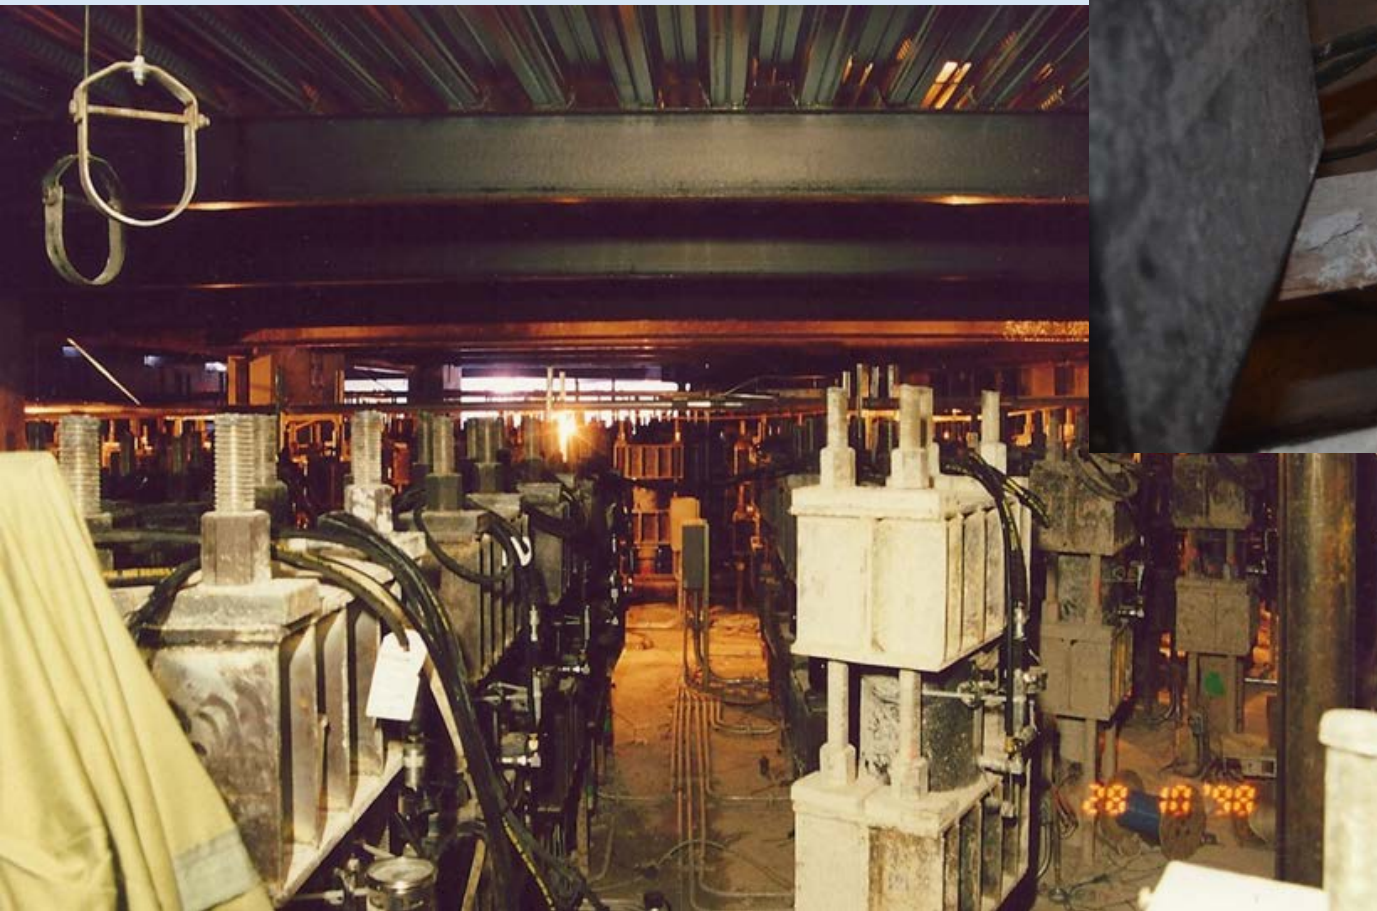
Micropile N31  
Installed 7/24/1998  
Load tested 8/4/1998  
Conditions 12/12/2013

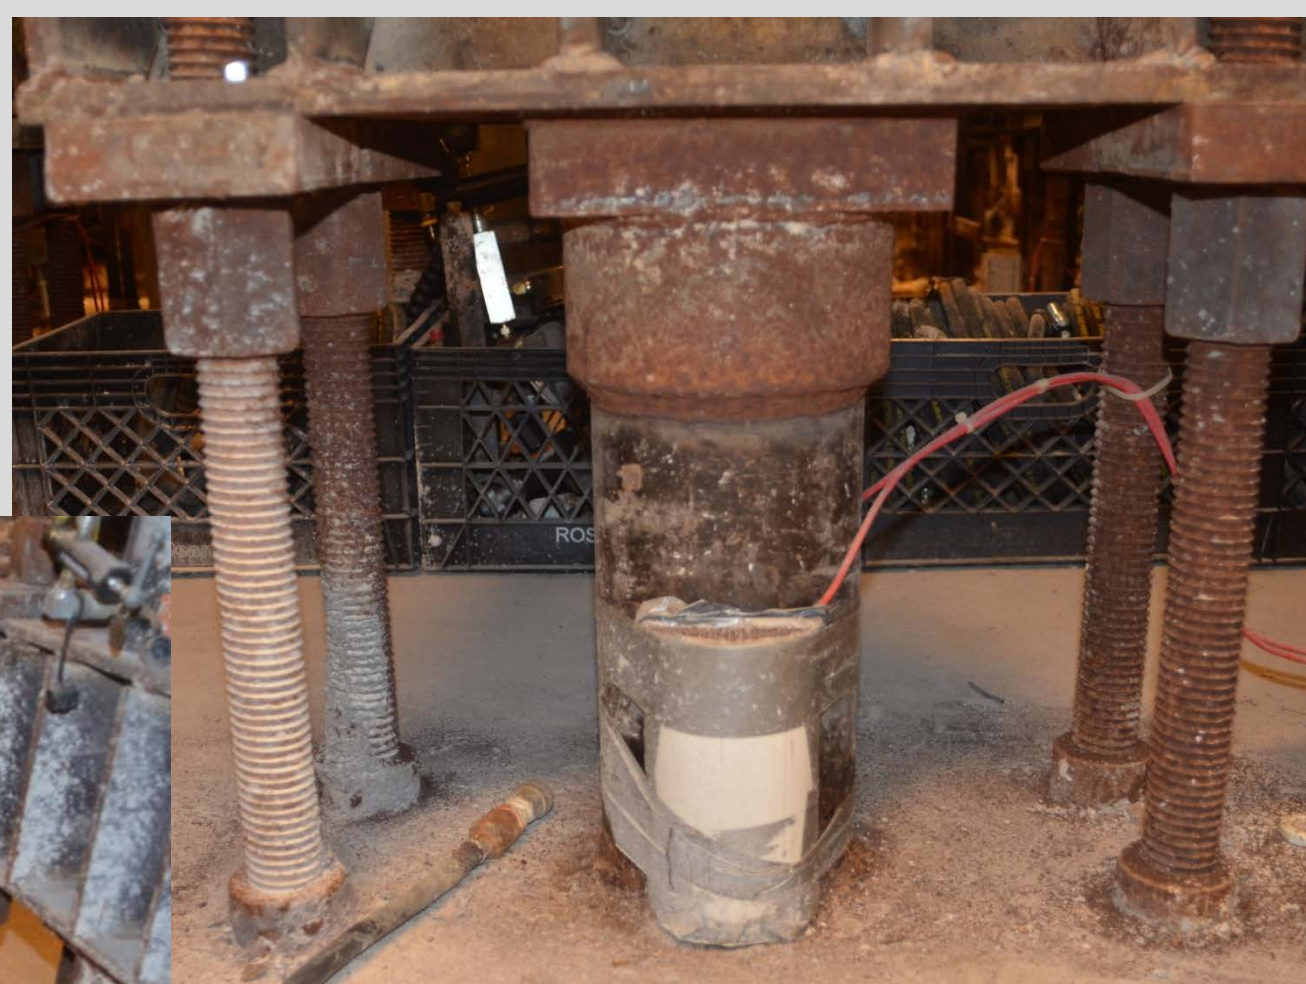
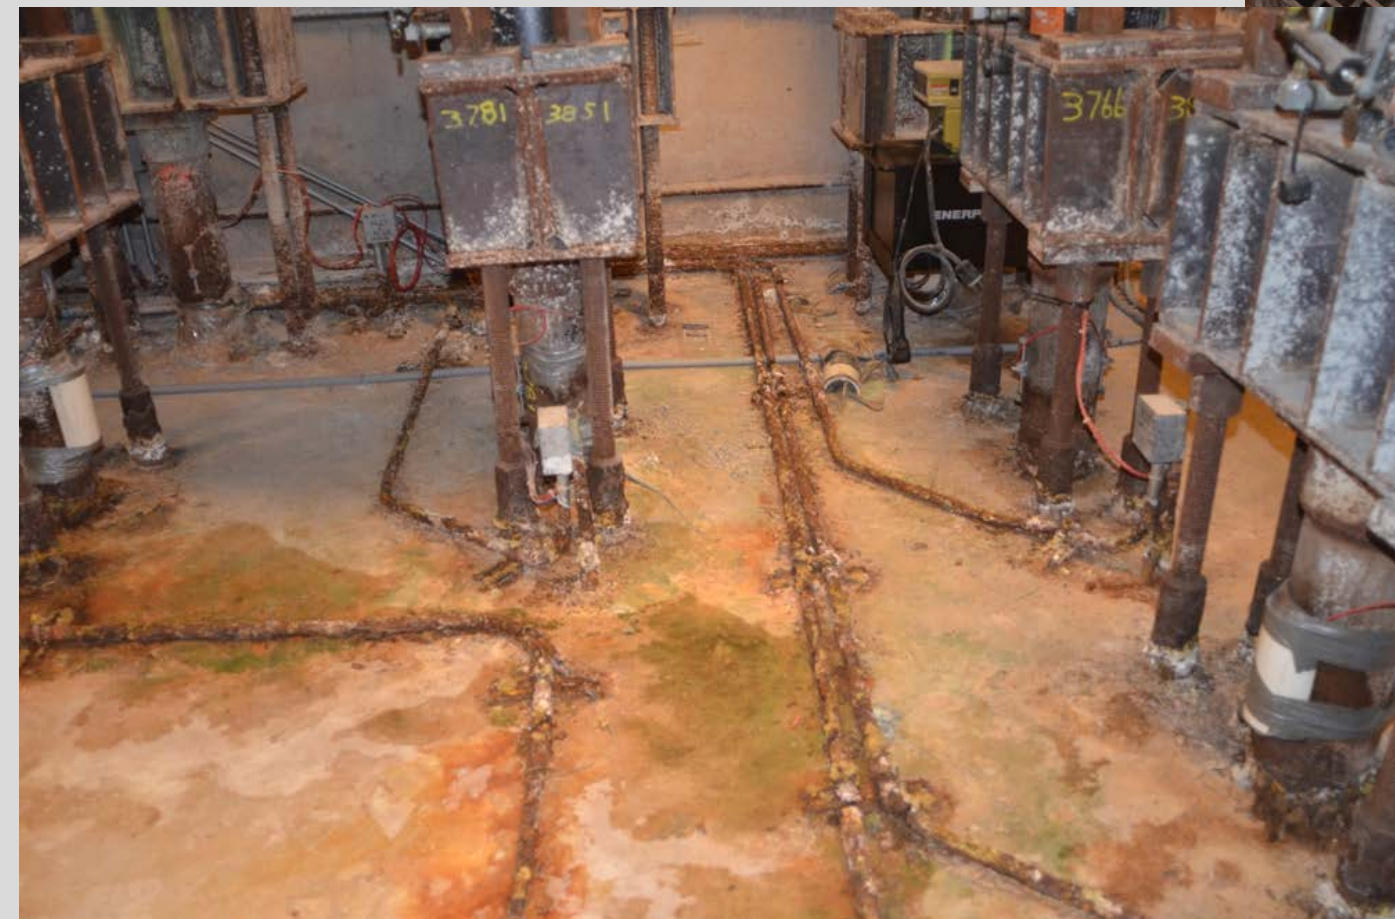
- Micropile grid lines 27 – 28 from row A (west side) 10/28/1998

- Condition at micropile grid Q32 on 12/12/2013

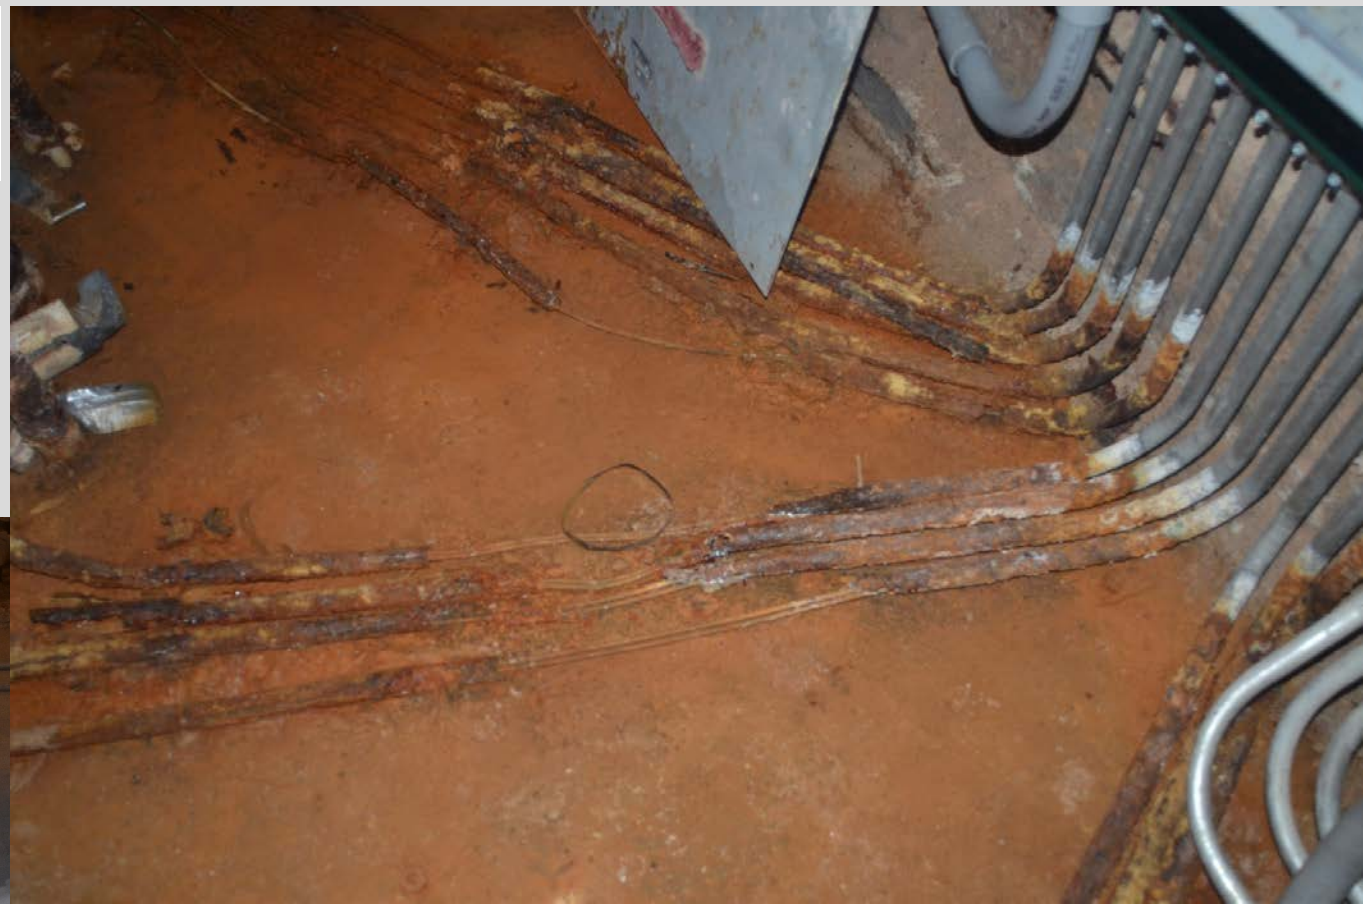
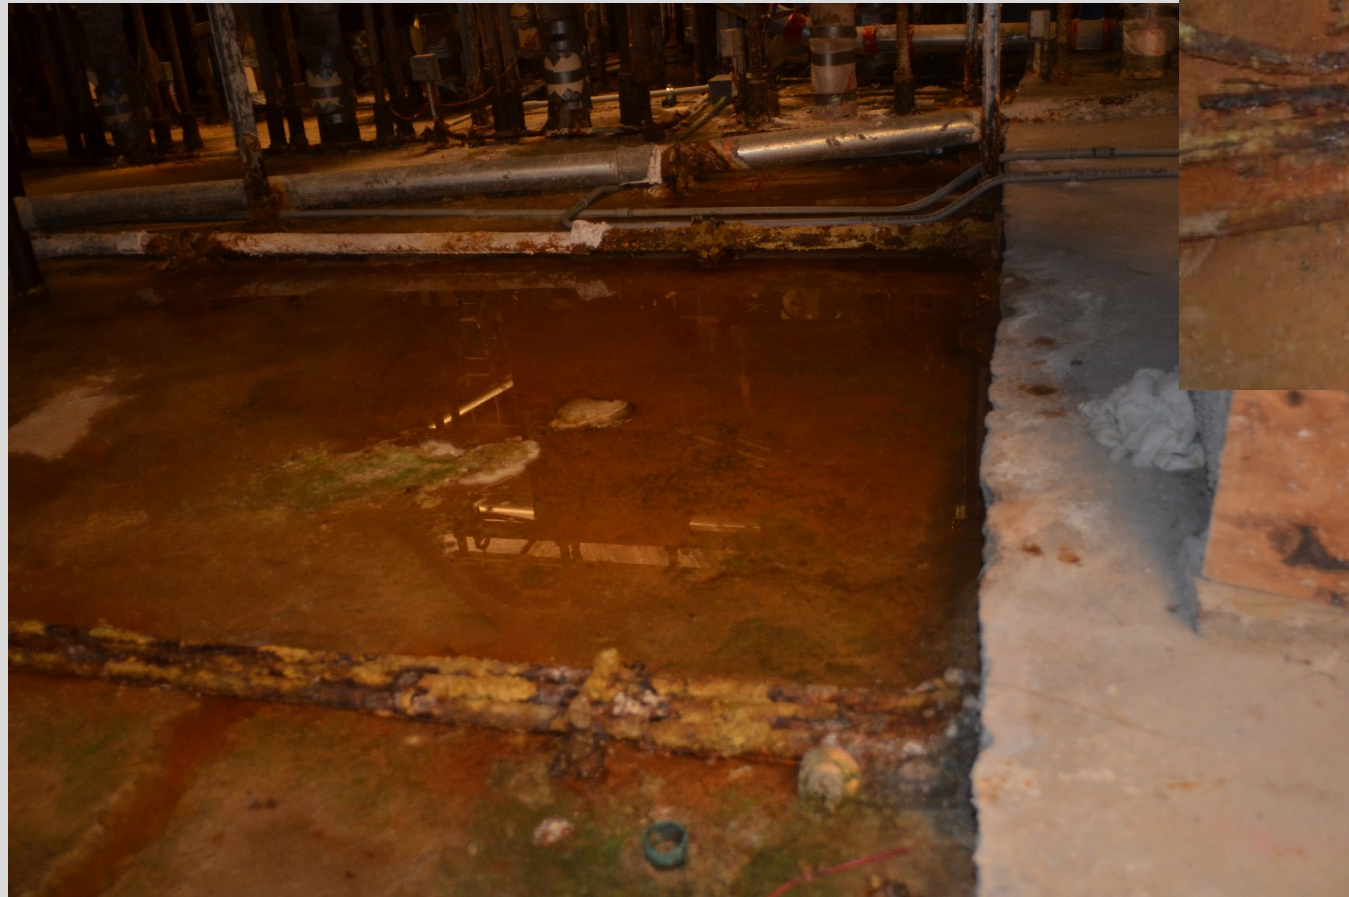
- Conduit conditions 12/12/2013 at grid lines 27 - 28

Conditions 12/12/2013 at cable box on north wall of NW elevator

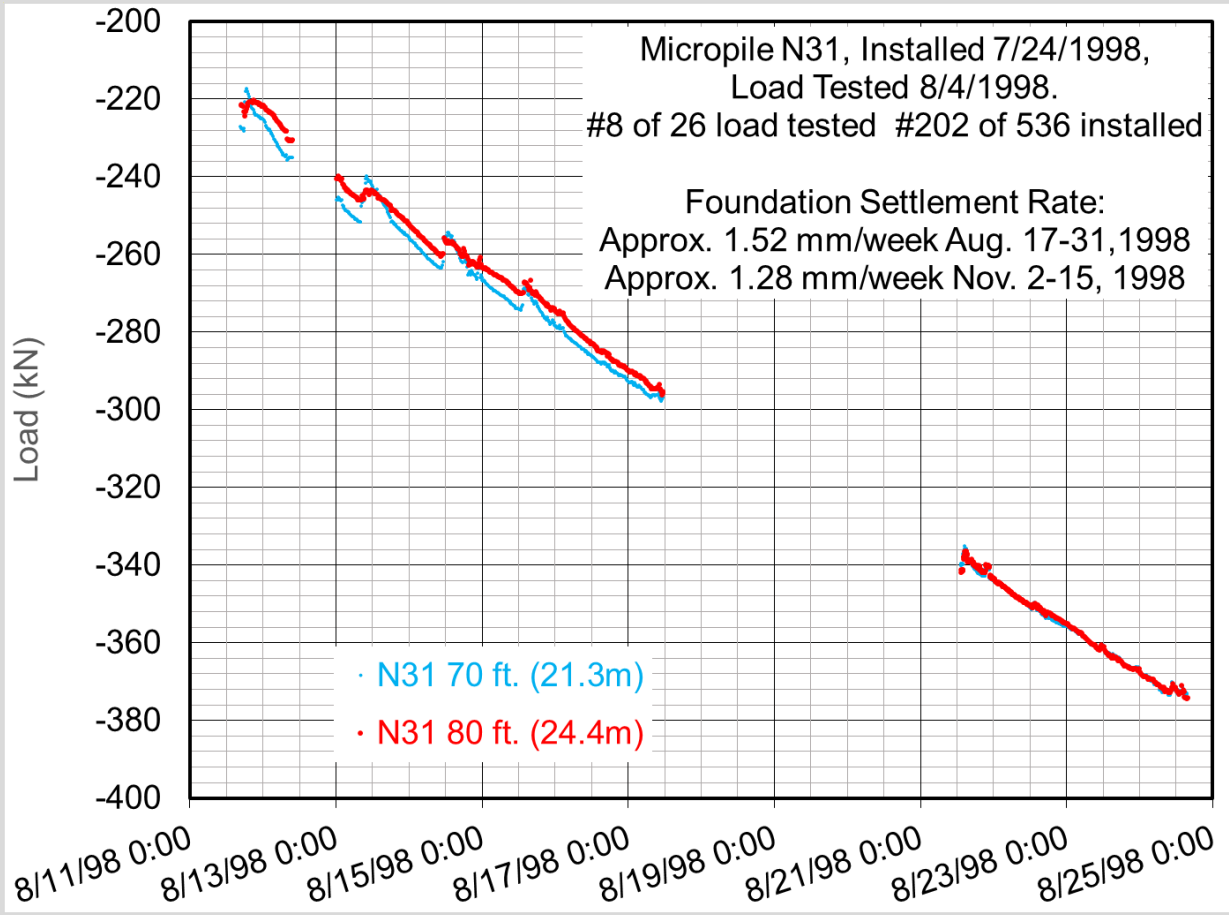
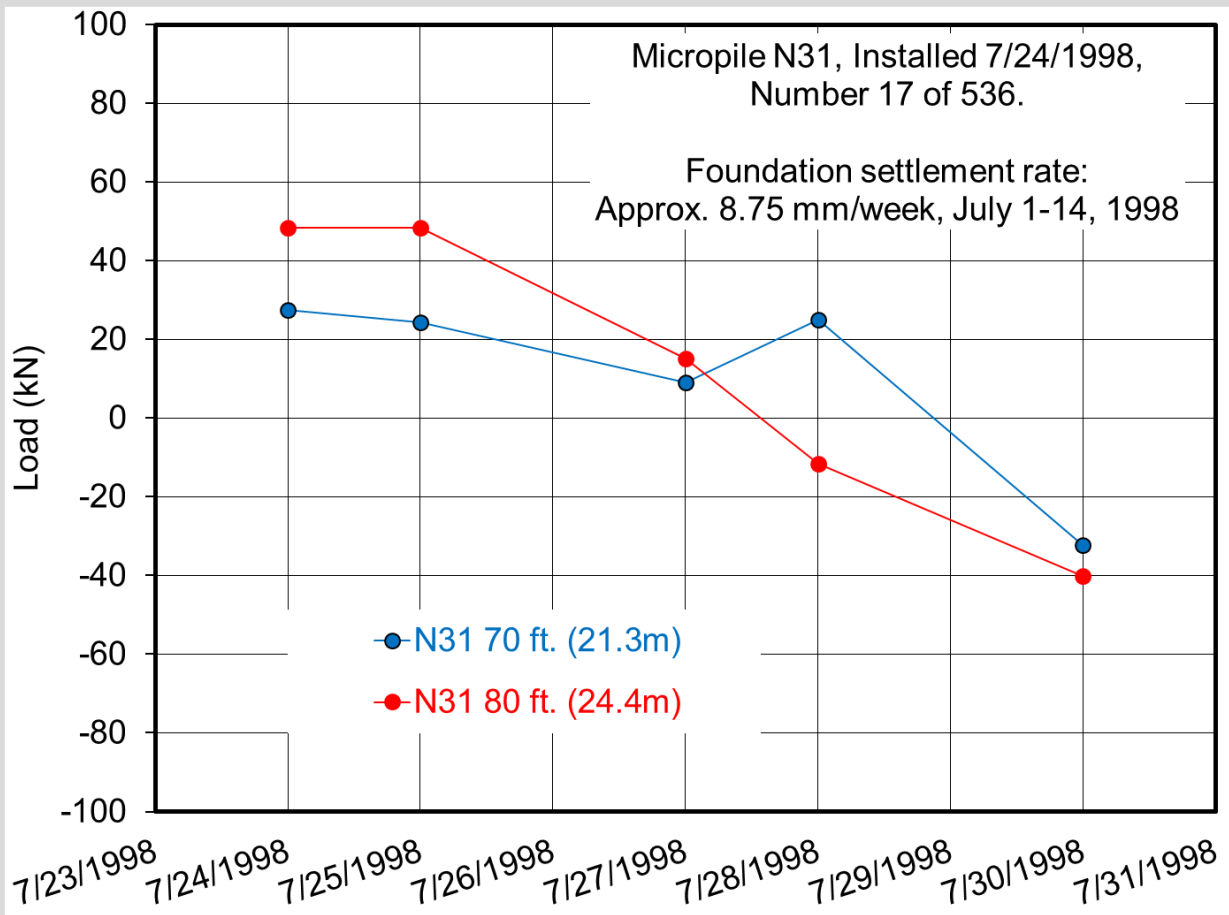
- Micropile plan, grid line J  
12/12/2013

- Micropiles began taking on load as soon as the grout set.
- Load development of approximately 15 kN/day before load test and 10 kN/day by 8/25/1998.

- Data only collected from one micropile (N31) between the load test (8/4/1998) and the 11/13/1998 load application due to site congestion.

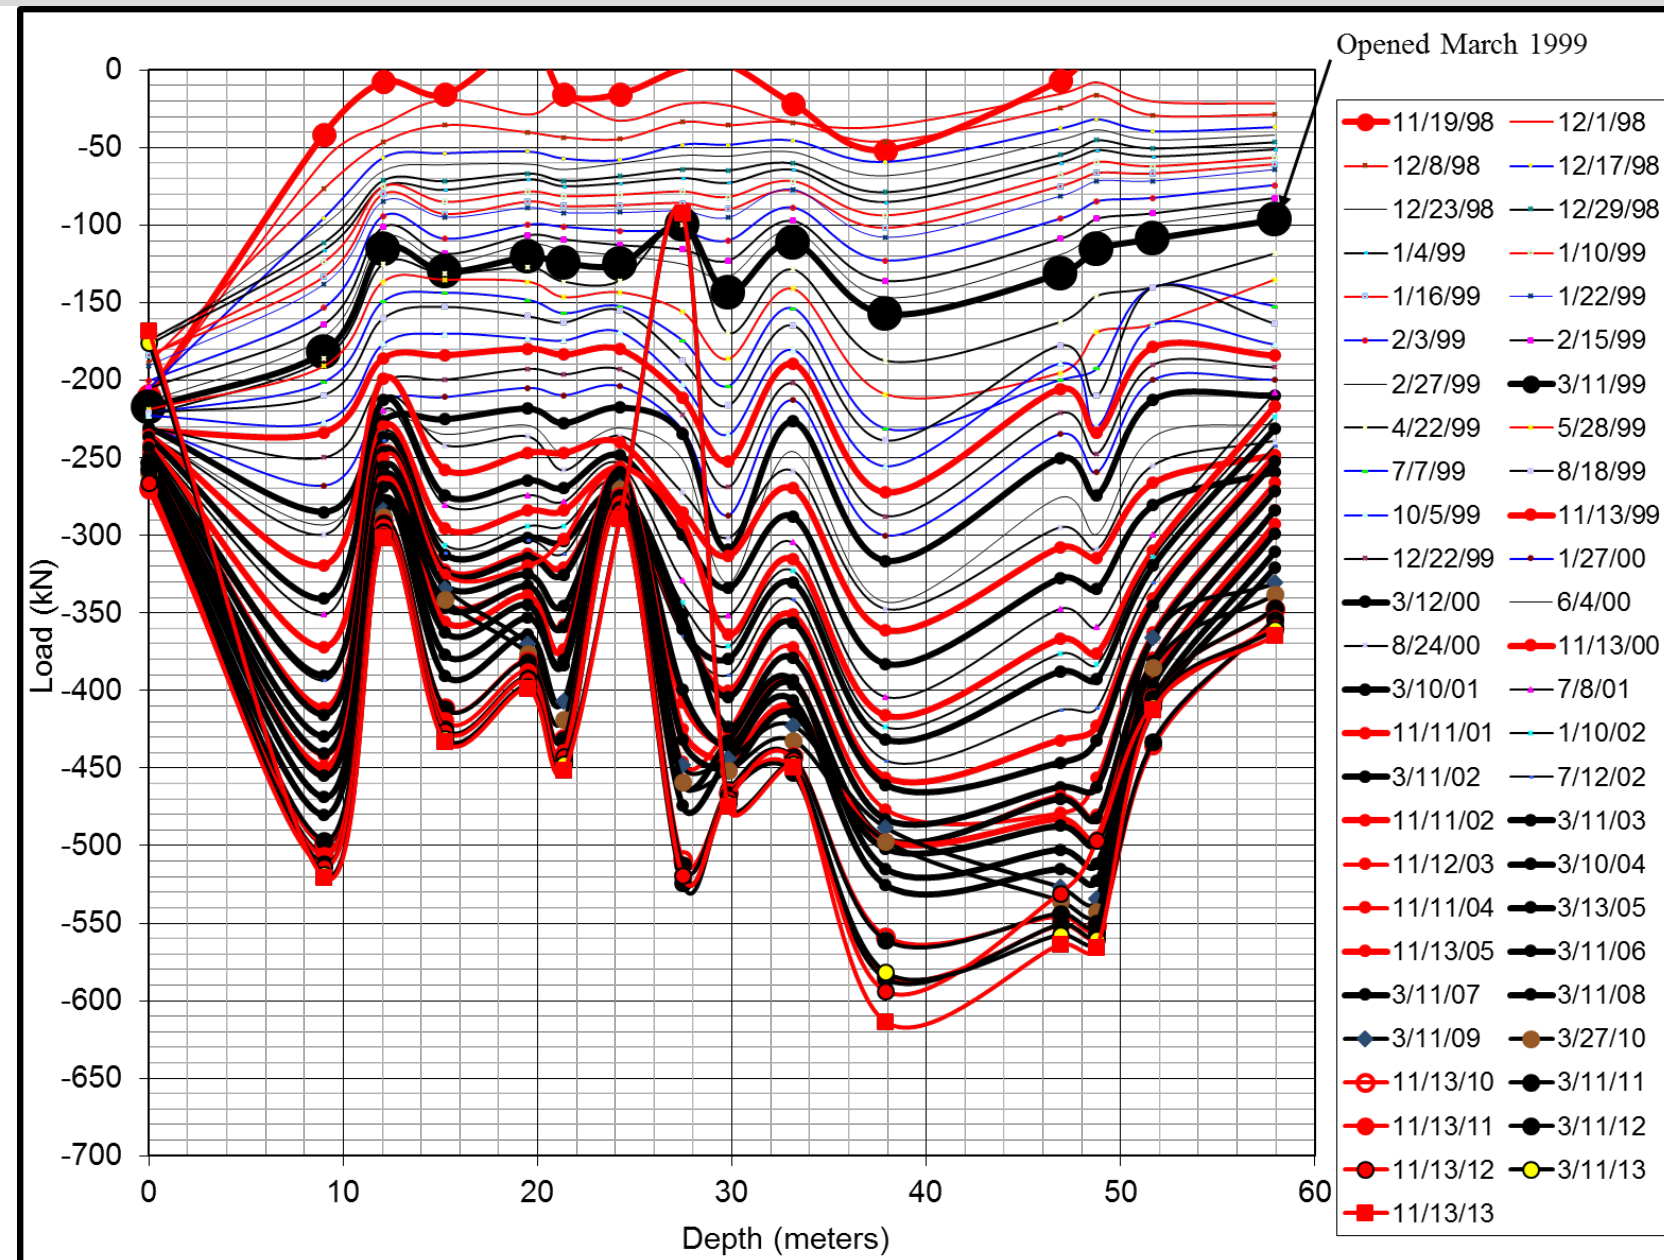
# Micropile load by depth interval in time domain

- Typical load pattern for 14 depth intervals.
- Fifty dates from the 15 year period
- November 13, 1998 load applied to top of each micropile - 222 kN/pile
- January 1, 2014 average load at top of each micropile 270 kN/pile
- Higher loads consistent with soft/compressible layers
- Lower loads consistent with cemented/strong layers

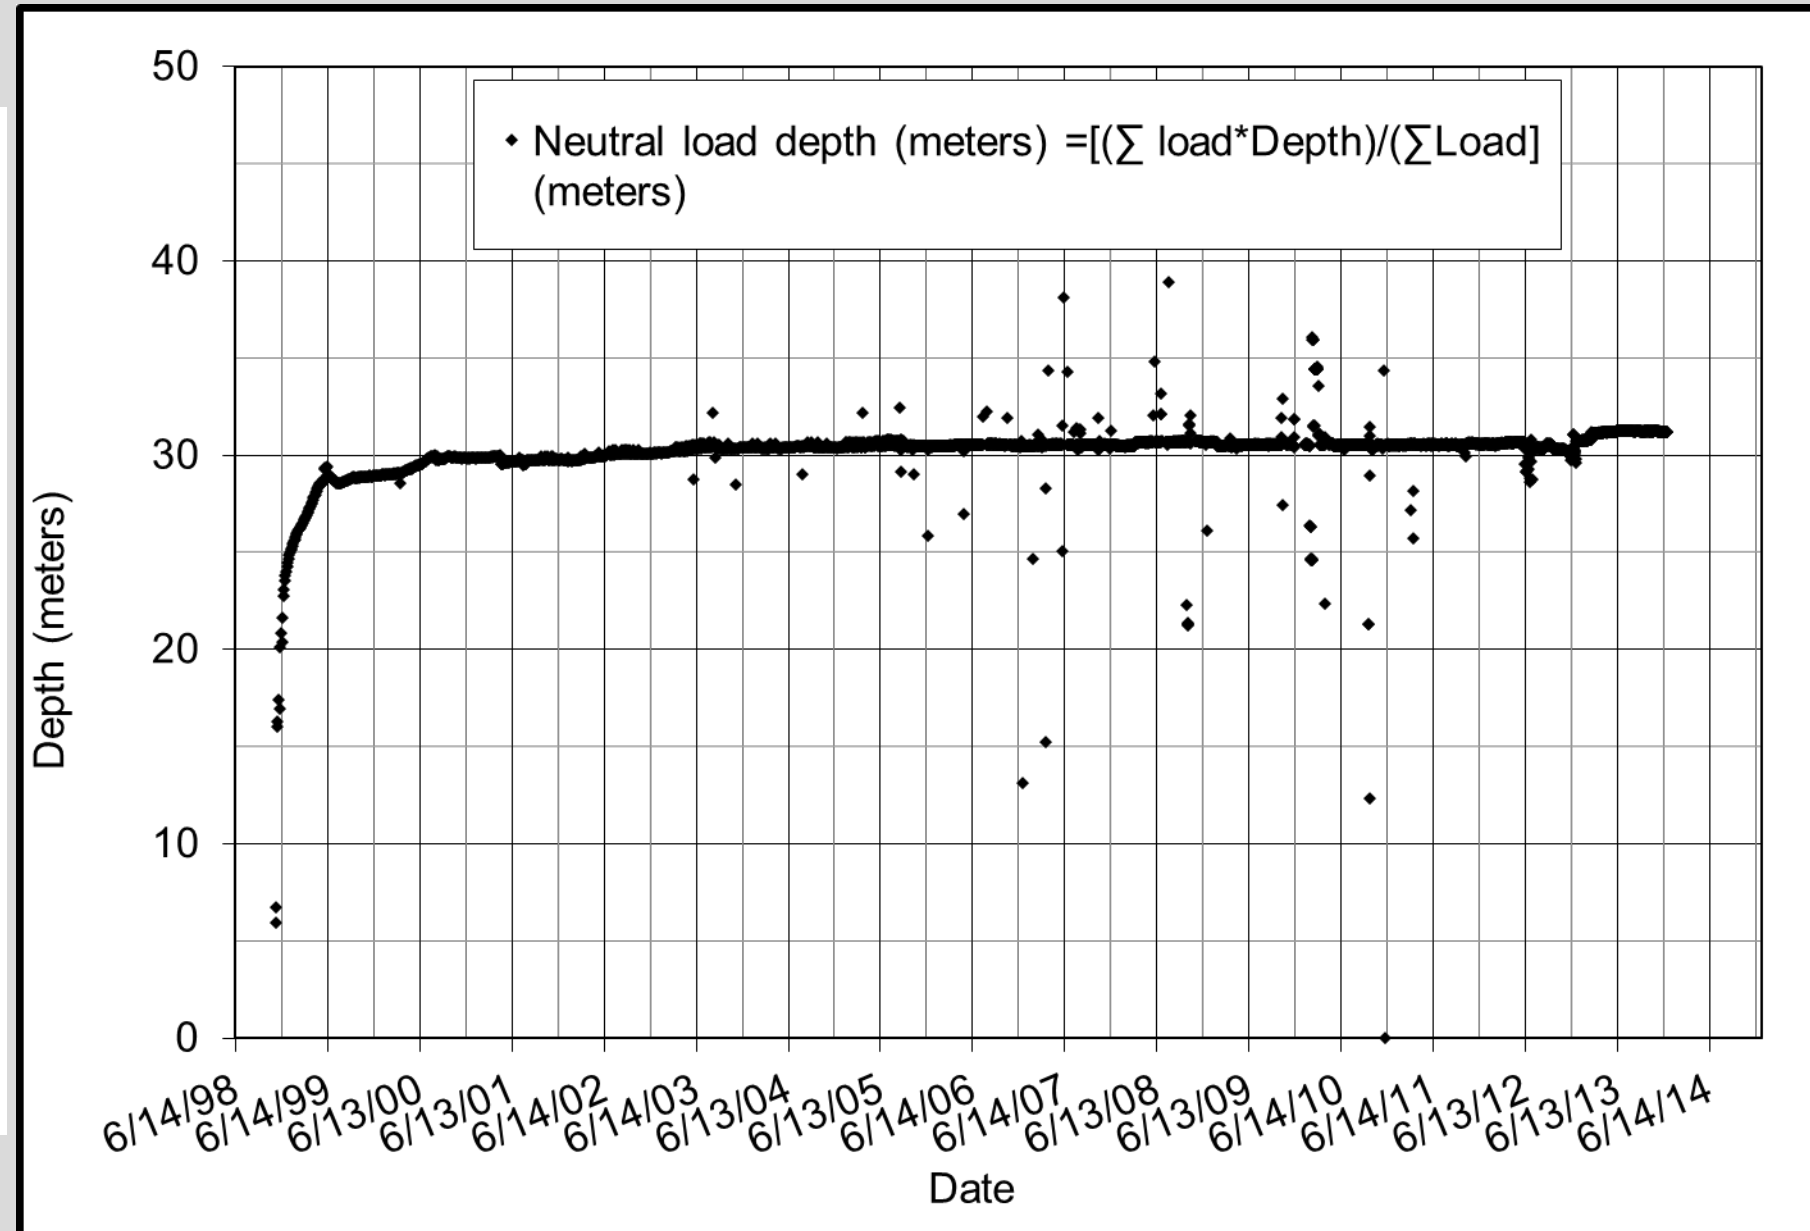
# Micropile load centroid in time domain

- Daily observations  
11/13/98 to  
12/28/2012
- Pile load migrated  
down the piles  
from 11/1998 to  
6/2000
- Load centroid depth  
has remained nearly  
constant for past  
14 years
