# **Micropile Performance and Durability**

**A fifteen year record of monitored micropile  
response to sustained static load**

# ISM 2014 Krakow, Poland

Walter E. Vanderpool  
P.E.

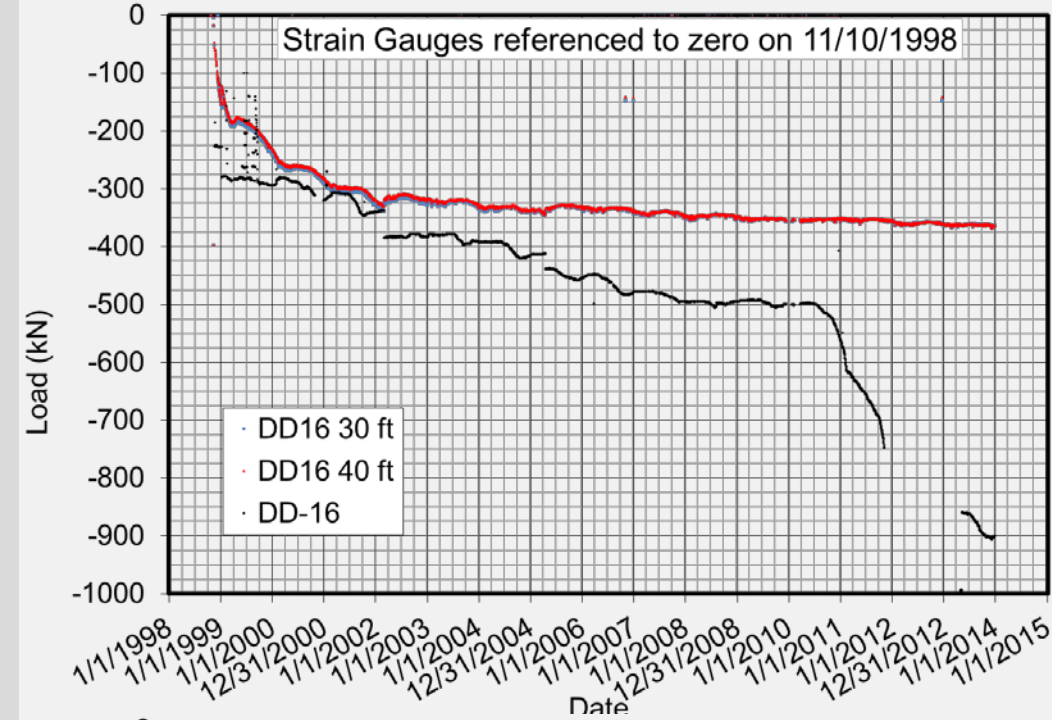
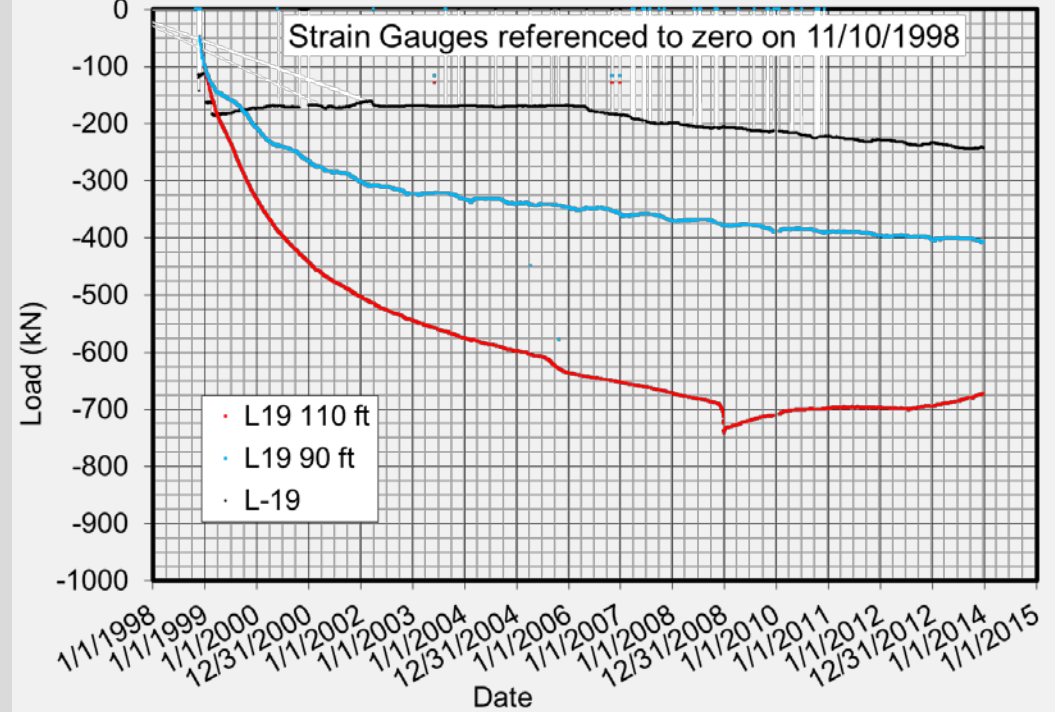
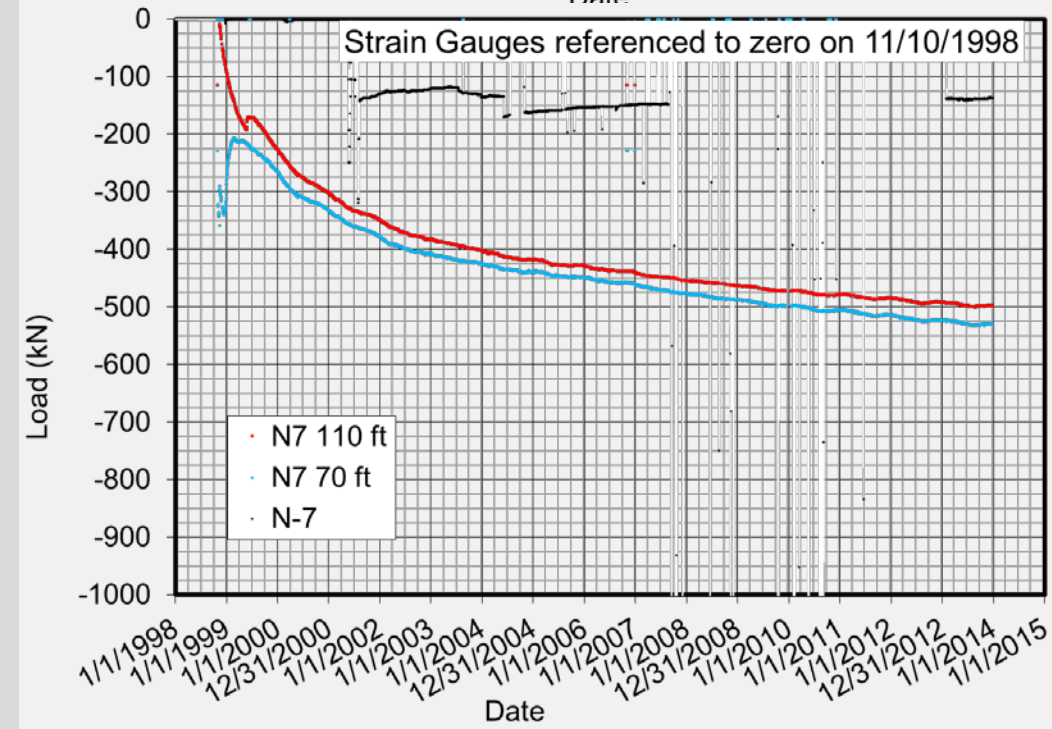
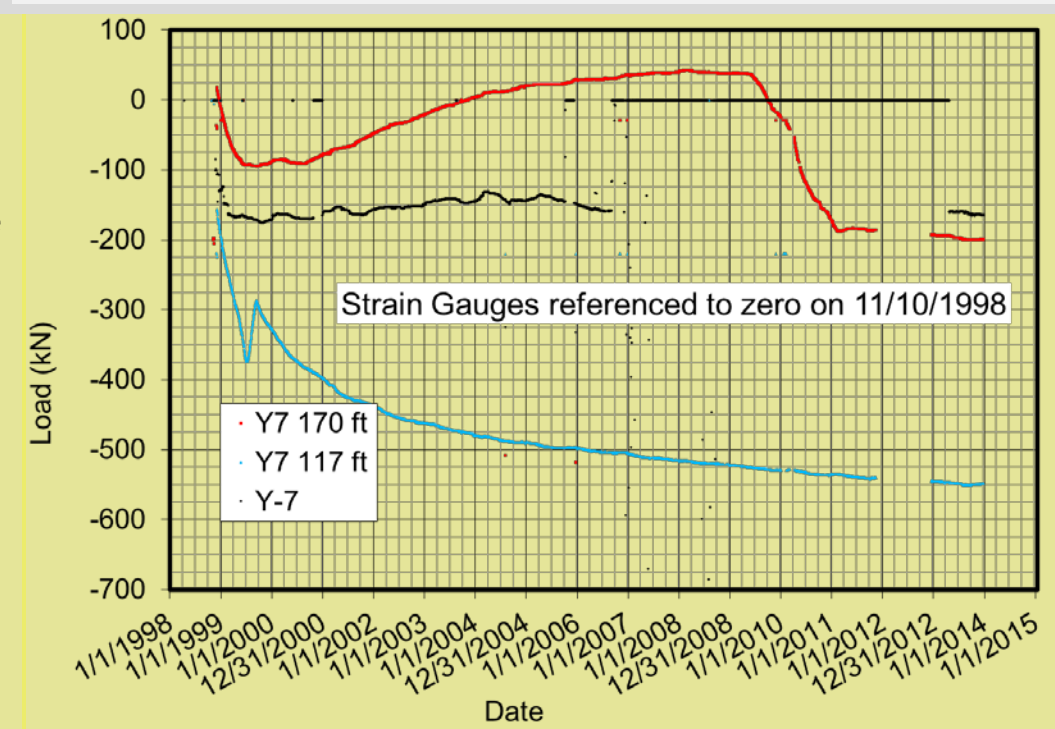
Implied tension based on the gauge zero reference established 11/10/1998
