Design of High-Capacity Micropiles for 2,900-ft Long Caracas-La Guaira Viaduct

Jesús E. Gómez, Ph.D., P.E., D.GE, Antonio Martin Fossa, Ing.

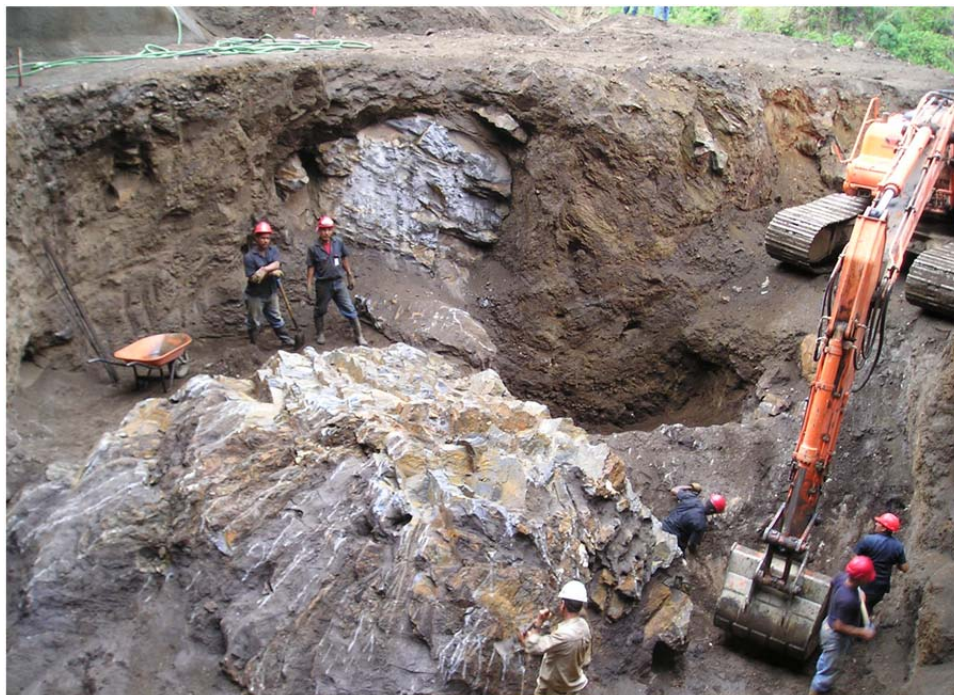
from soft to very hard. It is not uncommon to see very hard Quartzite intervals overlying softer and solutioned Calcareous Schist. Figure 3 is a view of an excavation at the site depicting the typical ground conditions.

Figure 3. Ground conditions uncovered in an excavation for pilaster foundation.

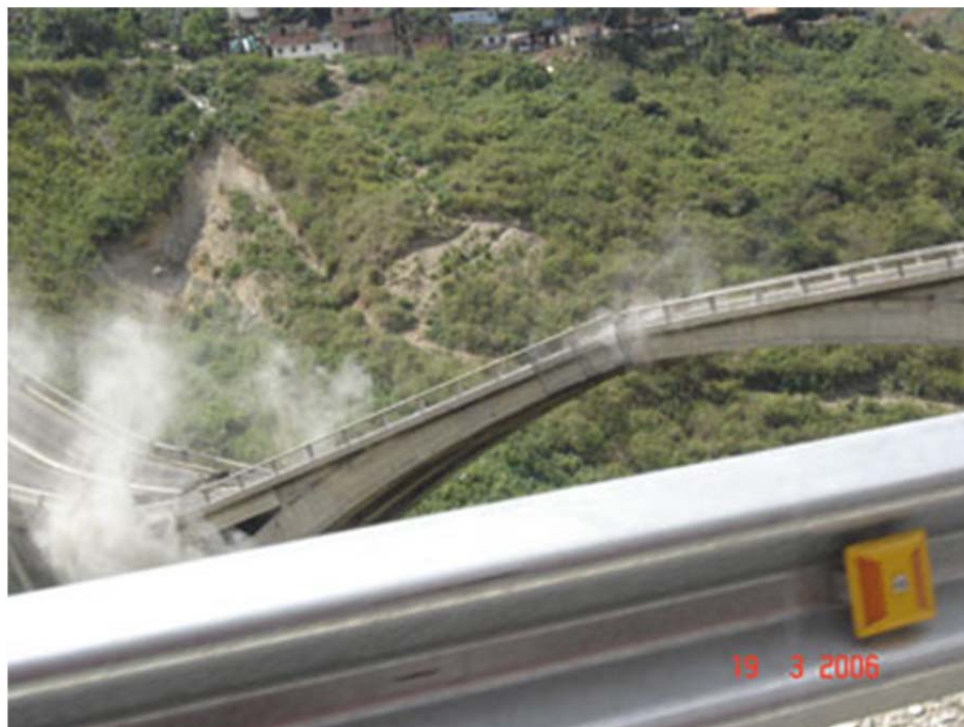
Figure 5. Moment of collapse. Photo by A. Fonseca.

The viaduct finally collapsed on March 19, 2006, two months after the viaduct had been shut down to vehicular and pedestrian traffic. During the time leading to the collapse, a temporary, alternate roadway winding to and from the bottom of the ravine had been constructed to permit vehicular traffic, which presented heavy congestion throughout the day. Figure 5 is a photo of the viaduct during its collapse snapped by a beachgoer. Figure 6 is a view after collapse of the viaduct.

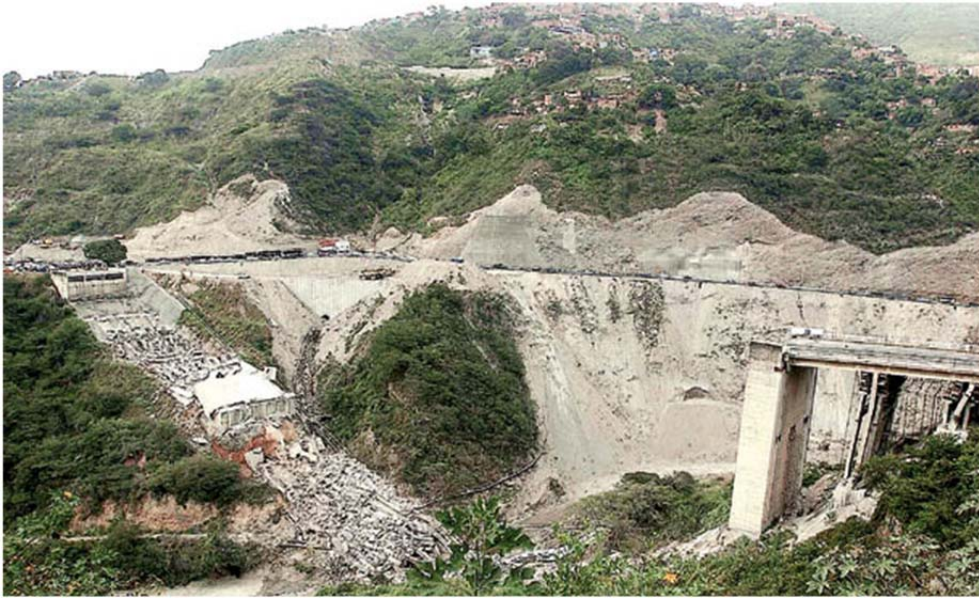
Figure 6. Viaduct after collapse.

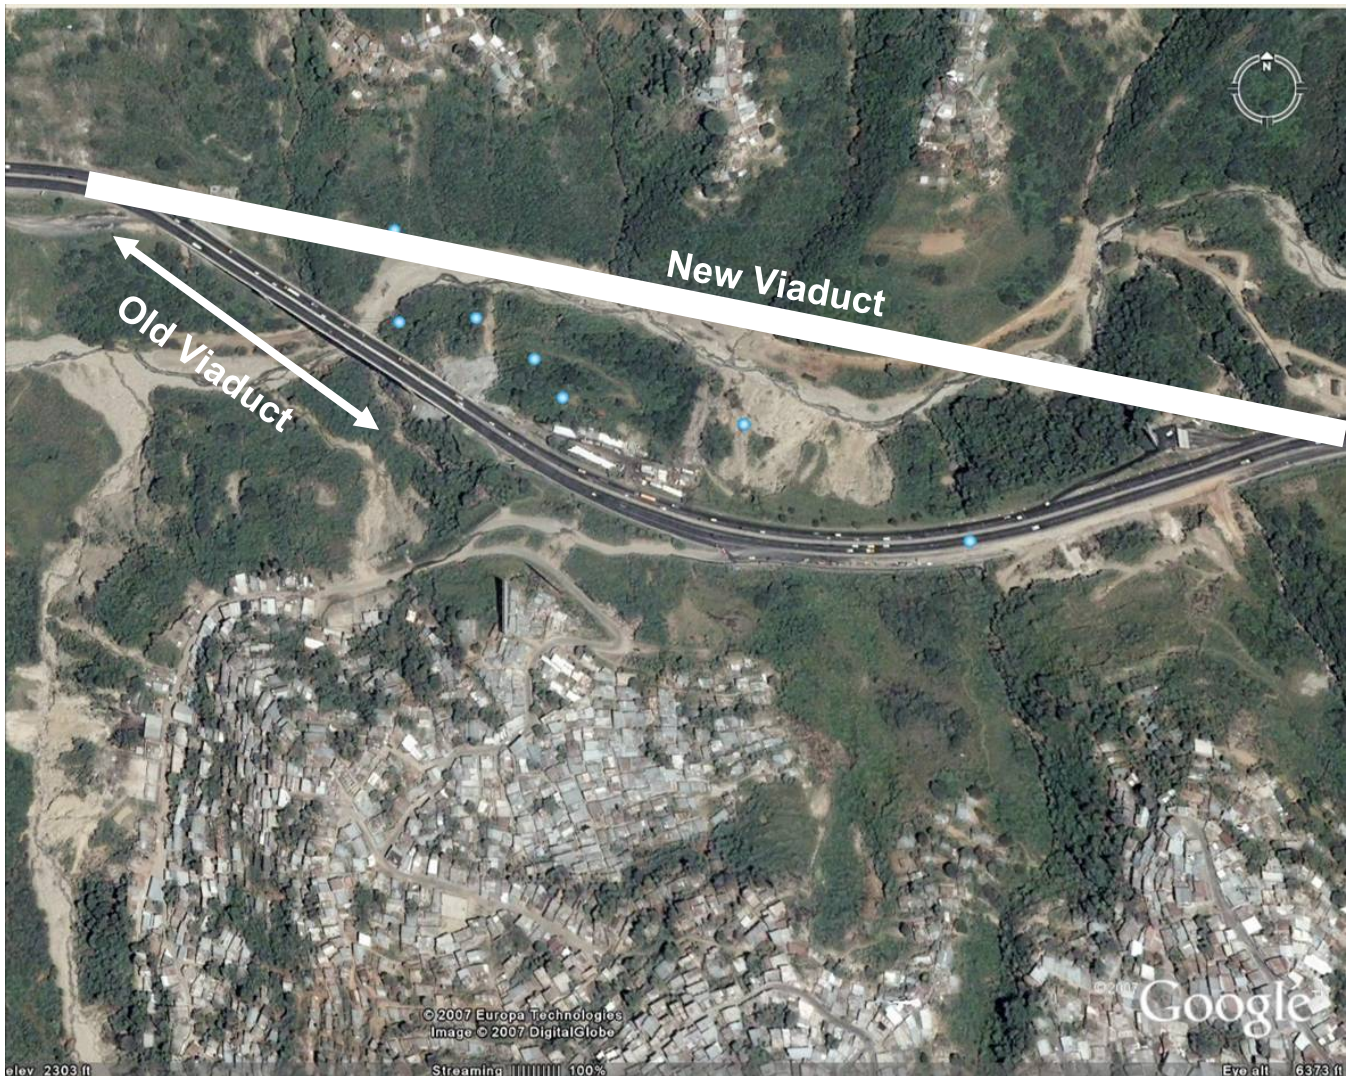
The new viaduct is approximately 803 m (2,675 ft) long and bypasses the unstable landslide area that caused the collapse of the original viaduct. The structure is supported on seven “hammer head” pilasters reaching a maximum height of 61 m (203 ft) measured from the top of the foundation to the top of the pilaster and not including the 4-meter (13.1 ft) tall hammer head (Figures 7 and 8).

Figure 7. Alignment of New Viaduct.

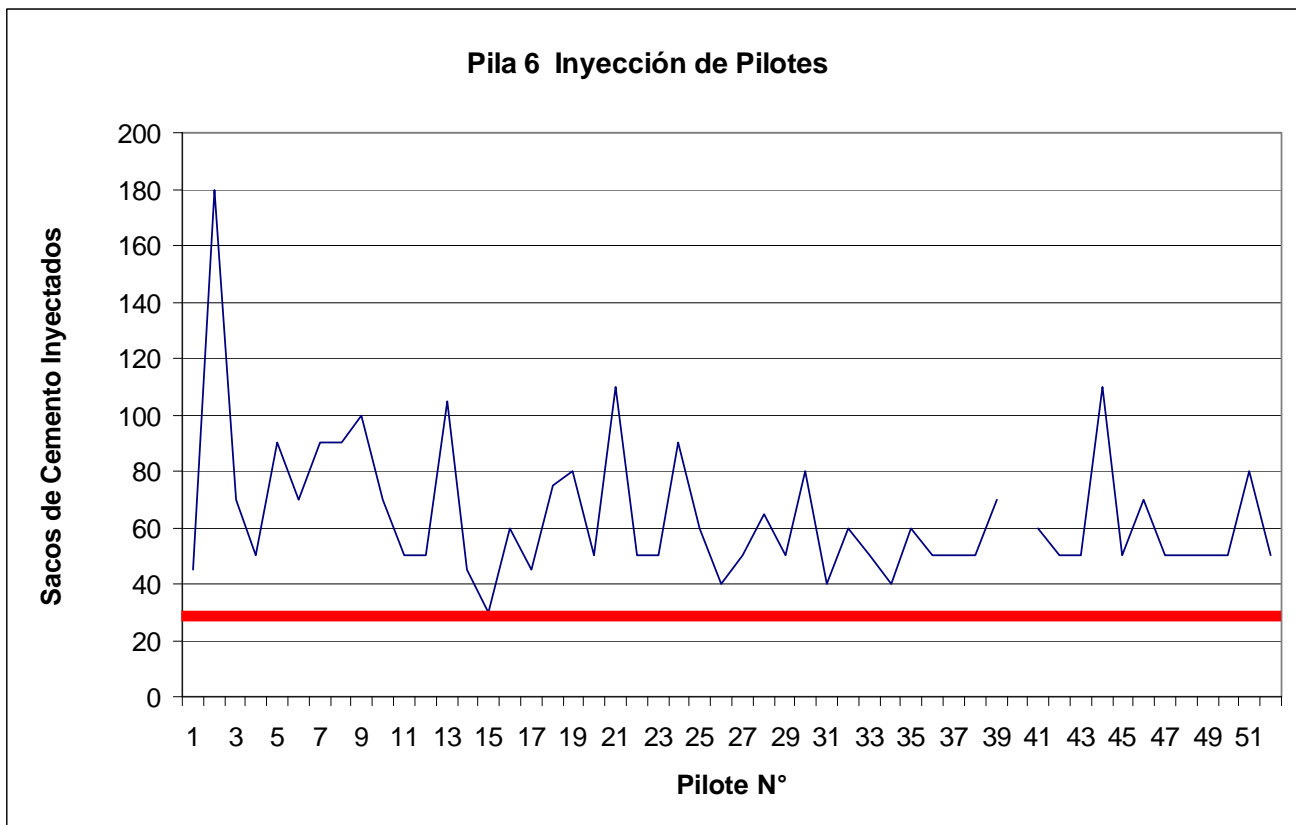
Figure 10 shows the grout take volumes measured at one pilaster location. It is seen that the grout take was larger than theoretical due to the fracturing and open voids within the rock; however, the grout volumes were relatively consistent among micropiles.

Figure 10. Grout take in bags of cement per micropile in Pilaster 6. Red line is the theoretical grout take.

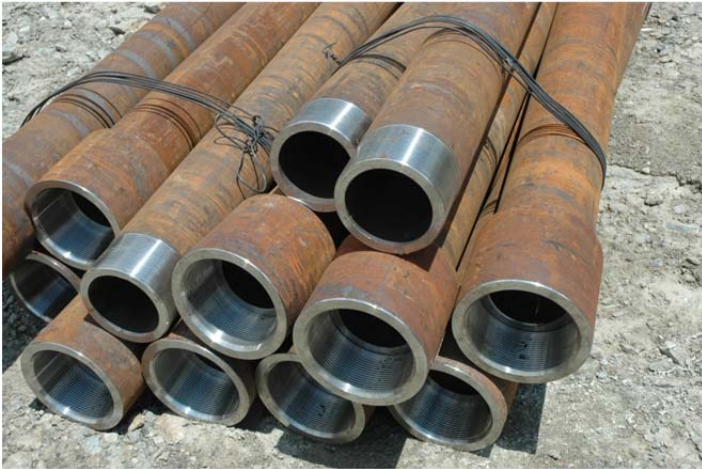
Immediately after grouting of the hole, the reinforcing casing was installed into the fresh grout. Figures 11 and 12 show various features of the micropile materials and installation.

Figure 11. Casing used as micropile reinforcement.

The casing steel had a minimum $F_y = 530$ MPa (73 ksi). The casing had an external diameter of 177.8 mm (7 in), and a wall thickness of 20 mm (0.787 in). It provided most of the axial compression capacity and the entire axial tensile capacity; thus, a central bar was not required. The casing was installed in sections spliced by the use of an external threaded ring with cross sectional steel area slightly greater than the area of the casing steel. This type of connection is not typical in the United States, where flush male-female threaded connections are preferred because the permanent casing is often used as drill casing as well.

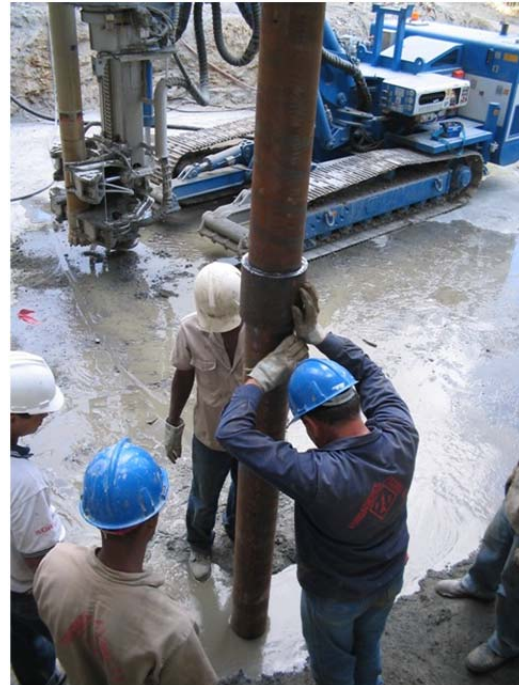
Figure 12. Installation of casing in grout-filled hole.

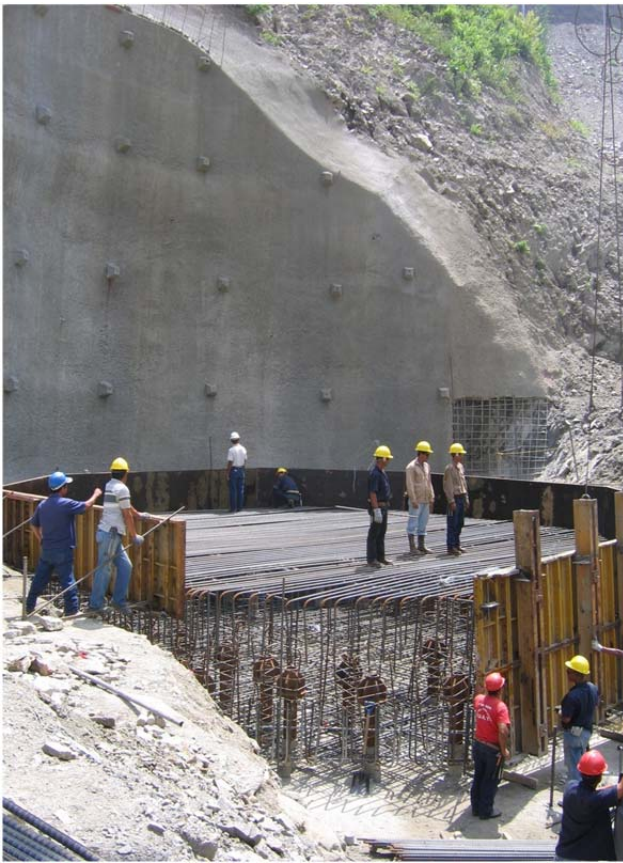
Figure 14. View of pile cap construction.

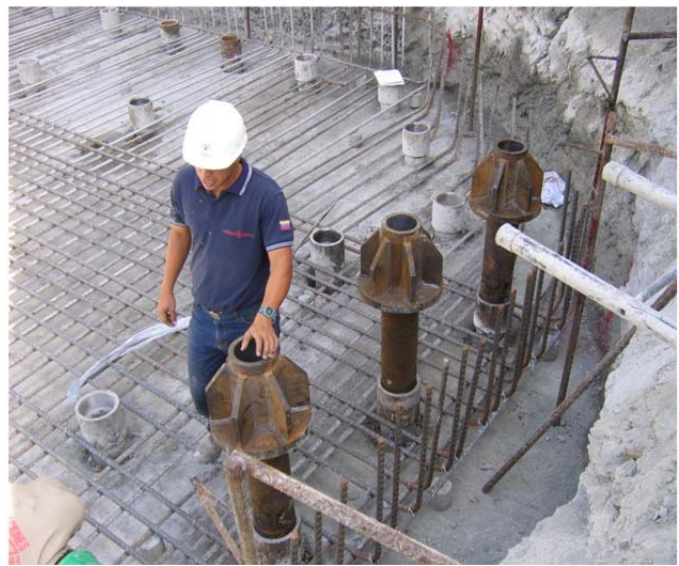
The micropiles were connected to the pile cap through a special head designed by the structural engineer. This special head consisted of a short section of casing identical to the micropile casing that could be threaded to the top of the micropile. Thus, the casing of each micropile at the cutoff elevation was terminated with a threaded end and the splicing ring ready to receive the connection head. The head was fitted with a relatively thick plate and stiffeners as depicted in Figure 13, designed to withstand the design compression and tension forces.

Figure 15. Connection of micropile-to-pile cap.

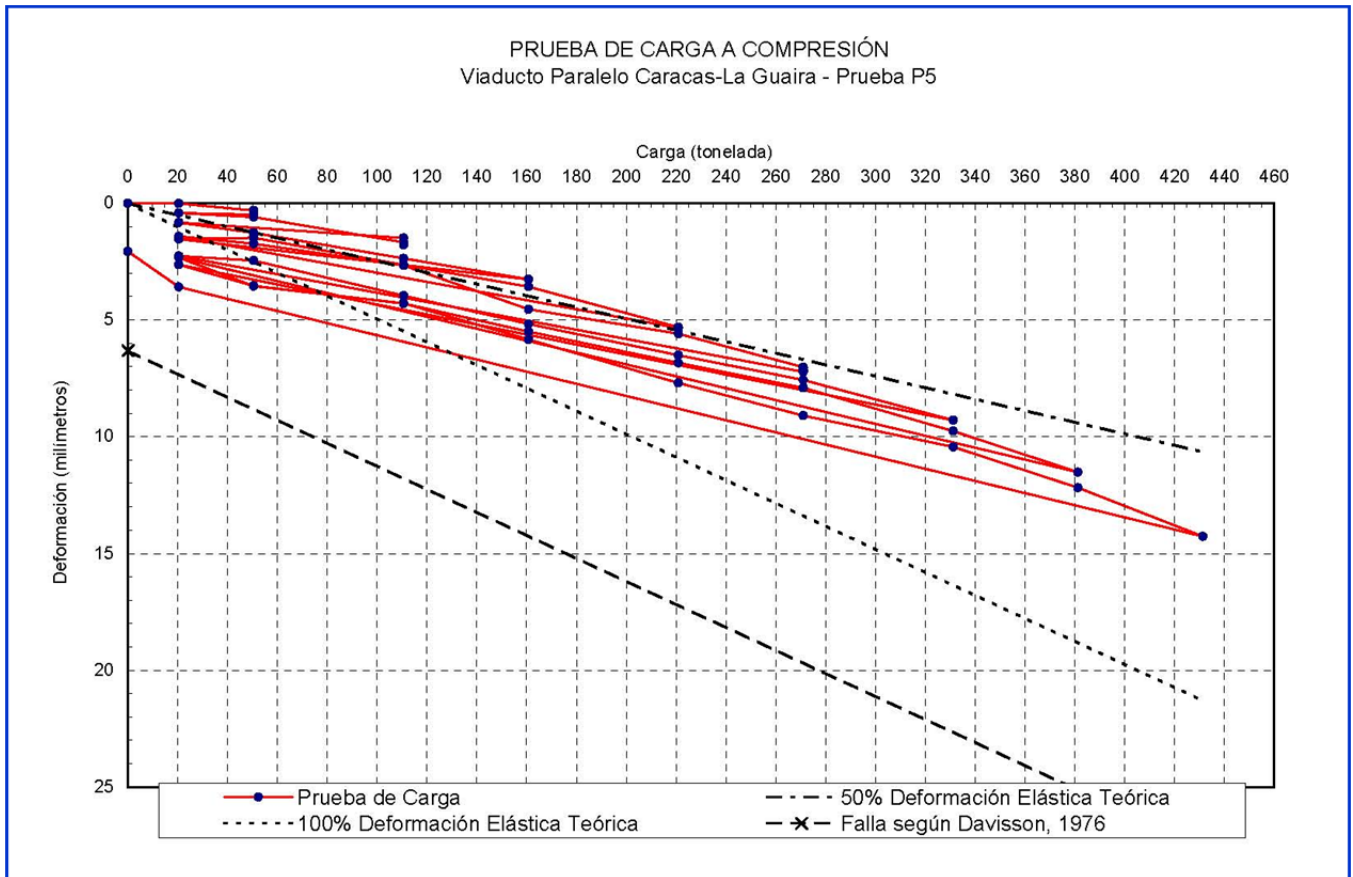
The load tests were carried to a maximum load of 430 metric tons (947 kip). This load was ten percent higher than the calculated nominal compression resistance of the micropiles and corresponded to twice the ASD-calculated allowable structural compression capacity of the micropile. None of the tests reached structural or geotechnical failure. The vertical deflection of the test micropiles ranged between 14 and 22 mm (0.55 and 0.87 in) under the maximum compression test load (see Figure 16).

Figure 16. Results of one micropile load test at the site. Loads in metric tons and deflections in mm (1 metric ton = 2.2 kip, 25.4 mm = 1 inch).

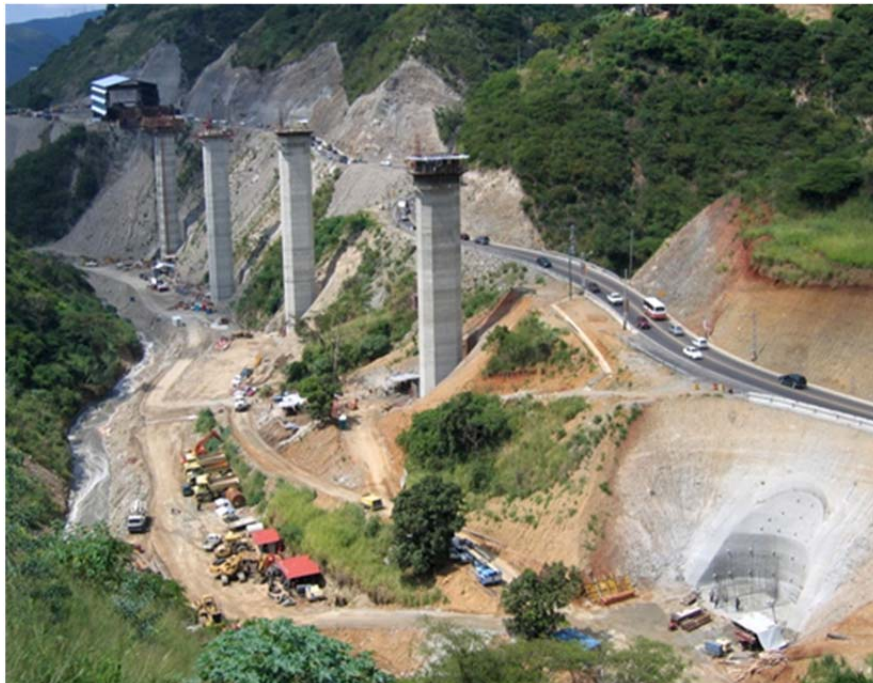
Construction of pile caps, pilasters and upper structure closely followed the advancement of micropile installation as depicted in Figure 17. The structure advanced from the northern abutment, which was the launching site for the bridge girders. The pilasters were constructed using four hydraulic formwork systems that would permit continuous concrete pouring as the formwork slid vertically. The average rate of advancement was 200 mm/hour (8 in/hour). The verticality and twist of the formwork were controlled using lasers.

Figure 17. Simultaneous foundation, pilaster, and girder installation.

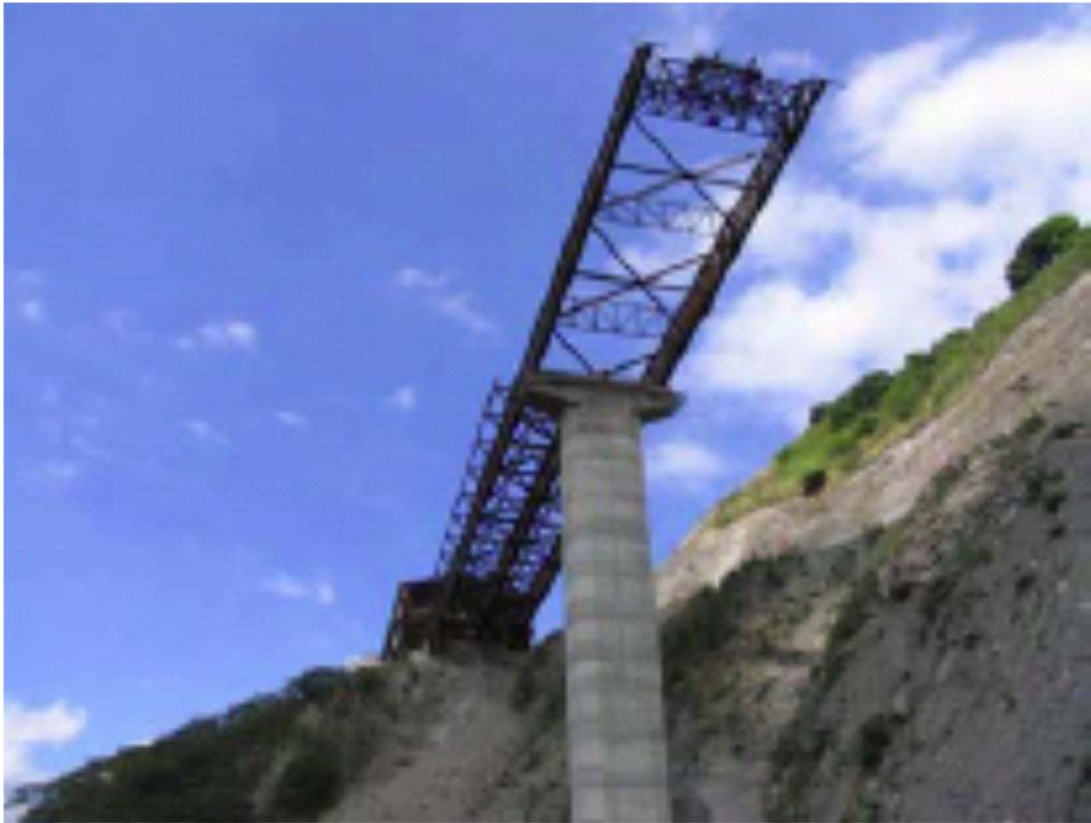
The girders were built-up sections fabricated off site in the industrial city of Puerto Ordaz, and transported in 20 m (65.6 ft) segments via cargo ship to the Port of La Guaira, where they would be loaded on trucks for transport to the site. Once the initial girder segments were spliced and laced together at the fabrication shop on the southern abutment, they were fitted with a leading truss and launched using hydraulic jacks and rollers over special rails. Figure 18 depicts the launching process.

Figure 18. Launching girder.

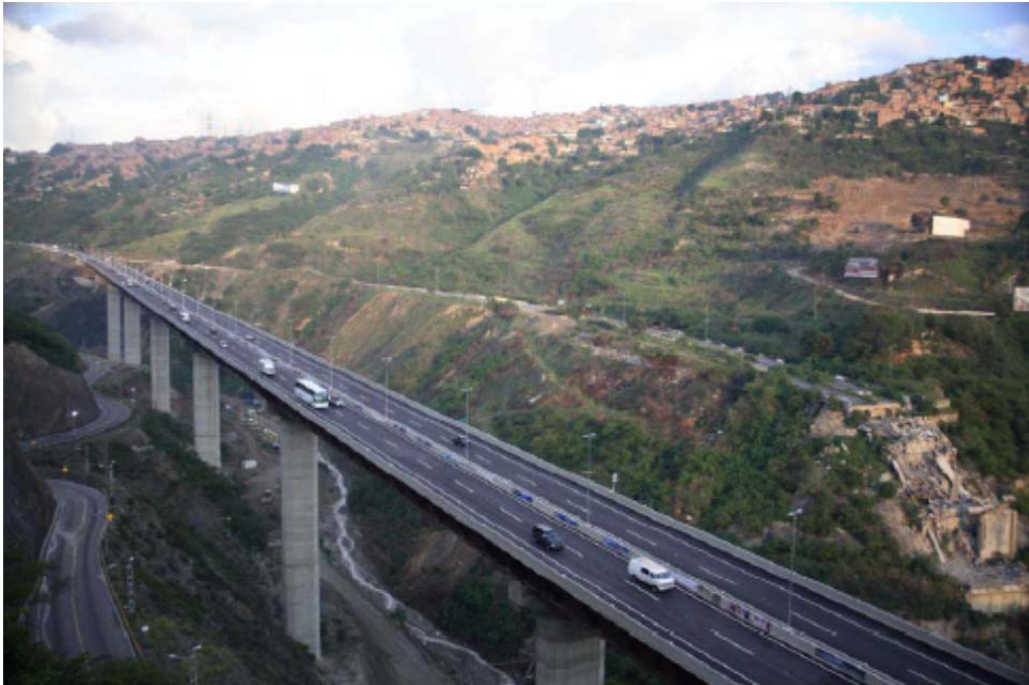
Finally, a 5-cm (2-inch) thick surface course of asphalt concrete was placed over the deck. Figure 19 is a view of the completed structure. Construction took a total of 16 months since the start of foundation work, and the bridge was opened to traffic on June 21, 2007.

Figure 19. Completed Viaduct.
