DESIGN-BUILD-TEST PROCESS FOR HIGH CAPACITY MICROPILES: CONSTRUCTION CASE STUDY ON DUTCHESS RAIL TRAIL BRIDGE FOUNDATIONS, POUGHKEEPSIE, NEW YORK

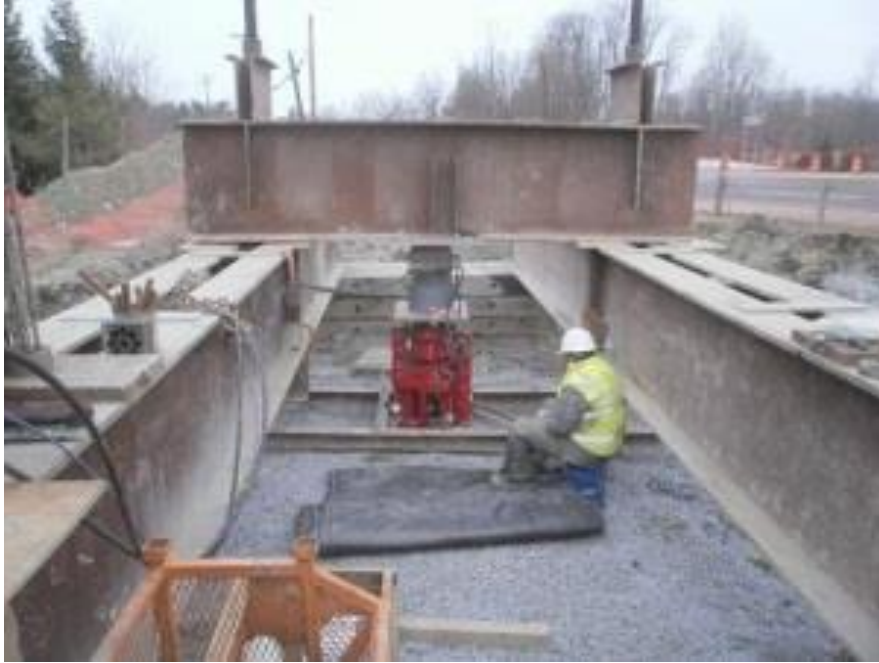
Figure 6. Picture of micropile load test setup

For each separate location a test micropile was required to verify design. Since the specifications required the micropile be tested in compression, soil anchors were required on either side of the test pile to resist the resulting upward load from the jack. The soil anchors can be seen in Figure 9. A picture of the load test set up can be seen below in Figure 4. During the load test, deflection readings were recorded and the integrity of the micropile observed.

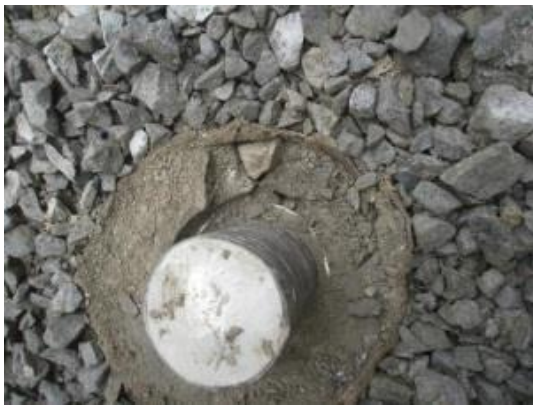
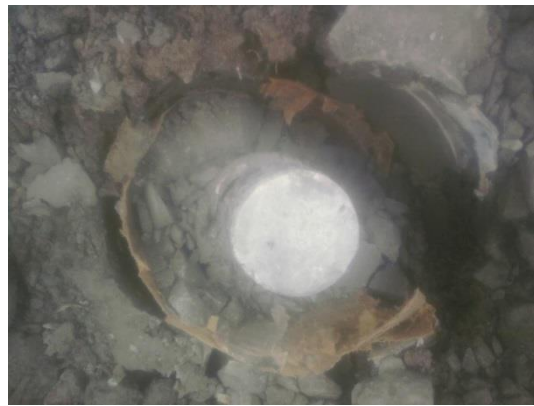
The calculated allowable structural axial capacity was greater than the service load of the micropiles, however structural failure was occurring during load testing.

Figure 7 and 8. Pier 3 (left) and End Abutment (right) test micropiles after failure.

The eccentric loading analysis shows expected failure from the grout. This supports the pictures taken after the failed load test for the end abutment. It is concluded the lack of steel at the outside edges of the micropile causes large stresses in the grout. Adding casing to the design will alleviate these additional stresses on the grout allowing the successful transfer of the load into the rest of the micropile. It has been determined the cause of failure of the micropile is due to bending from an unexpected eccentric loading during testing. It should be noted the free head scenario

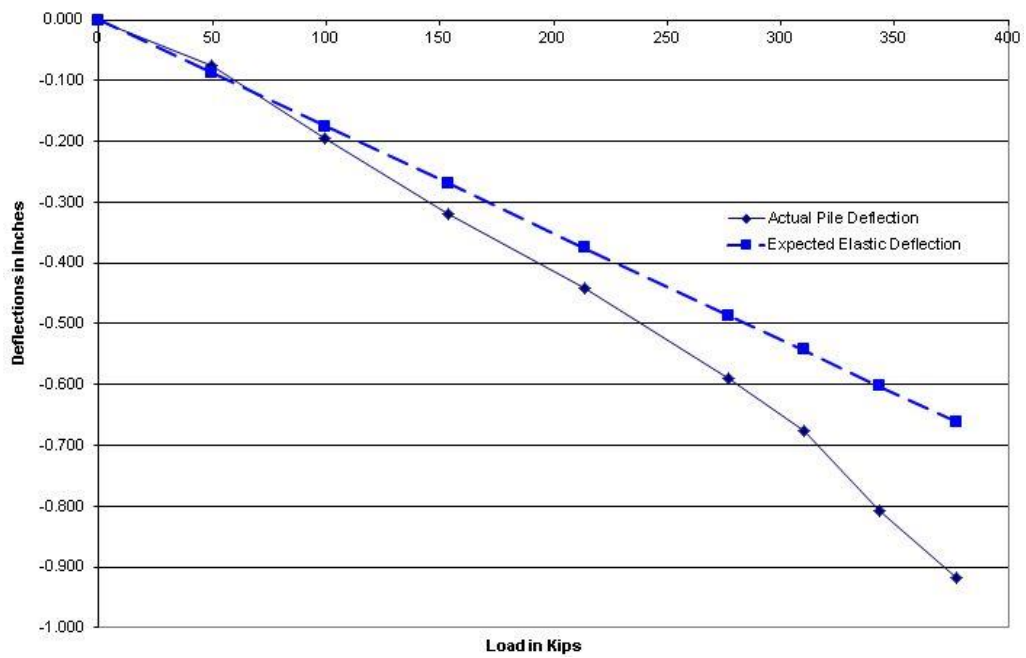
Failed Pile Load Test Pier Three Cycle One

Figure 10. Failed pile load test for Pier Three.

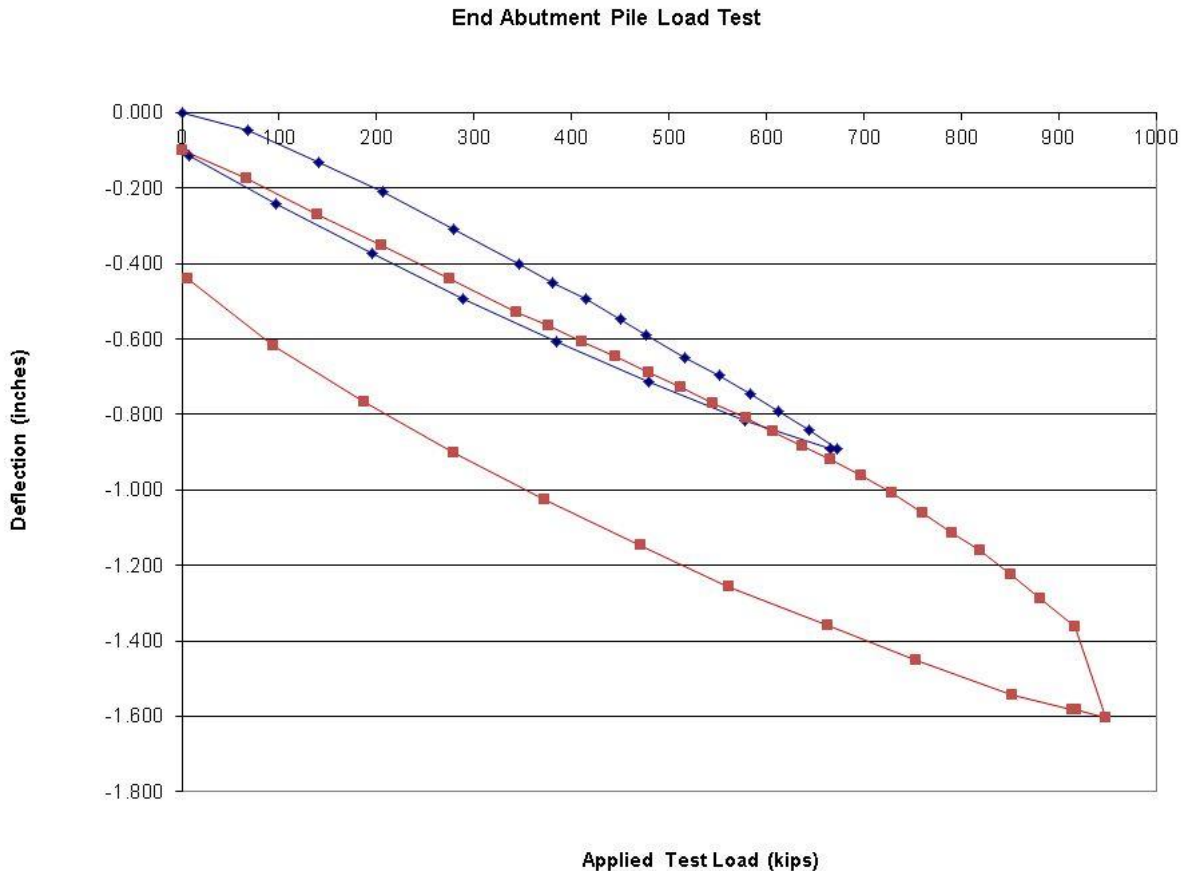
Verification from passed load tests allowed for the construction of production micropiles. Many phone calls and open communication lines were essential through the testing process. Keeping everyone that was involved informed of what was going on made the redesign successful. The final design of the End Abutment followed by passing load tests can be seen below.

Figure 12. Successful load test for the End Abutment micropile. The final design consisted of outside steel casing. Notice the plastic failure that occurs at the end of cycle two.

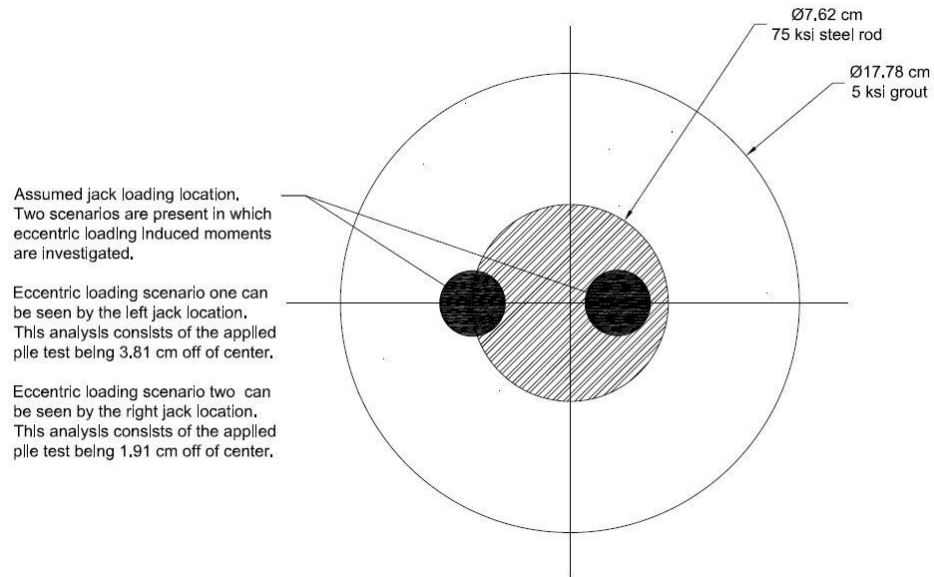
Due to the size of the jack apparatus being larger than the micropile, it was discussed that a possible moment may be induced at the top of the micropile. This would cause bending at the top of the pile putting some of the pile grout in tension and additional stress in compression. The low tensile strength of grout may have led to cracking. With the large loads being applied to the micropile, any loading applied off center could become eccentric. The importance of centering the jack on the micropile was further discussed with the field testing technicians and further caution was taken with subsequent micropiles. It must be noted that due to the large loadings required for a high capacity micropile any off center applied loading can result in large moments induced.

Figure 13. Eccentric loading scenario during pile load test.

An expected eccentric loading and the influence it may have on failed test results can be seen in the analysis below. An idealized elastic column with the cross section above reaches the maximum compression according to the following equation.
