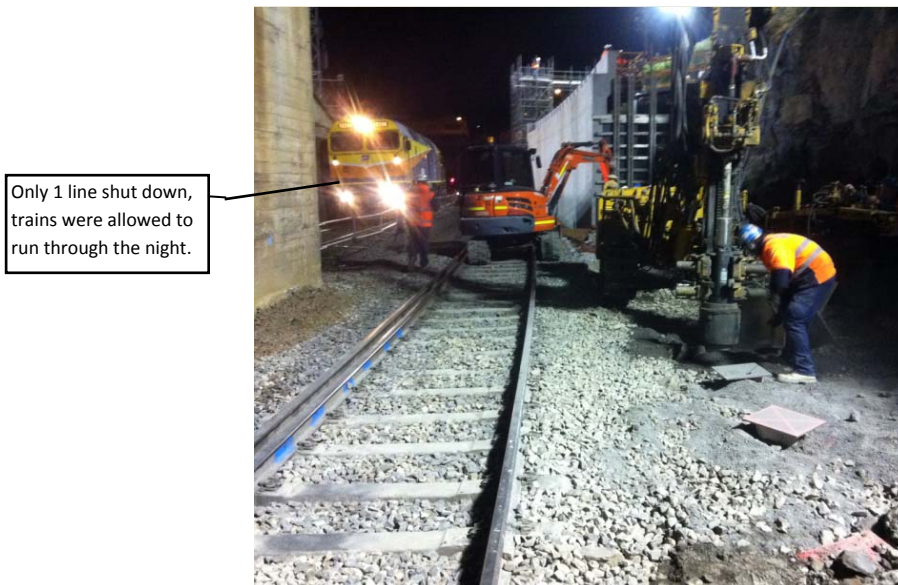
Figure 4: Predrilling the upper basalt with a 250mm DTH hammer

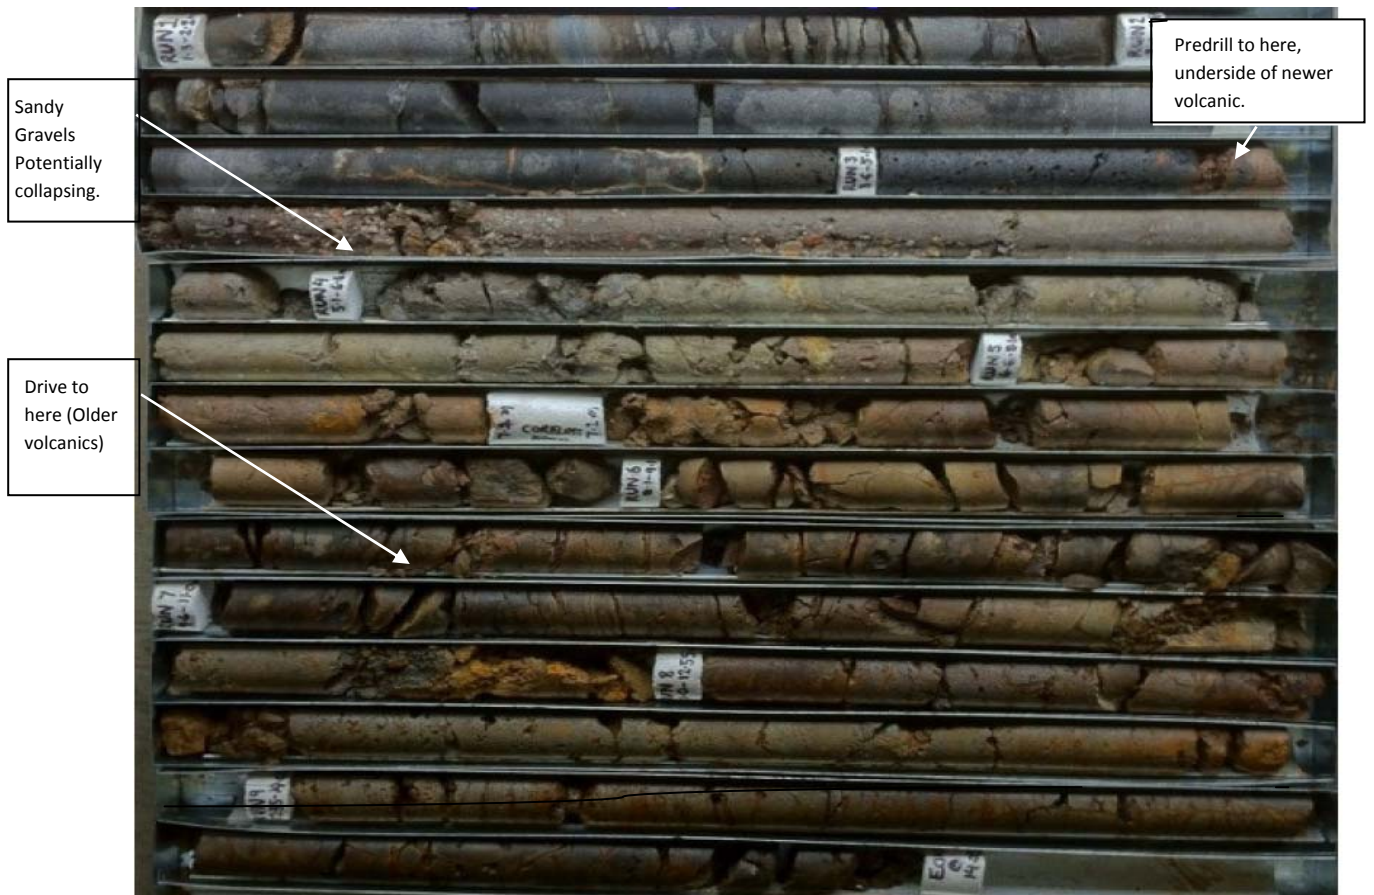
Figure 7: Photo of Borehole7 taken at Abutment 1

In figure 7 (Borehole 7) above you can clearly see the high strength basalt layer starting at 1.3m below the ground and finishing around 5.1m below the ground, this would be suitable for founding. In Figure 8 below (Borehole 10) the upper basalt is highly fractures possibly due to blasting (Irregular fractures) and not suitable for founding.

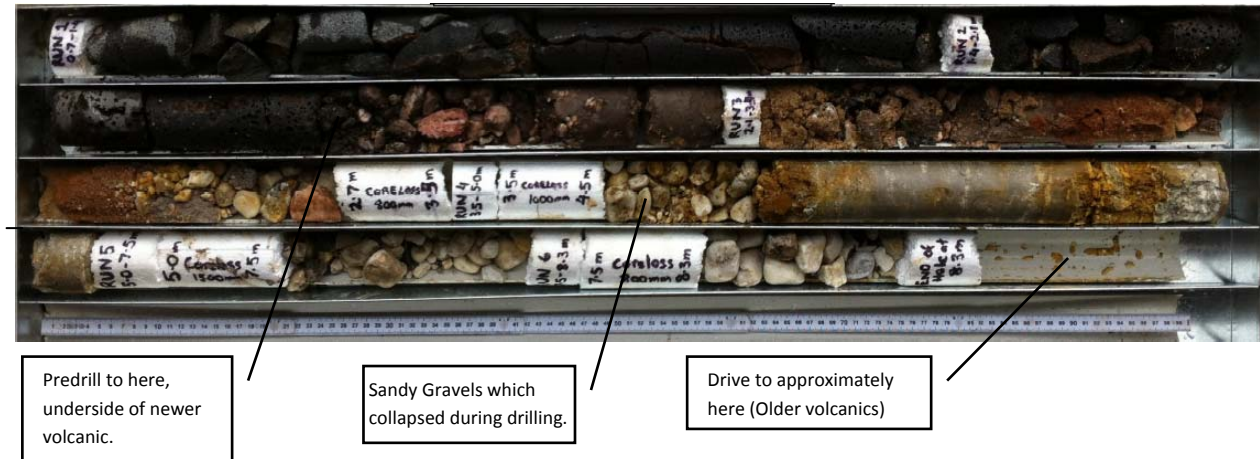
Figure 8: Photo of Borehole 10 taken at Abutment 2

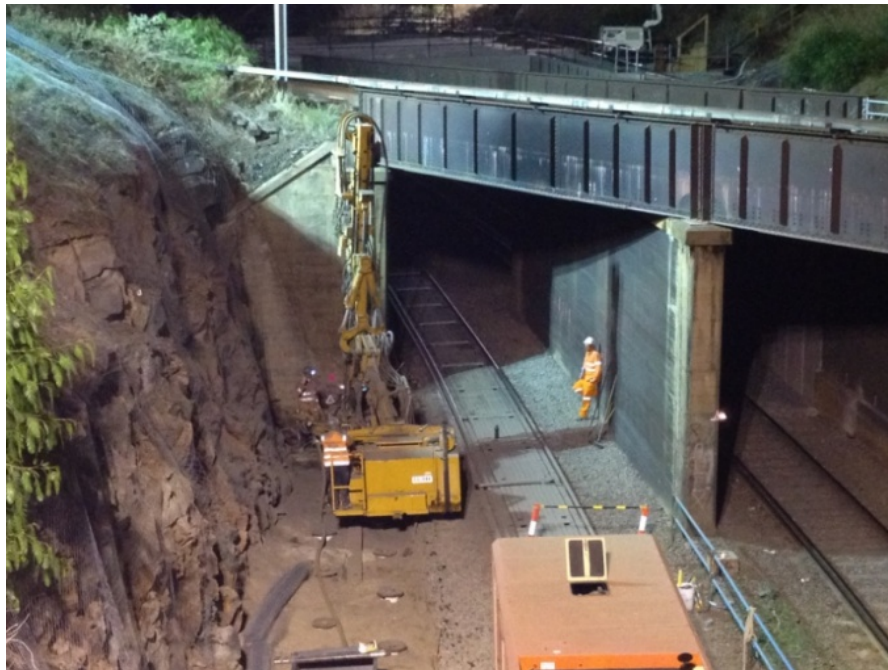
Figure 9: The Klemm predrilling the upper basalt

Once an area 3m clear of the tracks had had been prepared for the piling, the GKlemm 806 piling rig fitted with a 250mm diameter DTH hammer and 50mm air hose was lifted into the 8m deep cutting.

Percussion Drilling was commenced at each of the 18No pile positions on the Abutment 1 and would continue until the upper basalt was penetrated. (The high strength basalt drilled very well and a clear boundary was identified during the drilling.) Once the hole was complete, a hole guard was placed over the hole and the next hole commenced.

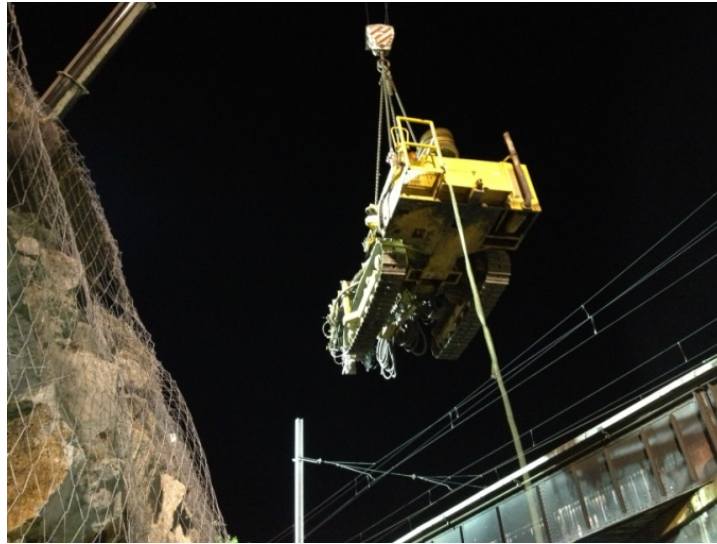
Figure 10:Klemm drill rig being lifted in at start of shift (1hr after last train)

On completion of the shift the rig needed to be lifted out of the cutting to allow train services to resume on both tracks.

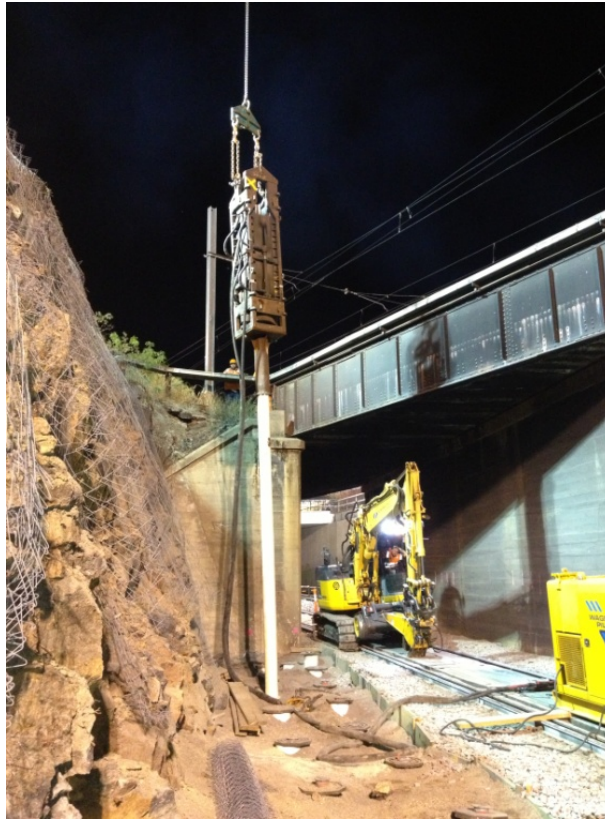
Figure 11: After being lifted into the predrilled hole the hammer is lifted onto the pile for driving.

A 4 tonne hydraulic hammer fitted with a bell mouth was then lifted over the tubes from the upper level and driving commenced. This did generate some noise but given the nearest neighbours were not that close and had been used to the train horns, there were no complaints. Surprisingly there were no requirements for noise or vibration monitoring.

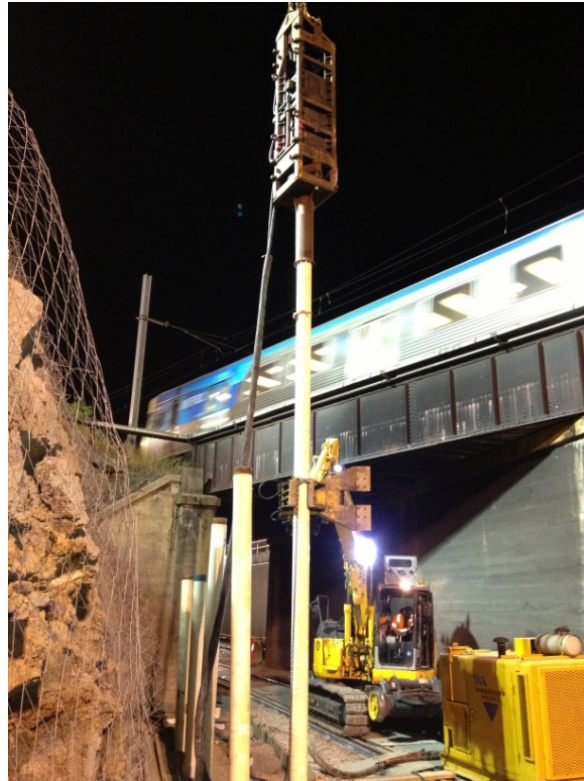
Figure 10: Piles were sequentially driven down until capacity was achieved.

Piles were driven through the Brighton Group clayey sands and onto the older volcanics starting around 8m depth. End of Drive Sets were taken for each pile and were correlated against a dynamic test (1No at each abutment) and subsequent CAPWAP to ensure capacity had been achieved. Remote testing was undertaken, enabling an engineer to remain at home until the gauges were installed and the PDA connected, the total test was completed within 15min on each abutment.
