MICROPILE UNDERPINNING AND SEISMIC FOUNDATION RETROFIT VETERANS ADMINISTRATION MEDICAL CENTER, MEMPHIS, TENNESSEE

John R. Wolosick, PE, D.GE¹ and Peter J. Nufer, PE²

ABSTRACT

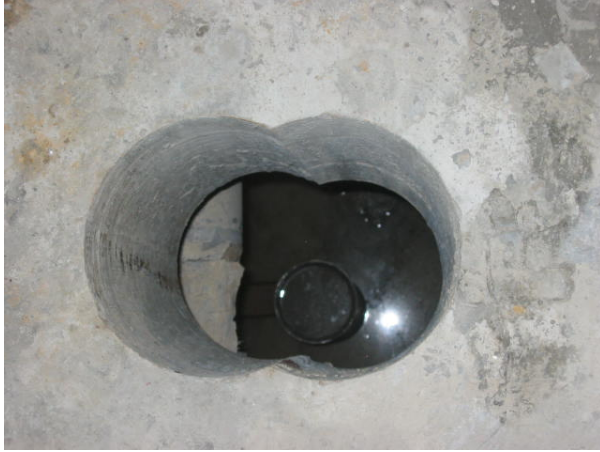
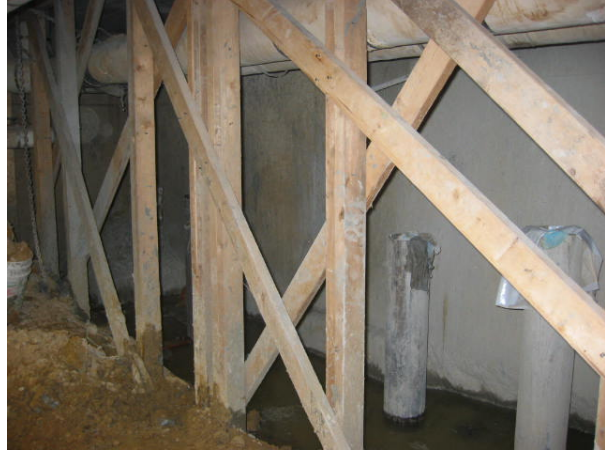
Figure 6. Core Holes through Floor Slab Figure 7. Shoring and Basement Micropiles

Several of the interior piles were installed at the crawl space/basement level by coring the concrete floor on Level 1 and installing the piles in the basement through the core holes. This required coordination with a spotter at the lower level with the driller above with two-way radios. In addition, it was deemed that the existing floor could not support the weight of the drill rig. This required shoring of the floor above while the new piles were installed. Figures 6 and 7 show the core holes through the floor slab for the micropile installation and the subsequent micropiles and shoring in the basement.

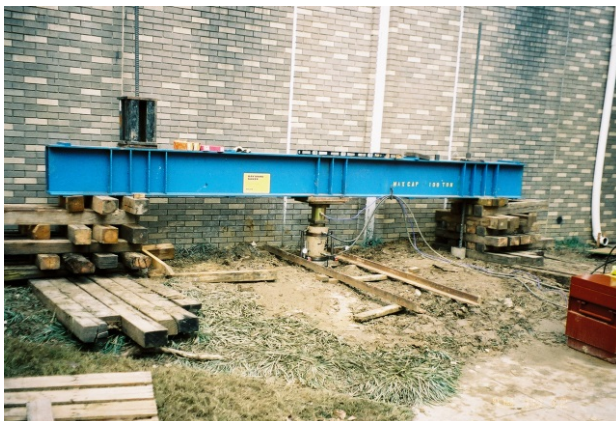
Figure 8. Perimeter Micropile Testing

A very extensive load testing program was required for the project by the specifications. Perimeter micropile load testing included compression verification (qualification) and proof load testing. Two verification tension tests were also performed on perimeter micropiles. The compression verification tests were performed using cyclic loading after the first test at P68 was completed. Figures 8 and 9 show the load testing set-up for the compression tests for the perimeter and interior tests. A shorter beam than required by ASTM D 1143 was required for the interior tests since it was impossible to get a 20 foot (6 m) long beam inside the building at the required test pile locations. Drilled and grouted steel bars were used for the reaction anchors for the compression load testing. Individual load test graphs for each of the tests are shown on Figures 10-20.

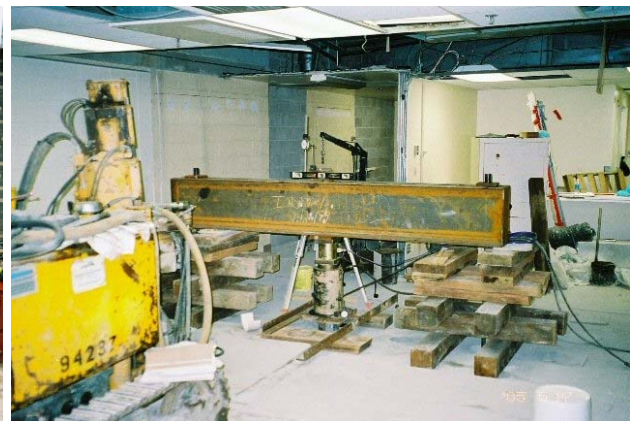
Figure 9. Interior Micropile Testing

The interior tests required special equipment to handle the materials within very tight confines. The owner allowed a shorter than specified load test beam (only 10 feet long (3 m)) to allow access to the test pile locations inside the building.

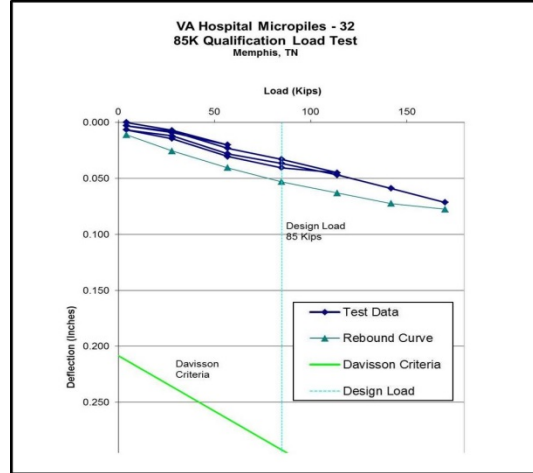
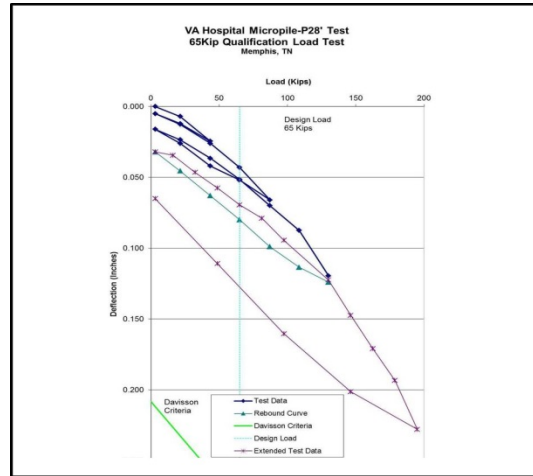
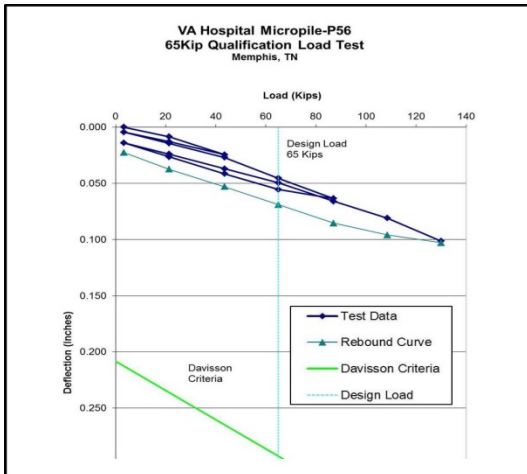
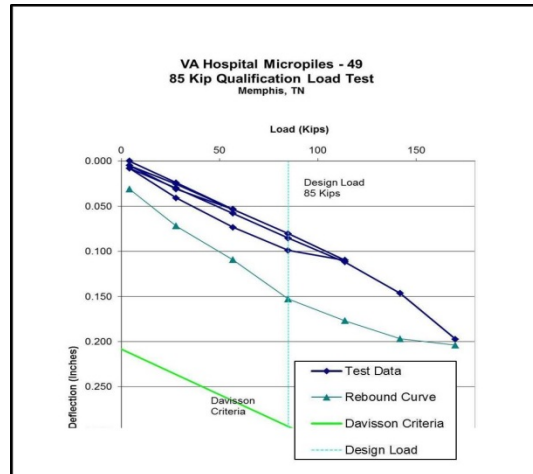
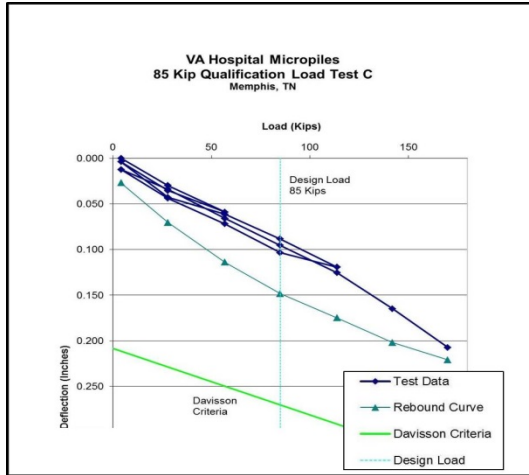
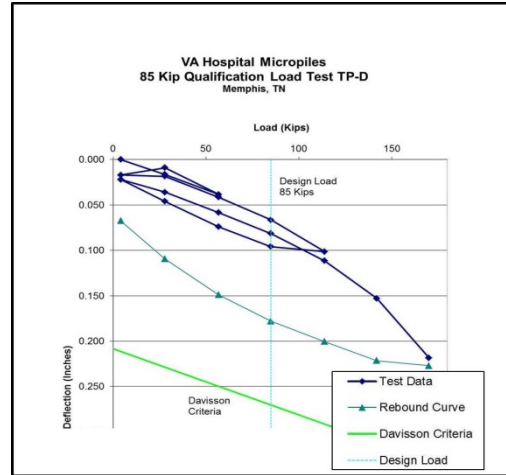
The observed pile response during the load tests was very stiff. The average deflection observed at the 65 kip (289 kN) design load from the five compression tests was 0.049 inches (1.25 mm). The average deflection observed at the 85 kip (378 kN) design load from the four compression tests was 0.076 inches (2 mm). The deflection observed during tension testing averaged 0.031 inches (0.8 mm) at the design load of 55 kips (245 kN). The specifications required that compression deflections be less than 0.375 inch (9.5 mm) at design load in compression and 0.25 inch (6.3 mm) at design load in tension. The maximum indicated bond stress measured from most of the testing was 29 psi (200 kPa). P28 indicated a maximum bond stress of 43 psi (300 kPa).

Compression verification test load test graphs are shown below on Figures 10 through Figure 17. Figure 18 is a compression proof test. Tension verification load test graphs are shown on Figures 19 and 20.

load, except for test P28, which was run to 3 times the design load. This extended test at pile P28 was performed in an attempt to find the ultimate bond stress, but the pile did not plunge. The sole proof test at pile P74 was run to 1.5 times the design load. Two tension tests were run on piles P5 and P50 to twice the design tension loading are shown on Figures 19 and 20. Production piles were mainly used for the testing, except for Test Pile C and Test Pile D, which were sacrificial piles. These two sacrificial pile tests were run in extremely confined conditions within the interior of the structure at new Shear Wall C and new Shear Wall D locations. Production micropiles were used as reaction piles for these two tests.
