# MICROPILE PERFORMANCE AND DURABILITY AFTER 15 YEARS UNDER LOAD

WALTER E. VANDERPOOL, P.E.<sup>1</sup>

## ABSTRACT

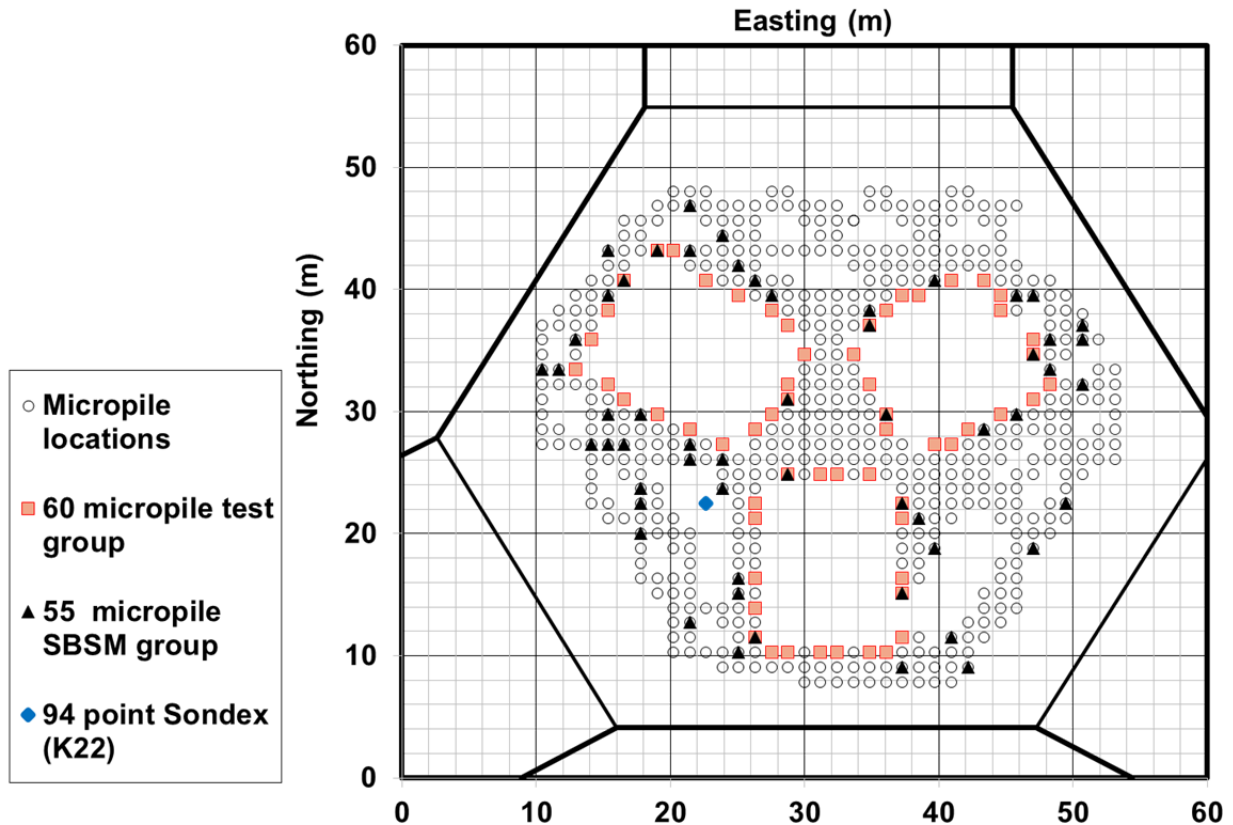
**Figure 1 - Micropile plan grid 1.2 x 1.2 meter**

A quality assurance plan was developed, submitted, and approved before production began. The plan required; continuous inspection of; drilling; grouting, and grout sampling; load testing every micropile; paired VWSG's mounted at the top of each pile; and sister bar strain meters (SBSM) embedded in at least 10 percent of the micropiles between the tops and tips. The duration of the monitoring is at the discretion of the governing agency, (Figure 1).

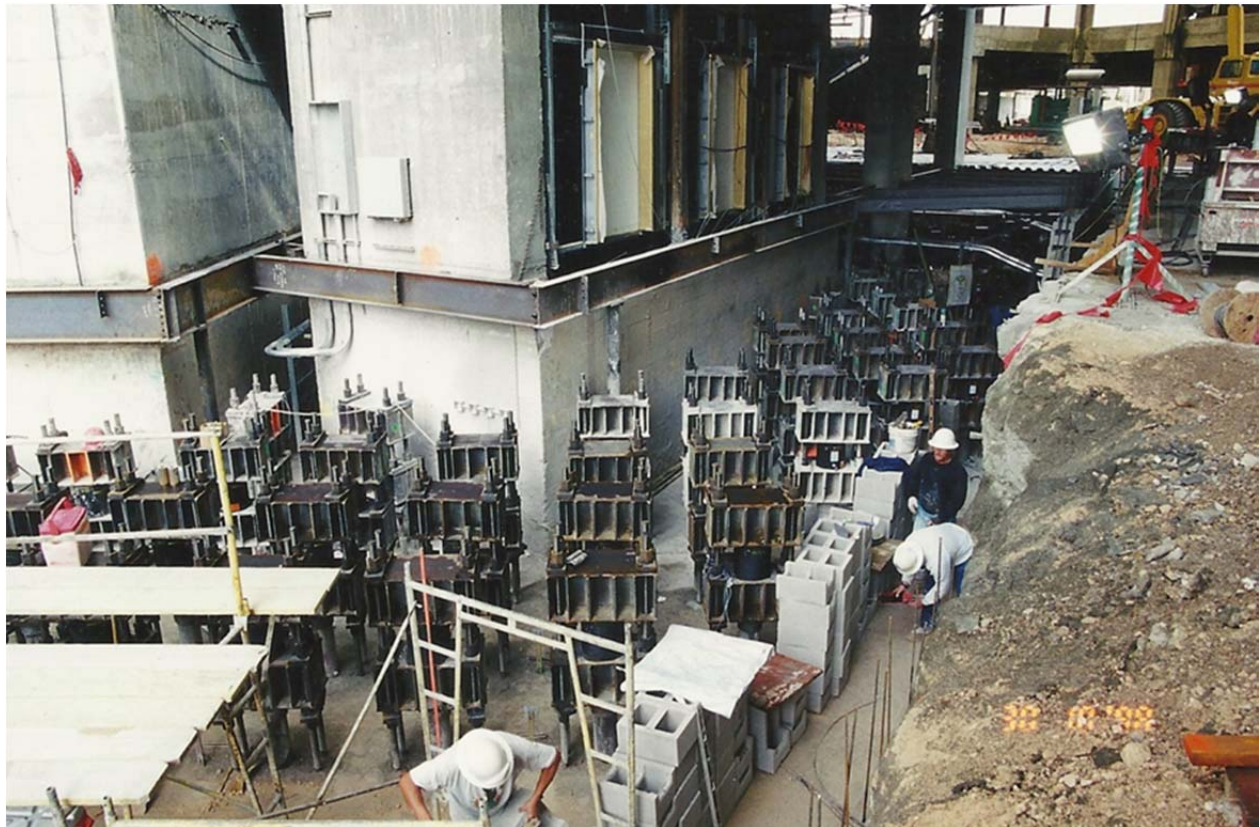
**Figure 2 –Micropile installation completed October 9, 1998.**

Figures 2 and 3 are representative of site conditions during the installation near the completion of the work. Load testing and the quality assurance testing are described in the 2002 paper<sup>2</sup>.

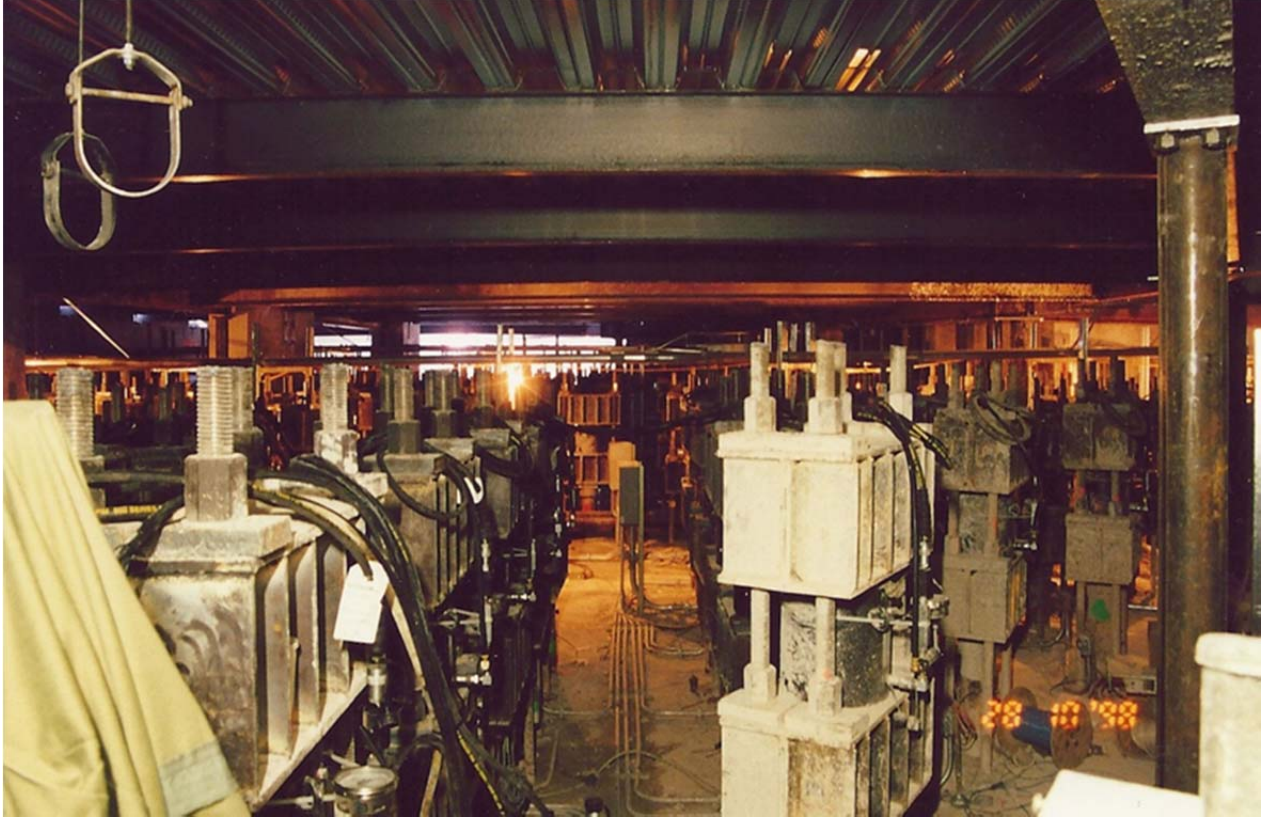
**Figure 3 – Between grid lines 27 and 28. Micropile H28 in foreground.**

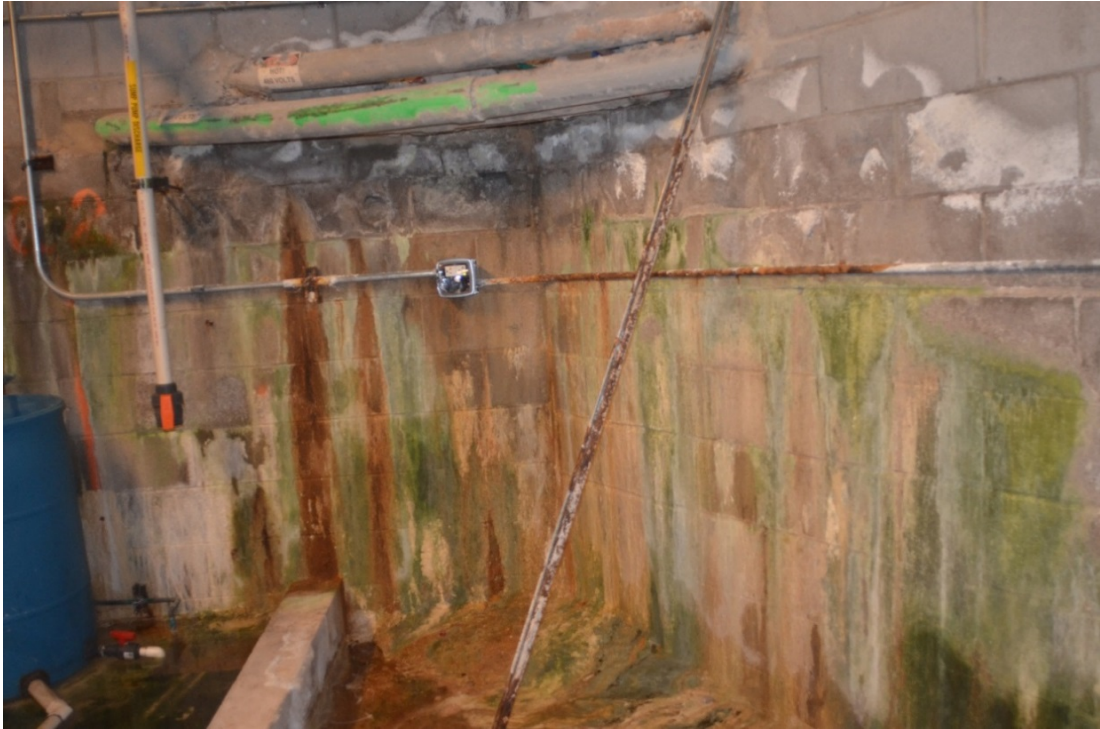
**Figure 5 - Seepage and staining, from leaking utility lines.**

Seepage infiltration from utility lines developed at some unknown date after the area was enclosed (Figure 5). Maintenance between November 1998 and March 2012 consisted of cutting shallow sumps and installing pumps into the top of the mat foundation (Figure 6). Infiltration is currently approximately one gallon per minute based on the sump volumes and the pump cycle rate.

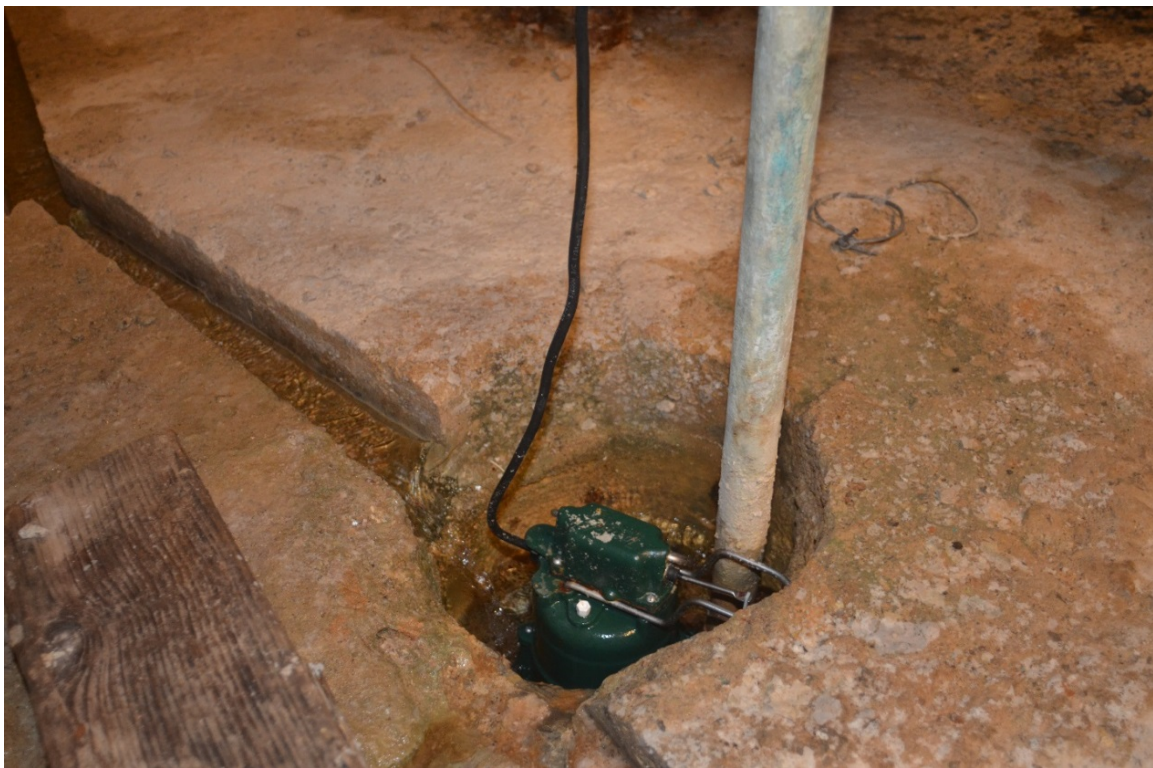
**Figure 6 - Sump and pump operating at approximately 1-minute cycle.**

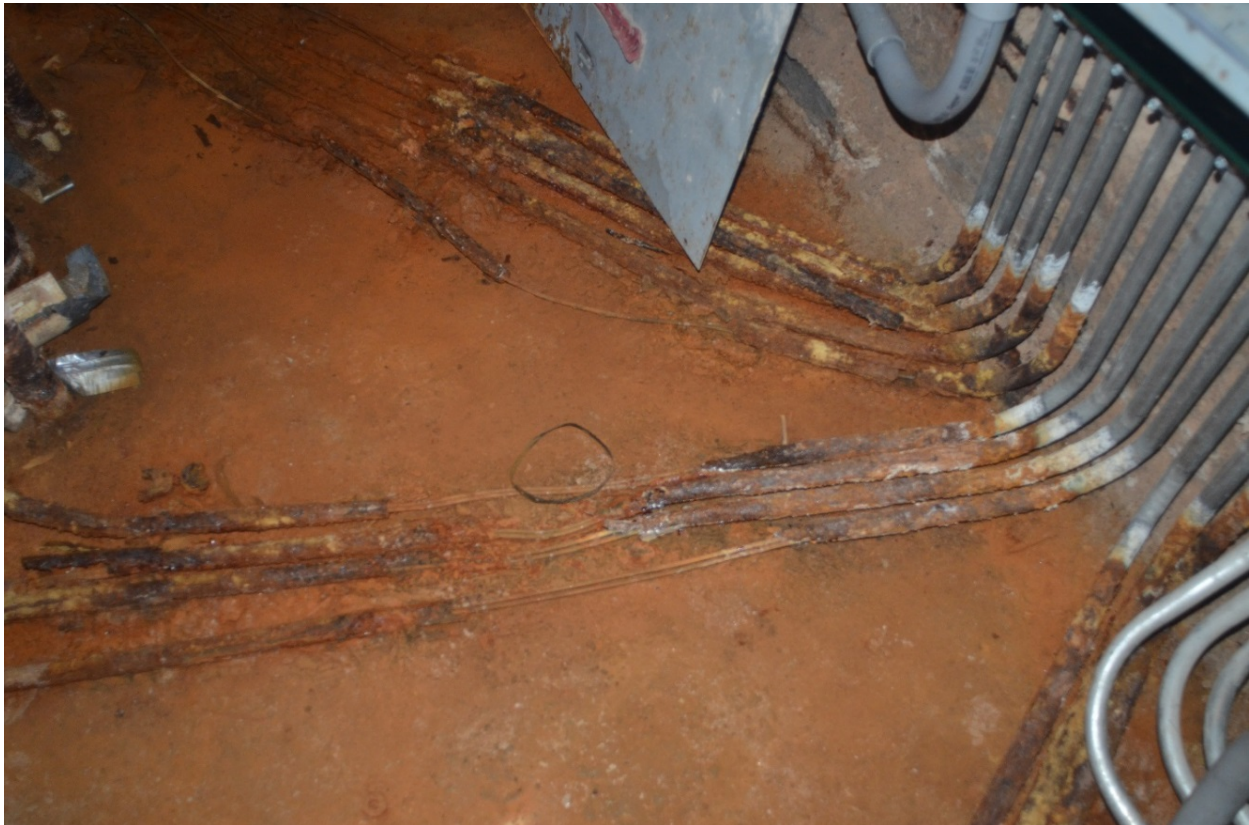
**Figure 7 - Steel conduit consumed by corrosion (12/12/2013). Data logger-5 mounted on the south wall of the west elevator.**

Signal cables from the 1072 VWSG's and the 119 SBSM's that survived the construction were routed to nine data loggers. The loggers were mounted on elevator walls at convenient locations around the micropiled area, (Figures 4 and 7).

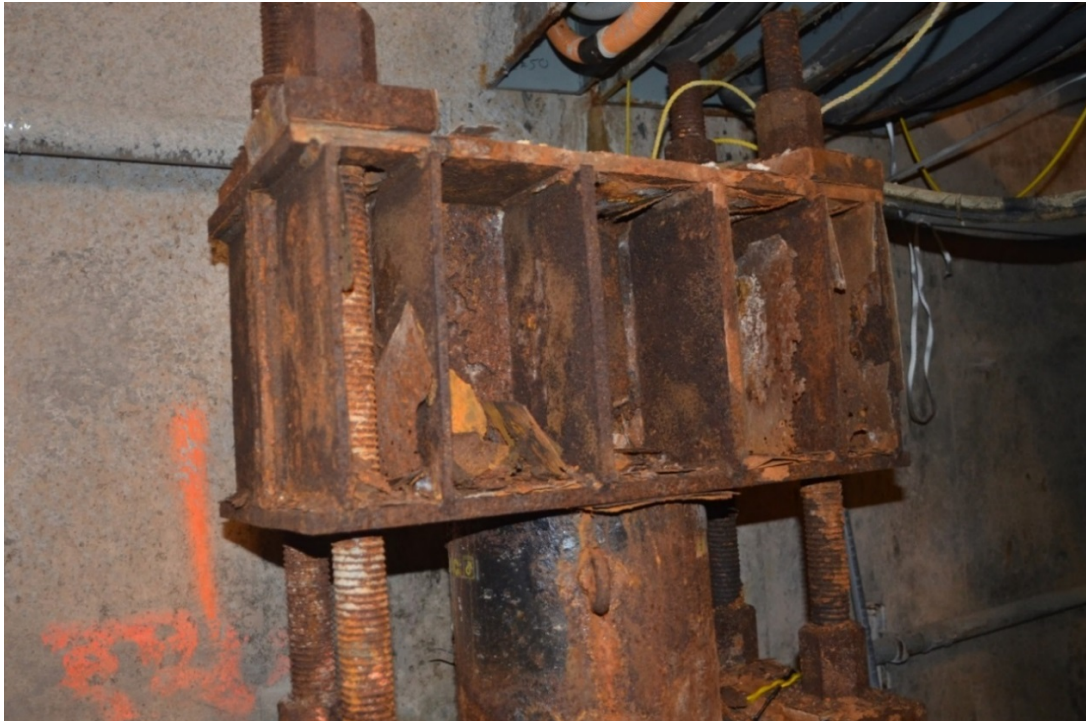
**Figure 8 - Micropile J19, 12/12/2013**

areas, (Figures 8, and 9). The corrosion shown in Figure 10 is more representative of the general conditions.

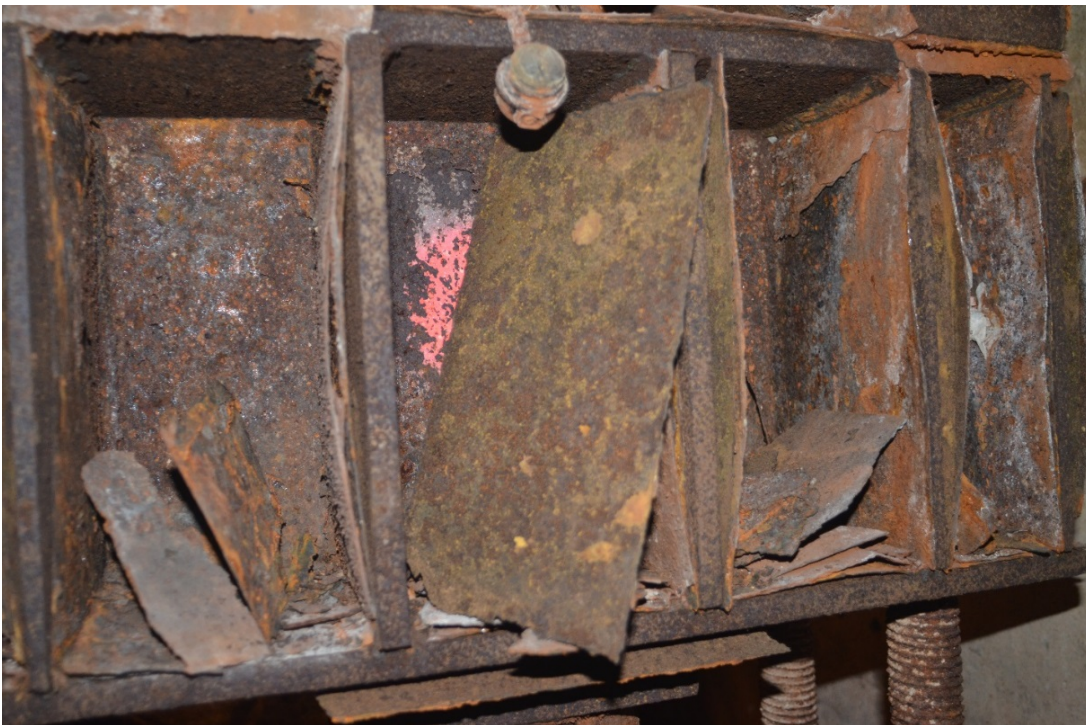
**Figure 9 - Micropile E14, 12/12/2013**

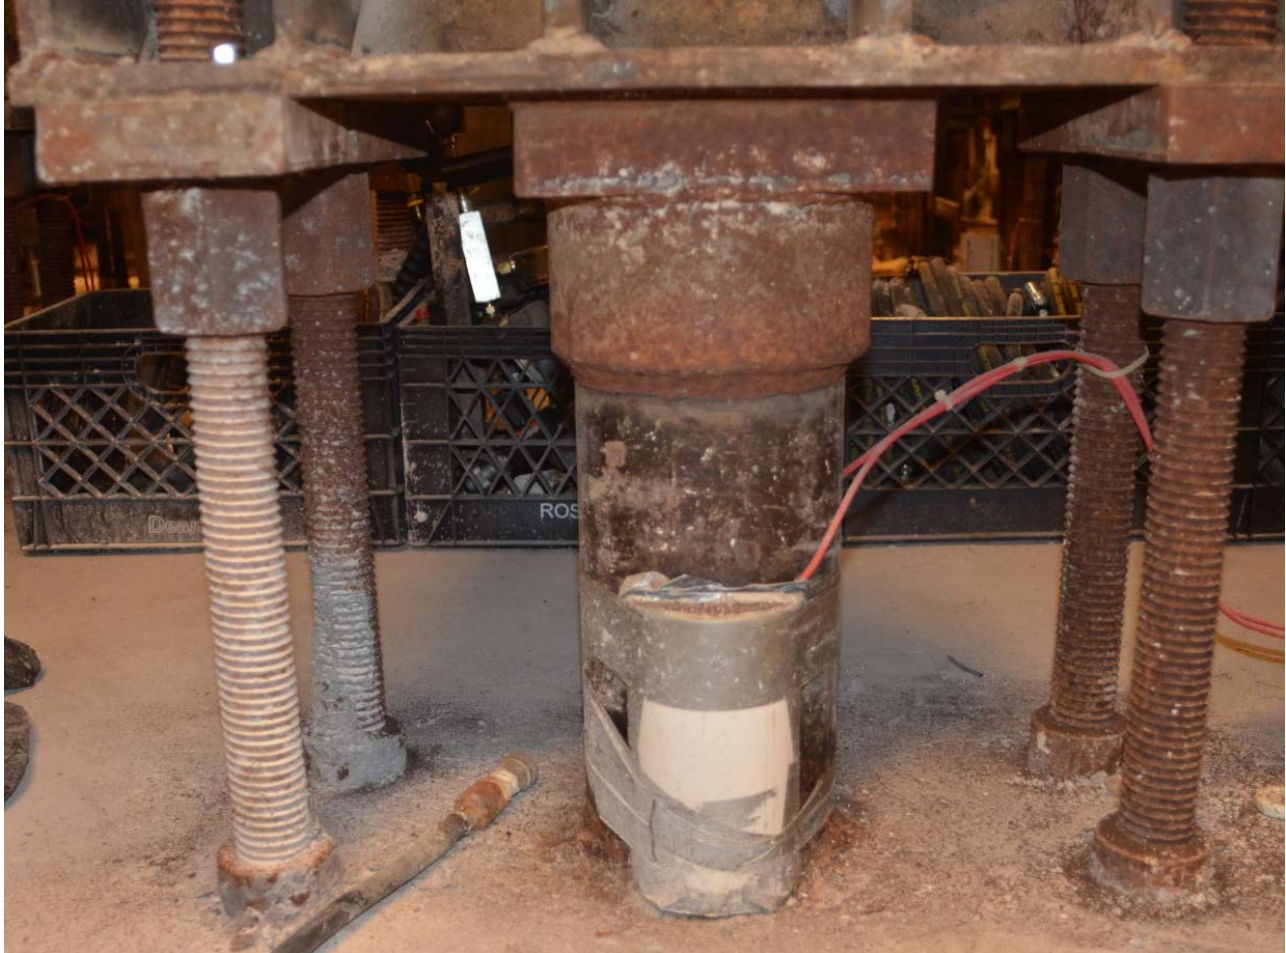
**Figure 10 - VWSG's on Micropile L33 with PVC covers.**

The VWSG's were protected by PVC covers, (Figure 10). By 2012, data from at least one of the VWSG pair on 146 micropiles were corroded beyond repair or data were unreliable, (Figures 11). A maintenance program was initiated to clean terminals and replace failed gauges, (Figure 12).

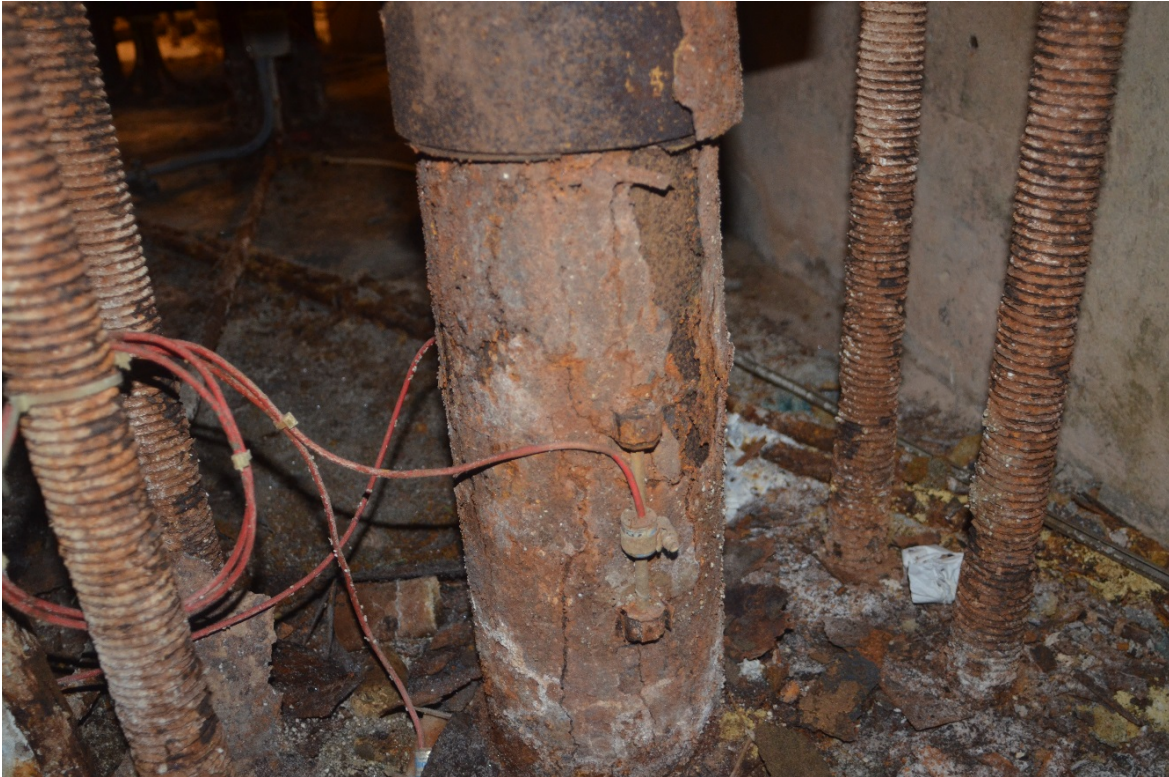
**Figure 11 - Micropile E14, 12/12/2013**

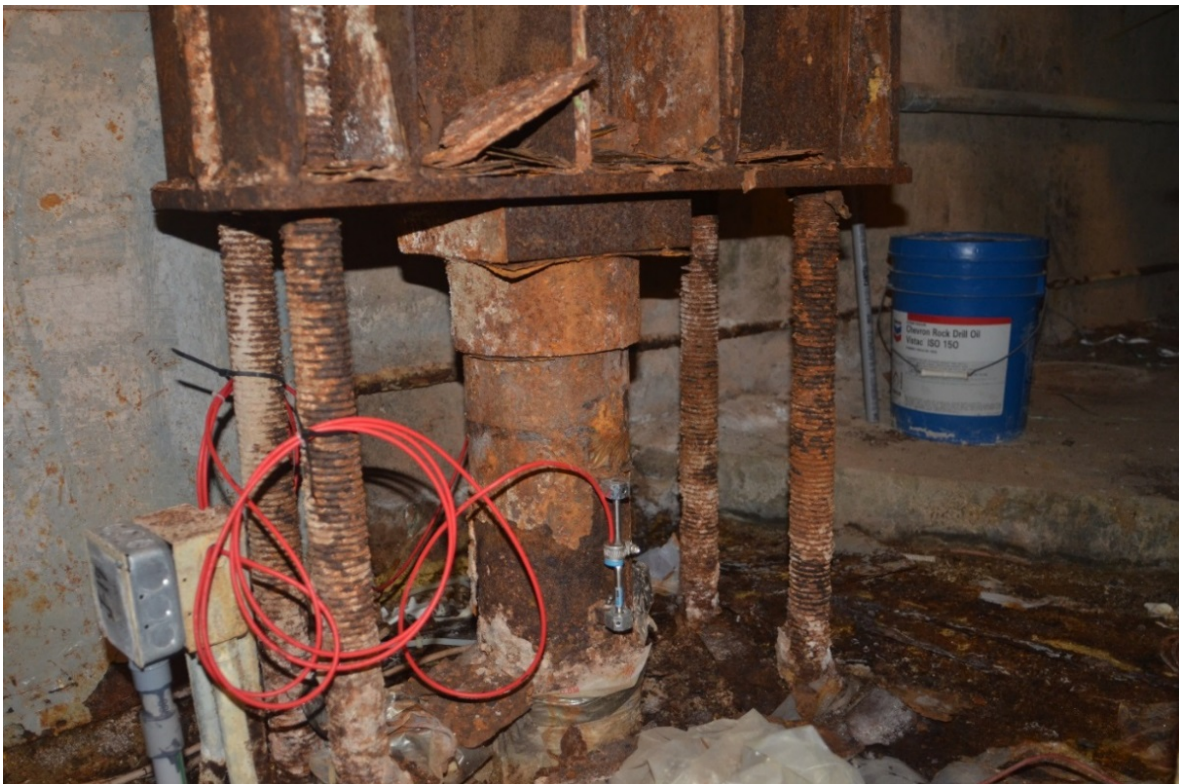
**Figure 12 - Micropile J19, 12/12/2013 with replacement VWSG's**

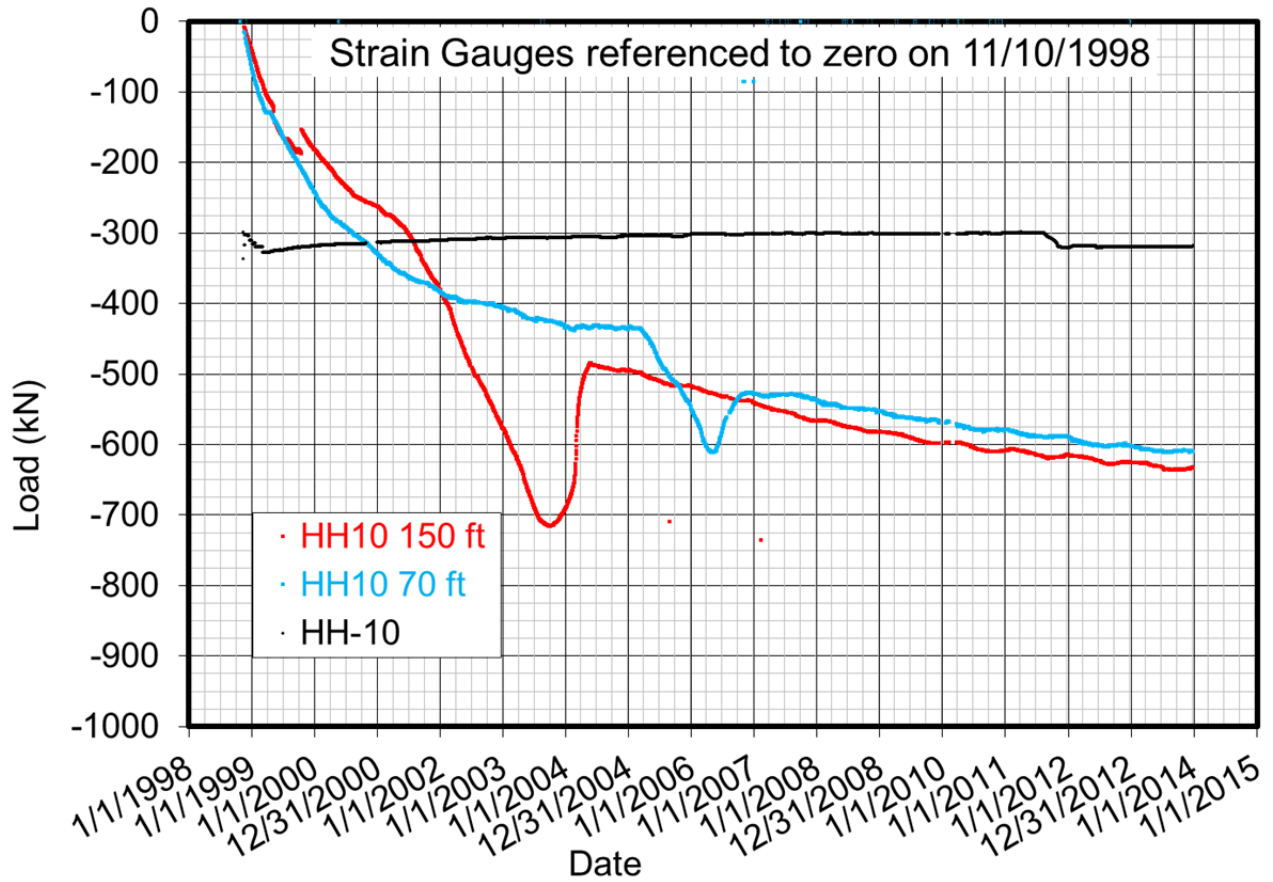
Figure 17 – Micropile HH10

By January 2001, time dependent events, and soil profile properties were clearly not uniform or static with respect to time or depth below the tops of the micropiles. The building load at the tops of the micropiles has been nearly constant since March 1999. The load within the micropiles migrated deeper in the first year and has increased in compressible layers over the past 15 years. Large excursions of the load, both decreasing and increasing, have occurred at discrete depths (Figures 17, and 18).

6. The pattern of changing load in micropiles HH10 and HH11 (Figures 17 and 18) was repeated in 16 of the 55 micropiles with SBSM's. However, the excursions from the typical constant or slowly increasing Micropile load pattern are not reflected in data from other depths in the same micropile or at the same depth in adjacent micropiles during the same time period.

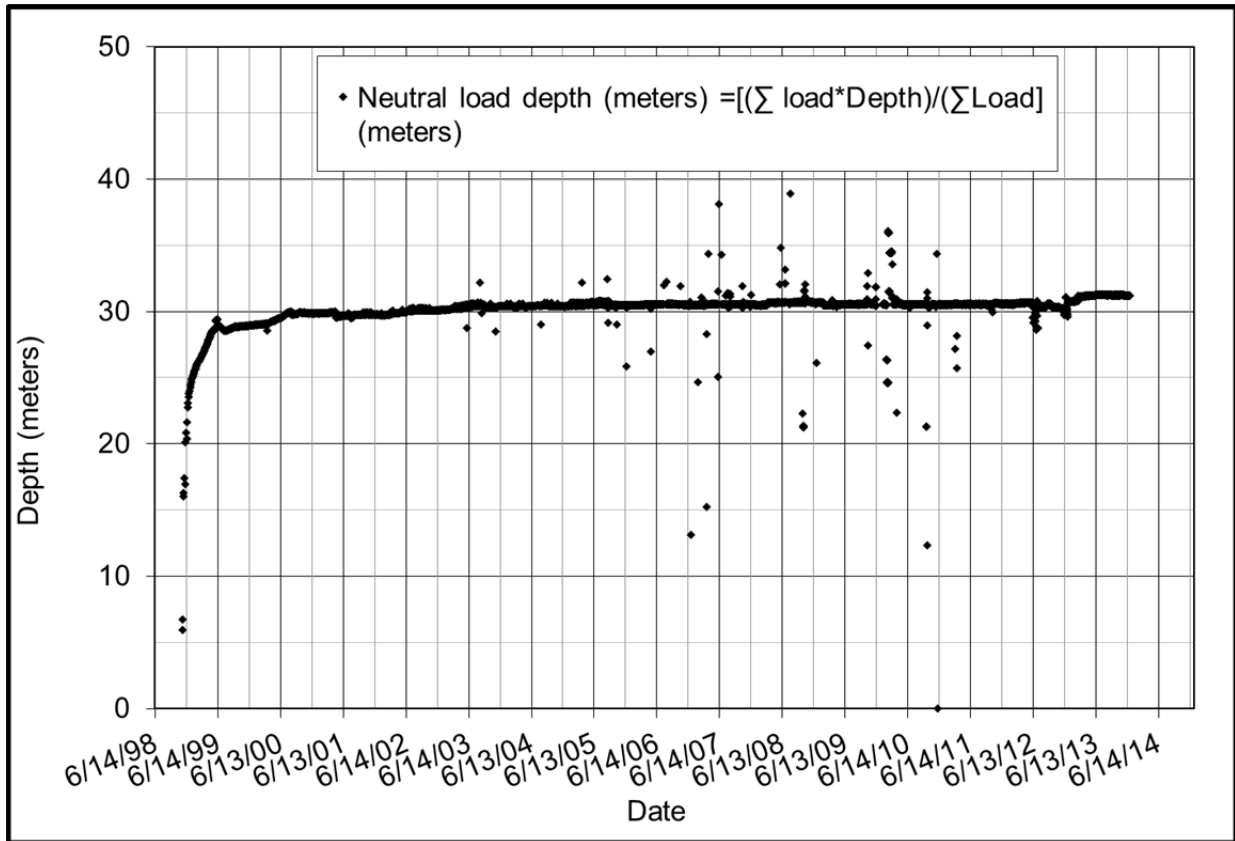
The data sets in Figure 20 represent the daily depth to the point of neutral compressive load for the group of 536 micropiles. This depth is the point where the cumulative load above and below this depth are equal, as measured by the average value for the VWSG pairs at the tops of the micropiles and the average values for the SBSM's at the 14 depth intervals 5.6 to 61 meters below the tops of the micropiles. Total structure load over the micropiled area has been nearly constant since the structure was occupied in March 1999.

**Figure 20 – Steady state achieved after approximately 18 months**

This depth centroid initially approximately 18 feet (5.6 meters) below the top of the micropile group in November 1998 descended to a depth of approximately 30 meters by July 2000. This depth centroid has remained nearly constant (+/- 1 meter) from July 2000 through December 2013.

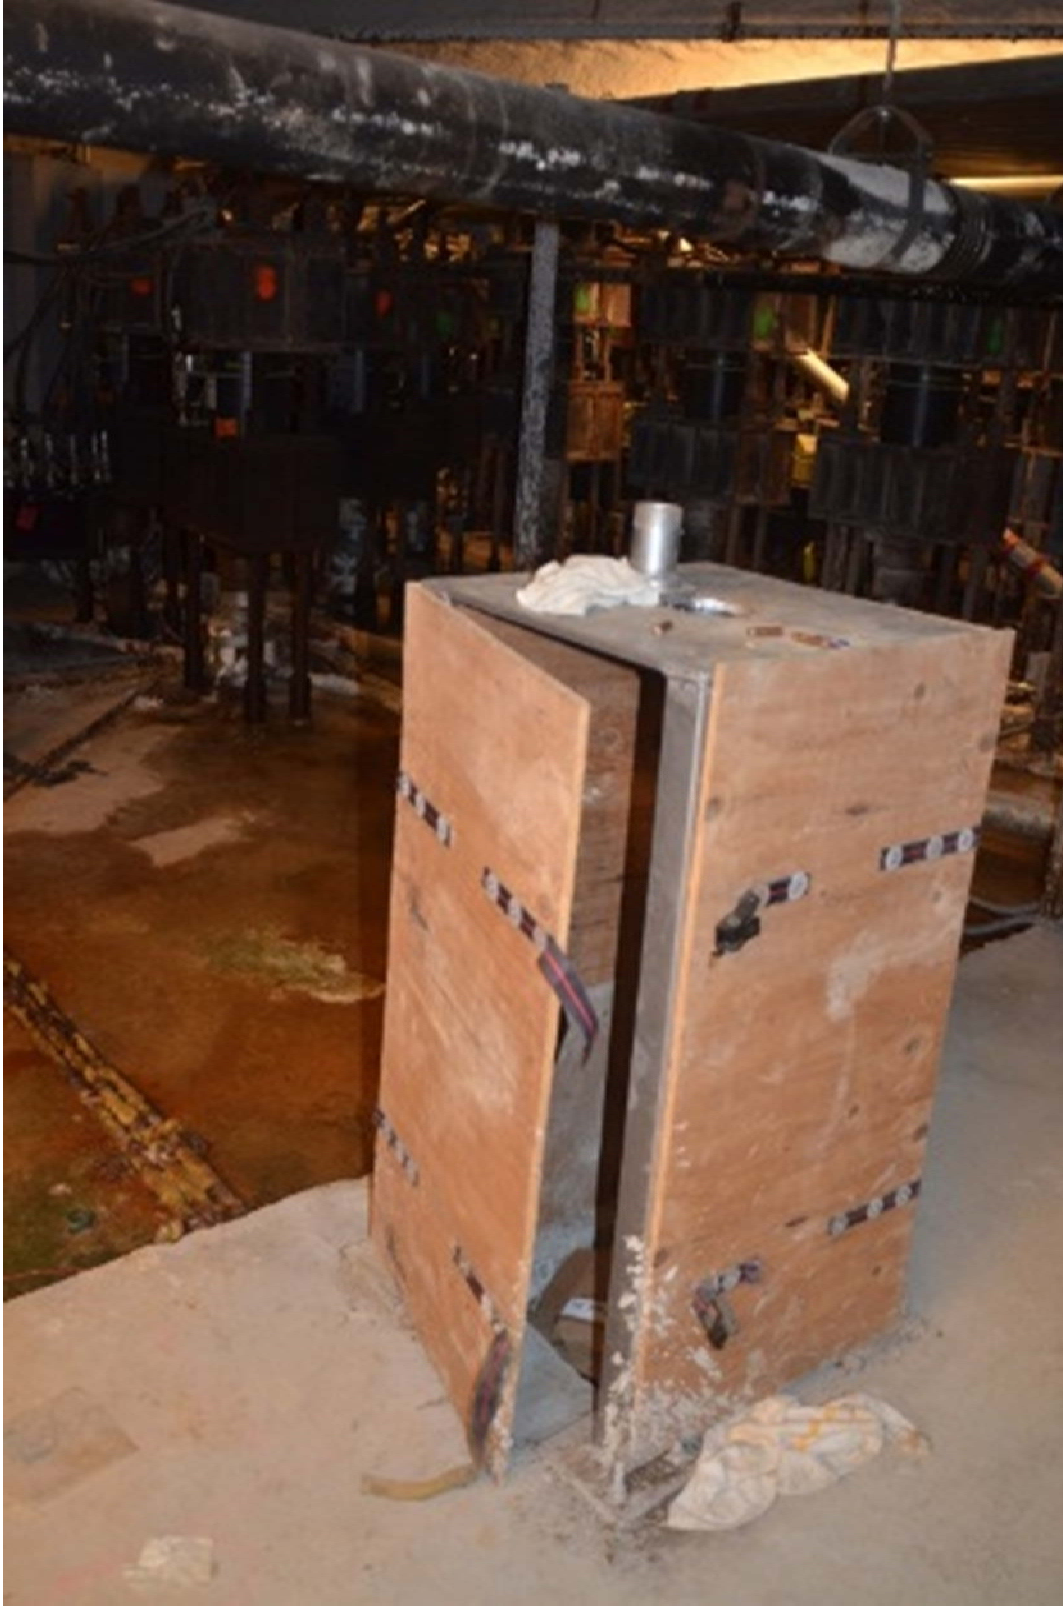
**Figure 21 - SONDEX ground deformation monitoring location. Grid point K22  
Total depth 210 feet with 94 settlement monitoring depth levels.**

On July 25, 1998 an inclinometer pipe with a corrugated PVC sleeve was installed to a depth of 210 feet (64 meters) at grid location K22 (Figure 21). Initial baseline data were collected between July 26 and August 5, 1998. Six additional data sets were collected between November 12, 1998 and May 30, 2001. Interpretation of the data sets is presented in Figure 22.

Ninety four sensors were mounted on the PVC sleeve at one to ten foot (0.3 to 3 meter) depth intervals. The borehole was backfilled by tremie with a soft bentonite/Portland cement grout. The inclinometer pipe was surveyed and found to be plumb within one diameter of the borehole (254 mm) from the surface to the total depth.

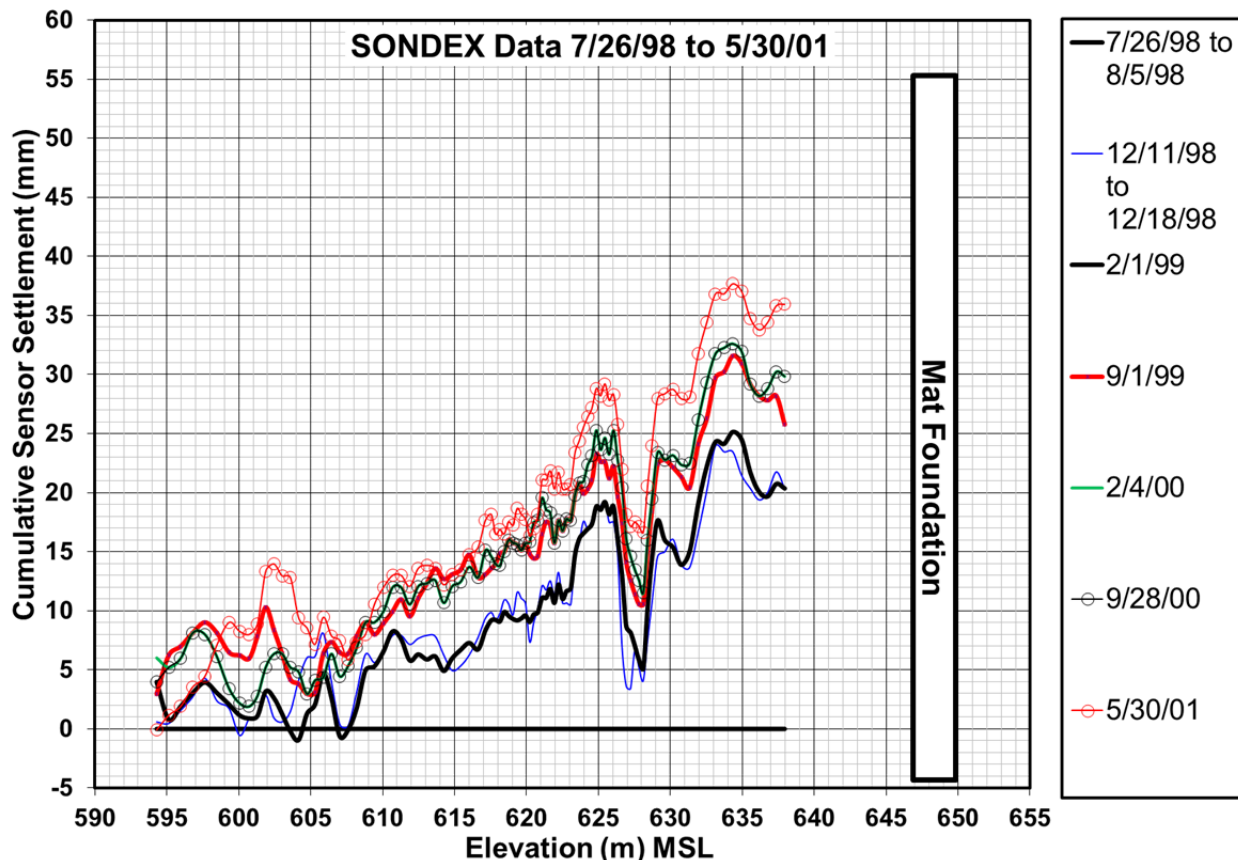
**Figure 22 – Interval and cumulative profile compression.**

1. Comparing Figure 19 and Figure 22, it becomes apparent that depth intervals where the greatest change in compressive load is indicated from SBSM data generally correspond with depth intervals where the greatest compression was measured in the inclinometer/SONDEX.
