HIGH CAPACITY MICROPILES IN WEAK DOLOMITIC LIMESTONE FOR CRANE FOUNDATION SUPPORT – A CASE HISTORY IN TEMPORARY FOUNDATIONS

Terence P. Holman, Ph.D., P.E.¹ and Brian D. Barkauskas, P.E.²

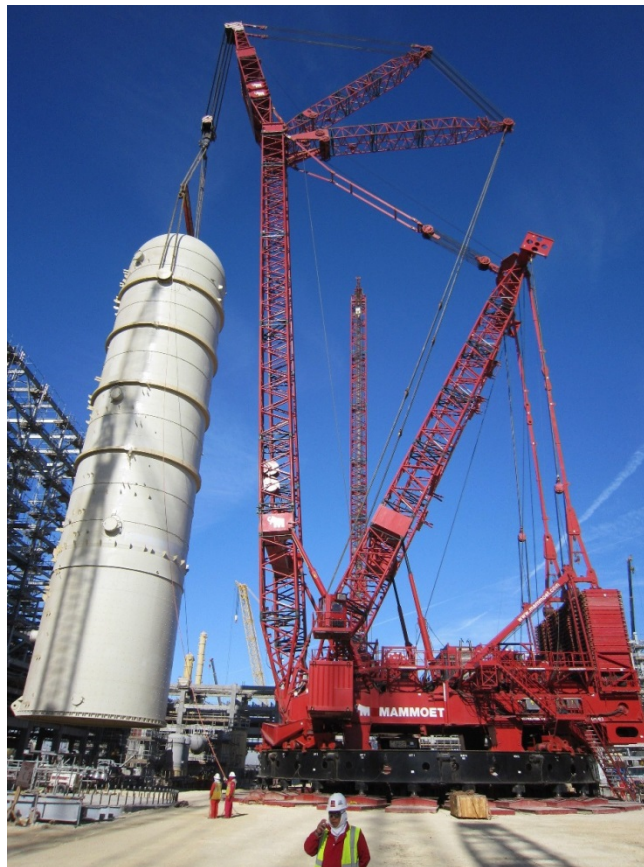
Figure 1. Photo of typical usage and setup for a Mammoet PTC35 ring crane (photo courtesy of Mammoet).

The largest crane pick for this upgrade cycle involved the use of an 1800 metric tonne capacity Mammoet PTC ring crane for a series of long-radius, high altitude lifts for refurbished precipitator units and other equipment. The largest pick load was 230 metric tonnes. The Mammoet ring crane, similar to that shown in Figure 1, required a stable foundation with an outside diameter of 27.3 m. Moreover, the crane had to be situated within an area congested with below ground utilities, many of whose precise locations and characteristics were unknown.

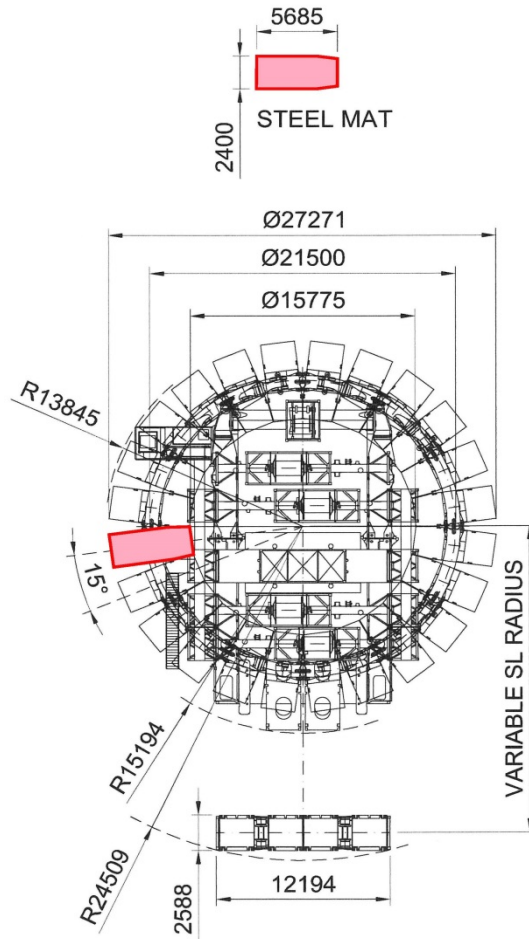
Figure 2. Crane layout and dimensions (in mm) for a PTC35 ring crane (image courtesy of Mammoet).

Ring cranes of the size necessary for this project typically require the use of a dedicated foundation to distribute their heavy loads and to limit detrimental movements under load. The base of the Mammoet ring crane is supported on 24 steel mats, to which tracks supporting the wheeled bogies are connected. Each mat is 2.40 m wide by 5.68 m long and is arranged in a radial pattern with a spacing of 15 degrees as shown in Figure 2. The design loading on each

steel pad is 4.02 MN, for a total of 96.51 MN. The adjustable slewing radius of the counterweight stack maintains all loading on the crane foundation in compression.

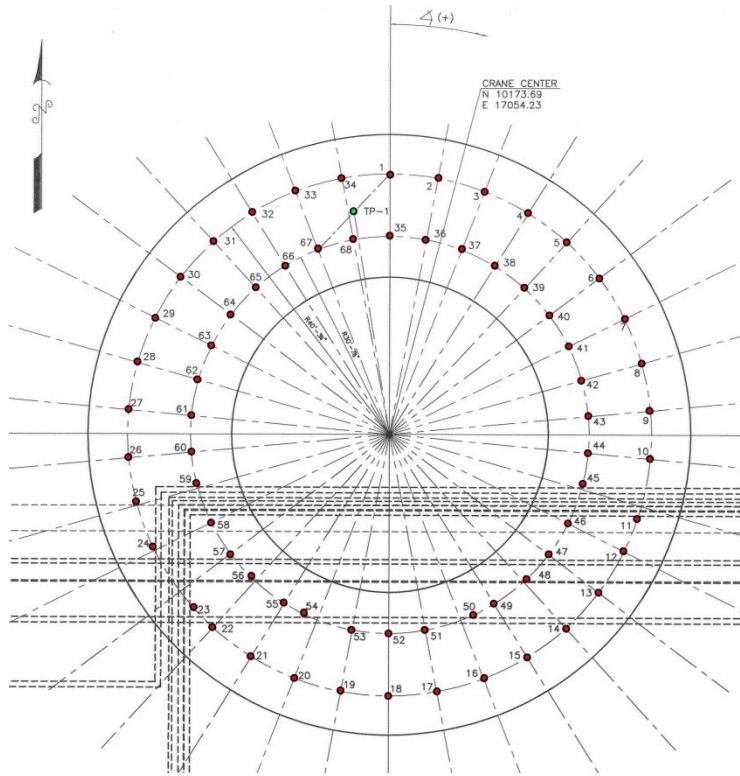
Figure 4. Original micropile layout for 68 piles.

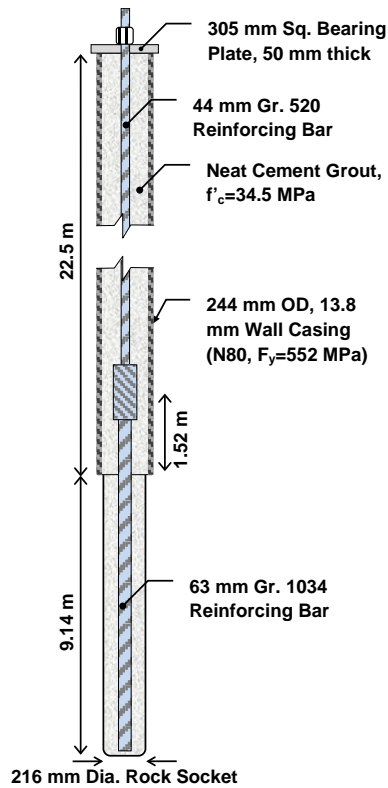
Figure 5. Typical micropile design profile view.

For constructability and drilling string rigidity, a 244 mm OD casing with 13.8 mm wall thickness was selected. This flush-joint casing was available in minimum yield strength F_y of 552 MPa. Figure 5 illustrates a vertical section through the design micropile section. A 44 mm diameter, Gr. 520 (ASTM A615) reinforcing bar was used in the cased portion of the micropiles to provide continuity into the bond length using a transition coupler. For the rock socket, assumed to be 216 mm in diameter, the reinforcing bar was required to be a 63 mm Grade 1034 (ASTM A722) threadbar assuming that the design compressive strength f'_c of the neat cement grout was 34.5 MPa. For the micropile cased and uncased zone (i.e. rock socket) described above and used in the preliminary design, the working structural resistances of the micropile segments are:

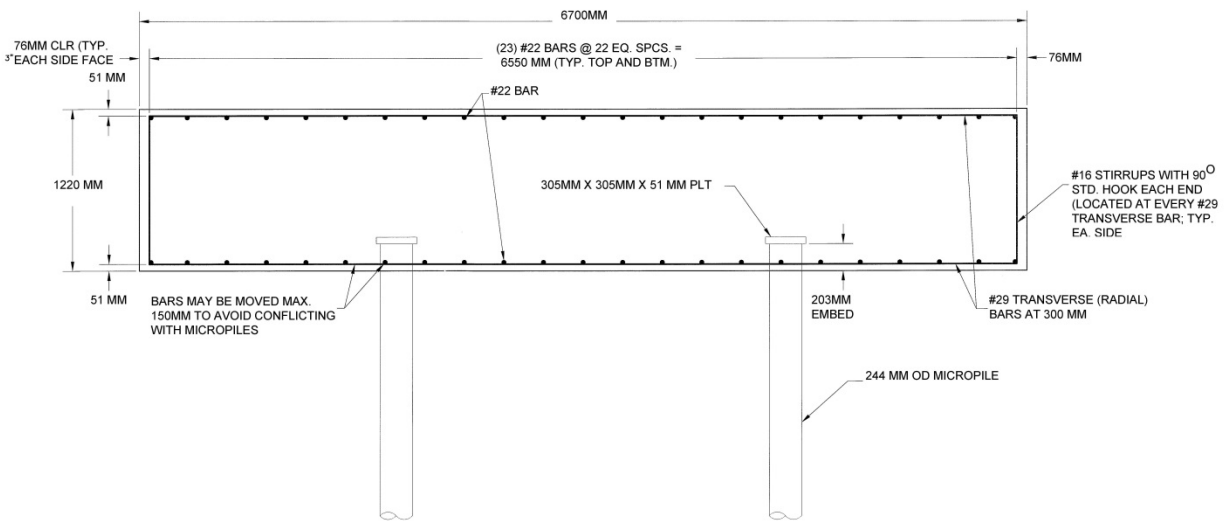
Figure 6. Reinforced concrete ring beam reinforcement layout and typical section.

Structural design of the reinforced concrete ring cap was performed by Civil and Structural Engineers, Inc. (CASE) of Lafayette, LA. CASE resolved the outrigger pad loads into an equivalent radial (line) load of 1,396 kN/m at the midpoint of the pad, located at a radius of 11 m from the centerpoint of the crane. When distributed to the two concentric rings of micropiles, situated at radii of 9.33 m and 12.27 m from the crane center, the resultant line loads are 823 kN/m and 626 kN/m respectively. Application of these line loads to a continuous member spanning between micropiles causes the critical span and moment to develop over the outer radial ring. Based on a factored maximum negative moment of -2,445 kN-m, the required flexural reinforcement in the 6.70 m wide cap was 8,450 mm², which was distributed through the cross section as shown in Figure 6. The transverse flexural reinforcement of 1,884 mm²/m was designed to resist a factored moment of 760 kN-m/m.

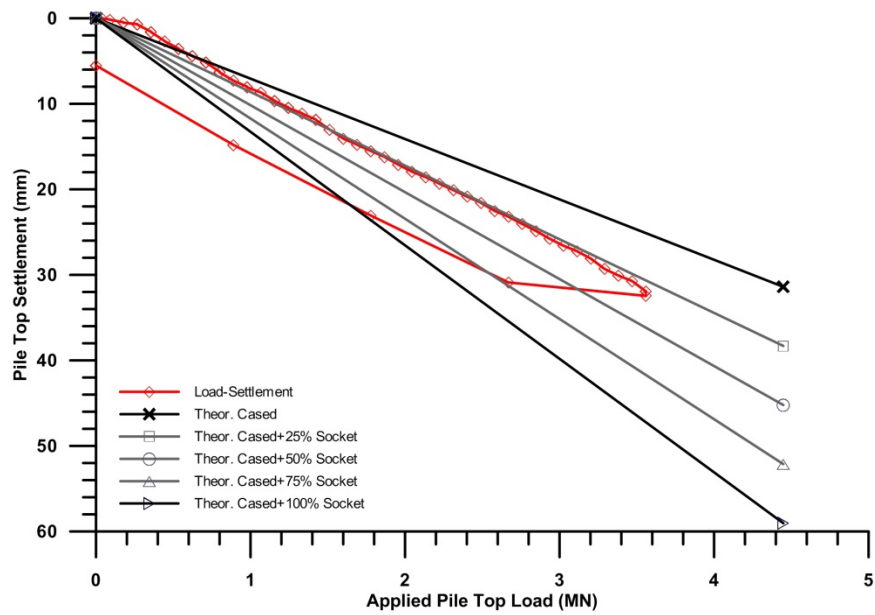
Figure 7. Load-settlement data from axial compression load test, including approximate elastic compression curves.

A plot of pile top load versus settlement is presented in Figure 7. The performance of the test micropile verified that the preliminary design was appropriately conservative. The measured settlements at design load (i.e. 1.78 MN) and test load (i.e. 3.56 MN) were 15.5 mm and 32.5 mm, respectively. Upon unloading back to zero load at the completion of the test, the permanent net settlement of the test pile was 5.7 mm, allowing that the gross load-deformation behavior to be classified as pseudo-elastic. Based on average elastic stiffnesses (i.e. $E_p A_p$) of 3,152 MN and 1,471 MN for the cased length and rock socket, it can be approximated that the load transfer in the test pile was limited to the upper 25 to 30% of the rock socket. Plots of the strain at each gauge level versus pile top load and a strain distribution with depth confirm this assessment; refer to Figures 8 and 9.

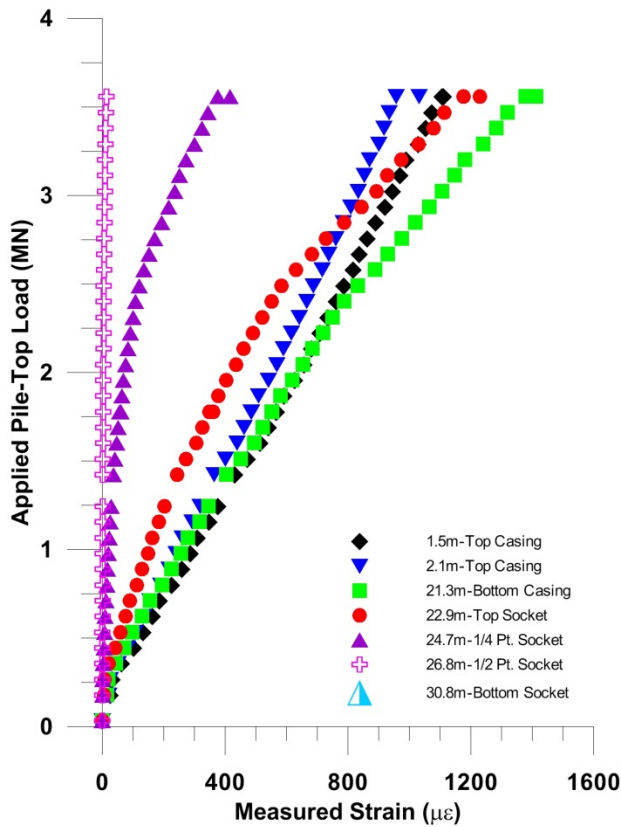
Figure 8. Measured strains at each gauge level versus pile top load.

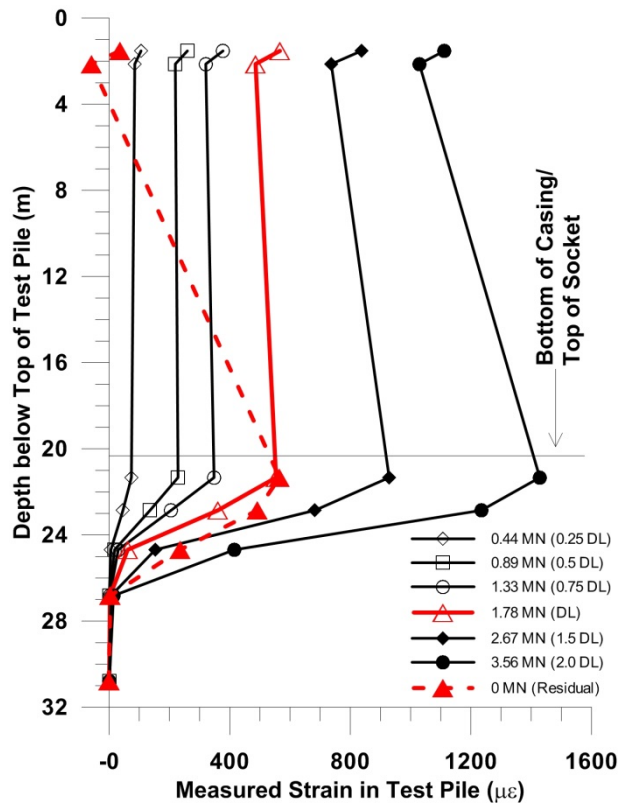
Figure 9. Strain distributions in the test pile at selected pile top loads.

The strain distribution within the test pile was used to estimate mobilized load transfer and unit bond stresses. As documented by Fellenius (1989), Holman (2009), and Kai (2006), composite deep foundations comprising steel and grout or concrete have nonlinear stress-strain behavior, with the result that tangent and secant moduli used to describe the axial compression response are not constant values. The general trend observed is that interpreted secant moduli E_p , and the pile axial stiffness $E_p A_p$ decrease with increasing strain levels. For micropiles, composite members with different cross sections and materials between the upper cased length and lower bond length, the decrease in stiffness has to be modeled for both sections of the pile (Holman, 2009). These procedures were followed for this project, and at each strain gauge level the load was estimated from

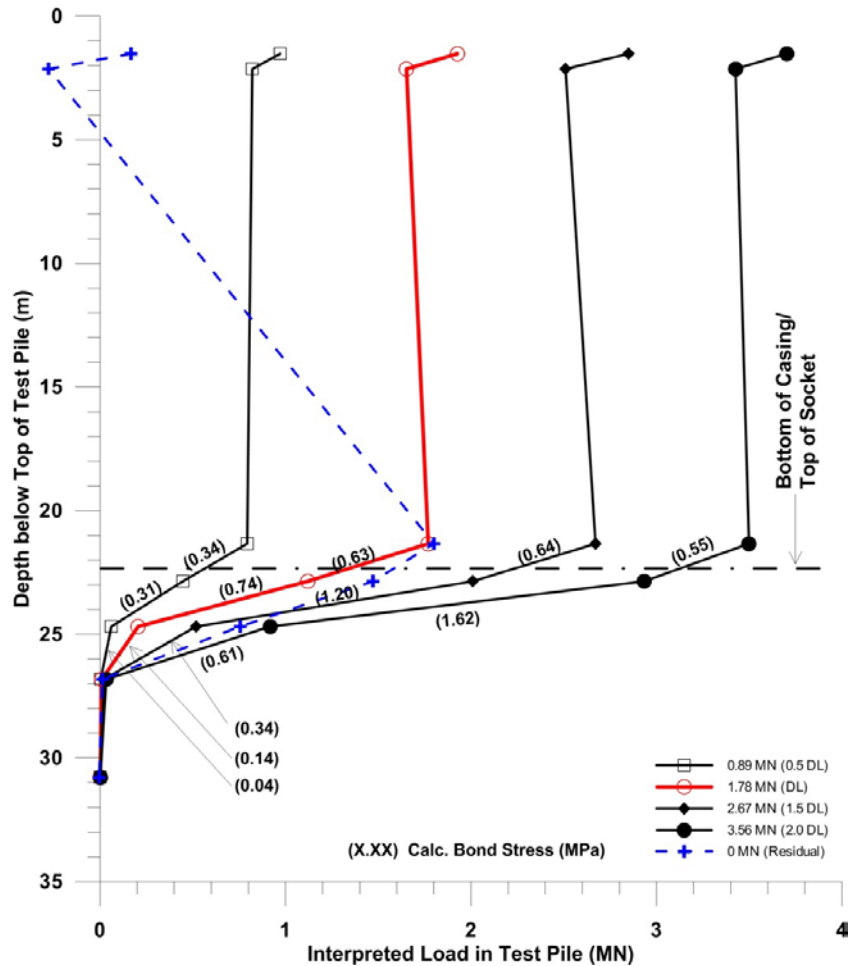
Figure 10. Load distribution and mobilized unit bond stresses in test micropile.

where ΔP is the decrease in load in the pile segment, d is the segment diameter, and ΔL is the segment length. Figure 10 shows the interpreted pile load distribution and τ_{mob} in the micropile for various pile top loads. The maximum mobilized bond stress was 1,620 kPa in the upper $\frac{1}{4}$ of the rock socket; this value is almost 2.5 times greater than the ultimate value assumed in the preliminary design. The load distribution indicates that effectively zero load transfer and unit bond stresses were mobilized below the midpoint of the rock socket at 26.8 m below ground surface. Upon unloading of the test pile, significant residual compression loads remained in the rock socket, with an interpreted average unit bond stress of 545 kPa still mobilized. The presence of residual loads is qualitative evidence that some level of permanent displacement occurred in the rock socket relative to the surrounding limestone.

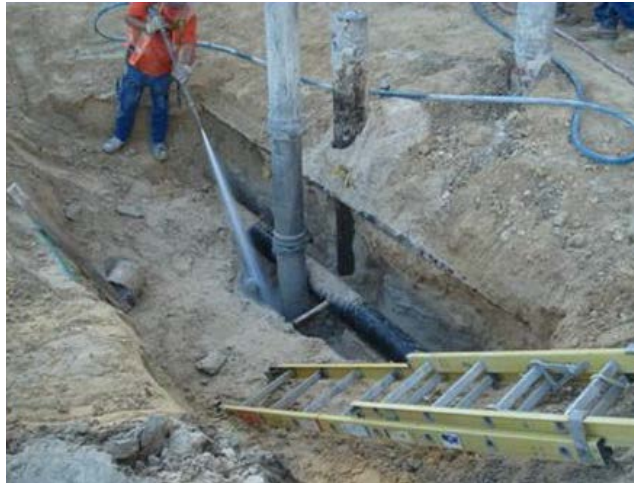
Figure 11. Micropiles surgically installed to clear existing utilities.

Moretrench exposed all of the utility lines within the vicinity of the crane pad. As anticipated, there were many conflicts between the planned micropile locations and the buried utilities. Figure 11 depicts one of the many utility excavations. An additional five micropiles were installed as a result of utility issues and the need to reduce spans between piles to make the pile cap thickness and reinforcement work. Figure 12 shows the final as-built pile layout, including the five additional piles. Even with the additional piles, extra reinforcement was required in many areas to allow the planned 1.22 m thick cap to be sufficient.

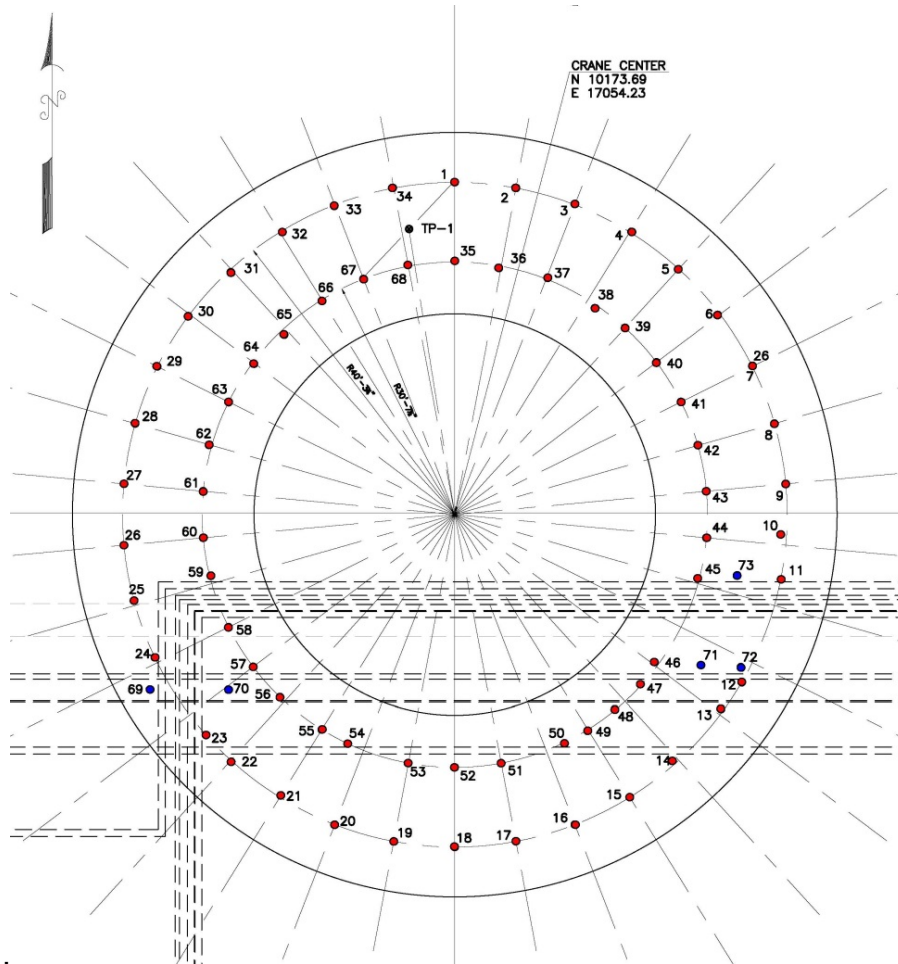
Figure 12. As-built arrangement of 73 micropiles including 5 additional piles installed to span utilities.

Based on the as-built micropile configuration, some localized overloading of the piles was anticipated due to longer spans. For example, working loads in the southeast quadrant were expected to reach 2.16 MN, a 22% overstress. In the southwest quadrant, the overstress was less than 5%. Based on the rigidity of the cap and the additional load-carrying capacity based on the load test results, the overstress was considered acceptable.

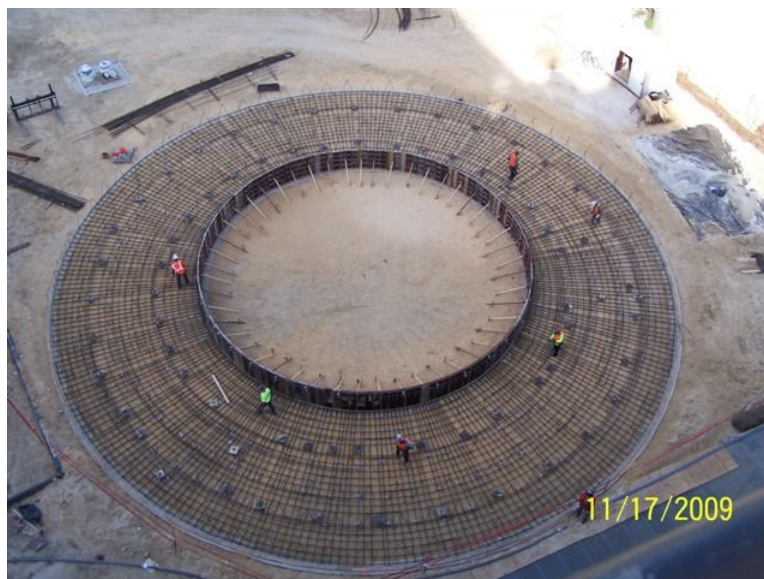
Figure 13. Placement of bottom mat of reinforcing steel and concrete formwork.

The ring beam pile cap reinforcement and formwork was constructed and concrete placement occurred on 24 November 2009. An in-progress photo of the reinforcement and formwork placement is shown in Figure 13. The design concrete strength of 34.5 MPa was reached in three days and a compressive strength of 41.4 MPa or higher was measured at seven days.

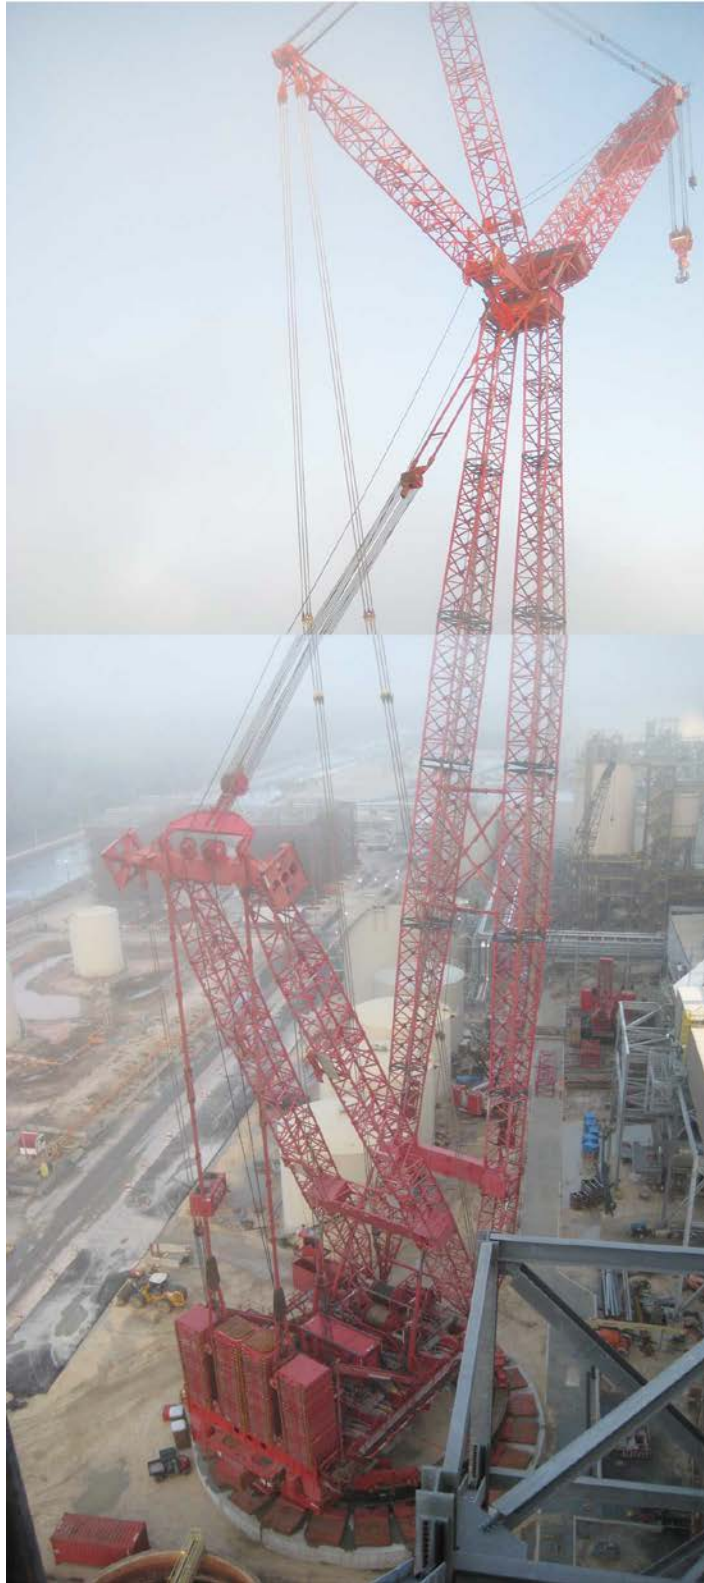
Figure 14. Mammoet PTC ring crane in operation, supported by the value-engineered micropile foundation.

The Mammoet 1800 metric tonne ring crane was assembled during December 2009 and January 2010. No issues were encountered with pile cap and foundation performance during the initial construction. During assembly and operation of the crane, on-board instrumentation did not indicate any deformations that were out of the range of safe operation. Active crane use began in February 2010 and continued until late May 2010. Figure 14 shows a photo of the ring crane during operation at the end of February 2010. The crane was dismantled during the period from May to June 2010; the foundation, including the micropiles, was demolished in June 2010.
