# **EDIFICIO PIEDRA REAL – CONCEPCION, CHILE**

## **CASE STUDY OF AN UPLIFT REINFORCEMENT PROJECT**

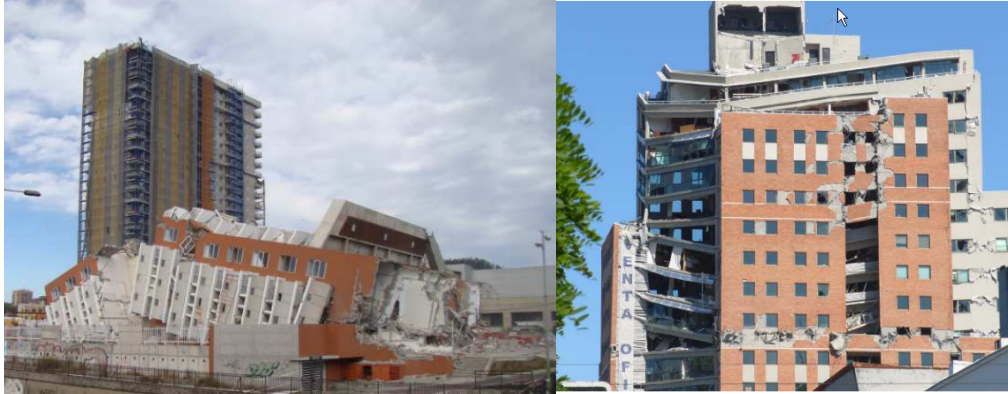
Examples of severe damage were observed in Concepcion, mostly in its downtown area, where one building fully collapsed (Alto Rio Tower) and several others had to be demolished due to partial failure at localized floors (Figure 5).

Figure 5 – Alto Rio Tower (fully collapsed, left) and O'Higgins Tower (partially collapsed, right) [2]

Based on field observations of severe damage on mid-to-high rising buildings, it seems that vertical irregularities - due to set-backs in the upper floors or due to stiffness differences of vertical elements (reduced cross-sections of vertical shear walls at the parking levels) - might have triggered the failure of vertical elements, as a result of an induced concentration of stresses (compression and tension), compounded with flexural solicitations experienced during the earthquake [1]. The observed damage has been also associated with site and/or basin effects, ground failure (displacements caused by liquefaction) as well as with the soil classification, that led to define both the design spectra and the foundation type [9].

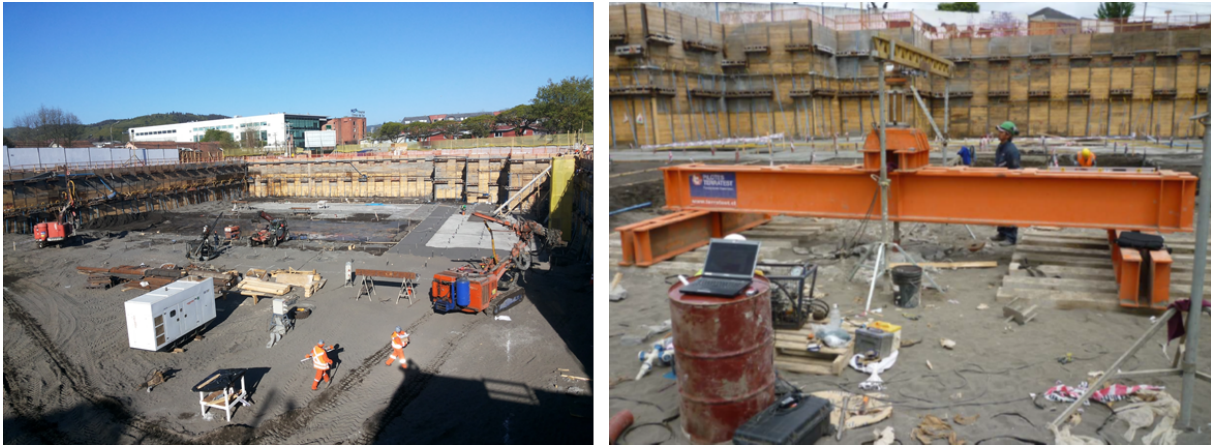
The micropiles were installed from the bottom of the excavation pit (Figure 11). Up to three drilling machines were used for the installation: two Tamrock rigs and one Morath drifter (HB70), attached to a telescopic jib (Manitou). The achieved drilling performance was approx. 100m/day/equipment.

After installation, load tests were carried out in order to verify the adopted design considerations, especially regarding the skin friction of the layer H3. Three test micropiles were executed: 1x73/53, 1x 52/26 and 1x40/16. The micropiles were subjected to maximum test loads, equal to 90% of the yield force (at 0.2% elongation) for the correspondent micropile type, without reaching the ultimate limit state of the pull-out resistance (Figure 12). The required safety level and the adopted design considerations were validated. The registered displacements for the design loads were between 9 and 13mm.

Figure 11 – Installation of the micropiles (left) and load tests (right)

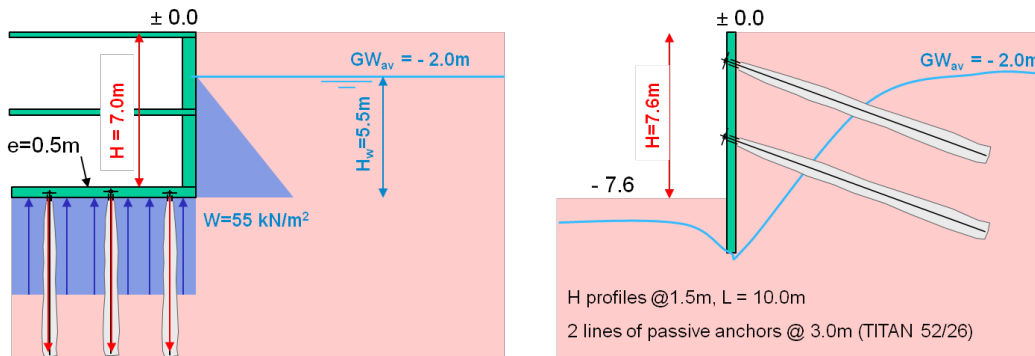
The implementation of the presented uplift reinforcement solution had also a positive effect in the temporary shoring and groundwater lowering, since the excavation depth was considerably reduced to 7.6m, making possible to optimize the design of the above mentioned items (Figure 14).

The lateral support for the soldier pile wall was also materialized with TITAN tension piles (passive anchors). This solution was also proven to be more convenient than the originally considered use of strand anchors, since the higher installation speed of self-drilling anchors (>100meter/day) enabled to finish the excavation shoring faster. Furthermore, the installation of anchors and micropiles was carried out using the same equipment, simplifying the logistic at the construction site and reducing its costs (i.e. mobilization).

Figure 14 – Adopted design approach (left) and constructive measures for the temporary excavation shoring (right)
