HIGH CAPACITY MICROPILES AT PROJECT IN CAMBRIDGE, MA, USA

Anthony C. Barila, P.E., John R. McKinnon and Amy D. Apfelbaum, P.E.

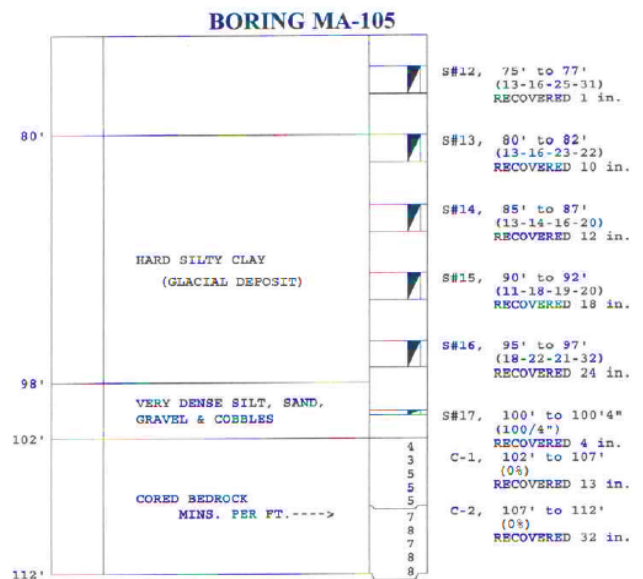
Run No.	Sample Depth [Feet]	Sample Recovery [Inch]	RQD%	Drill Time [Min./Foot]	Sample Description
RC-1	102'-107'	13"/60" 22%	0%	4-3-5-5-5	Soft, severely weathered, extremely fractured, grey, amorphous CAMBRIDGE ARGILLITE. Too weathered to describe joints, dipping or bedding.
RC-2	107'-112'	32"/60" 53%	0%	7-8-7-8-8	Soft to medium hard, severely weathered, extremely fractured, grey, fine grained CAMBRIDGE ARGILLITE, close, smooth to rough joints, with thin, moderately dipping bedding.

Figure 2: Rock coring portion of the boring log

The pile load test was performed on the site immediately adjacent to a new test boring that was performed to better identify the rock quality at the test pile location. Refer to Figure 2 for the rock coring portion of the boring log. The rock cores indicated the upper 10 feet to be weathered and highly fractured with low to moderate recovery and very low RQDs (0%). The rock is a fairly soft sedimentary rock - the Cambridge Argillite formation.

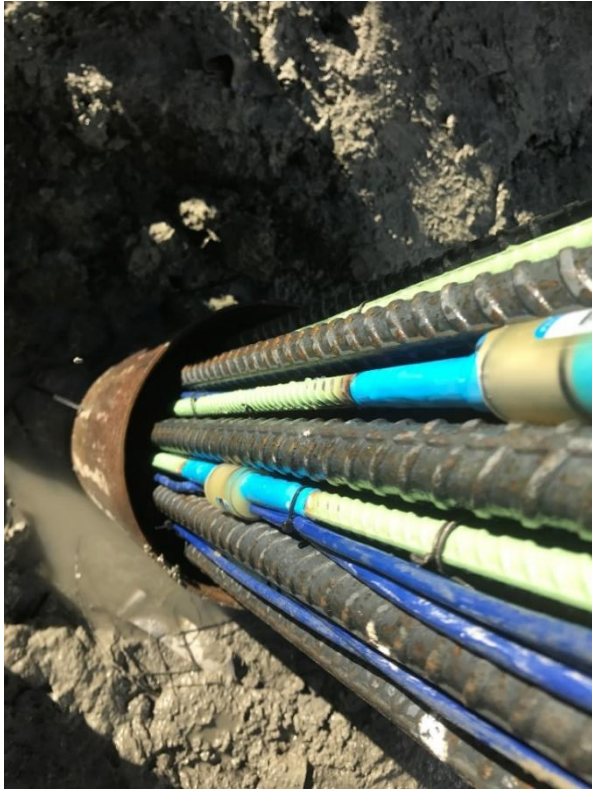
Photo 1: Test Pile Socket Reinforcing and Instrumentation

was required to accurately set the reinforcing steel and the large amount of instrumentation, and to make it all fit within the permanent drill casing. The entire length of the socket reinforcing, which consisted of the No.32 Grade 80 bar and the 7" O.D.x 0.408" casing, was constructed prior to setting it into the pile. This was done with a service crane. Photo 2 shows the test bar being lowered while the installation crew guided this bundle down the hole while holding the many strain gauge wires to avoid damaging them. The remaining threaded bars were set in 25 ft lengths and coupled together. Photo 3 shows the installation crew threading the massive No.32 couplers and bars together.

The test pile was drilled on 1/19/18 and grouted on 1/10/18. The test pile was heavily instrumented. Figure 1 also shows the location of the instrumentation (strain gauges and tell-tales). Note the high frequency of the strain gauges in the upper 4 feet of the rock socket where we anticipated that most of the test loads would be dissipated in. The strain gauges are utilized to monitor very small movements to correlate to load at that location. Tell-tales are utilized to determine movement at the top and bottom of the rock sockets. As seen in Photo 1, a high level of detail

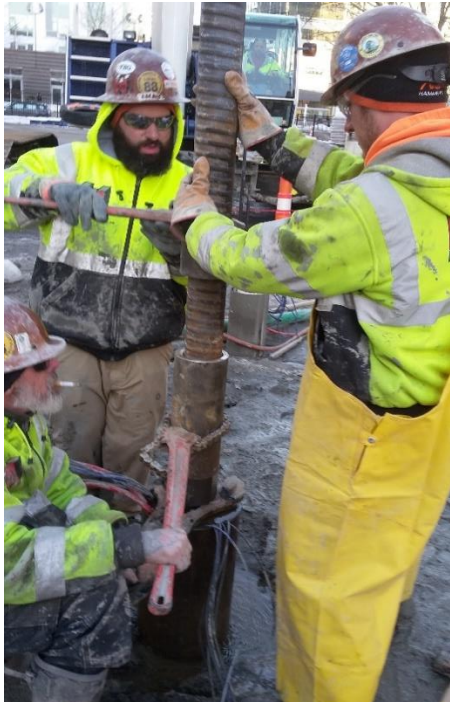
Photo 3: Threading together No.32 Bars

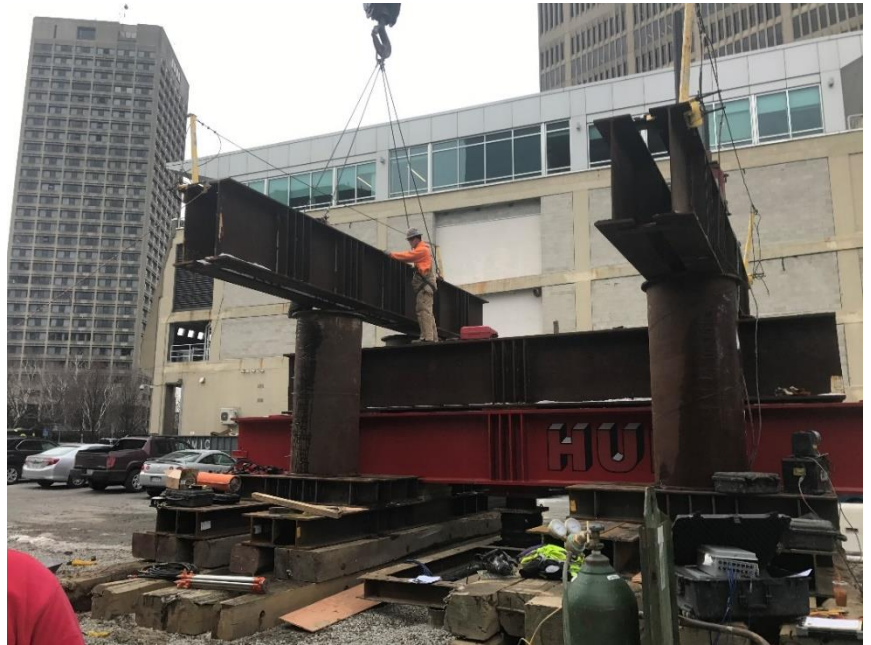
Photo 4: Constructing the Test Frame

The test frame consisted of two double beams stacked one atop the other. This double stacked setup can provide over 1800 tons of reaction capacity with reasonable deflection. Photo 4 shows the crew constructing the large frame. Double beam reaction beams were used to tie the reaction tiedowns into the system. Also seen in Photo 4, a network of H-beams were used to transfer the 2000 tons of tiedown force evenly to the soil. If the load was not transferred evenly, the frame could undergo differential settlement during the lockdown process which would necessitate redoing this time-consuming process.

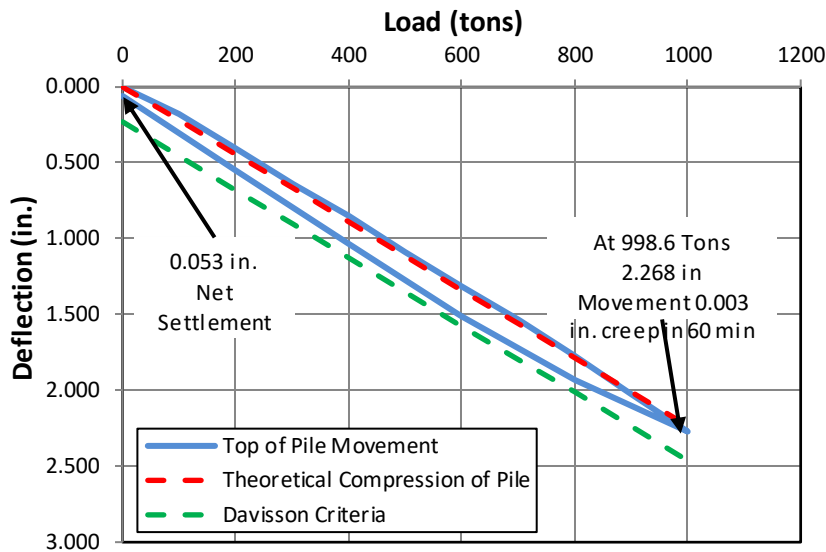
Figure 4: 1000 Ton Settlement v Load Graph

Figure 4 provides the settlement v load test plot for the second cycle to 998.6 tons. The total settlement was 2.268” with a 60 minute creep rate of 0.003” and a net settlement of 0.053”. Like the first cycle, the pile settlement followed the theoretical compression for the full test load and the rebound of only 0.053” shows minor non-elastic settlement. This test would have documented a 500 ton allowable design load.

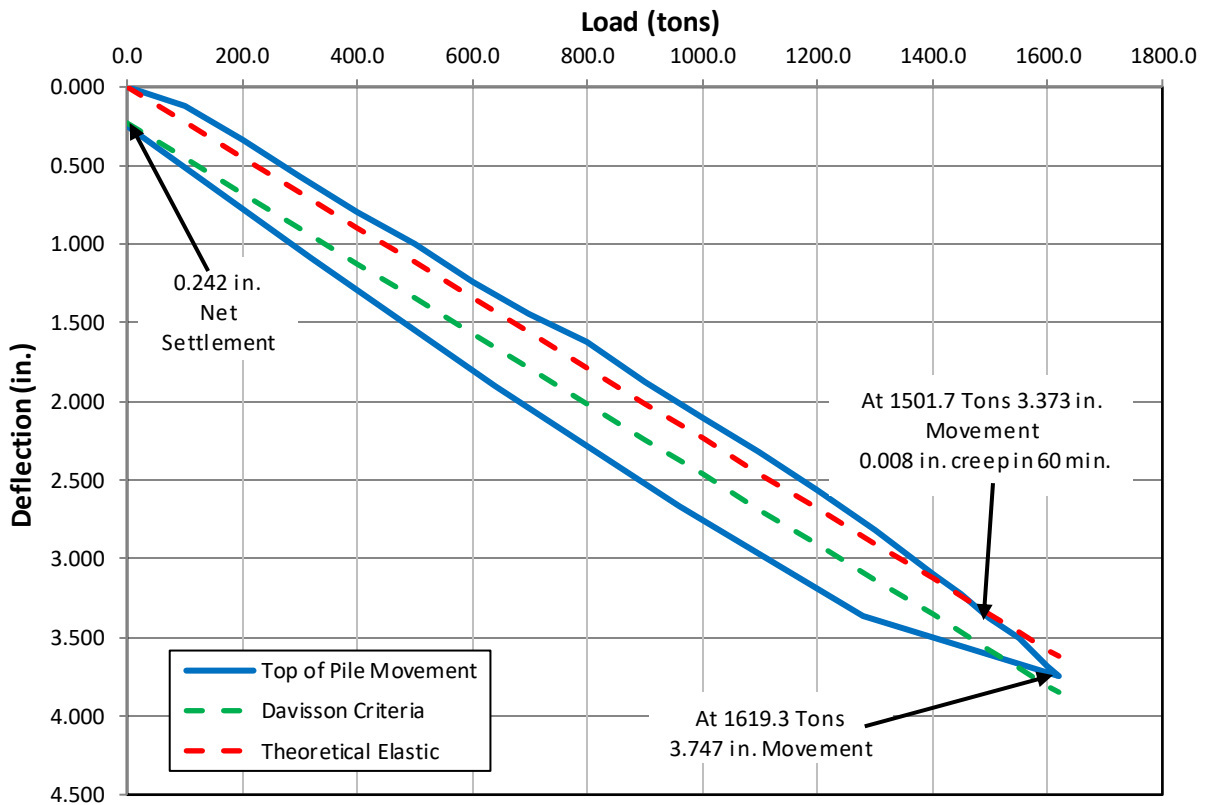
Figure 5: 1619 Ton Settlement v Load Graph

Figure 5 provides the settlement v load plot for the last cycle to 1619.3 tons. The total settlement was 3.747", with a 10 minute creep rate of 0.001" and net settlement of 0.242". The pile settlement was essentially parallel to the theoretical compression and the settlement of only 0.242" shows minor plastic deformation. This test could have documented an 800 ton allowable design load.

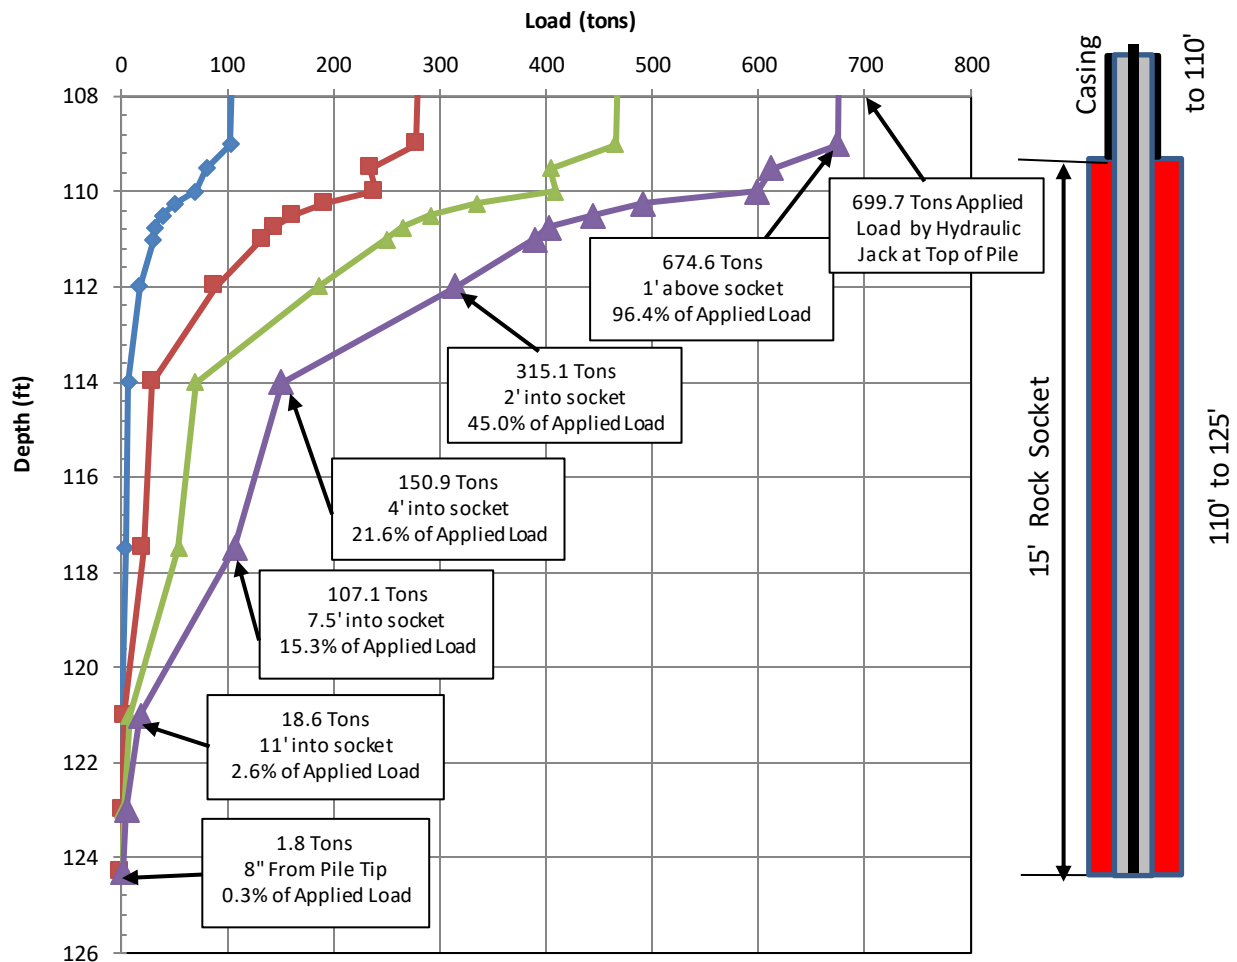
Figure 6: 700 Ton Load Distribution Graph

One of the points that the authors made in the paper presented at the Vancouver ISM is that the majority of the test loads are transferred in the upper 5 feet of the rock socket. Figures 6 and 7 provide a detailed view of the load distribution of the 699.7 ton and 1619.3 ton cycles within the upper portion of the rock sockets. For both cycles, approximately 100 to 120 tons of the test load was transferred at the bottom of the casing. Approximately 310 to 519 tons were transferred 1 foot below the casing for the 699.7 ton and 1619.3 ton cycles, respectively. At 4 feet below the casing, approximately 549 to 847 tons were transferred for each cycle respectively. This is 52% to 78% of the maximum test loads.

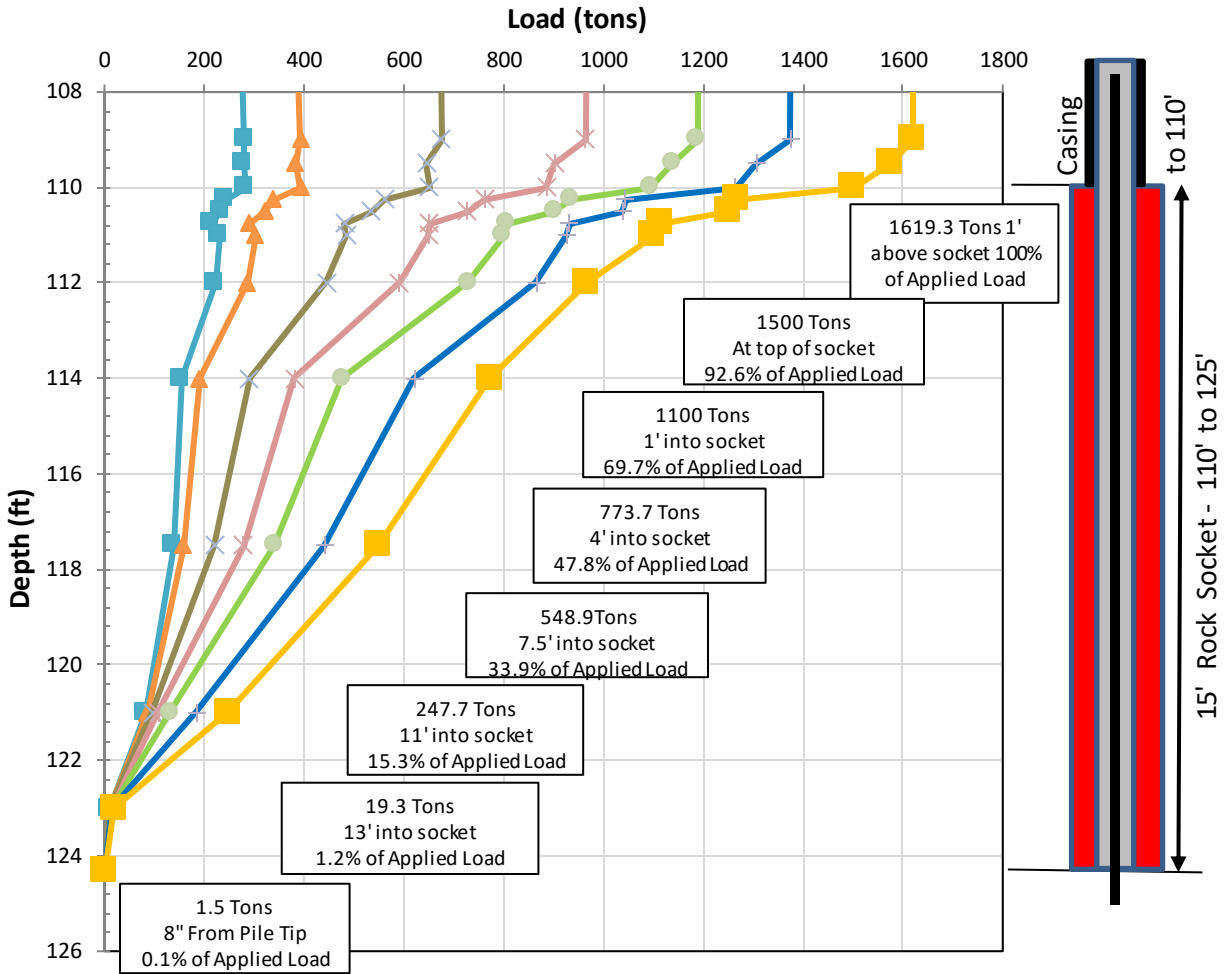
Figure 7: 1619 Ton Load Distribution Graph

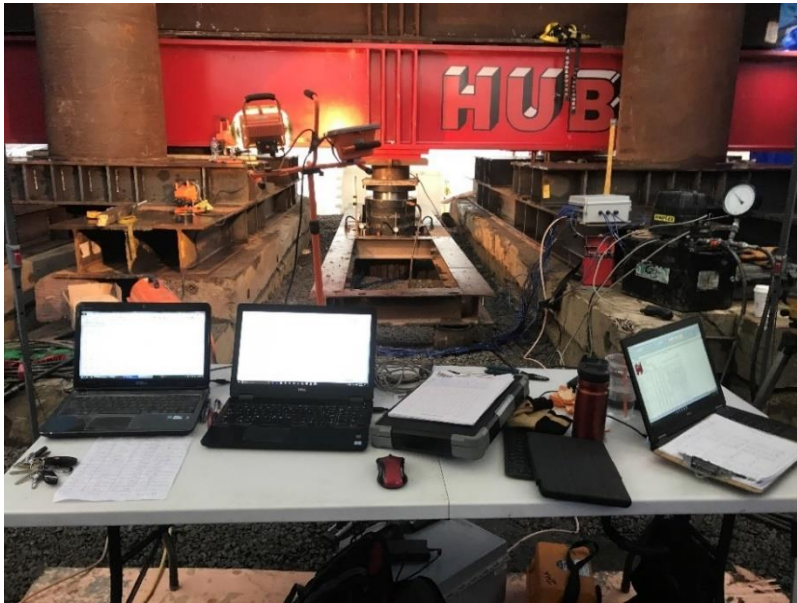
Photo 5: 1000 Ton Test

Photo 5 shows the test during the 1000 ton test cycle. During the testing, all the instrumentation was monitored and analyzed to provide a complete real time picture of settlement and load distribution within the test pile.

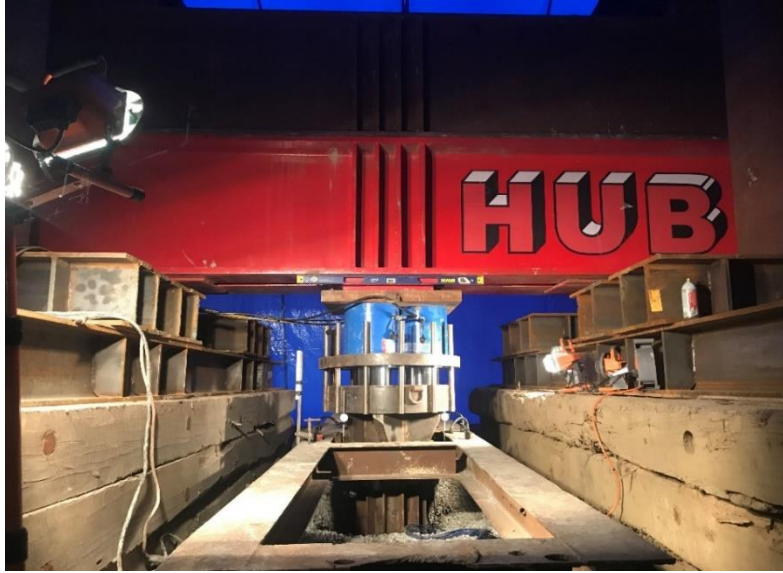
Photo 6: 1619 Ton Test

Photo 6 shows the test during the final cycle which resulted in the final test load of 1619.3 tons. Note the cage that was constructed to house the triple jack setup. It is critical when testing at extremely high loads to identify any and all hazards and provide additional measures to mitigate the hazards. And in the event that a failure of some sort occurs, to have safety measures to protect the people and equipment close to the test.

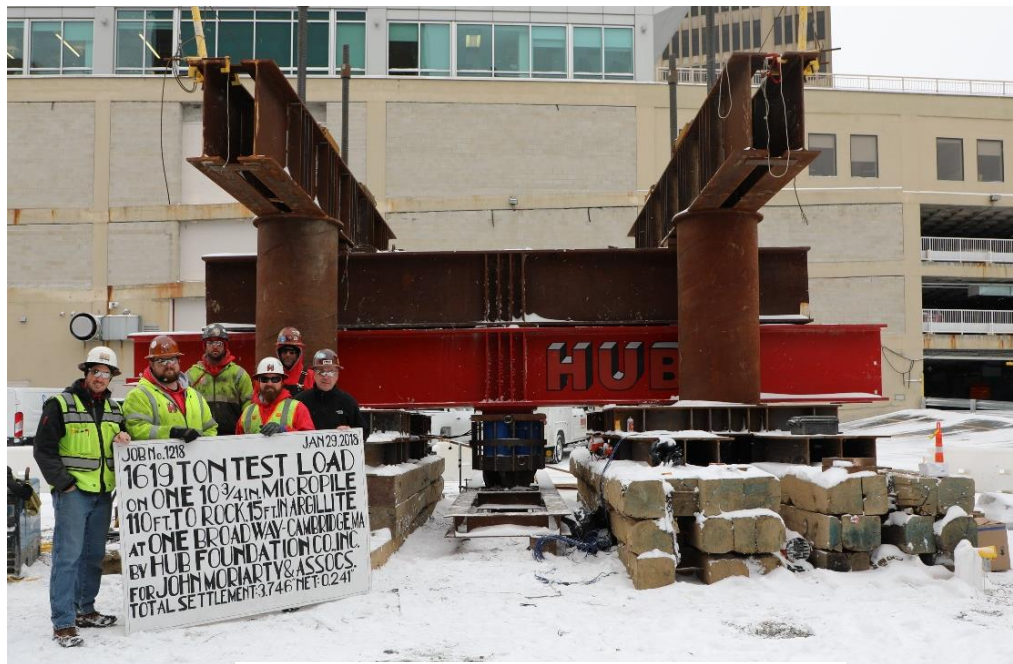
Photo 10: 1619 Ton Pile Load Test on Micropile Performed on Site

It is noteworthy, as shown in Photos 9 and 10, to highlight one of the established and highly praised views within the specialty foundation drilling industry of the dedication of Hub Foundation to enhance and innovate our industry. The 1969 photo shows a record-setting pile load test on a driven H pile at a site in Springfield Massachusetts. The 2018 photo, taken at this site, shows the continuation of this tradition to advance our industry and to take our products to the highest limits possible and safely.
