## Schrobenhausen 2006

### The use of micropiles to strengthen old walls and stabilise steep slopes in Quedlinburg, Germany

#### Brief description of the current position

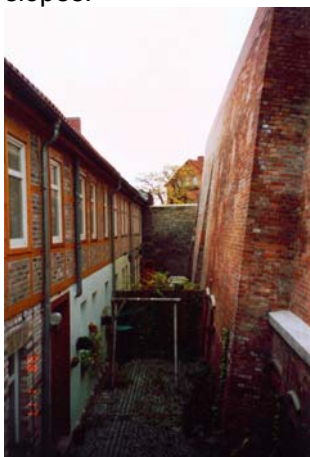
*Photograph of same location (Axis 9)*

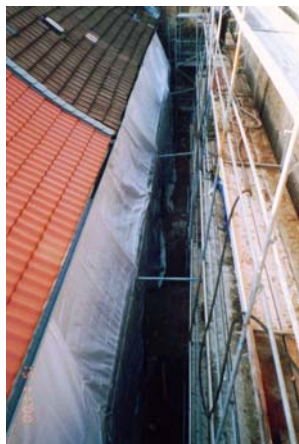
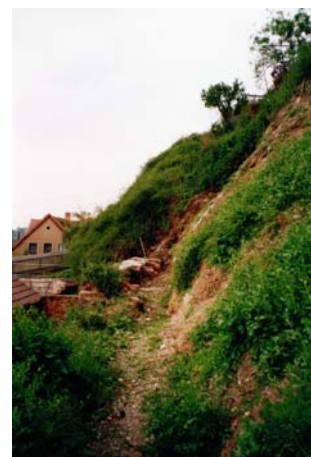
*Steep slope*

Various slopes have over many decades been built up with the “cultural layer“ (“Kulturschutt“) and building rubble to such an extent, that they have become ultracritical. In some isolated cases this has already resulted in retaining structure and slope stability failures.

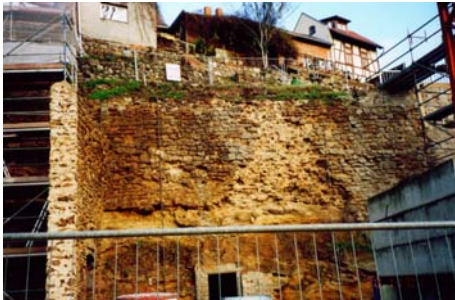
The deterioration / decay of the old walls was basically due to the following reasons:

- Load increase due to increased height of slopes / embankments or new / additional traffic loads.
- As the back of the walls was not waterproofed isolated, surface water seeped / diffused through the wall section resulting in "flushing out" / "washing out" of the binding agent, which in turn caused the internal bond of the walls to approach zero.

*(photograph of deteriorated / decayed wall)*

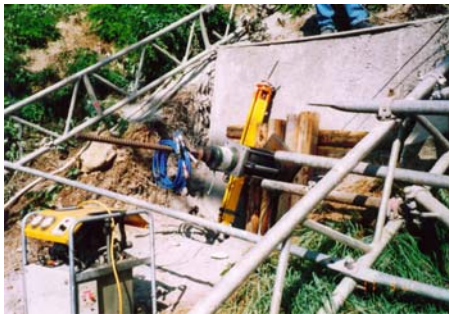
It goes without saying that we carried out static load tests (tension and compression) on each site in advance of the main works.

*Static load test*

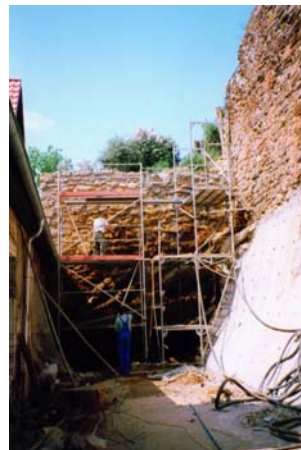
*Old situation*

The joints of the wall contained only very small amounts of binding agent.

The sandstone beneath the foot or base of the wall was also leached or washed out and, therefore, quite weakened.

The retained road surface behind the wall was now used by heavy goods vehicles which didn't even exist at the time the wall was built.

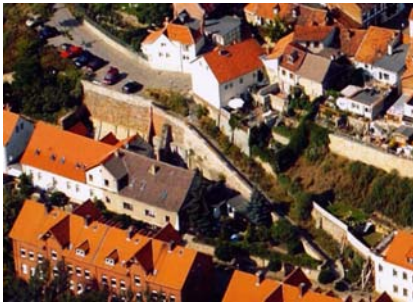
- Stabilisation of the foot / base of the wall. To that end we used prestressed anchors (the only time at the Münzenberg) because of the limitations on deformation.
- Injection of binder in the sandstone.
- Strengthening of the brick wall (grouting, dowelling).
- Installation of a piled wall with micropile tie-back anchors.
- Excavation of the space between the old brick wall and the newly installed piled wall.
- Waterproofing back of old wall and installation of drainage system.
- Backfilling space between walls, whereby the lower section was backfilled with single-sized aggregate concrete to such a level that enabled the brick wall to resist the silo wall pressure resulting from the soil backfill.

*General view after finish*

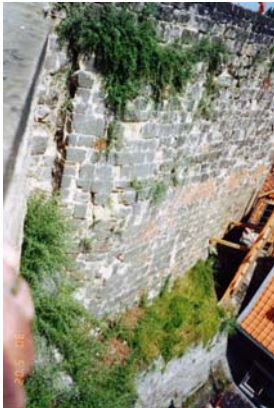
This roughly 9.6 m high wall stepped at 7.7 m had developed a very severe bulge which had been hidden for many years behind the houses along this stretch of the road.

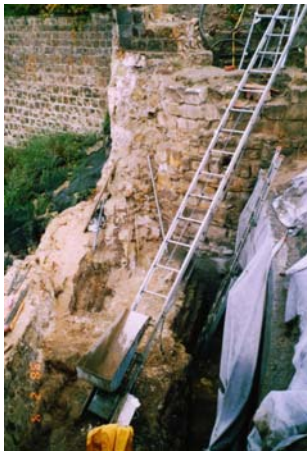
During the process of dismantling the wall we discovered (as a partial explanation for the stability of the old wall) a Baroque wall and the apsis of the oldest chapel of Quedlinburg.

View on apsis

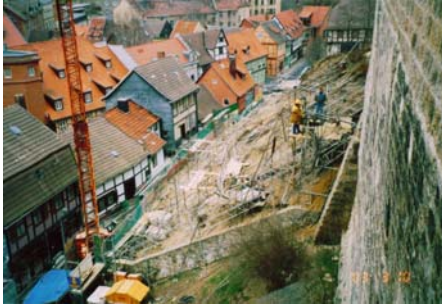
Anchor drilling

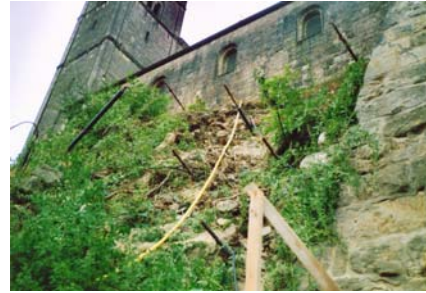
Anchors in slope

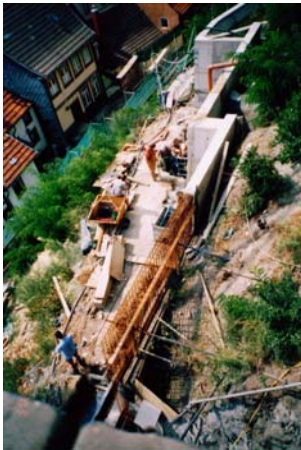
Wall panels from above

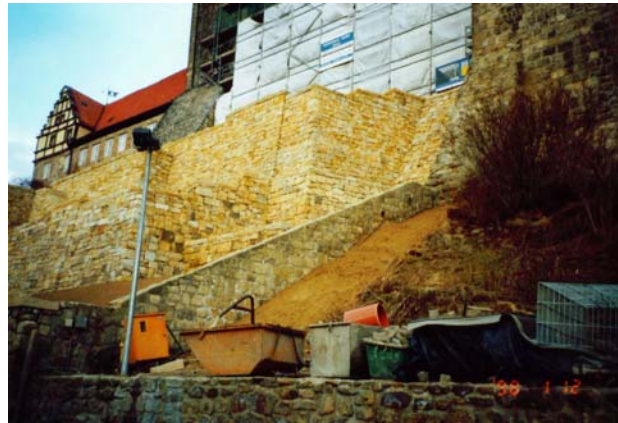
Finished construction
