HIGH CAPACITY MICROPILES IN MINED GROUND FOR BRIDGE SUPPORT: A CASE HISTORY OF SITE INVESTIGATION, GROUND CHARACTERIZATION AND THE EVOLUTION OF FOUNDATION DESIGN AND TREATMENT CONCEPTS

ABSTRACT

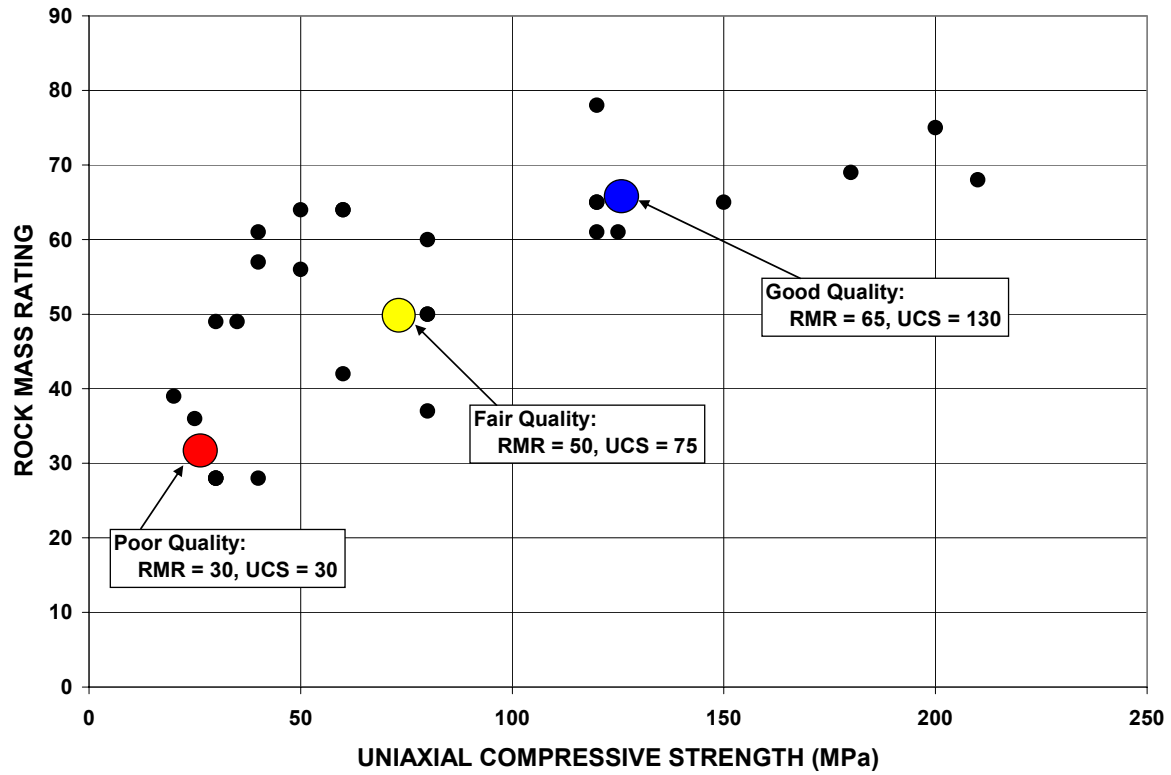
Figure 4. Rock Mass Ratings for Load Bearing Zones (“Roof Beam”)

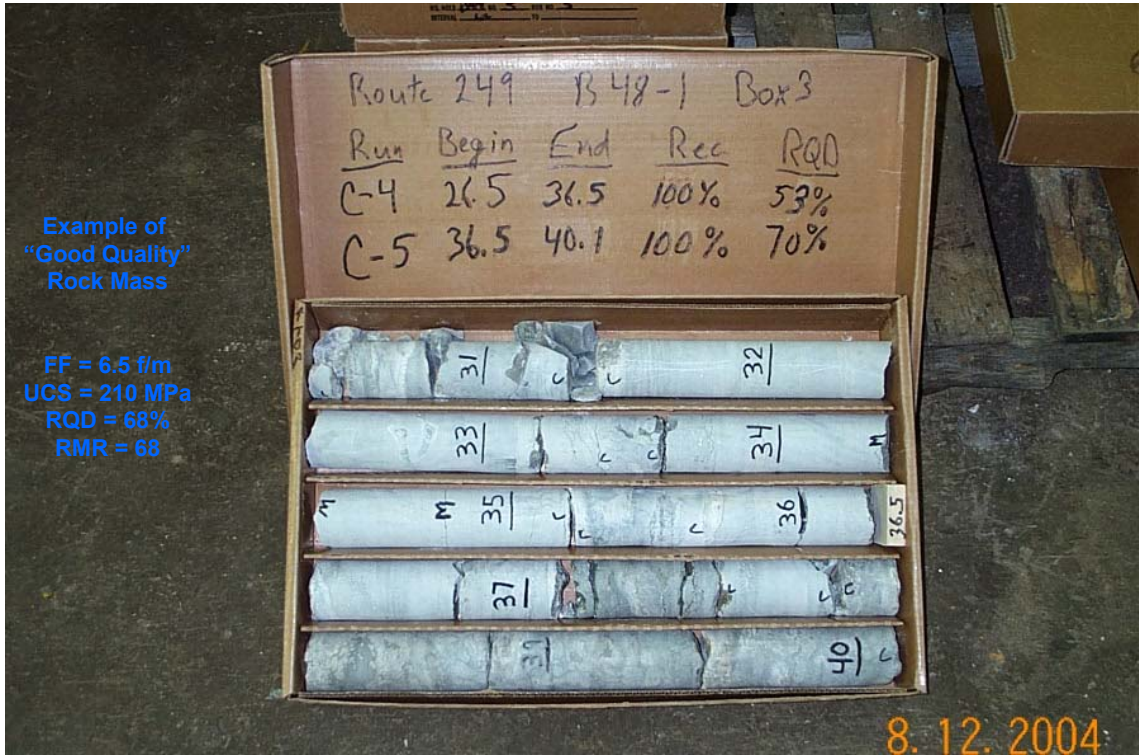
Figure 5. Example of “Good Quality” Rock Mass

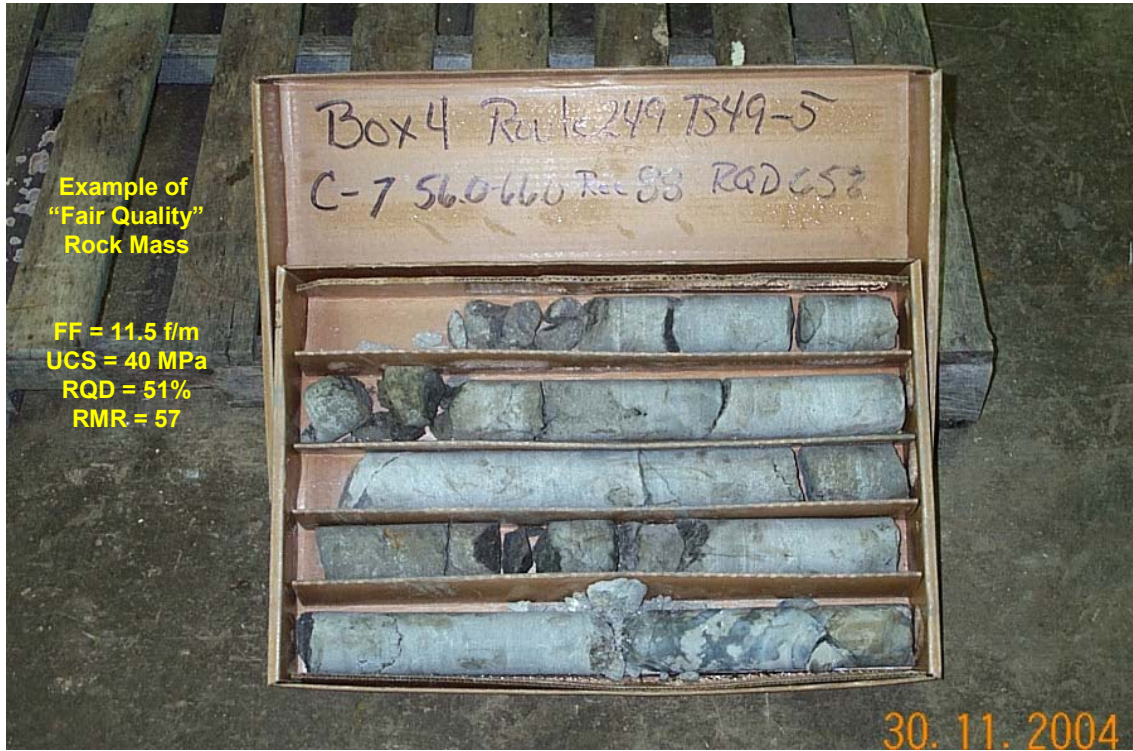
Figure 6. Example of “Fair Quality” Rock Mass

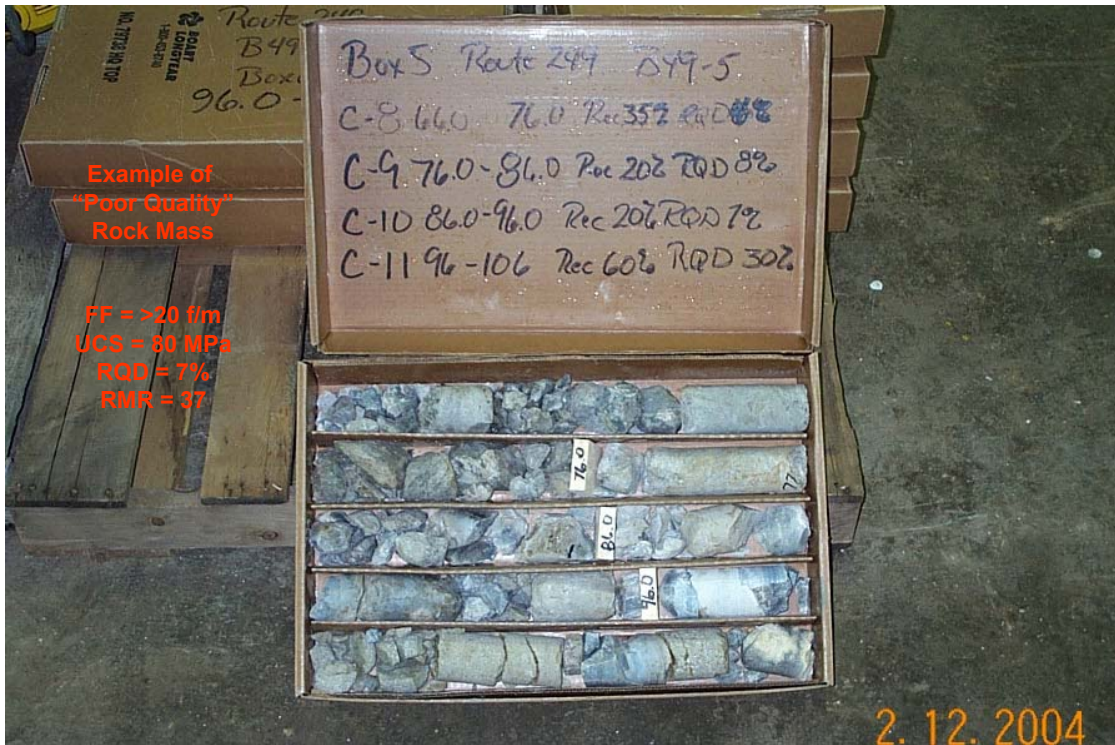
Figure 7. Example of "Poor Quality" Rock Mass

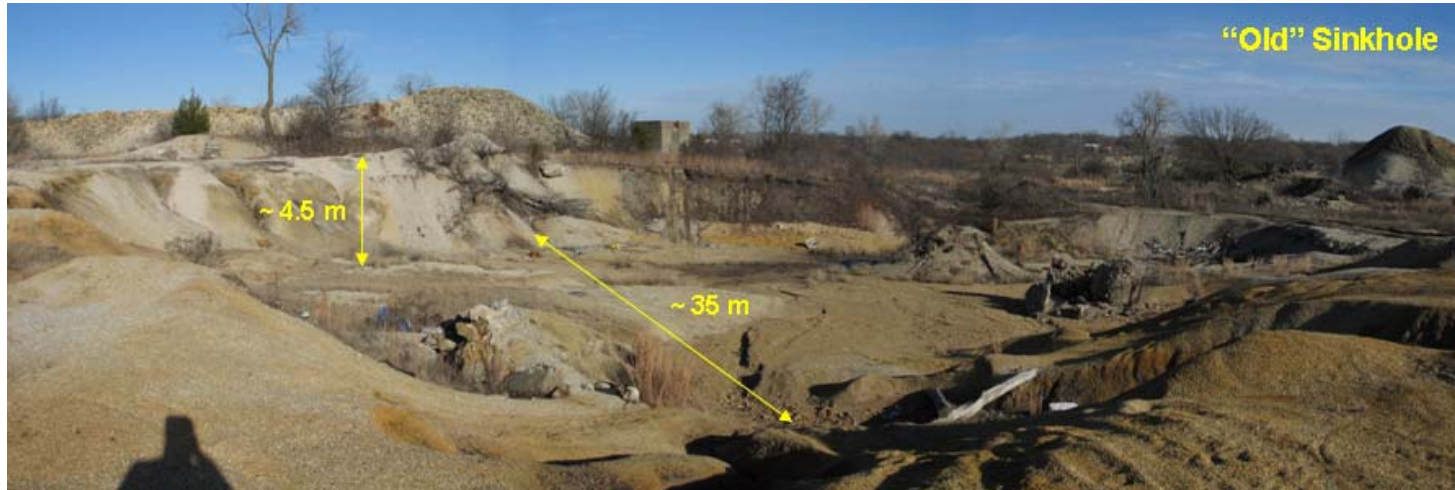
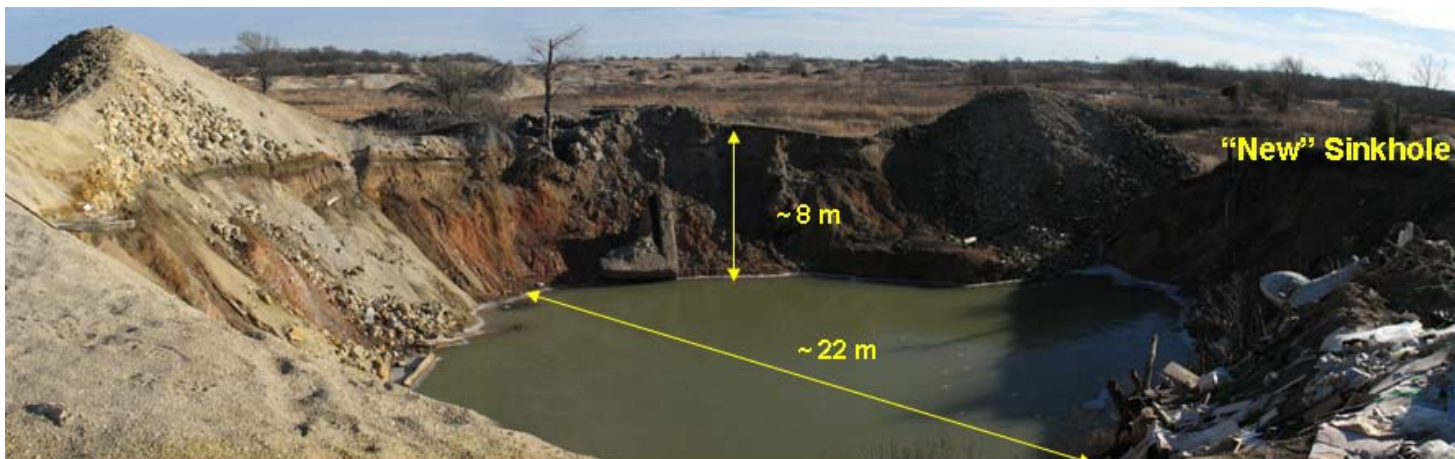
Figure 9. Horizontal Continuity Estimation of Voids

The initial stress analyses attempted to calibrate the model by determining the combinations of rock quality, void width and beam depth that would replicate the observed sinkhole development shown in Figure 9. An example of this analysis is shown in Figure 12 in which it is shown that Fair Quality rock over a 40 m void at 10 m depth would have marginal stability.

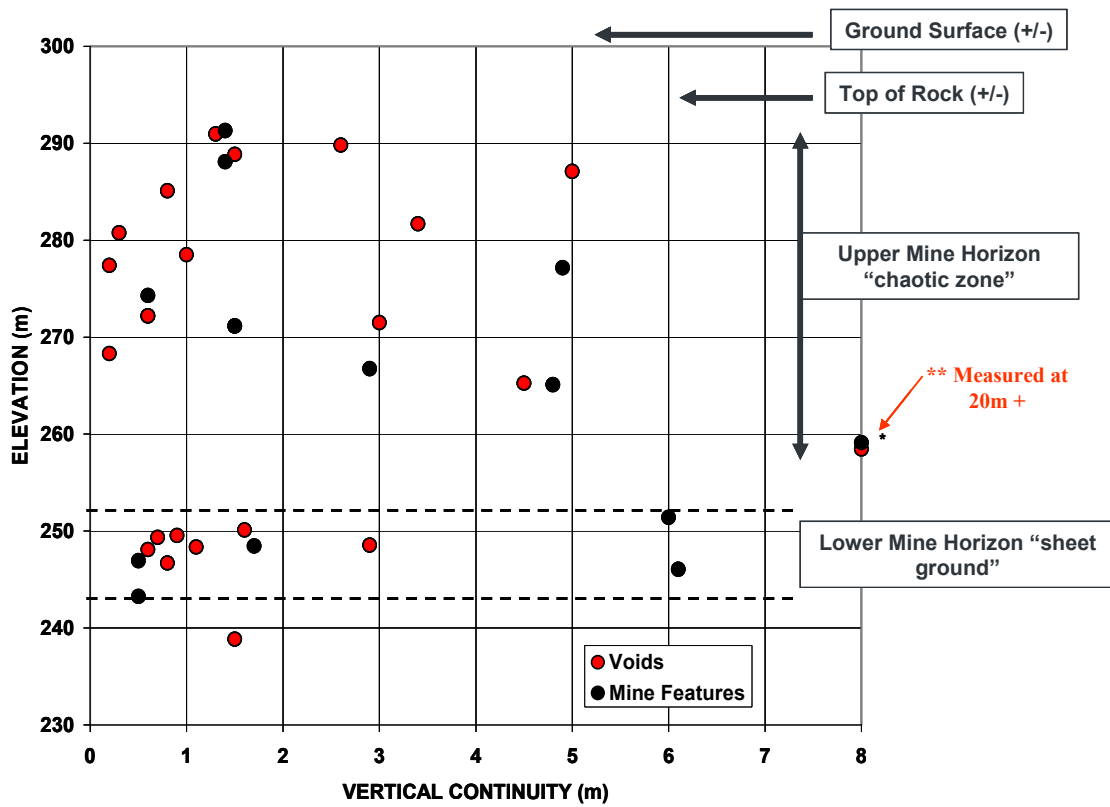
Figure 10. Vertical Continuity Estimation of Voids

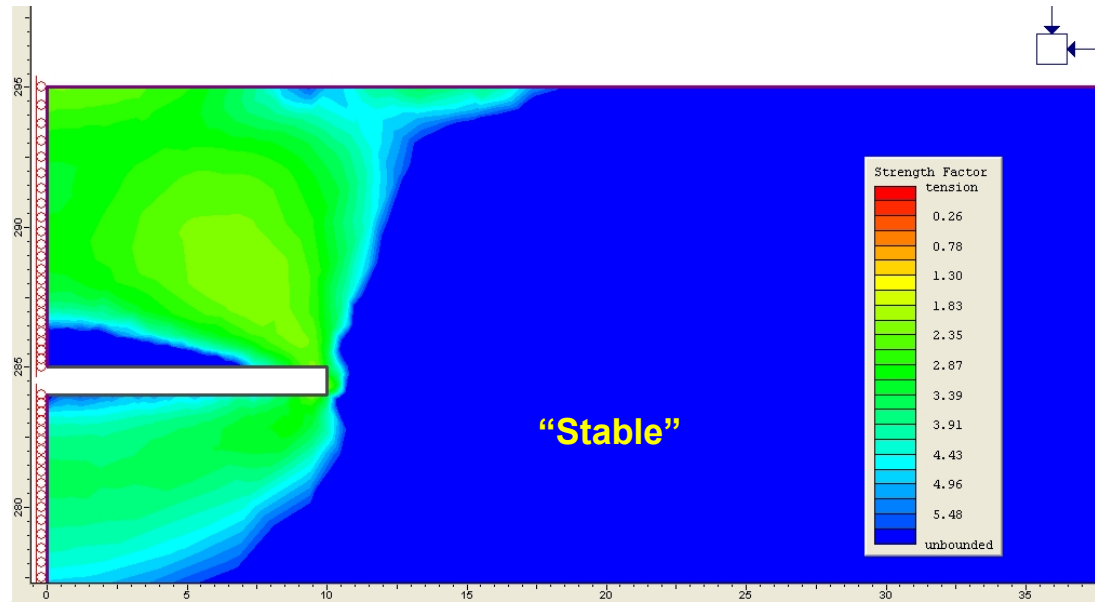
**10 m beam depth
20 m void width
Self weight**

**10 m beam depth
40 m void width
Self weight**

Figure 12. Finite Element Analyses – Roof Stability over Void

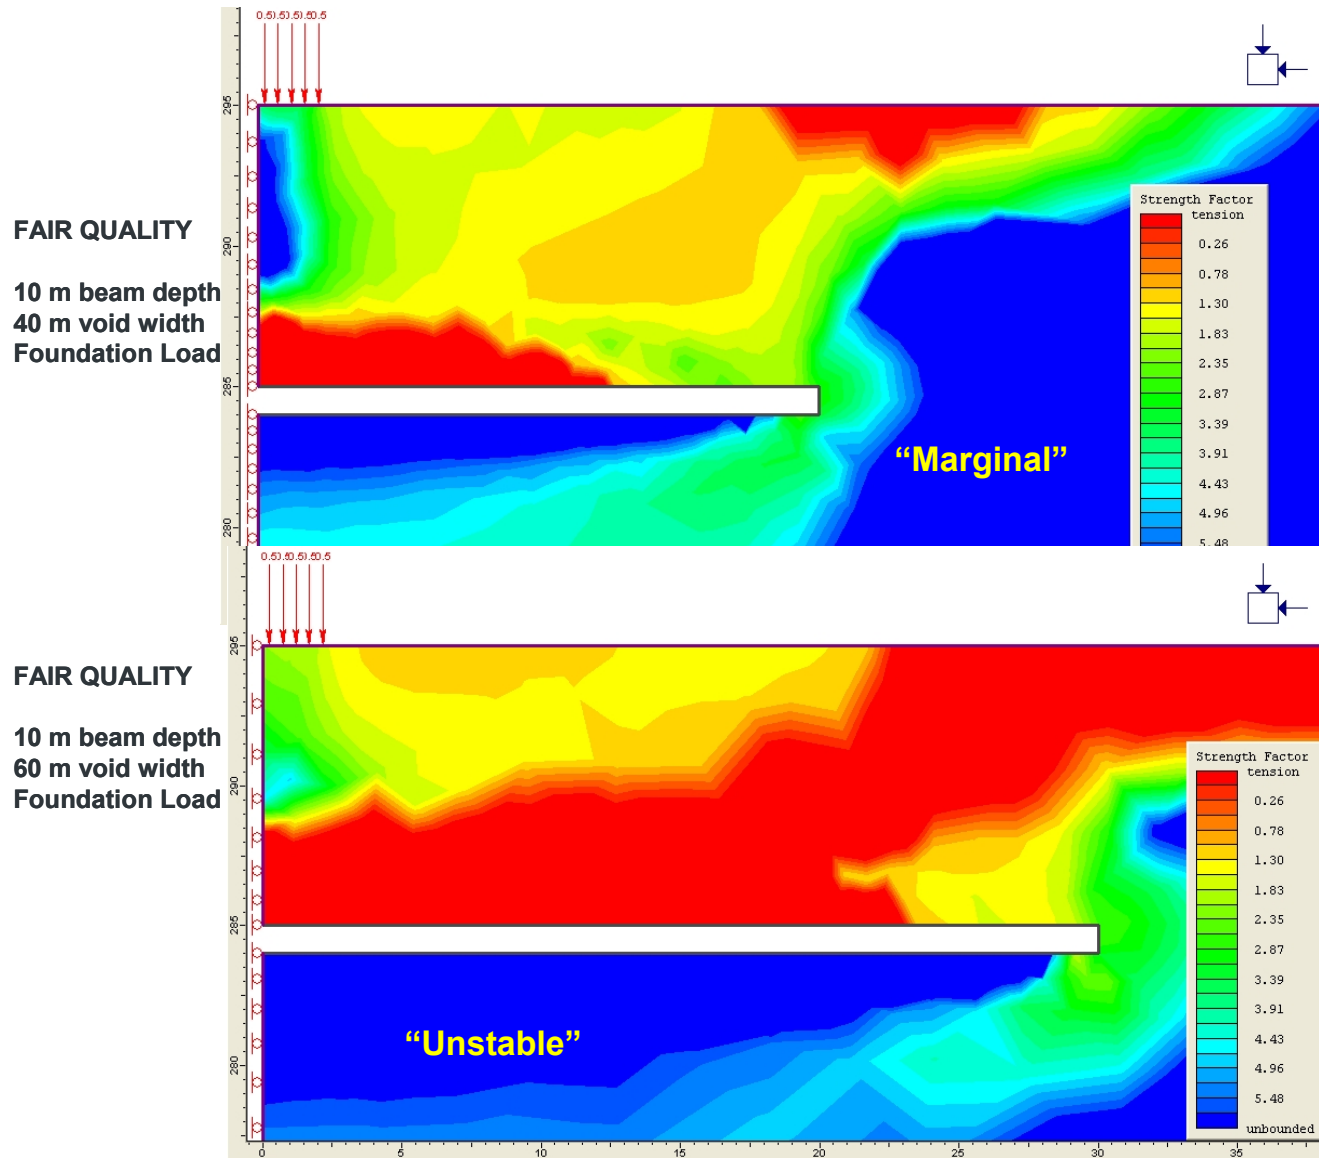
Figure 13. Finite Element Analyses – Roof Stability over Void with Foundation Load

Having demonstrated the applicability of the model, a series of analyses were performed that included foundation loads (Figure 13) and foundation and embankment loads (Figure 14). For the generic sensitivity analyses the foundation load was set at 0.5 MPa and the embankment load at 0.196 MPa. Figure 15 summarizes the entire set of sensitivity results developed from the stress analyses. The combinations of rock quality, void width and beam depth highlighted in red or yellow were predicted by the model to have unacceptable stability.

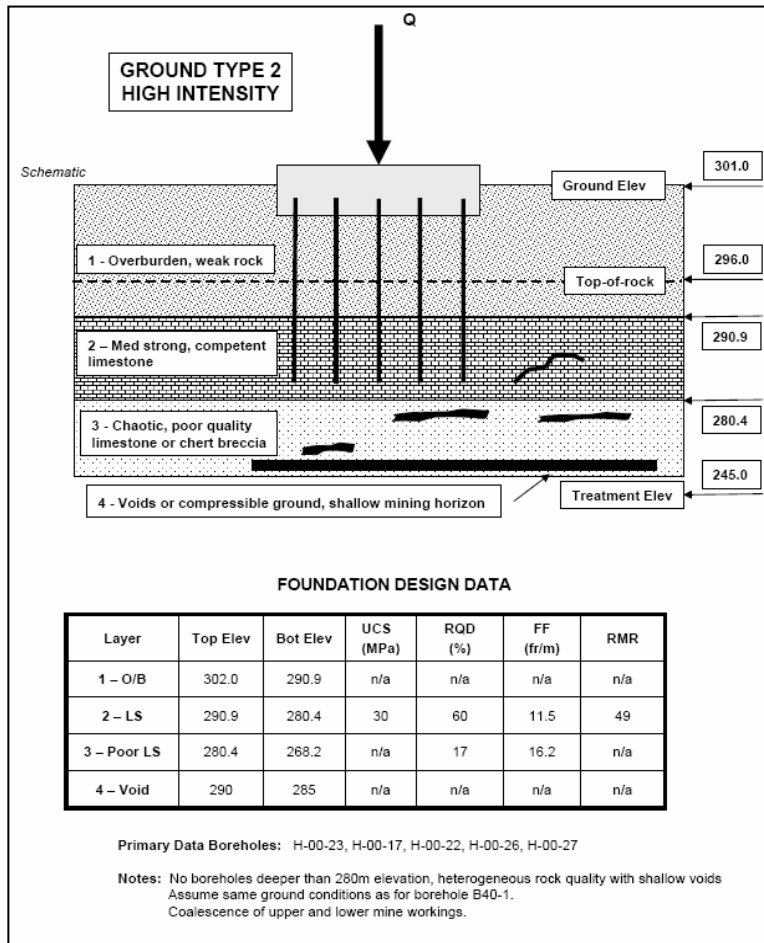
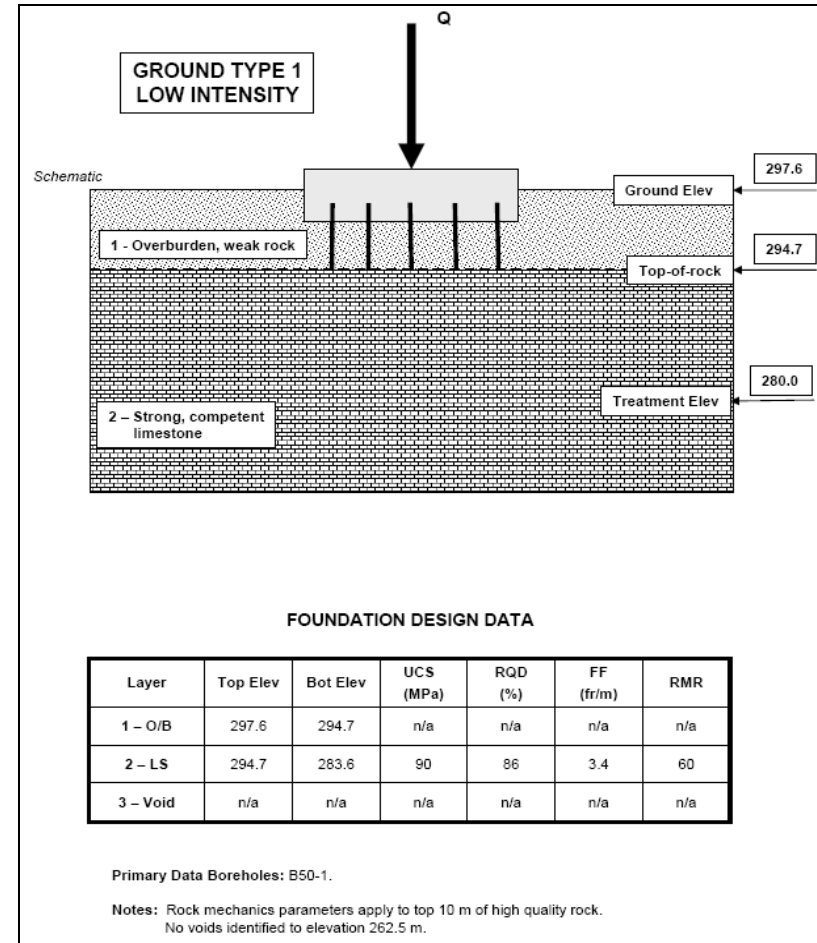
Figure 18. Presentation of Ground Conditions for Foundation Design

The analytical results, site specific ground conditions and actual foundation loading were used to develop bent-by-bent summaries for selection of foundation types and for foundation design. In order to simplify the extensive quantity of data, for each foundation location an idealized interpreted stratigraphy with associated geotechnical parameters was produced. For the load bearing strata, the intact rock strength (UCS), RQD, fracture frequency (FF), and rock mass rating (RMR) were provided. The UCS value were assigned based on rock mechanics testing and point load testing, suitably discounted to a design value based on engineering judgment. The RQD and fracture frequency values were weighted averages for the idealized layers derived from the geotechnical core logging. These idealized interpreted stratigraphy and geotechnical parameters were then used to select the intensity of production exploration/treatment and the foundation type at that location. Figure 18 shows two examples of these summaries which also included the recommended depth for ground treatment by grouting prior to foundation construction.

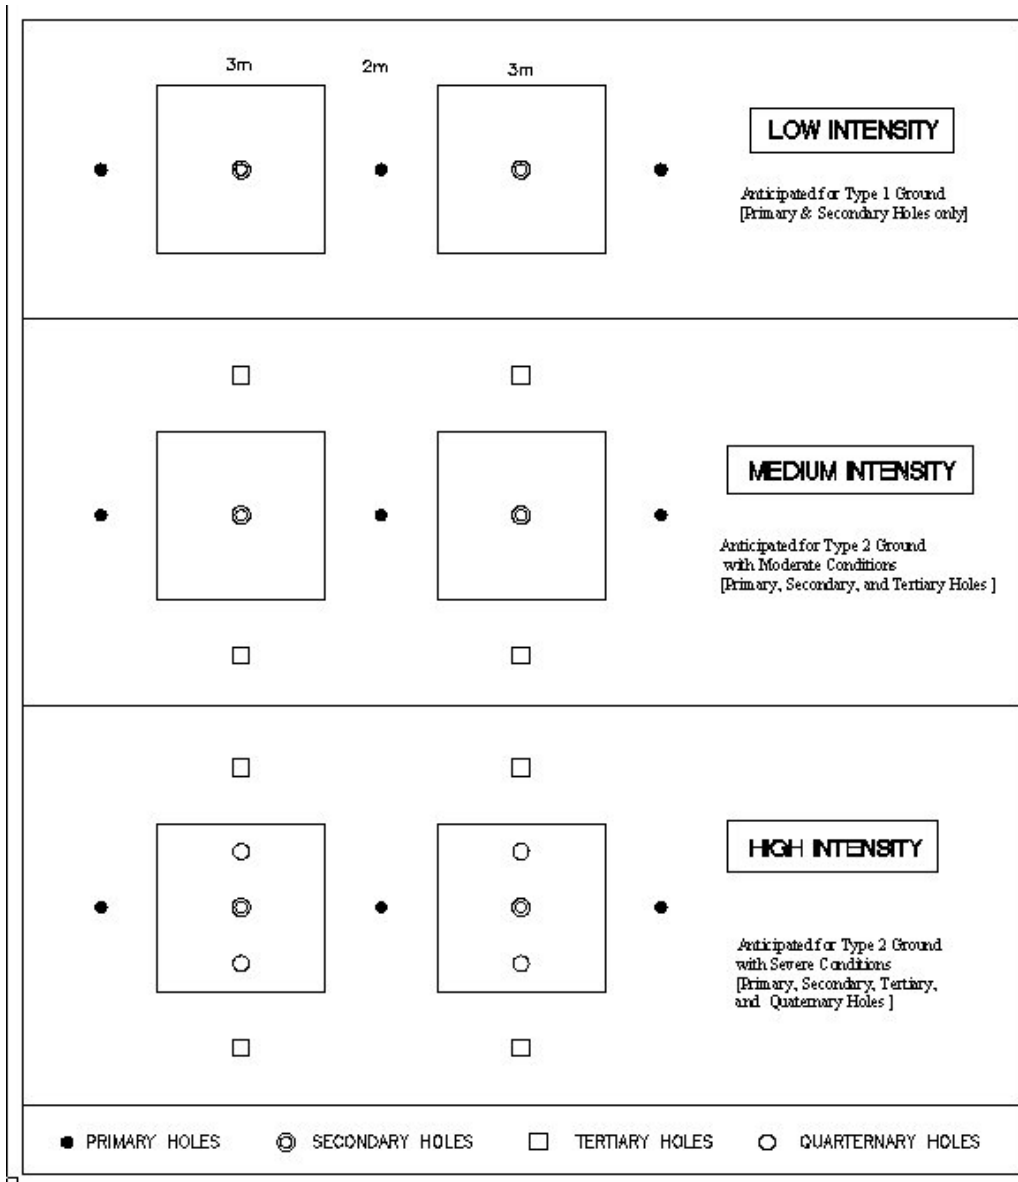
Figure 19. Treatment Intensity

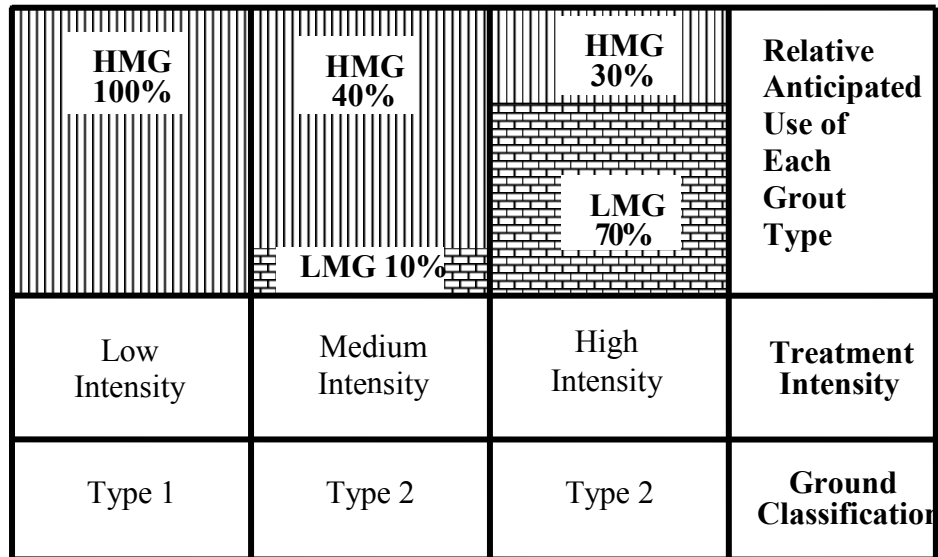
Figure 20. Anticipated Grout Type Use Versus Ground Classification and Intensity of Treatment.

Low Mobility Grout (LMG) was used in voided conditions (apertures greater than 100 mm). High Mobility Grout (HMG) with or without sand was used in tighter ground conditions as illustrated in Figure 20.
