CN King Road Grade Separation -

Case 2 Micropile Networks

(Workshop Paper # 24)

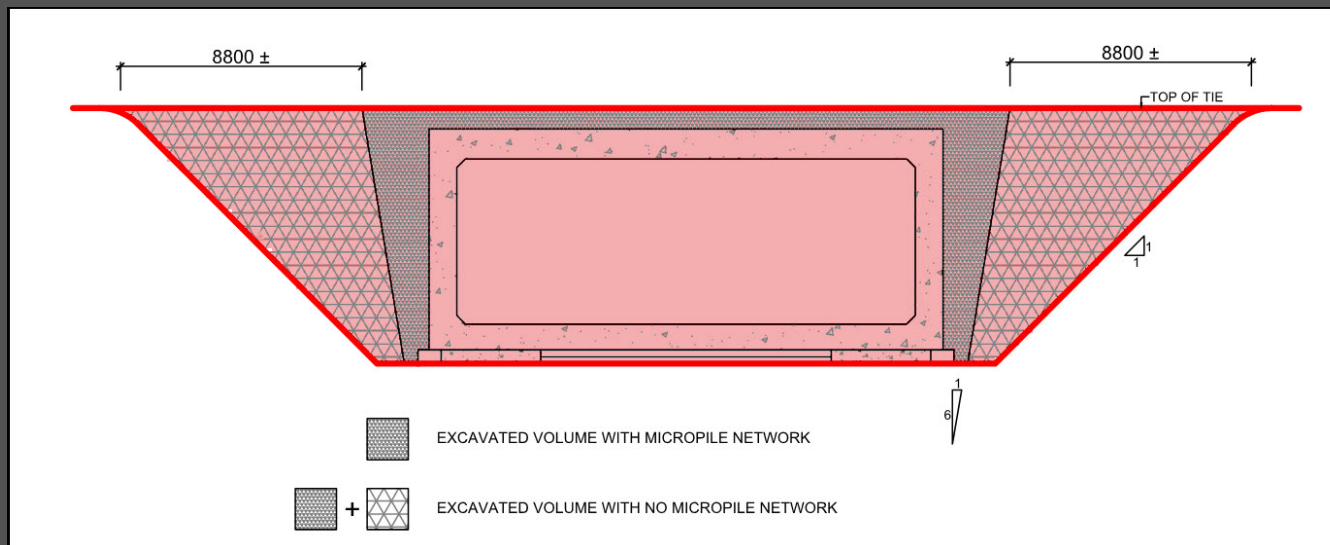
- ◆ Option 1: open cut excavation
 - Longer duration
 - More volume of soil to cut
 - More volume of soil to backfill
 - Much more track and ballast to remove and replace (remember, 4 tracks)
 - Added risk of slope stability due to ground water

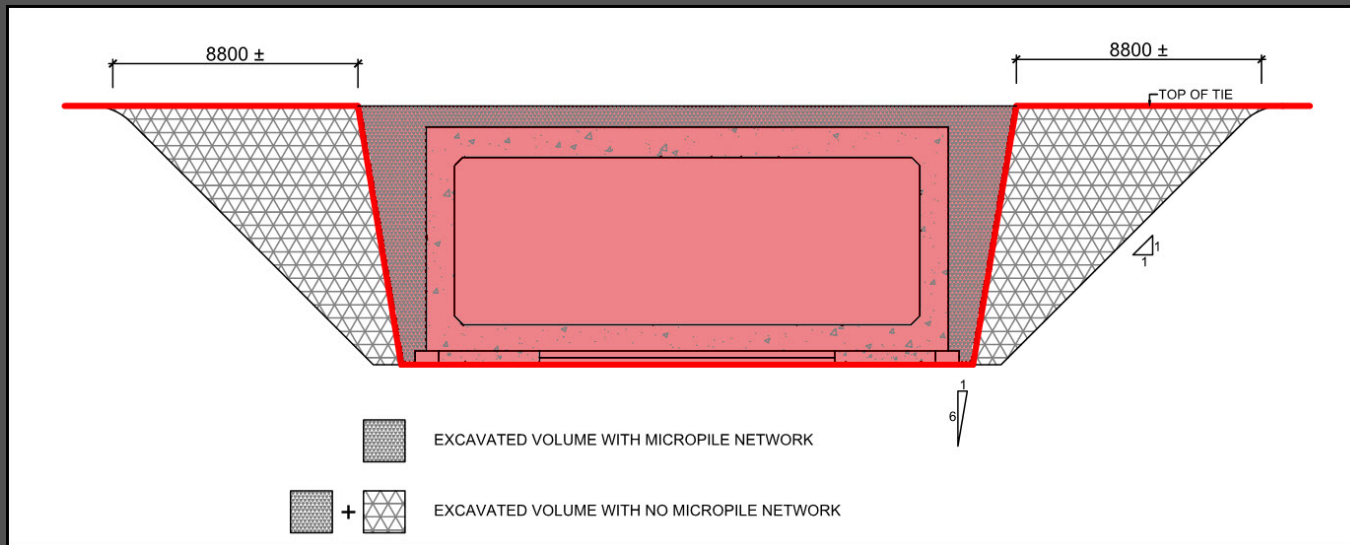
- ◆ Option 2: excavation support
 - Would enable shorter excavation duration
 - Less volume of soil to cut
 - Less volume of soil to backfill
 - Much less track and ballast to remove and replace (remember, 4 tracks)
 - Reduced risk of slope stability due to ground water

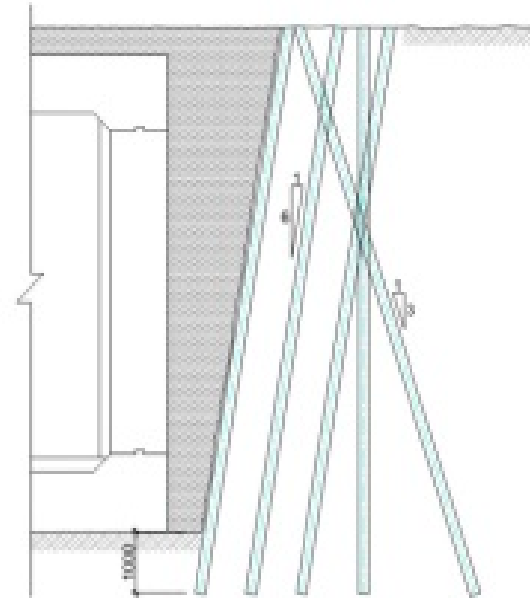
CASE 1 EXAMPLE

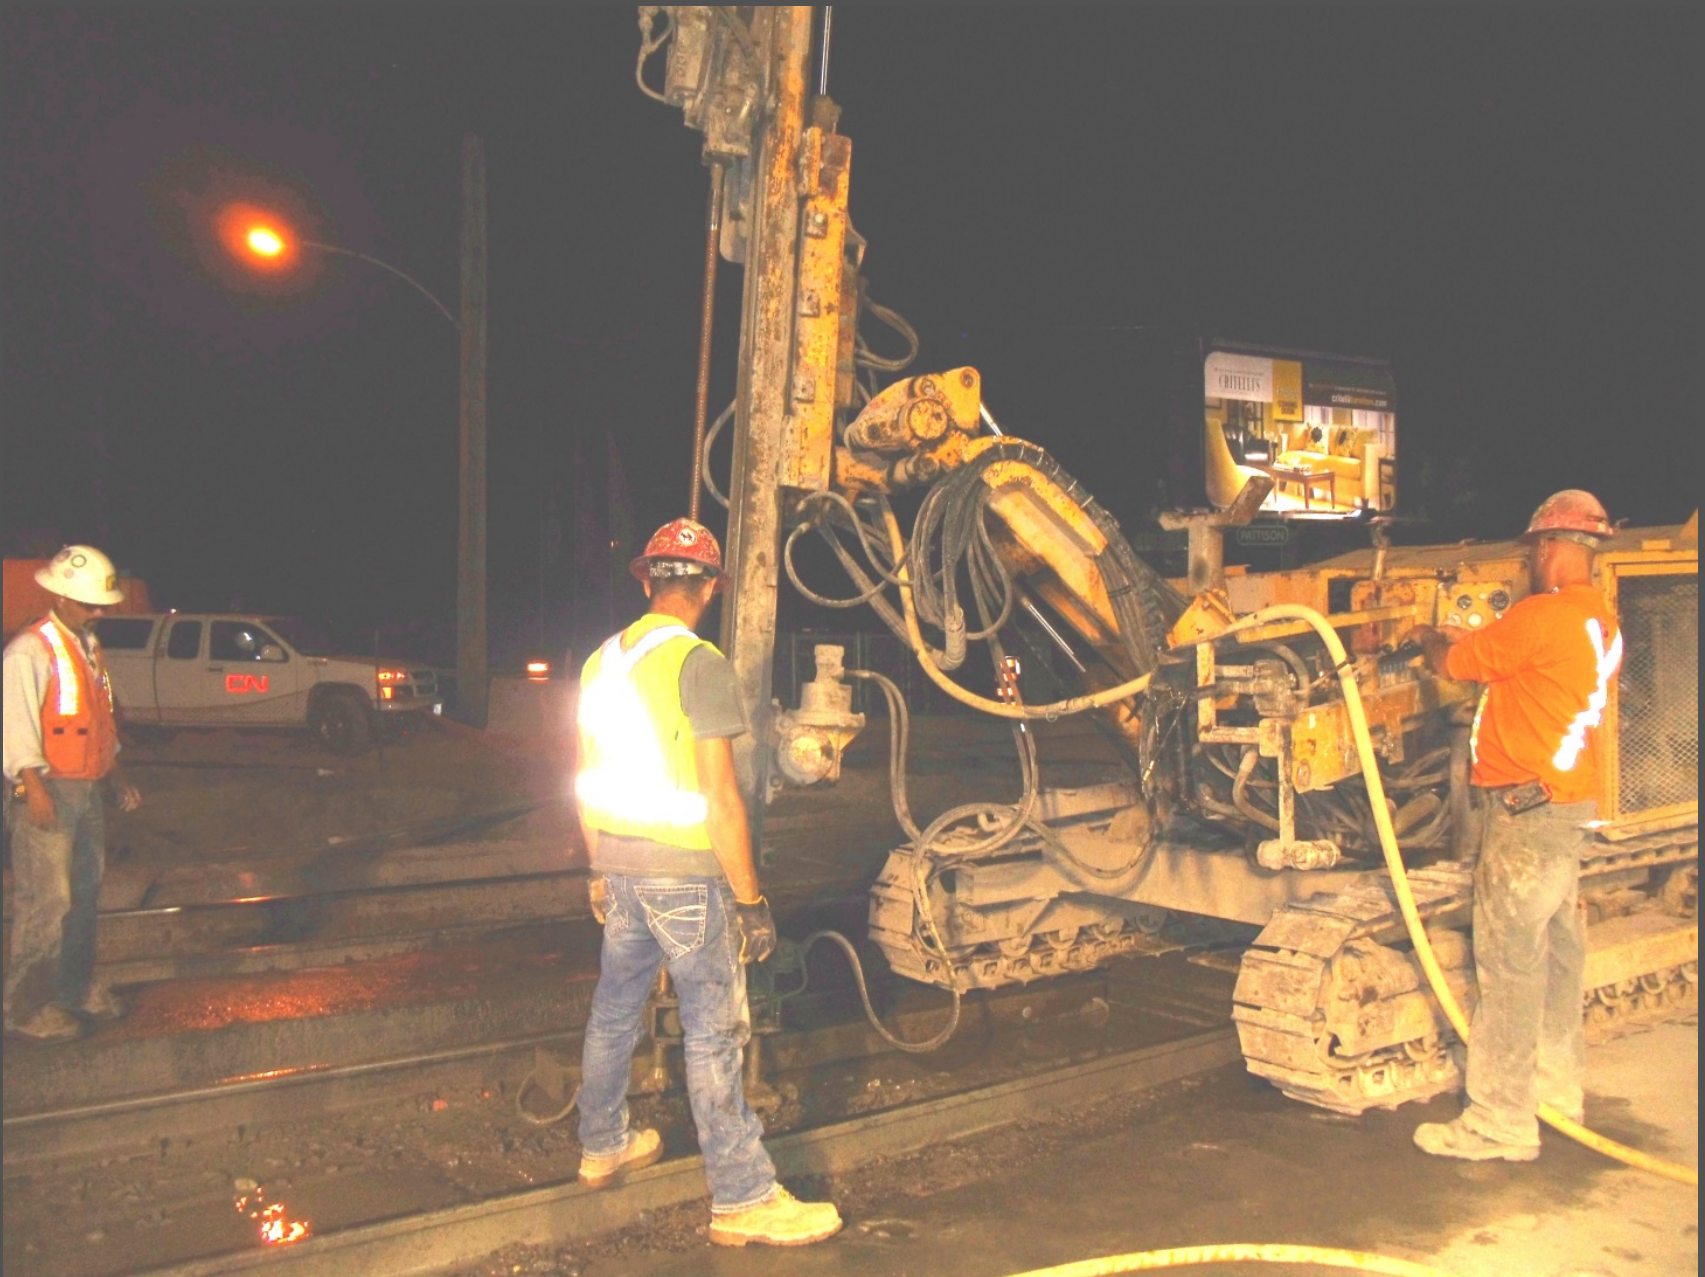
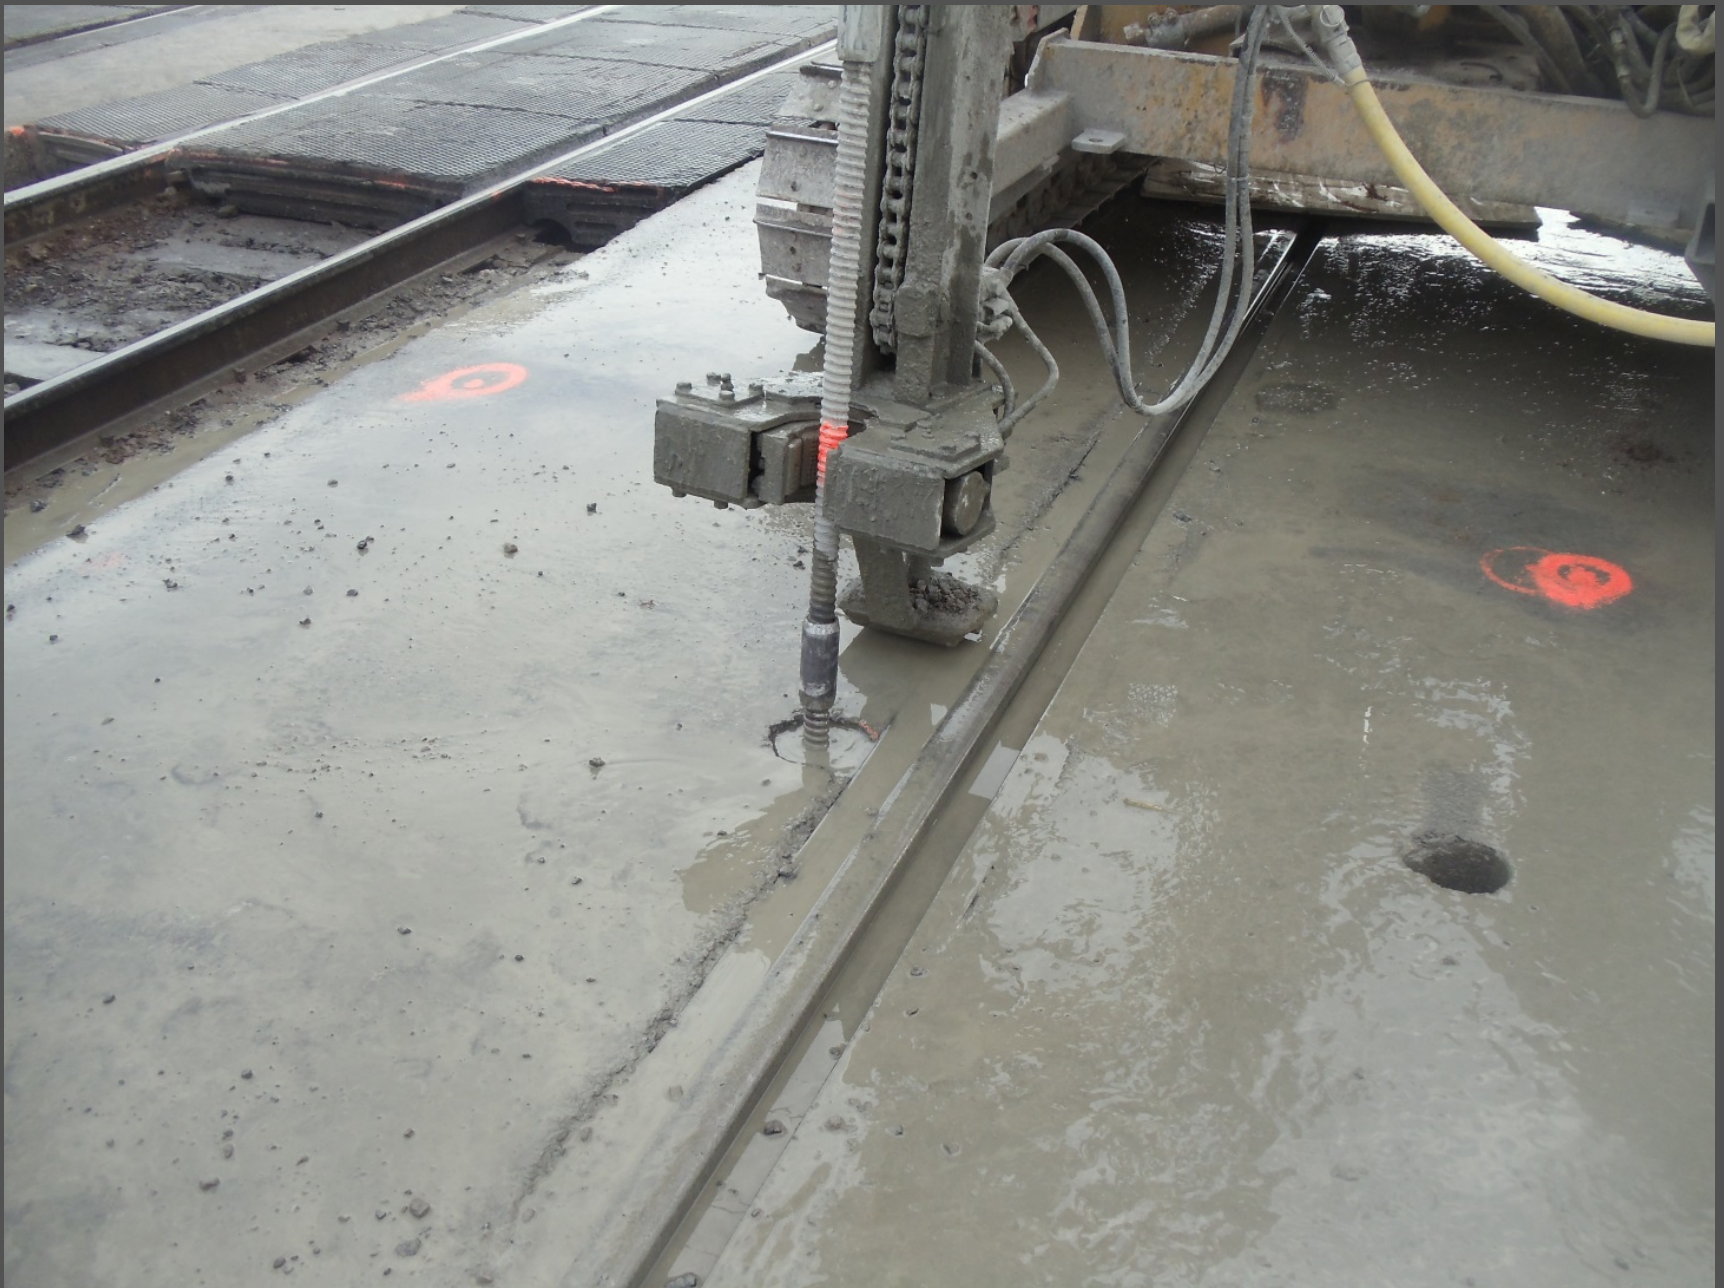
Design approach:

- ♦ the design and stability analysis is based on the micropiles forming a reinforced soil mass which is similar to a dam. The matrix is analysed for plastic deformation of the soils between the micropiles and the structural failure of the micropile in either compression/ tension or shear. The driving force is simply that anticipated by Rankine or Coulomb wedge failure theory. Analysis of the face support or stability is generally empirical. The soil will arch between the exposed micropiles with varying effectiveness based upon grain size, grain size distribution, cohesion and moisture content. The changing nature of the soil upon continued exposure must be evaluated, as well as the effects of exposure on intended face performance. For example, the soil might be expected to effectively arch but spall – such a scenario would be acceptable in terms of structural performance but unacceptable for worker entrance to the base of the cut face.

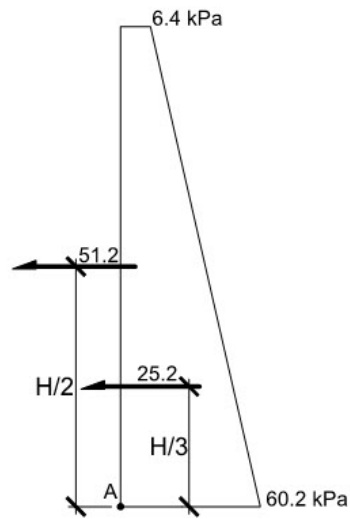
STABILIZED BLOCK

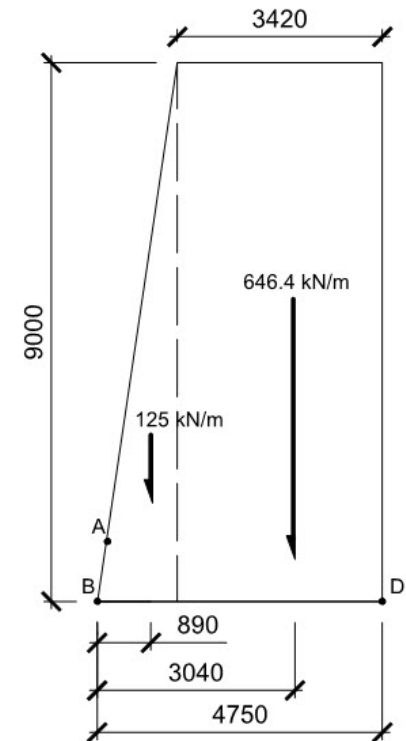
$$\gamma = 21 \text{ kN/m}^3$$

$$\phi = 31^\circ$$

$$K_a = 0.32$$

$$P_{\text{surcharge}} = 20 \text{ kPa}$$

DRIVING FORCES

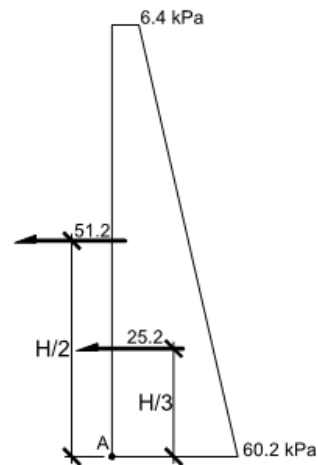
$$\begin{aligned}\gamma &= 21 \text{ kN/m}^3 \\ \phi &= 31^\circ \\ K_a &= 0.32 \\ P_{\text{surcharge}} &= 20 \text{ kPa}\end{aligned}$$

STABILIZED BLOCK

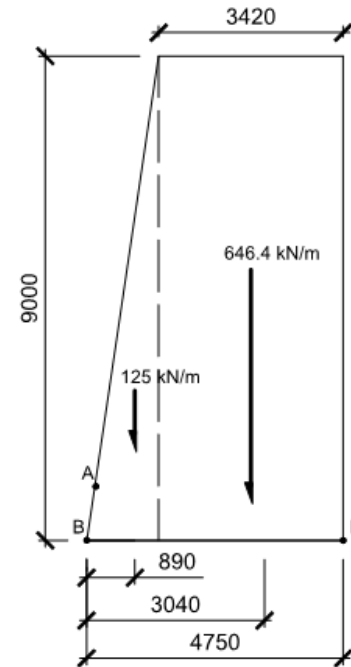
DRIVING FORCES
