Successful slope stabilization under severe conditions

Andreas BRANDNER, Dipl.-Ing., Chartered Consulting Engineer

Case 1 – Slope stabilization in high alpine surrounding

Case 2 – Slope stabilization in India

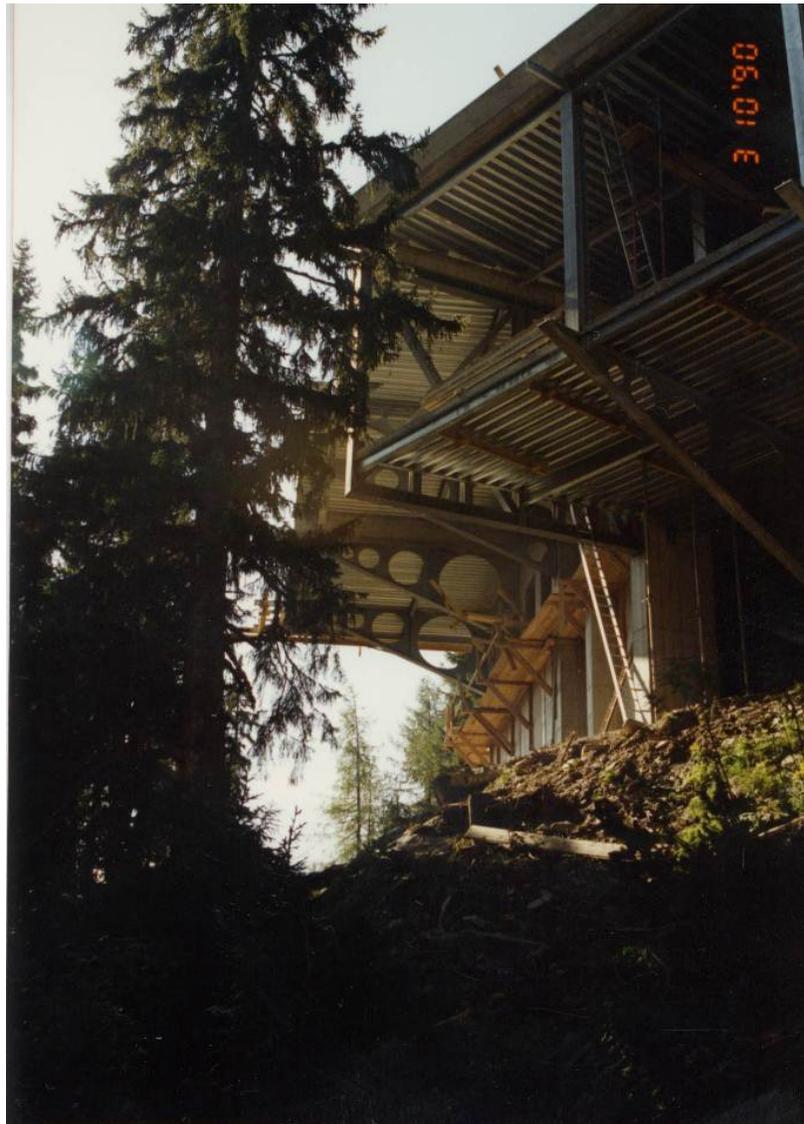
In 1990 a difficult foundation of a ropeway station was erected on a steep slope near St. Anton/Arlberg. Vertical column loads of more than 4500 kN, avalanche loads in horizontal direction of about 10 kPa and information of supposed creeping – although no survey proved this – were a big challenge. To get necessary information on soil test drillings were made to a depth of 15 m, which showed a subsoil layer of about 6 meters covering a weathered rock surface. Water could be found at the upon rock surface.

In late May 1999 following a winter with an immense amount of snow, heavy rain caused a slope slide at the bottom of the station, which left parts of the station building standing free on the micropile foundation. The damage was repaired by the use of additional micropiles and concrete foundation to close the gap and prevent further damage.
