DAMAGES TO BRIDGE FOUNDATIONS DURING THE HANSHIN EARTHQUAKE
Mr. Fukui, PWRI, Japan

DAMAGE TO BRIDGE FOUNDATIONS DURING THE HANSHIN EARTHQUAKE

Michio Okahara ¹⁾, Jiro Fukui ²⁾, Yoshitomi Kimura ³⁾

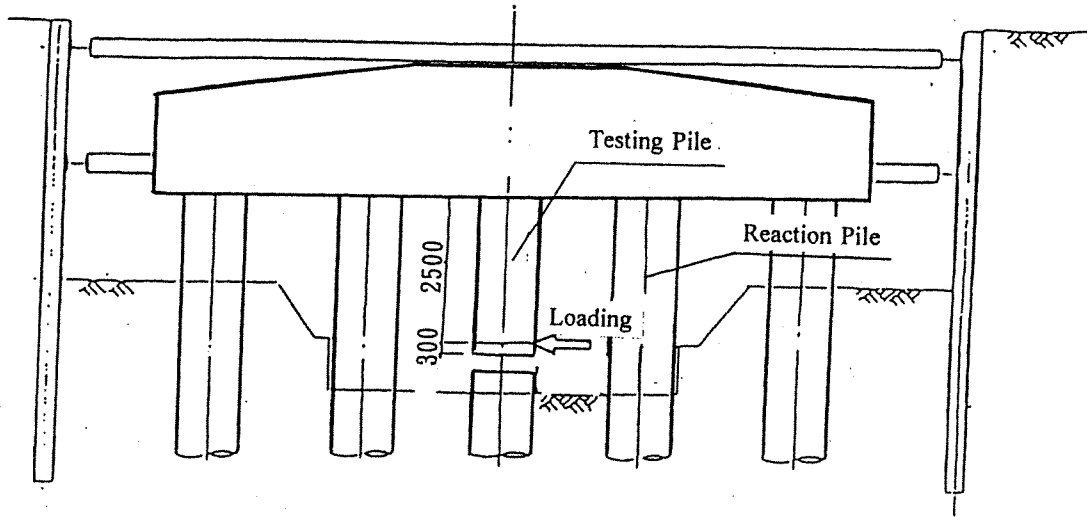
Figure 6 Pile Bending Test (No.126 Pier)

Pile body bending testing was performed on the pile tops where cracking appeared as shown in Figure 6. Test piles were obtained by cutting the pile bodies at a depth of 2.8 m below the bottom surface of the footing, then horizontal loading was done at a depth of 2.5 m below the footing using adjacent piles as the reaction piles. The loading, which was one-direction multi-stage loading, was performed up to 25 tf, equivalent to about 60% of the calculated yield bending moment of the tops of the piles. Figure 7 shows the relationship of the horizontal load with the horizontal displacement at the loading point. In order to grasp the effects of the decline in stiffness of the top of the piles, the relationship of the horizontal loading with the horizontal displacement of the piles when the pile tops are assumed to be sound was found through analysis, and this was compared with the results of the loading testing. The analysis of a sound pile referred to here was performed using the stress-strain relationship of concrete indicated in the "Guide Specifications for Reconstruction and Repair of Highway Bridges Which Suffered Damage due to the Hyogo-ken Nanbu Earthquake" (Ministry of Construction, Feb.24, 1995), and in this analysis the horizontal displacement by pulling the main reinforcement bars out of the footing is included. According to the material testing described above, the yield strength of the reinforcement bar and the compressive strength of the concrete in the pile body were assessed as $3,750\text{kgf/cm}^2$ and 425kgf/cm^2 respectively. The horizontal displacement of the loading testing is greater than the analytical value for the same horizontal load when the pile tops are considered to be sound, and the stiffness of the pile tops declines.

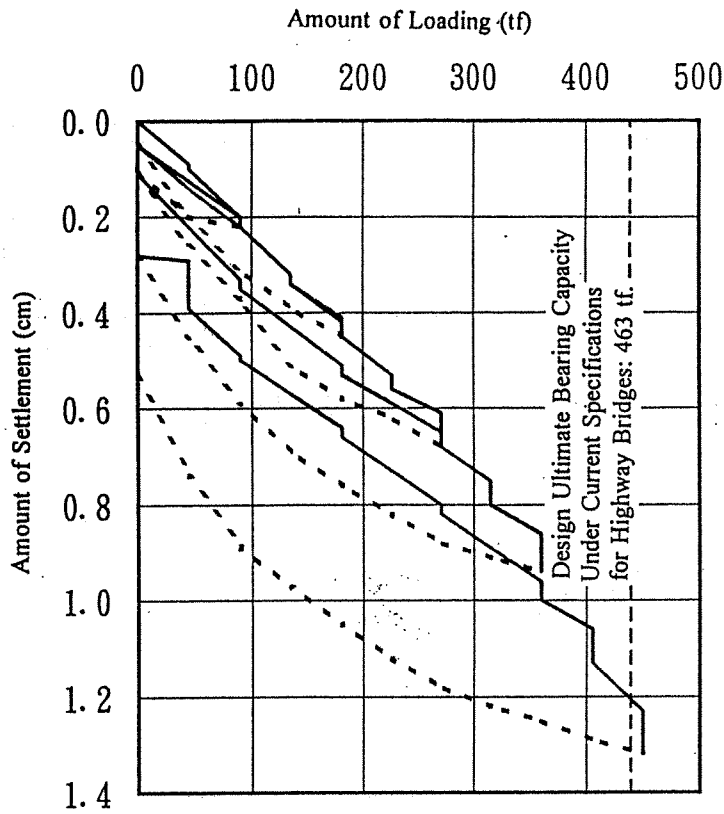
Figure 8 Amount of Loading - Amount of Settlement Curve During the Vertical Loading Test of the Piles (No.126 Pier)

To perform the vertical loading testing and the horizontal loading testing, two piles were cut at a depth of 1.2 m from the bottom surface of the footing, and the piles below this level used as the specimens for the two tests. Vertical loading was applied to the top of one pile and horizontal loading to the top of the other. Figure 8 shows the amount of loading - amount of settlement relationship for the vertical loading testing. It confirmed a bearing capacity as high as 450 tf : a value exceeding the design ultimate bearing capacity of 436 tf calculated by the present Specifications for Highway Bridges. The pile top settled 1.3cm, much less than 10cm, which is 10% of the pile diameter, and the amount of

settlement usually forecast when calculating the ultimate bearing capacity of piles, which confirms that the ultimate bearing capacity of the pile exceeds the design ultimate bearing capacity. Figure 9 presents the amount of loading - horizontal displacement curve obtained from the horizontal loading testing. This figure shows that the value of the coefficient of ground reaction in the horizontal direction found assuming that the horizontal displacement is 1% of the pile diameters is 1.9 kgf/cm³, which coincides closely with 2.3kgf/cm³, the coefficient of ground reaction in the horizontal direction estimated from the N value obtained from a standard penetration test according to Specifications for Highway Bridges.
