DOUBLE NICKEL MICROPILE LANDSLIDE STABILIZATION

ABSTRACT

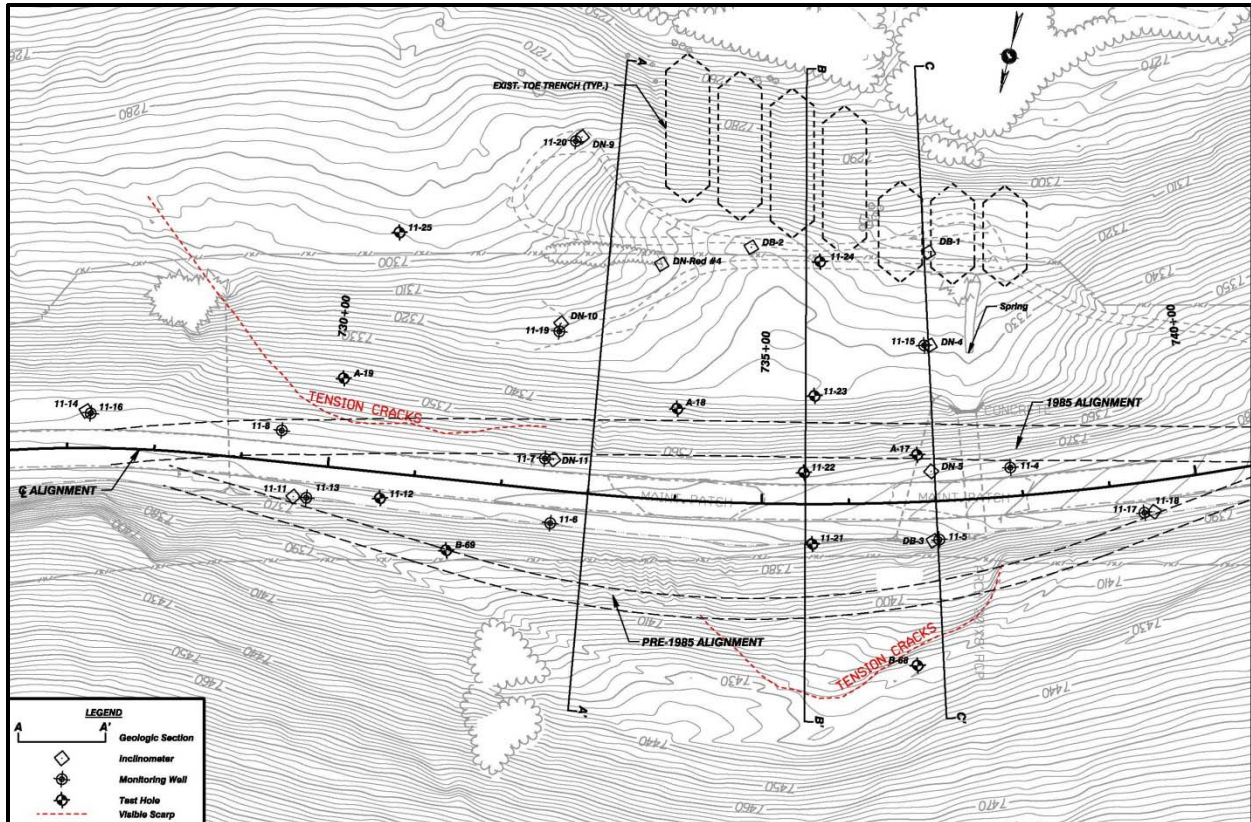
Figure 2. Site and Boring Location Plan.

Continued movement after the installation of the toe trench drains in 1992 necessitated a more extensive landslide repair. In 1994, WYDOT designed a landslide repair including realignment of the roadway to the north (i.e. upslope), placement of lightweight tire shred fill, and installation of four additional rock-filled toe berms. Furthermore, a three-sided box culvert was constructed to collect and discharge the spring water. Refer to Figure 2 for a plan view illustrating the various roadway alignments and location of previous improvements.

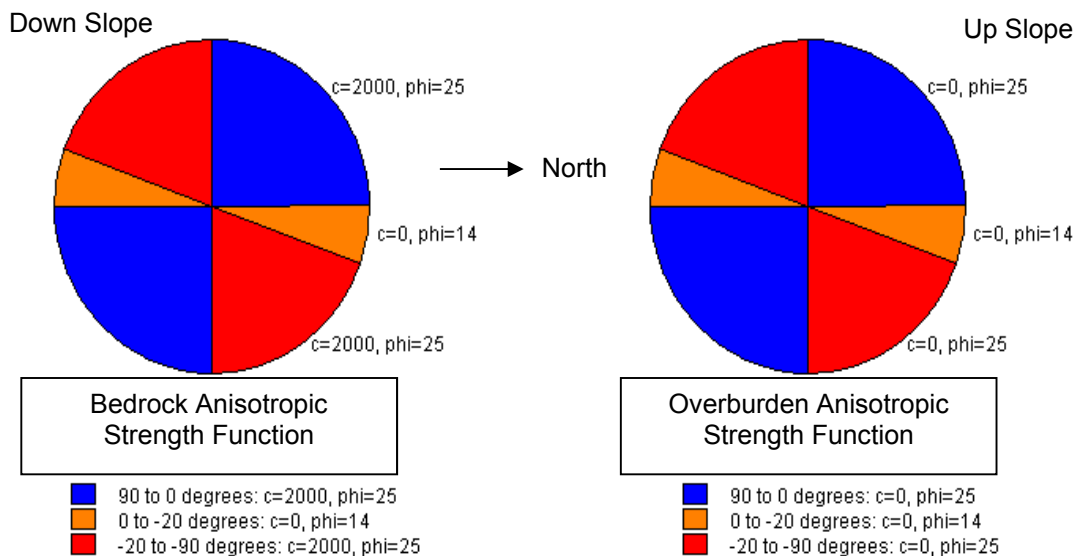
Figure 5. Anisotropic Strength Function.

In order to achieve a FS of unity (i.e. on the verge of failure), the residual friction angle of the pre-sheared layer and along potential bedding planes in the bedrock was lowered to 14 degrees. This is in good agreement with available residual direct shear test results on samples at or near the inferred slide plane and WYDOT’s experience. A residual friction angle of 14 degrees also correlates well with published relationships based on Plasticity Index (PI). The same material parameters were then used in the stability model along the side flank of the slide.

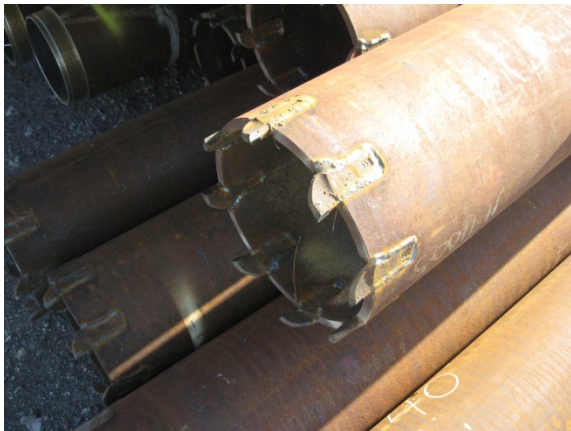
Figure 10. Initial Lead Casing Set-Up.

Based on the information in the geotechnical report, the initial drill tooling selected for the project consisted of carbide-tipped “J” teeth welded to the lead end of the 11 7/8” OD permanent casing for the outer string, along with an aggressive claw-type bit with carbide-tipped “bullet” teeth coupled onto the 7 5/8” OD drill rod for the inner string. In addition, due to the known presence of the rock fill in the toe drains for some of the shear piles located in Row 4, an 8” downhole hammer and button bit set-up was also selected. It was anticipated that this percussive set-up would need to be used in selective locations to deal with the toe drain rock fill, as well as some of the hard sandstone seams identified during the geotechnical investigation.

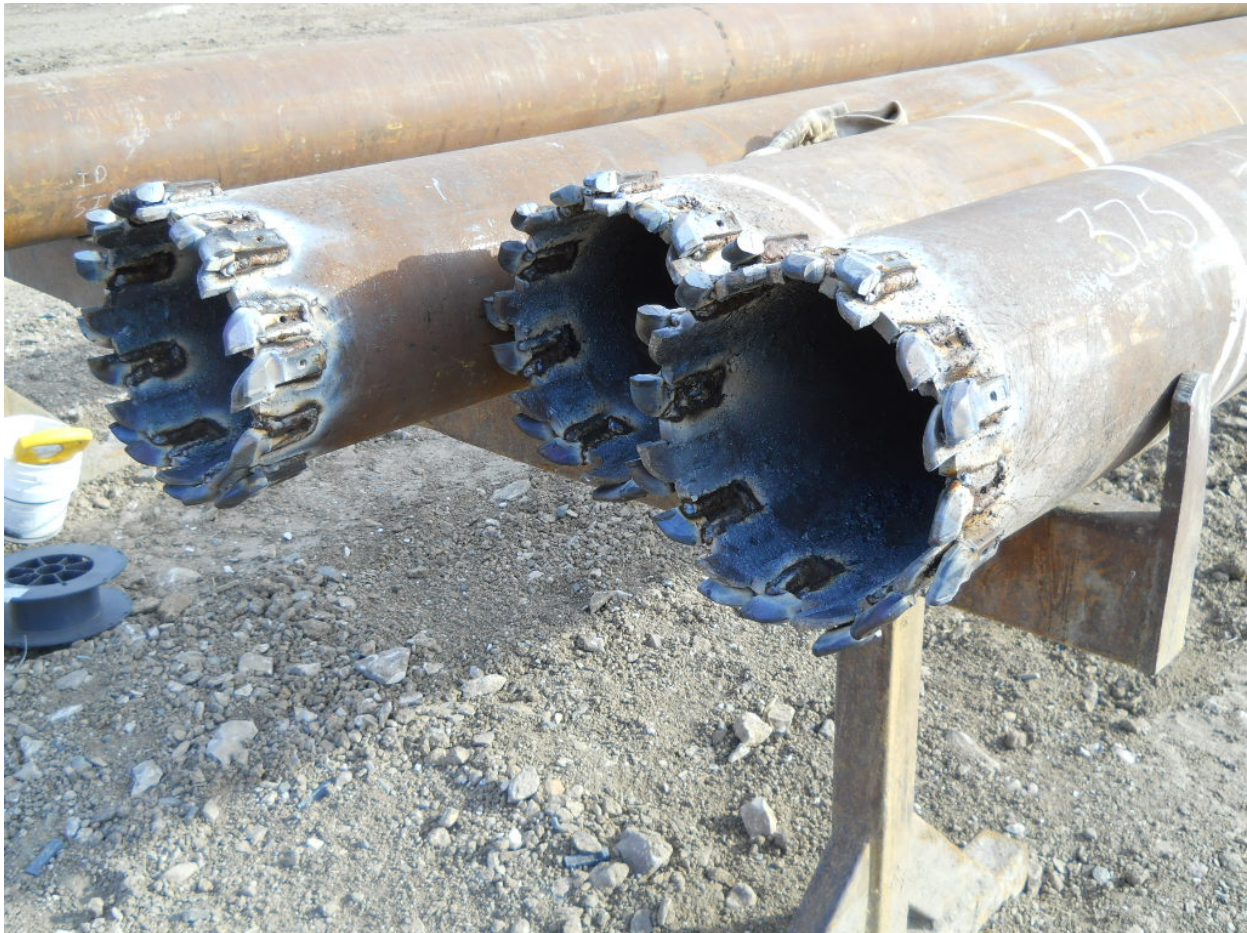
Figure 15. More Aggressive Casing Leads

There were challenges in the early stages of production at Row 4. In two instances, the casing could not be advanced to the required tip elevation. Initially, these challenges were attributed in part to the learning curve with the new equipment and drilling system, as well as the known ground conditions at Row 4. Various modifications were made to the drill tooling, including changes to the bit configuration and the type and quantity of cutting teeth on the permanent casing. In addition, the button bit and downhole hammer set-up was used on several shear piles during this period of the project. While production improved somewhat with these adjustments, it was still not adequate to meet the schedule requirements for the project.

However, this particular system was available in limited supply. With the remaining quantity of drilling left on the project, it was necessary to develop an additional tooling configuration that was available in adequate supply to allow the project to be completed on schedule. This additional system consisted of a 10" downhole hammer paired with a 10" button bit. The lead section of casing was modified with thicker carbide "J" teeth than originally selected. Various modifications were made to the quantity of the cutting teeth on each lead section of casing during the course of pile installation
