15TH International Workshop On Micropiles

WHEN HEAT TREATMENT GIVES YOU LEMONS...

Quality Control for Galvanized Washers

presented by Justin Toney, P.E. | Crux Subsurface

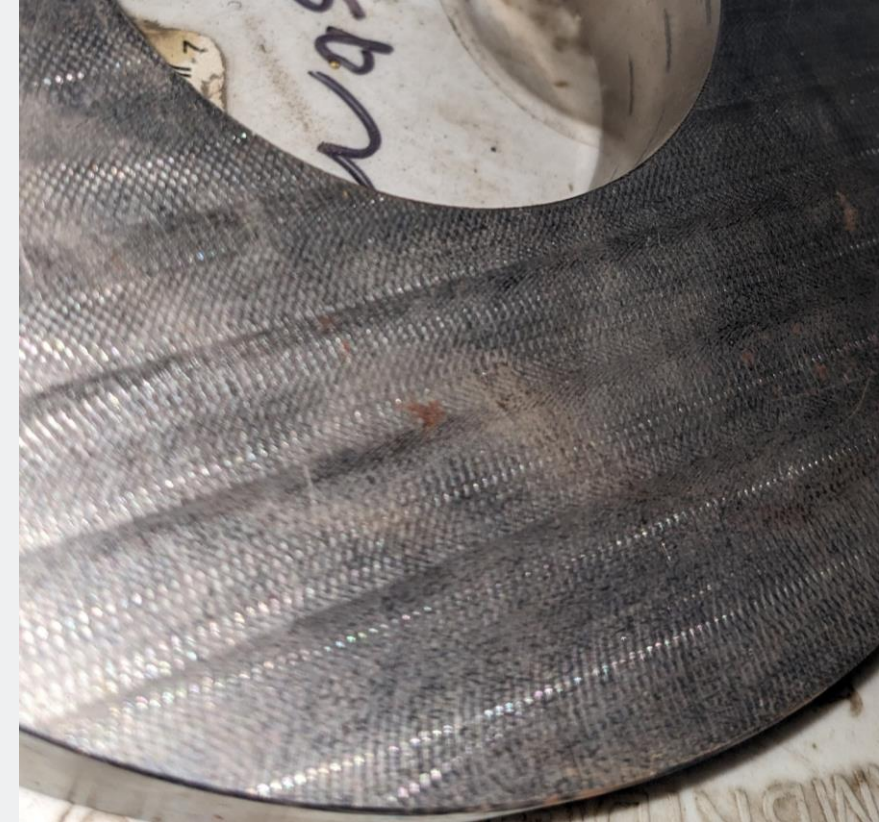
“Warped” Washers - Fix

- Flatness tolerance established for fabrication
 - 0.032” ASTM F438 washers greater than 3” nominal size
- Out of tolerance washers removed and re-worked to within tolerance where possible
- Solutions for future fabrication
 - Slower feed rate when cutting
 - Manually checking every washer
 - Additional machining prior to galvanizing

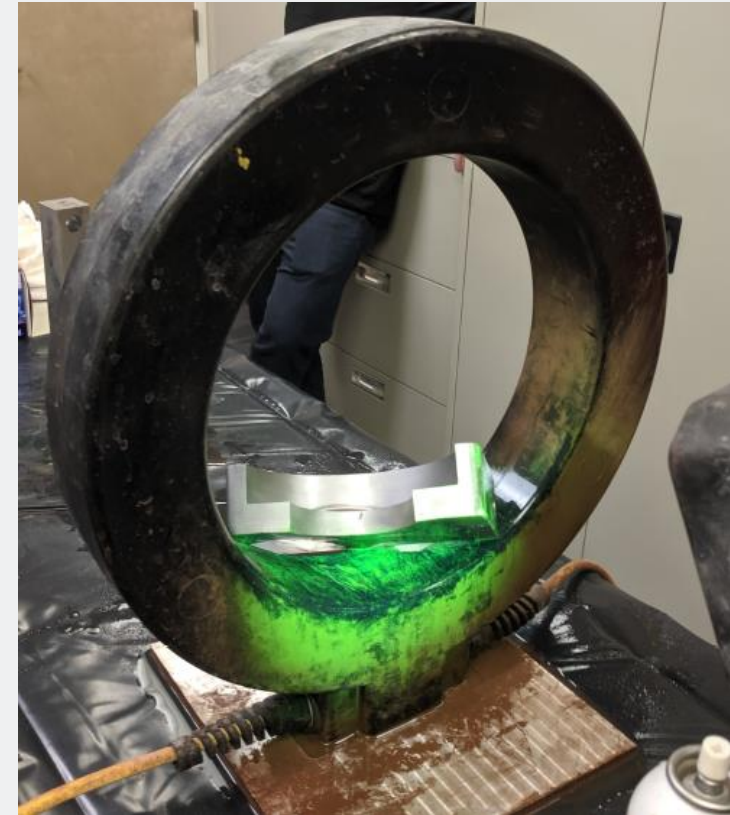
How Do We Fix It? Revised Replacement Washer

- **August 2019** changes to test program
 - Scale up test loads 1.16 factor for F_y fabricated steel (58/50 ksi)
 - Extended hold times
 - 15 minute hold at 1.0 DL and 1.5 DL
 - 25 cycles at 1.0 DL
 - Additional measurement locations, closer to center of washer
 - Magnetic particle testing
 - Prior to loading
 - Post 1.0 DL static and 1.0 DL cyclic
