High Capacity Micropiles in Mined Ground for Bridge Support:
Joplin County, Missouri

Paper 4 LOAD TESTING

2. Technical Requirements2.1 Specifications

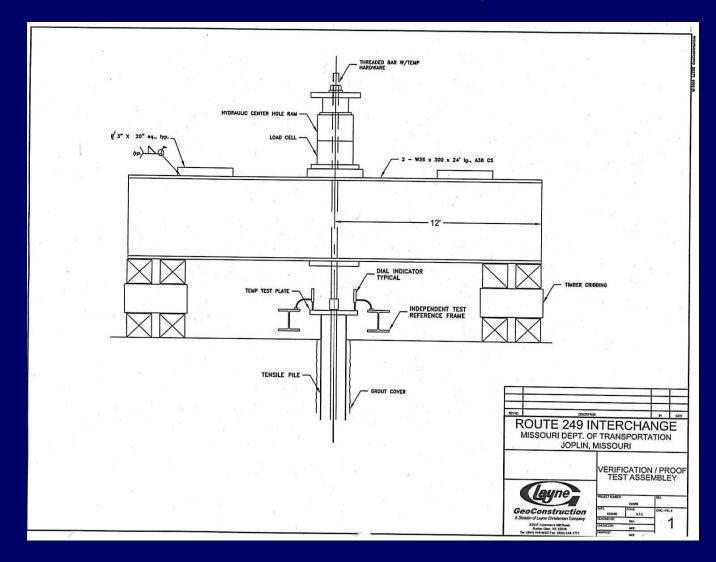
Tension Test Setup

- Total of 220 production piles (vertical and inclined).
- 16 Proof Tests locations at each bent to be selected in the field by the Engineer.
- Simple incremental tensile loading to 1.2 DL, with 60-minute creep test (Modified ASTM D3689 Quick Test).
- Acceptance criteria:
 - 1. No failure at TL.
 - 2. Debonding at TL ≤ 50% bond length.
 - 3. Creep rate ≤ 1 mm per log cycle (1-10 mins.) or ≤ 2mm per log cycle (6-60 mins.).
- If failure occurs, test another pile in the same bent, and consider modifications, down rating, replacement, etc.
- Each test paid for on lump-sum basis.

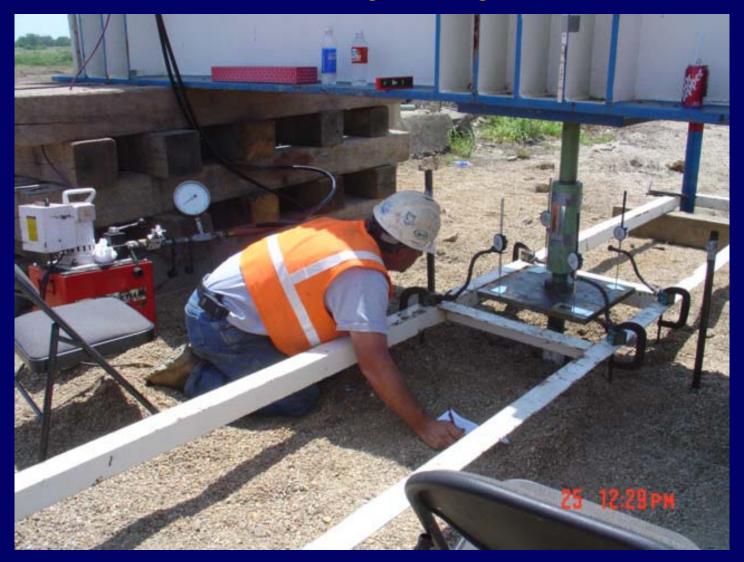
Load Testing in Progress

- Every micropile reached the test loads (986-2,269 kN).
- At TL debonded lengths were exceptionally small and in only one case did it extend beyond the cased length.
- Permanent movements at TL ranged from 0.34 to 6.45 mm (typically < 3 mm).
- All load-movement curves were very linear.
- Every pile comfortably satisfied the creep criteria.
- Paper contains full details (Table 7).
