## **Micropile Wall Supporting a Complex Environmental Excavation**

Matthew Janes, M.E.Sc., P.Eng., Isherwood Associates

Abstract: Case 1 (non-reticulated) micropiles are commonly used to stabilise earth for bearing applications. They may also be effectively used as a shoring solution. In Victoria BC a complex environmental clean-up problem was solved using a capped, Case 1 micropile wall. The site was bordered by a major thoroughfare with a buried high voltage power duct on the uphill side and a salmon bearing stream within a municipal park on the downhill side. Mineral oil coolant had leaked from the duct and contaminated the soils beneath the road way and were now leaching into the stream. BC Hydro required a clean-up of the embankment soils, a leachate collection system to capture pollutants until an alternate power supply to the city could be completed (permitting de-commissioning of the leaking duct) and a cut off wall to prevent future contamination of the stream. The site was further complicated by overhead power and communication lines within the construction footprint. Excavation depths of up to 4.5 m were required (14.8 ft) to the planned contaminant depth, with the re

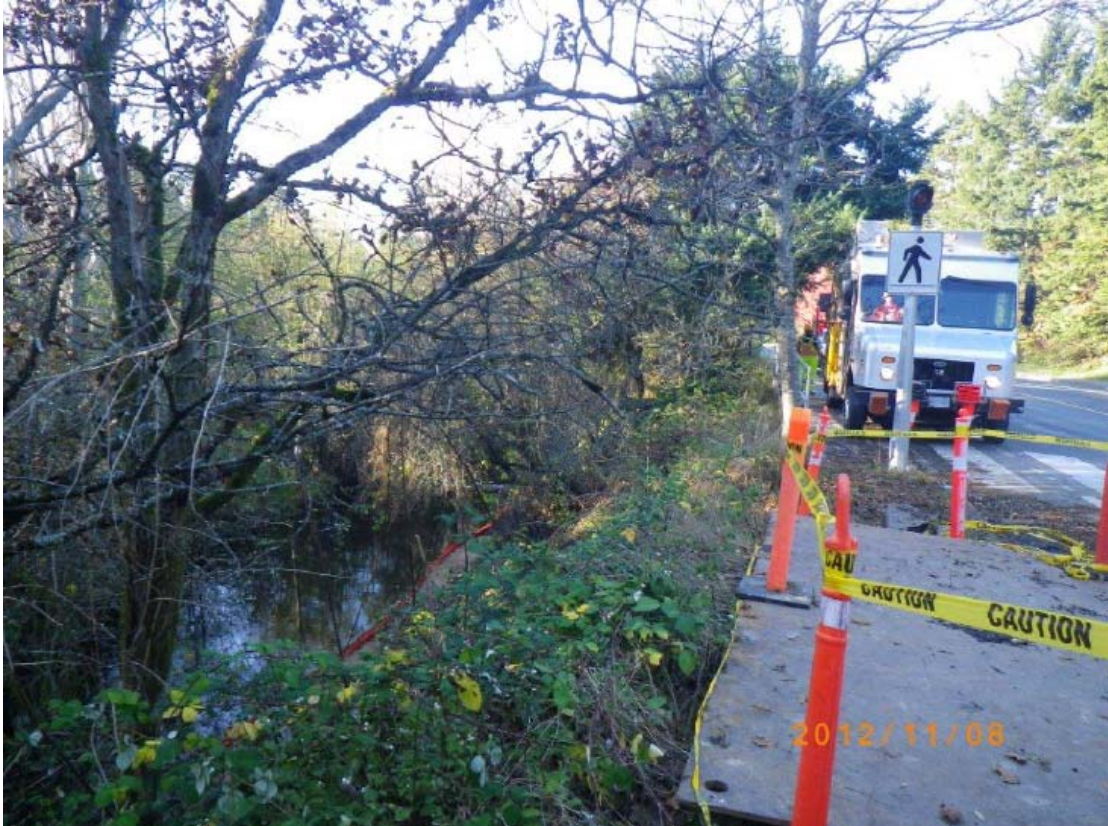
Figure 2. Site photo showing the easement and existing Colquitz Creek embankment.

The photograph below shows the site from the SW looking NE. A very narrow shoulder adjacent to Interurban Road formed the top of slope construction easement. A steep, vegetated slope leads down to Colquitz Creek which resides within a municipal park. The creek had to be protected from siltation or other construction activity as it is a salmon bearing stream. Access for equipment and removal of spoil was permitted across the creek and through the park trails, as no easement or laydown area was available along Interurban Road. The buried hydro duct carrying high voltage lines lies directly beneath the pavement edge at a depth of 1.5 m (5 ft.).

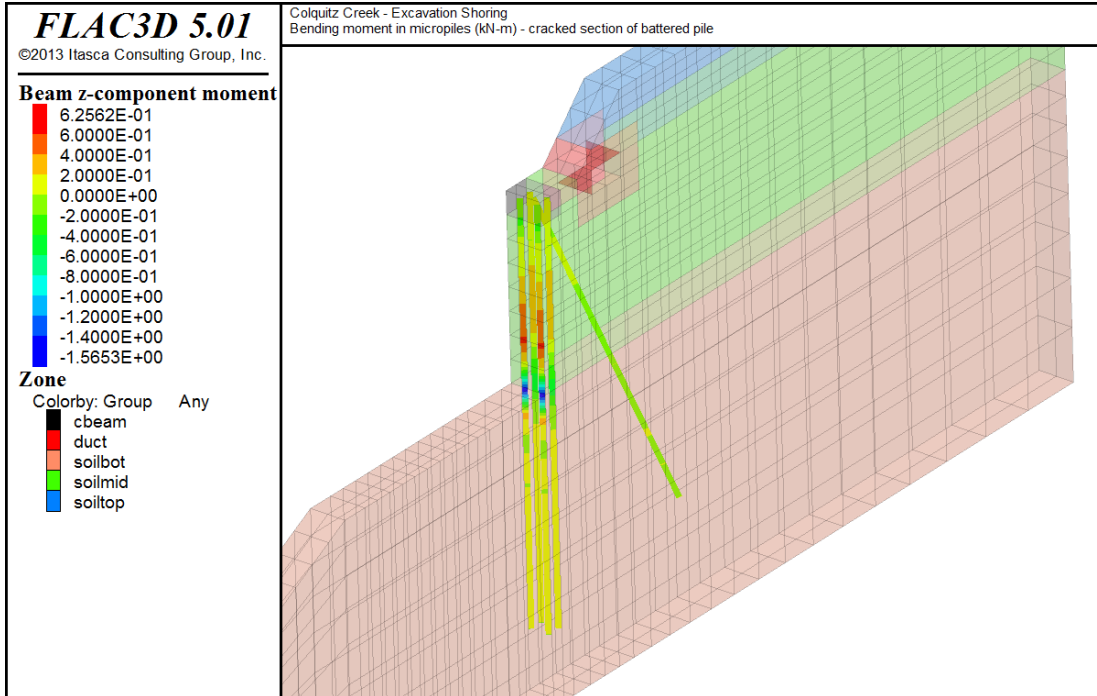
Figure 6. FLAC prediction of micropile bending moment, Compression positive.

Figure 6 predicts the maximum micropile bending moment occurs within the front row of piles at the base of the excavation. The magnitude is on the order of 1.6 kN-m (1.2 kip-ft.) for front row micropiles and 0.5 kN-m (0.4 kip-ft.) for the rear row, with piles spaced at 400 mm c/c, for a total moment 5.25 kN-m/m (1.7 kip-ft./ft.) of wall (sum of both rows). But this only tells part of the story. Upon review of the axial loading we can calculate an axial force couple of 25.4 kNm/m (8.2 kip-ft./ft.). Classical pressure envelope analysis predicts a bending moment on the order of 68 - 80 kNm/m, depending upon assumptions. Thus the FEA predicts bending moments and axial loads well below the classical methods. The FEA takes advantage of combined bending and truss action of the wall and likely less conservative soil parameters than those used for classical analysis. The Young's Modulus selected for the clay soils was 100 MPa (14.5 ksi).

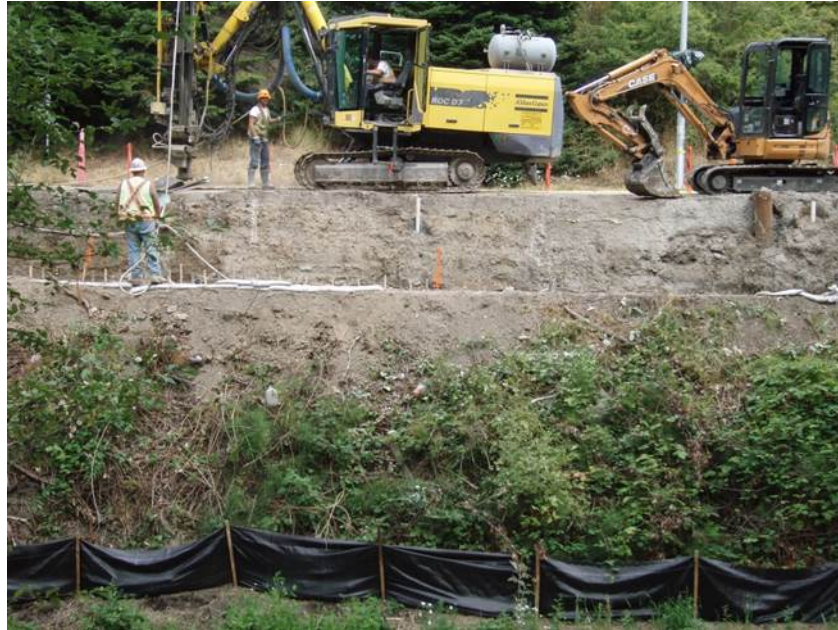
Figure 9. Drilling the micropiles at the crest of the partially excavated slope.

The construction sequence is shown in photos 9 through 12. Photo 9 shows the air drill working within the confined easement at the top of the wall. The photo shows the steep creek embankment and the creek at the base. Note there is no evidence of drill spoil or grout loss on the existing slope. Great care was taken in both procedures and design to minimise the chance of fouling the stream. Photo 10 shows the completed micropiles within the construction trench and the steel cage for the pile cap. In the

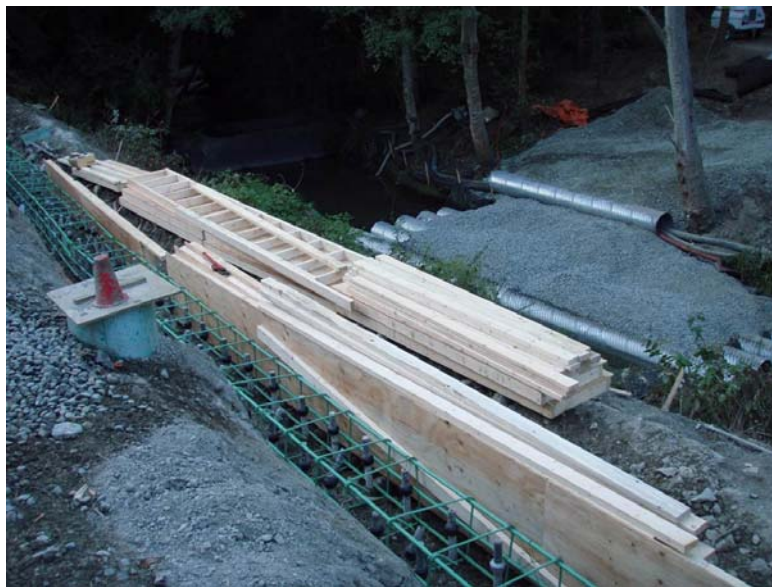
Figure 10. The completed micropiles, cap steel and cap forms during assembly.

distance is shown the creek diversion with galvanised corrugated steel pipe and gravel overlay. Silt curtains placed up and down stream prevent siltation due to the placement of gravel or travel of the excavation spoil into the stream. Within the foreground a vertical corrugated pipe is seen. This provides access to a survey point mounted atop the B C Hydro duct. Optical survey indicated the duct moved less than 2 mm laterally or vertically (the accuracy of the survey). This compares favourably to the FLAC predictions of less than 1 mm.

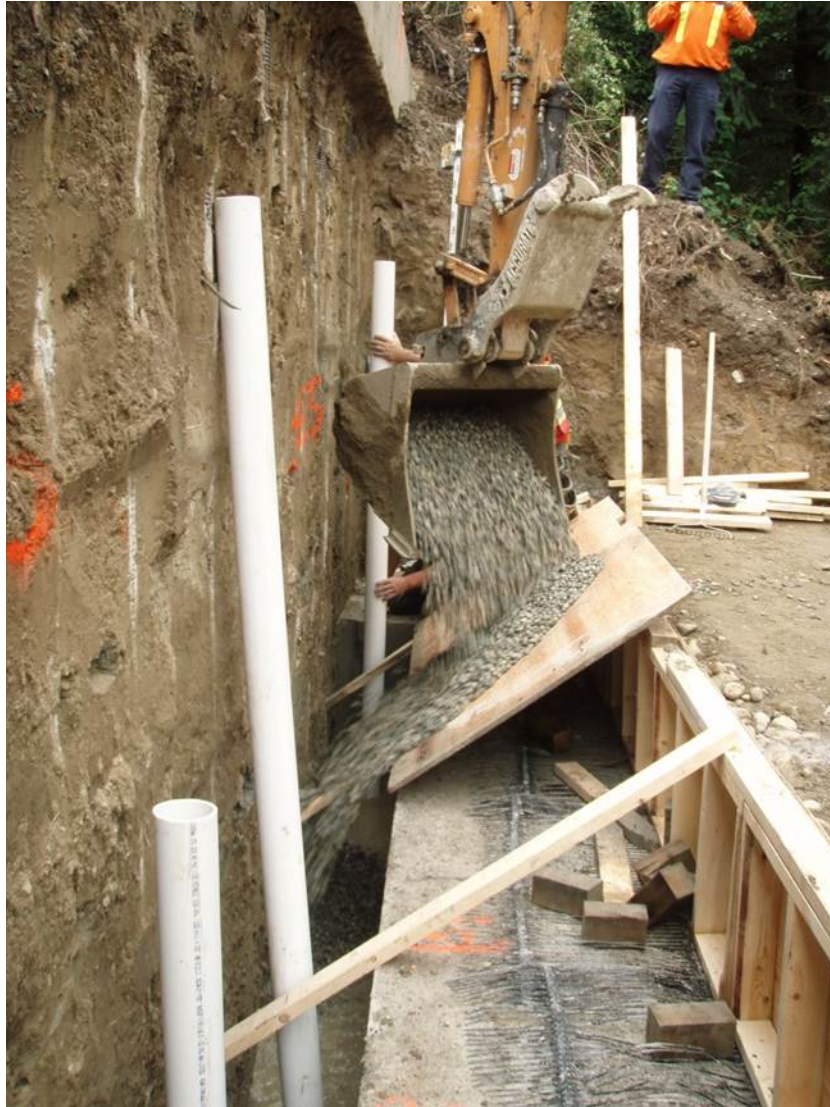
Figure 11. Placing the leachate collection gravel with the vertical collection pipes. CDF wall placed.

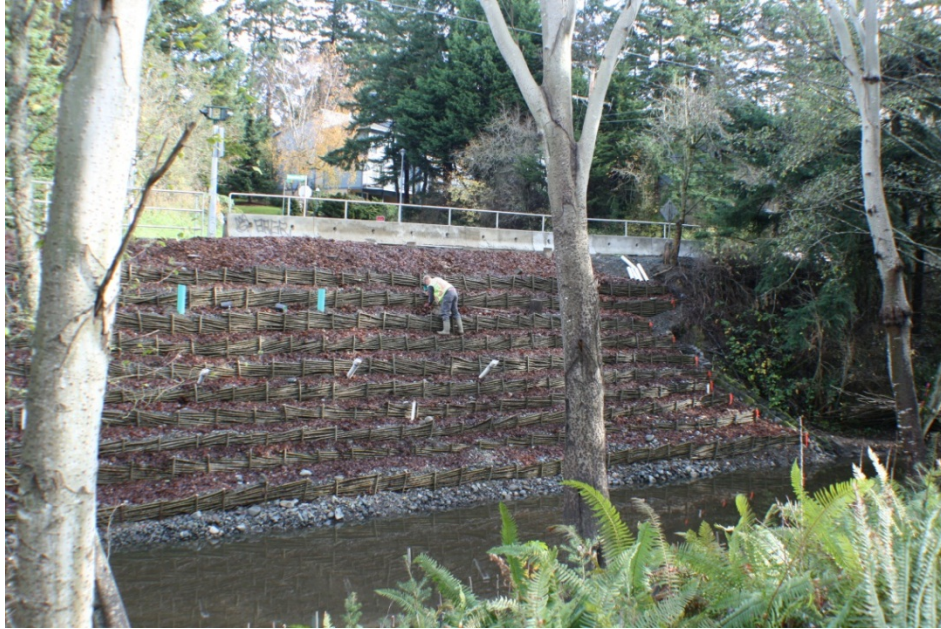
Figure 12. Completing the living earth wall.
