Improving Small Diameter Drill Rig Front End Safety - A Discussion

Daniel R. MacLean, P.Eng.
Broadbeach, QLD – ISM 2019
August 22, 2019

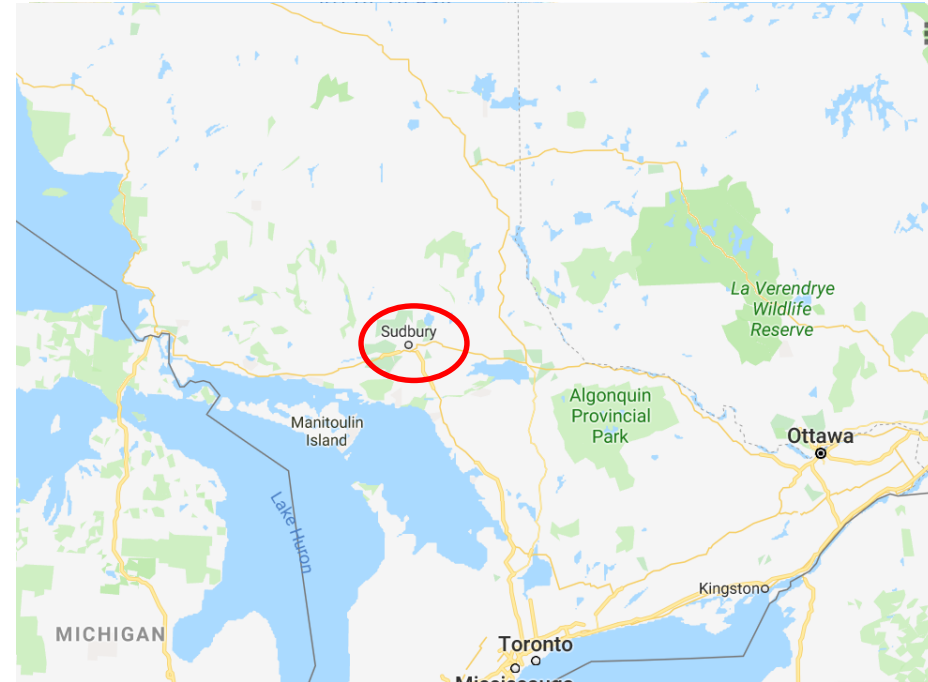
Subsurface Conditions

- Site located at the boundary of Sudbury Basin in Ontario Canada
- Thick Layers of consolidated slag at shallow depths – Highly Corrosive
- Overburden of the Sudbury Basin, native dense silty sands to gravely sands
- No ground water present

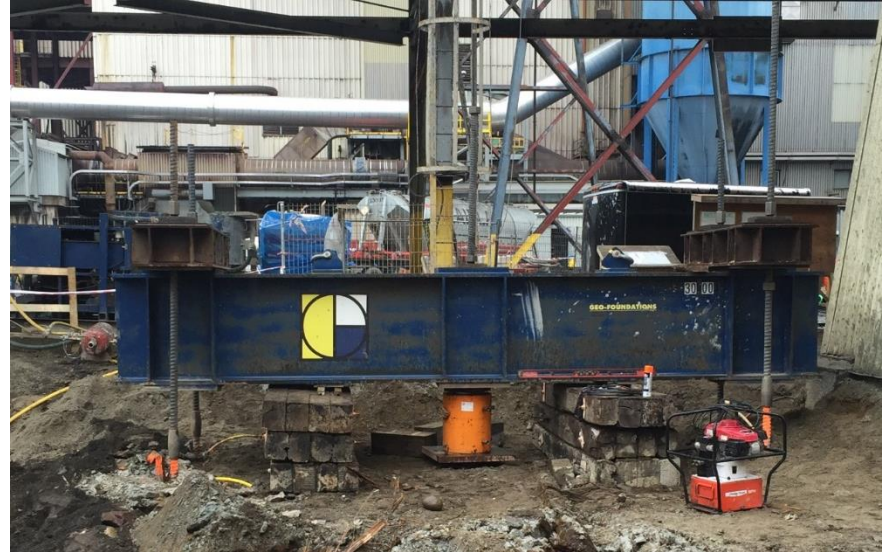
Testing

- 3 sacrificial test micro-piles
- 11 post-production proof tests
- Utilize General's excavator to maneuver the large beams safely into position.
- All test passed successfully

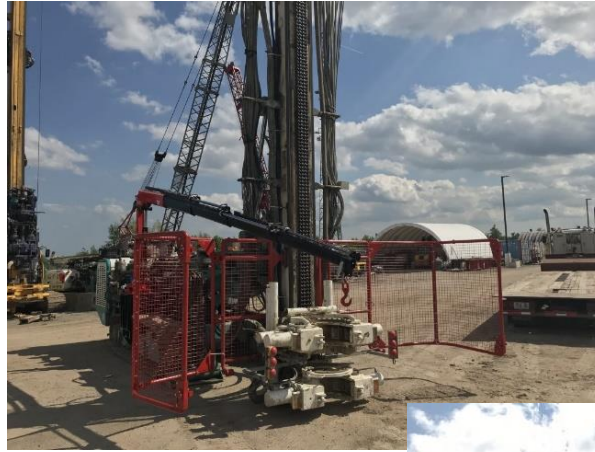
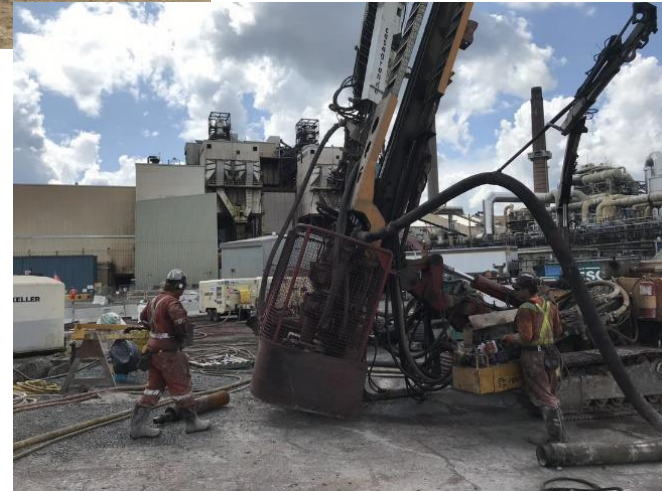
Year Two Issues

- Initial cost
- Production slightly slower due to the fact nothing can work until cage is closed
- Client requested we put a shield at the bottom of the cage as it did not extend to the ground
- Difficult to load rods around cage

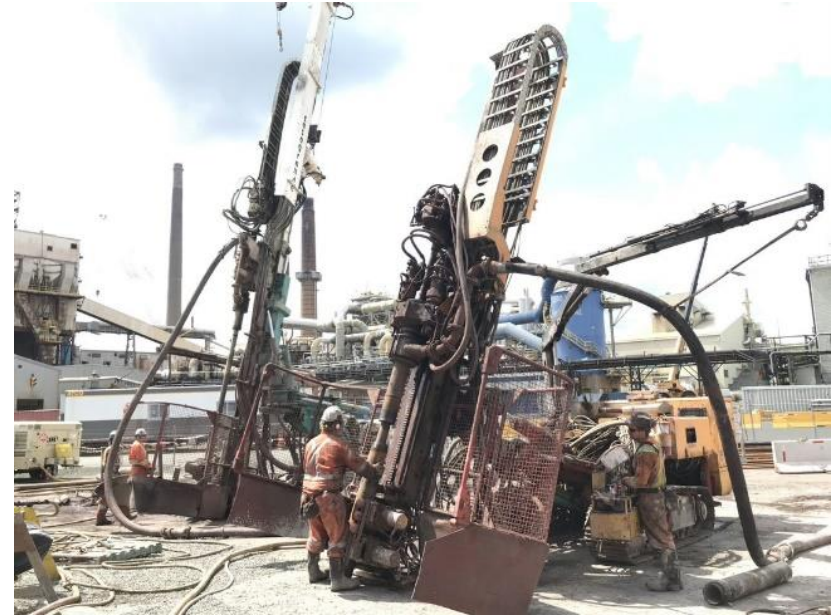
Year Two Improvements

- More efficient setup at each hole compared to construction fencing
- Looked professional which caused fewer stoppages by mining officials
- No construction fencing blowing over
- Overall better production rates compared to year one and no injuries on the project.
