Underpinning and Seismic Upgrade

Salt Lake City Capital Building

Marc Mastrantuono, P.E. Geotechnical Division Manager Ischebeck USA, Inc.

ISM Workshop 06/2023

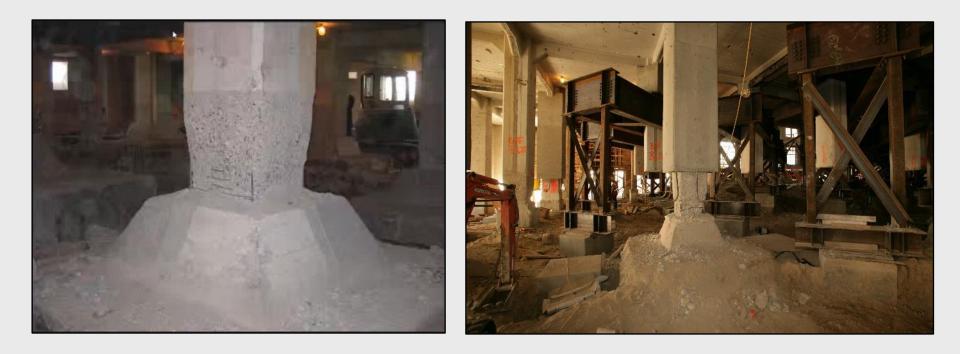
- 30" temporary load transfer slab
- ~ 5ft wide

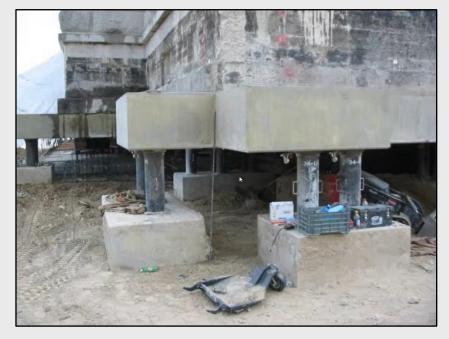
- Jacks to apply pressure just until there was a load transfer
- Not wanting to lift

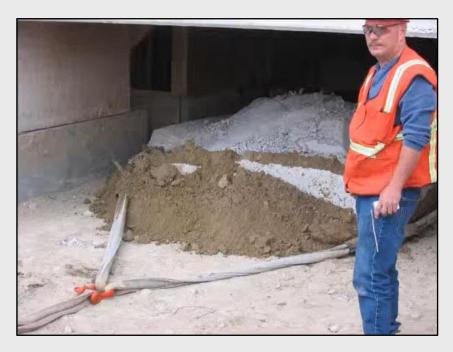
- During construction, the structure could not sustain more than 1/16" or movement
- Actual movement up to 1/1000th inch

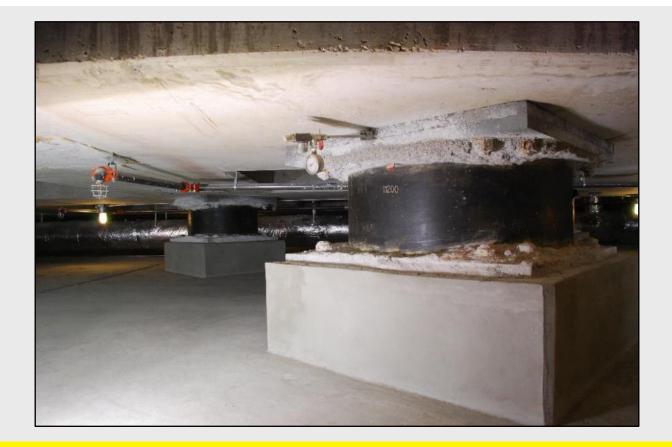
- Each rotunda pier carried close to 10,000kips
- Micropiles used for soil retainage to create pit for new pile cap
- Soil underneath new rotunda pile caps required 20kips per sqft of bearing capacity
- Micropiles used solely for ground improvement
