# Foundation Improvement of historic buildings by micro piles, Museum Island, Berlin and St. Kolumba, Cologne

Klaus Dietz<sup>1</sup>, André Schürmann<sup>2</sup>

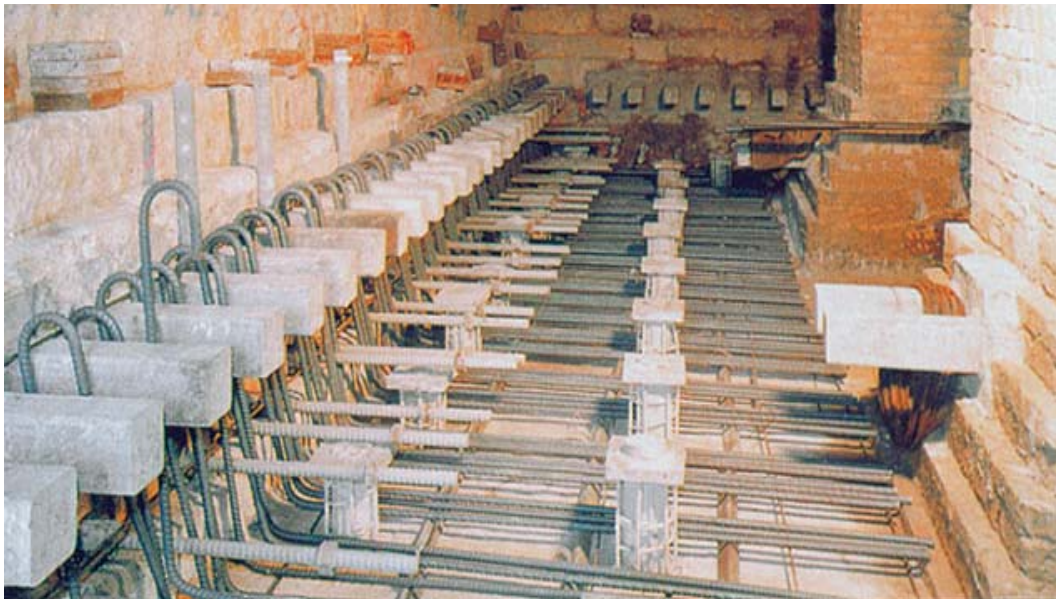
A special pile arrangement may be required owing to the fact that the wall is only accessible from one side. In this case, the so-called “rampant” or “one-sided” constructions are used where the wall load is transferred via a support to a pile located next to the wall. For absorption of the resultant moment inclusion of a tension pile might be required (Fig. 4).

**Fig. 4:** “Rampant” construction (New Museum, Berlin)

The drillings for insertion and/or through-girders in the existing foundations were carried out as core drillings with particular care. Installation of the girders was

followed by special mortar grouting to ensure an optimal frictional connection (Fig. 4).

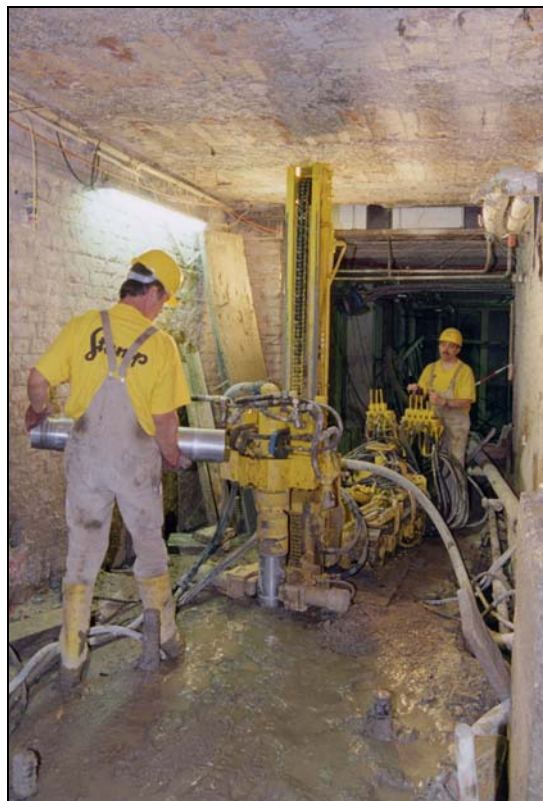
The drillings for the piles foreseen inside the building had to be carried out using special drilling gear, as the room height was only 2.30 m in most cases (Fig. 6). In some cases, the weathered timber piles had to be drilled through over their total length using special equipment as for lack of space a relocation of the piles proved impossible.

**FIG. 6:** Drilling operations for pile manufacture

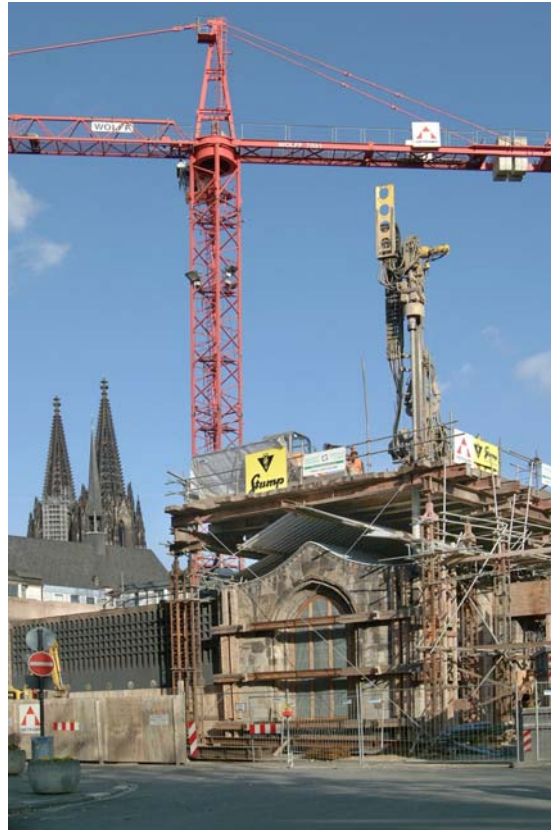
Following pile installation the piles were grouted with cement suspension. The first cement fill reached up to ground level. After the cement had hardened the cement fill was completed up to approx. 10 cm below top of implant. The upper section of the pile up to top of implant was filled with 'Pagel' sealing mortar V1/50. Fig. 13 shows the drilling operations carried out on the foundation piles of the 'Böhm'sche' Chapel.

**Fig. 13:** Drilling work from working platform

The working platforms to a height of up to 9 m were designed for a drilling gear weight of 20 tons plus 10-ton advance and backhaul forces. With the scaffolding so dimensioned it was possible to have the drillings carried out using 'Klemm 806/3' heavy-duty anchor drilling gear. The working platforms were provided with a fully accessible working level. In the area of the northern wall which aligns with the double-storey deep basement building-pit, the platform had to be erected cantilevering over part of the building pit.

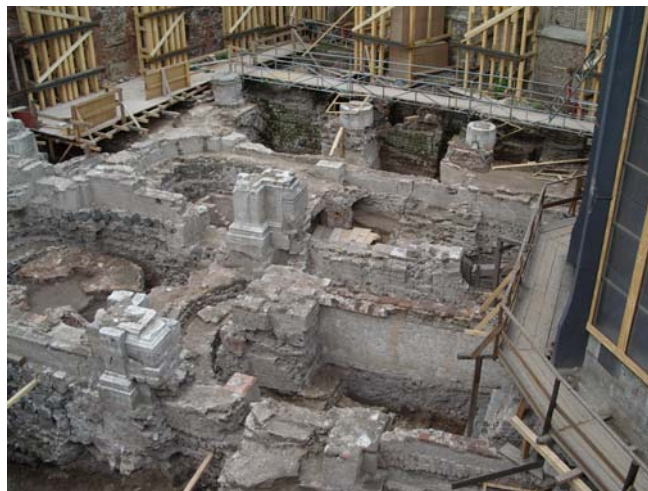
Part of the drilling starting points were up to 6 m below the heavy-duty scaffold. Owing to the small number of load application points scaffold support proved difficult so that major distances had to be bridged in some cases. Fig. 15 shows parts of the still uncovered digging field. Small service and working routes designed for the drilling gear loads consisting of dead weight and working operations were provided for the drilling gear above the pile starting points. In addition, this scaffold was only dimensioned for loads resulting from the stored material.

**Fig. 15:** Digging field surface

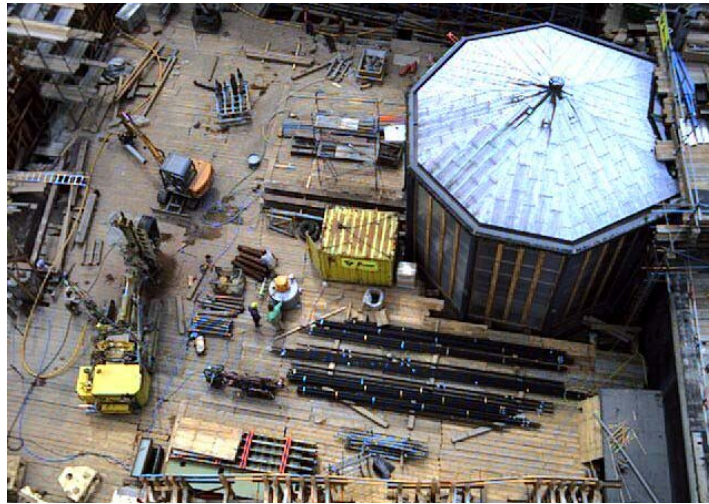
Fig. 16 shows the manufacture of the foundation piles in the covered-up digging field. The photograph was taken from a high-rise crane. The 'Böhm'sche' Chapel is clearly visible as is the drilling gear set with storage space for the pile material. At the areas above the pile starting points the pile manufacture working level could be opened.

**Fig. 16:** Drilling work in the area of the digging field
